243Z Complex Demolition Report

As Left Characterization

Document Type: RPT Program/Project: PFP Closure

Date Published
April 2017

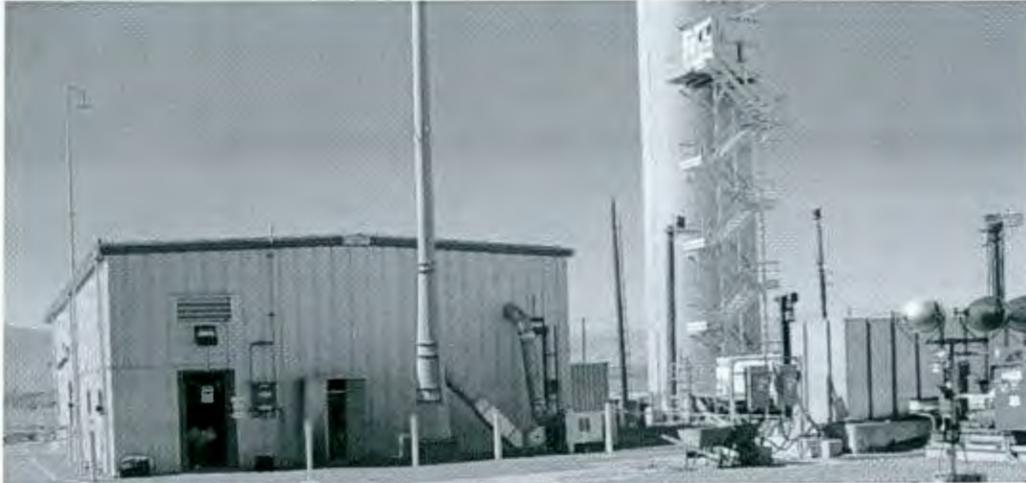
The 243Z Building and associated 296Z015 stack (Figure 1), known as the Low-Level Waste Treatment Facility (LLWTF), housed two waste water treatment trains and was constructed in 1993. This building was located south/southeast of the 234-5Z Building and had an approximate footprint of 2,450 ft². It was a metal fabricated structure built on a slab that contained no below-grade spaces. The single story building was a braced frame steel structure with metal siding. The walls and ceiling had batt insulation. The interior walls were finished with fiber-reinforced plastic wall panels, and there was a suspended acoustical ceiling. The 296Z015 steel exhaust stack was located adjacent to the north end of the building (Figure 1). The stack was 42 ft high with a foundation that extended to about 4.5 ft below-grade. Additional detail is available on drawings H-2-82724, *Architectural PFP LLWTF Floor Plan and Sections* (building), and H-2-82718, *Structural PFP LLWTF Stl Stack Pln, Sctns & Dtls* (stack).

Figure 1. 243Z Building Before Demolition

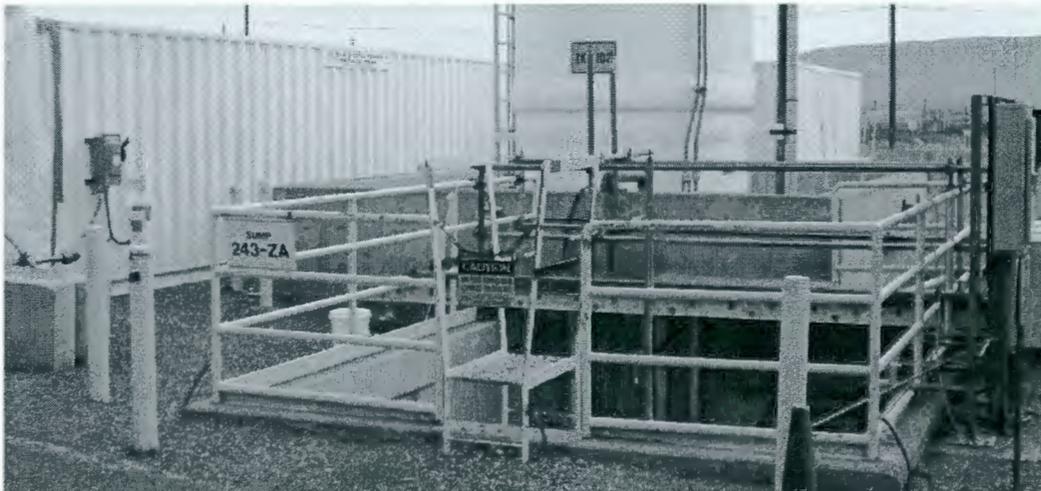
The 243ZA facility (Figure 2), known as the Low-Level Waste Storage Facility (LLWSF), was affiliated with the 243Z LLWTF. It collected and stored waste water from various PFP sources, pumped the waste water to 243Z for treatment, then stored the treated water in tanks prior to disposal via TEDF (HNF-SD-W049H-ICD-001, *200 Area Treated Effluent Disposal Facility Interface Control Document*). The tanks were constructed of fiberglass (isophthalic polyester resin). The waste water tank (TK-101), with a holding capacity of 1,000 gal, was located in a 17 ft deep sump pit along with pumping equipment and piping. TK-102 was a tank in a concrete above-grade secondary containment with a holding capacity of 5,600 gal. TK-102 was about 5 ft in diameter by 22 ft tall and was used as a surge tank to receive the treated water from 243Z. The 524 ft² structure, built in 1993, was 312 ft² above-grade and 212 ft² below-grade. Drawings H-2-82719, *Structural PFP LLWTF Tank Fnd Pln and Sections*; H-2-82720, *Structural PFP LLWTF Sump Pit Conc Sctns & Dtls*; and H-2-82721, *Structural PFP LLWTF Sump Pit Frmg Pln & Sctns*, provide additional detail.

Figure 2. 243ZA Storage Facility Before Demolition

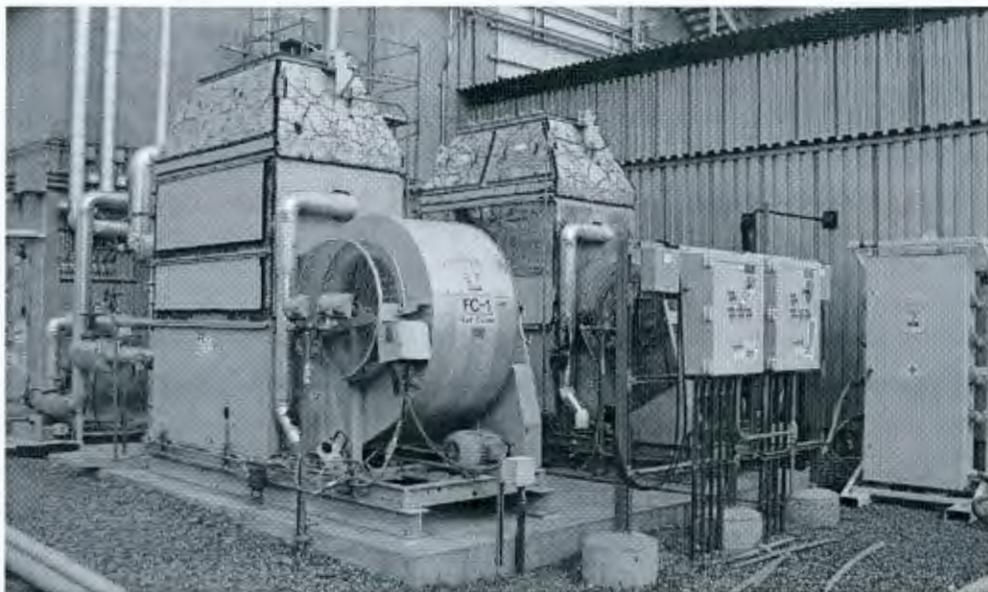
The 243ZB cooling towers and concrete pad facility (Figure 3) was affiliated with the 243Z LLWTF. Constructed in 1993, 243ZB was located north of the 243ZA LLWSF. The two cooling towers were mounted on a concrete slab, approximately 24 ft by 15 ft. 243ZB housed the closed loop cooling water system and two fluid cooling units that supported 243Z Building operations.

Figure 3. 243ZB Cooling Towers and Pad Before Demolition

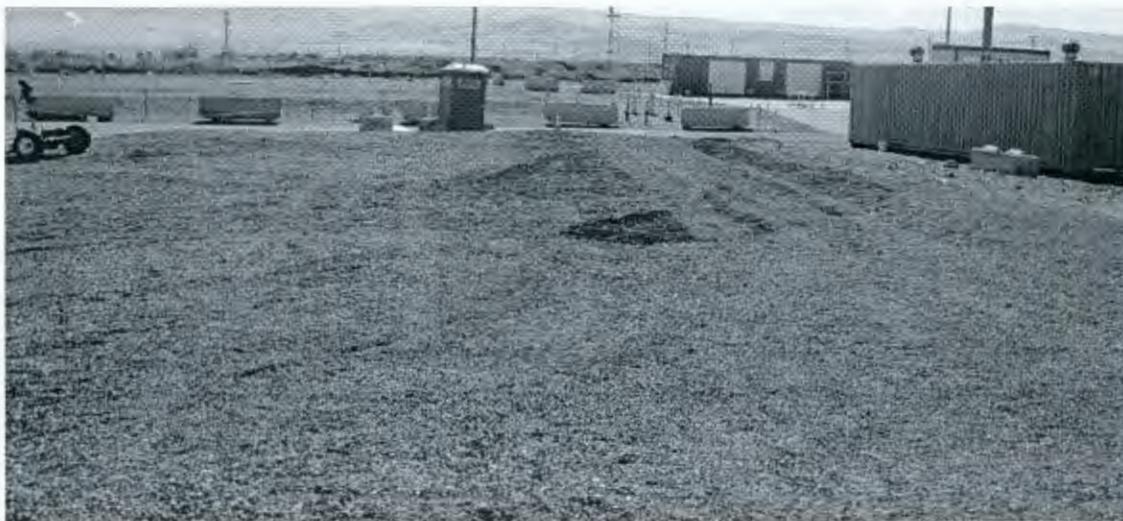
The building slab at 243Z LLWTF has been covered with gravel as shown in Figure 4. The below-grade equipment was removed from the 243ZA sump pit, the buried line was plugged (Figure 5), and the pit was backfilled (Figure 6). The single buried line leaving the sump pit to TEDF was isolated and plugged (Figure 5) along subsequent buried lines isolated at manholes 3 and 4 (Figure 5). The slab at 243ZB was been left uncovered (Figure 7).

Figure 4. 243Z Post Demolition Slab As-Left Condition

The 243Z Complex slabs were left in a clean slab-on-grade condition (with and without gravel) (Figures 4, 7, and 8). Buried line isolations were made with plugs in manholes 3 and 4, and the effluent line to TEDF from the 243ZA sump was plugged prior to backfill.

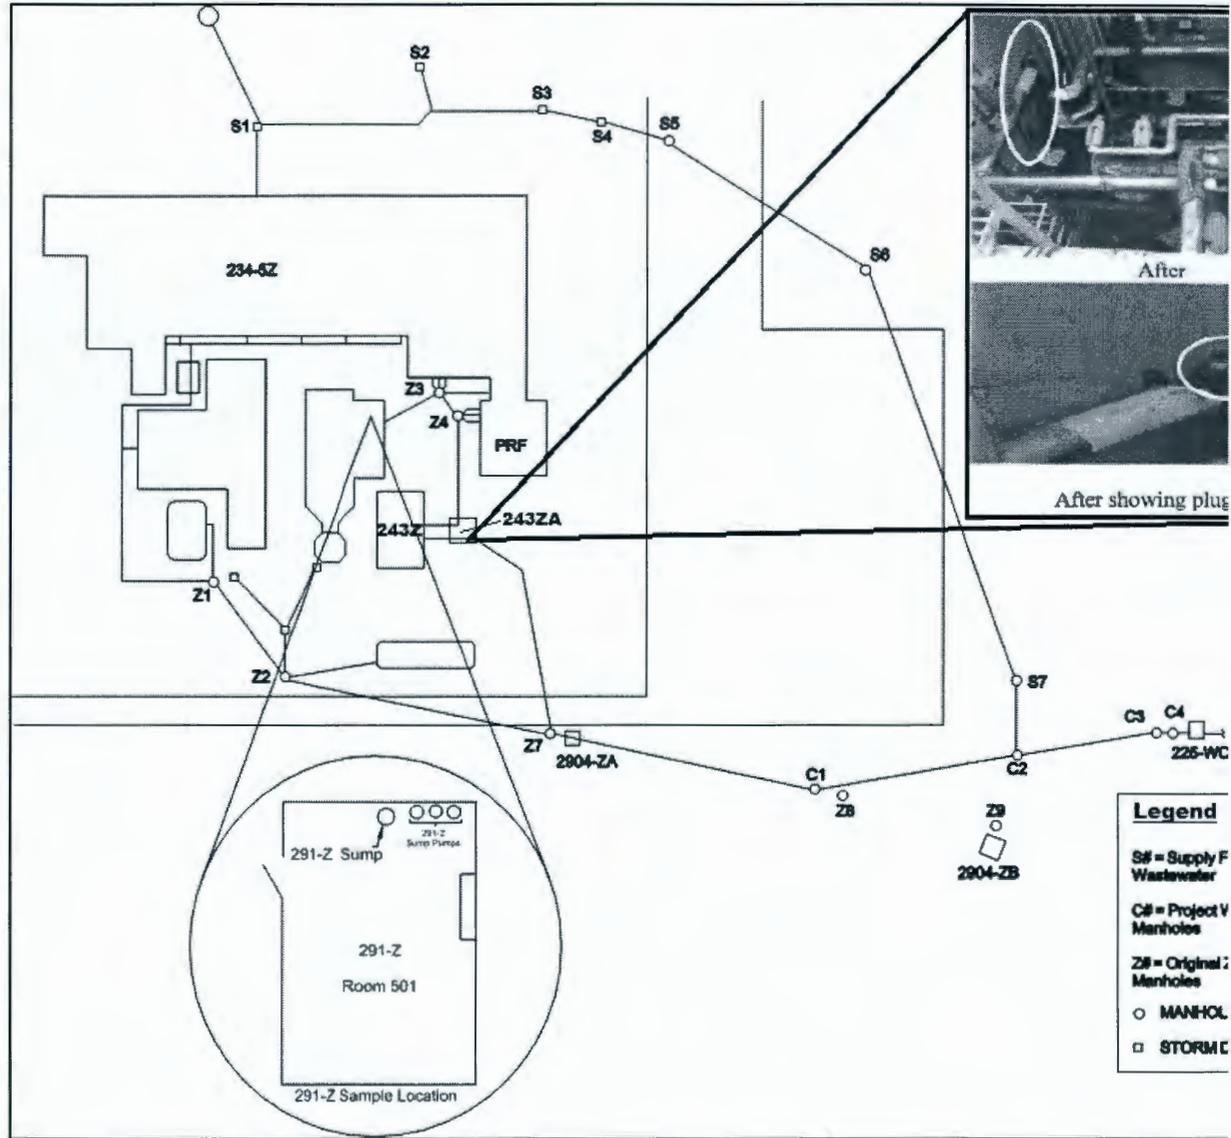
Figure 5. 243Z Underground Piping Schematic Isolations at Manholes 3 and 4 (Z3 and Z4) and 243ZA

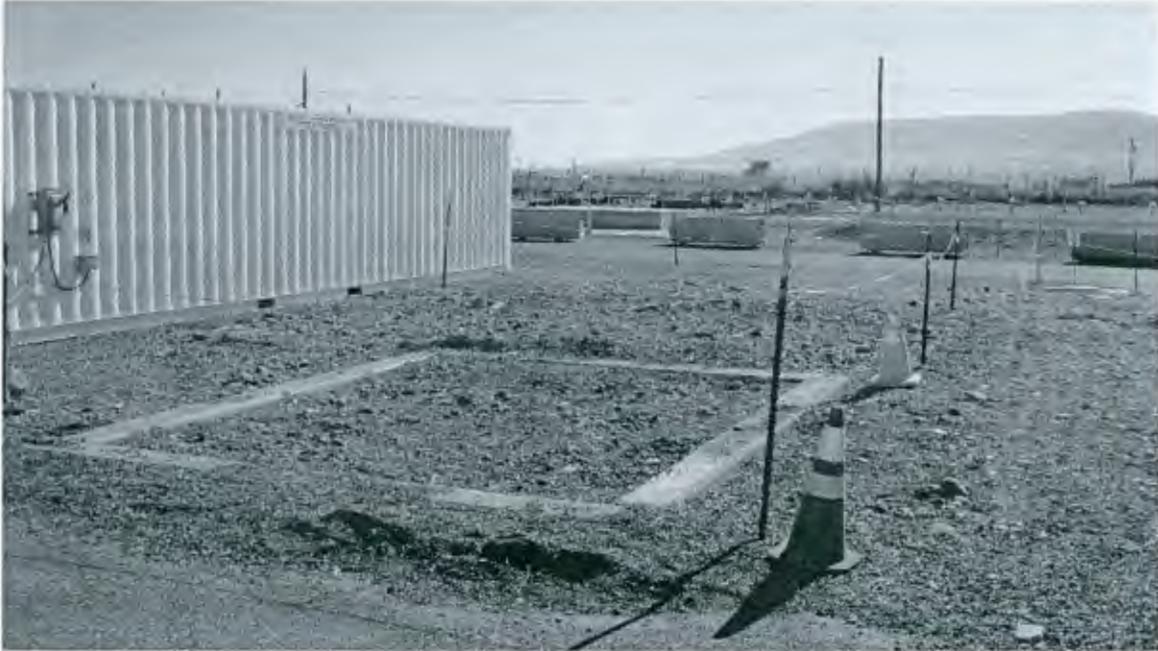
Figure 6. 243ZA Facility Slab As-Left Condition

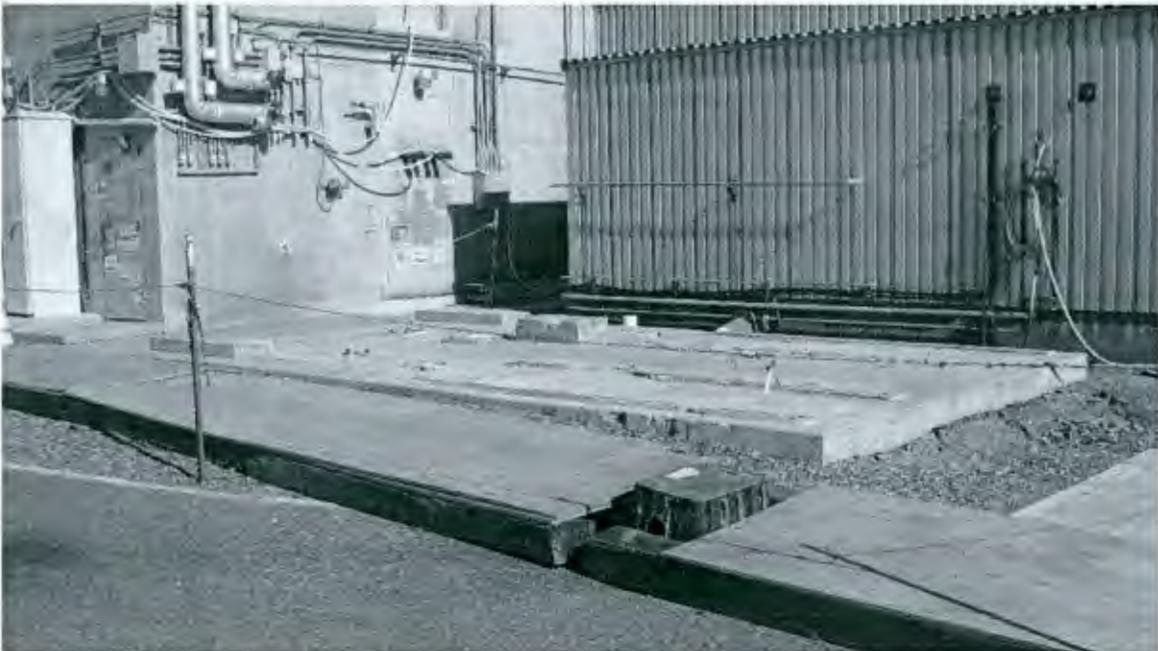
Figure 7. 243ZB Cooling Towers Slab As-Left Condition
