## FACILITY STATUS CHANGE FORM

<b>Date Submitted:</b> January 25, 2013 <b>Originator:</b> Chris Strand <b>Phone:</b> 554-2720	<b>Area:</b> 300 Area <b>Facility ID:</b> 3707H <b>Action Memorandum:</b> Action Memorandum #1	<b>Control #:</b> D4-300-079
---	---	---------------------------------

#### 3707H Craft Change House

# 300 D4 3707H Slab Excavation GPERS Radiological Survey Gamma Track Map

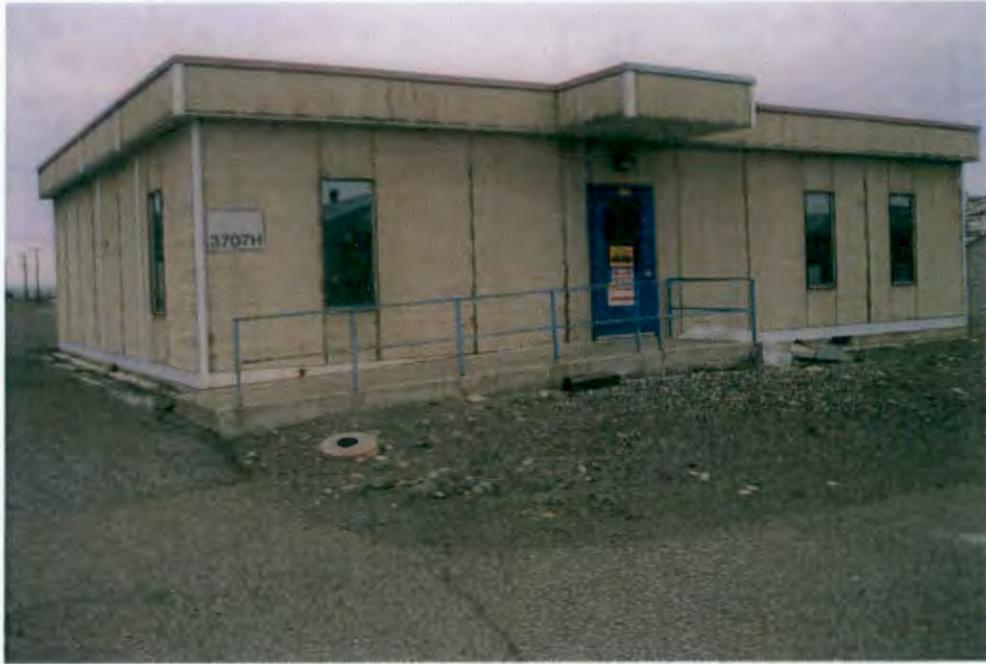
**Photograph 1: 3707H looking northeast, December 5, 2005.**

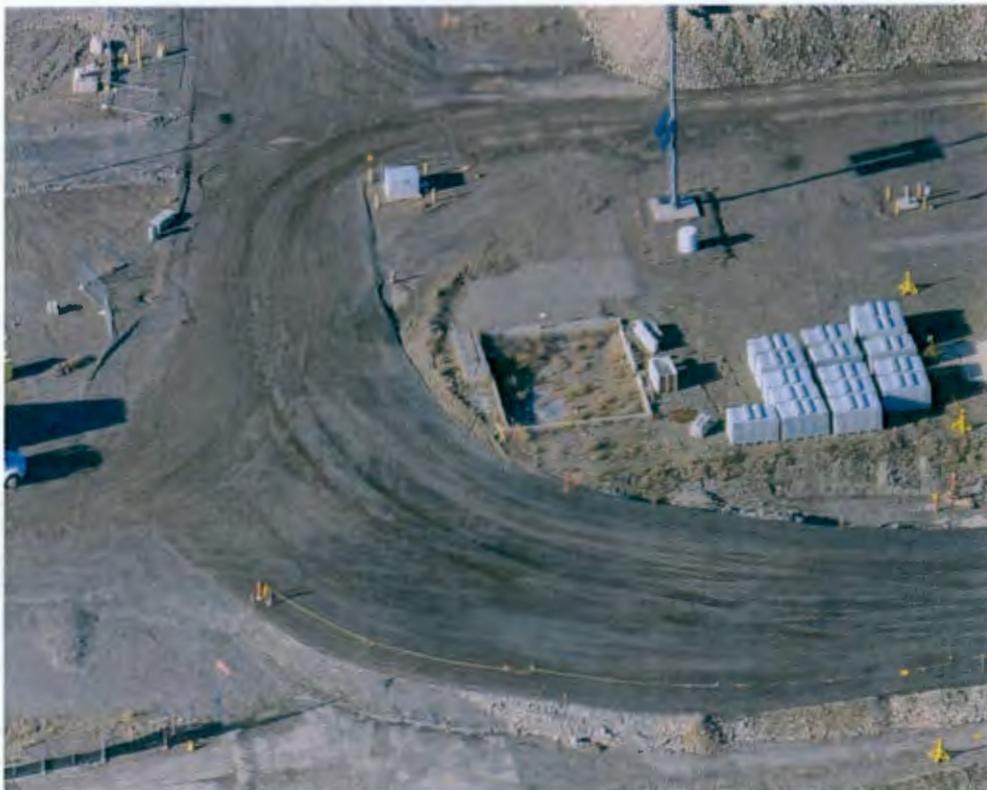
**Photograph 2. Aerial view of 3707H foundation, looking west on December 4, 2012.**

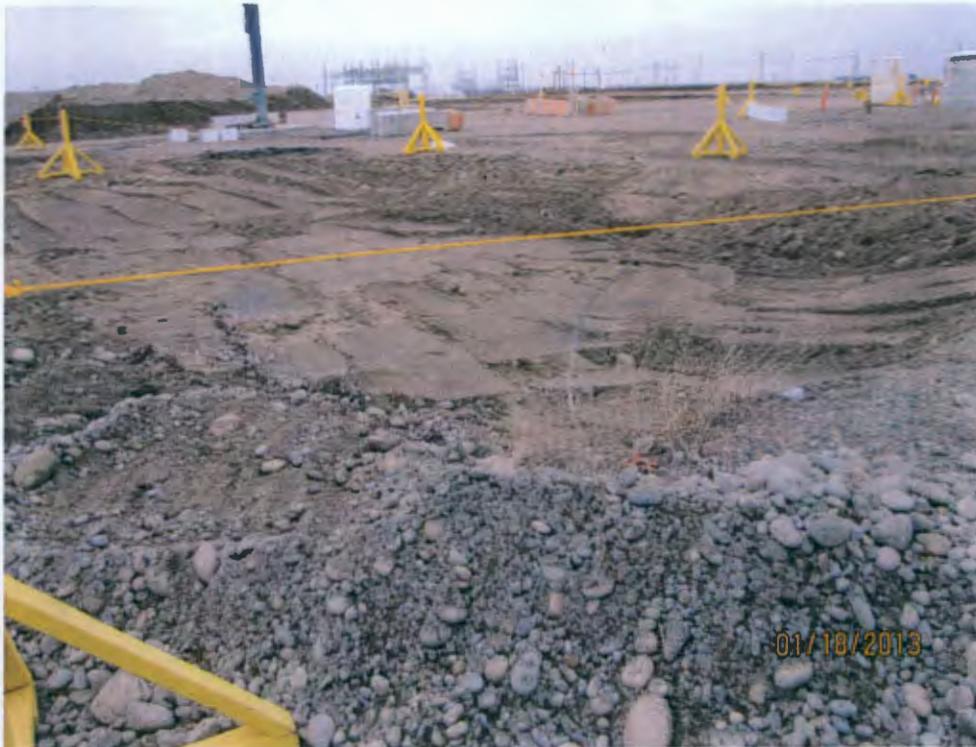
No anomalies were discovered during demolition. Soils beneath the slab and foundation displayed no visual evidence of staining or discoloration. A final GPERS survey of the excavation following below-grade demolition identified no radiological contamination.

**Photograph 3. 3707H excavation looking northwest, January 18, 2013.**

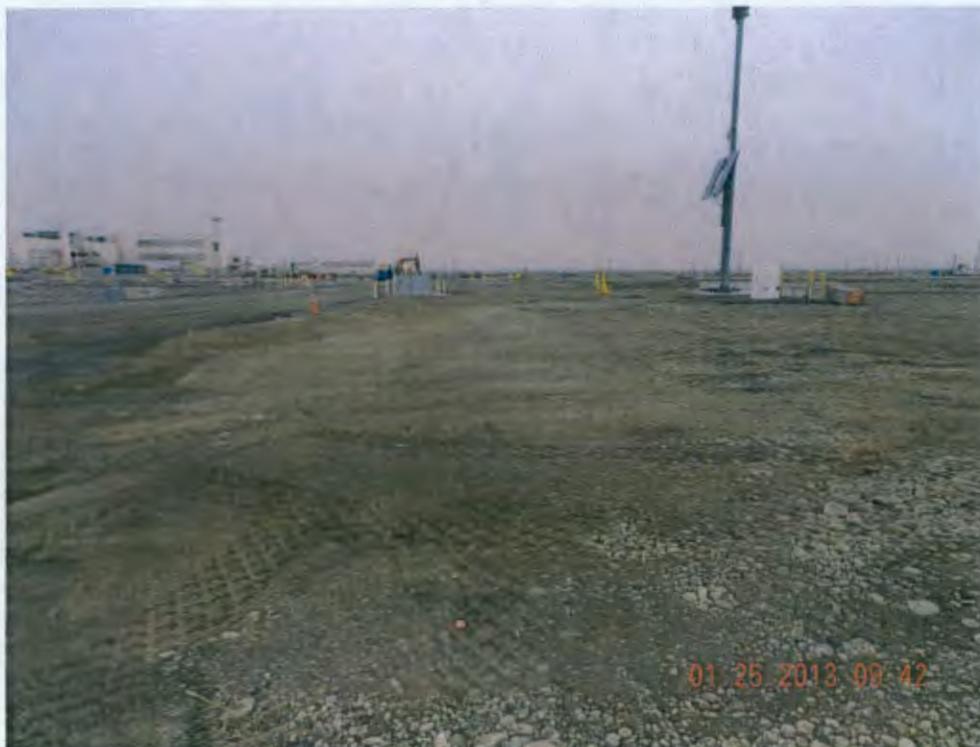
All above-grade structures and foundations were removed. Excavations were backfilled to grade with clean fill. GPERs surveys were performed prior to backfill. No radiological or Industrial Hygiene postings remain.

**Photograph 4. 3707H backfilled, looking west on January 25, 2013.**

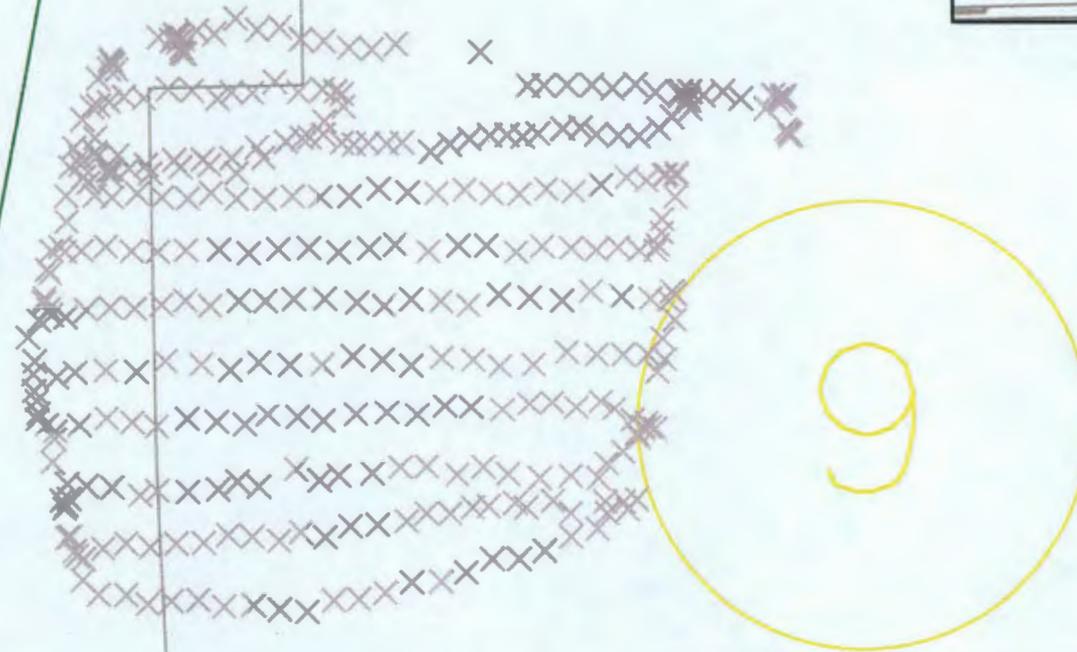
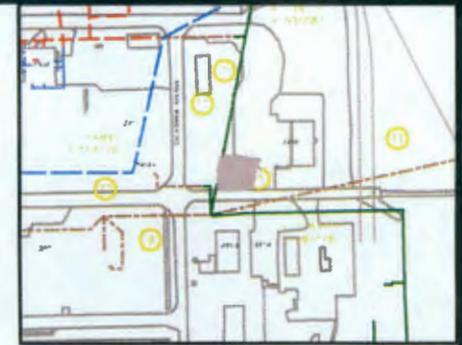
**Attachment 3: GPERS Survey of the 3707H Excavation  
Prior to Backfill**

↑  
Bkg Location  
348 meters N  
1383 cpm

Coverage File: D4\_021  
Number of Data Pnts: 369  
Type of Survey: gamma  
Max GCPM: 2377  
Avg Bkg CPM: 1383  
Survey Date: 1/21/2013  
Area Surveyed: 60 m<sup>2</sup>  
Project File: ESRFRM130008  
Pdf File: ESRFRM130008C
