## FACILITY STATUS CHANGE FORM

<b>Date Submitted:</b> 12/12/2012  <b>Originator:</b> David Warren  <b>Phone:</b> 539-6040	<b>Area:</b> 100-N  <b>Facility ID:</b> 1903-N Sanitary Sewer System  <b>Action Memorandum:</b> 100-N Ancillary Facilities	<b>Control #:</b> D4-100N-0045
---	---	-----------------------------------

# D4 Project Facility Completion Form

This document provides information regarding the history, characterization, and final status at the completion of deactivation, decontamination, decommissioning, and demolition activities of the 1903-N Sanitary Sewer System, formerly located at the 100-N Area.

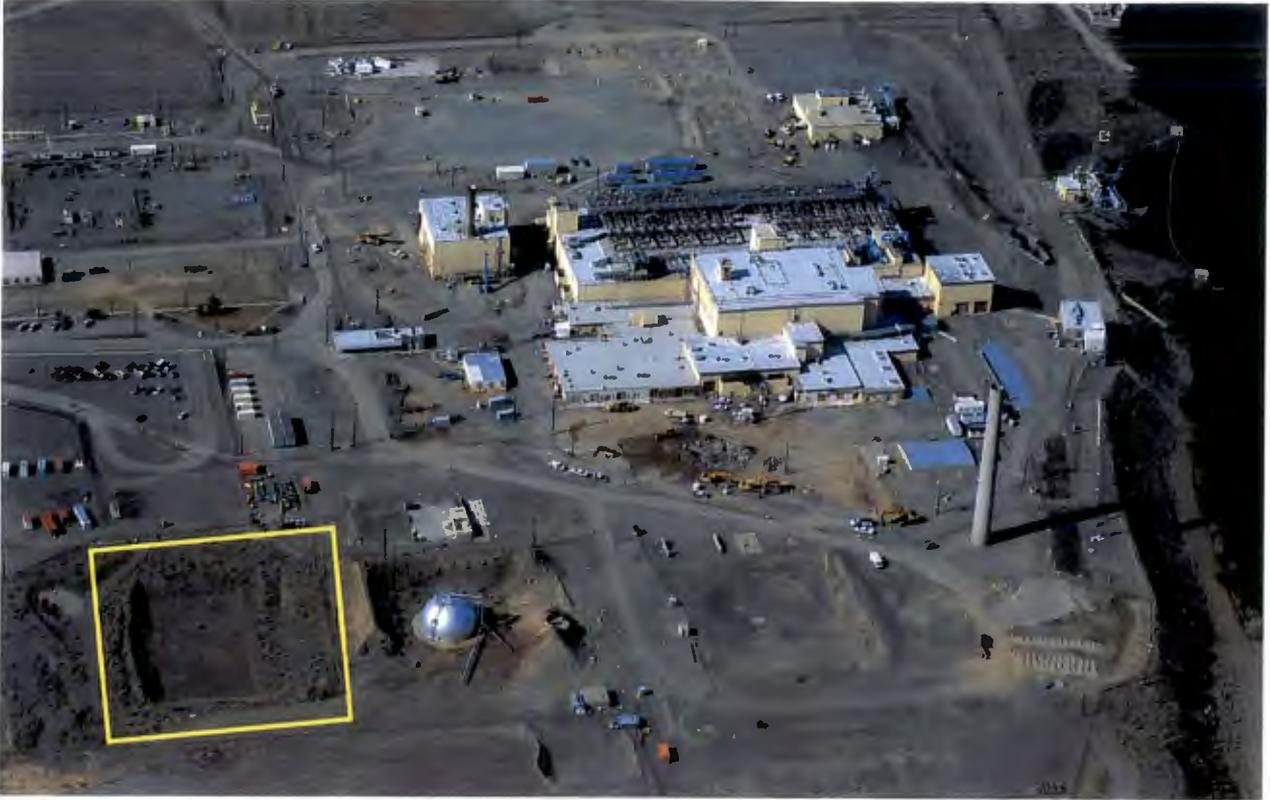
**1903-N Pre-Demolition**

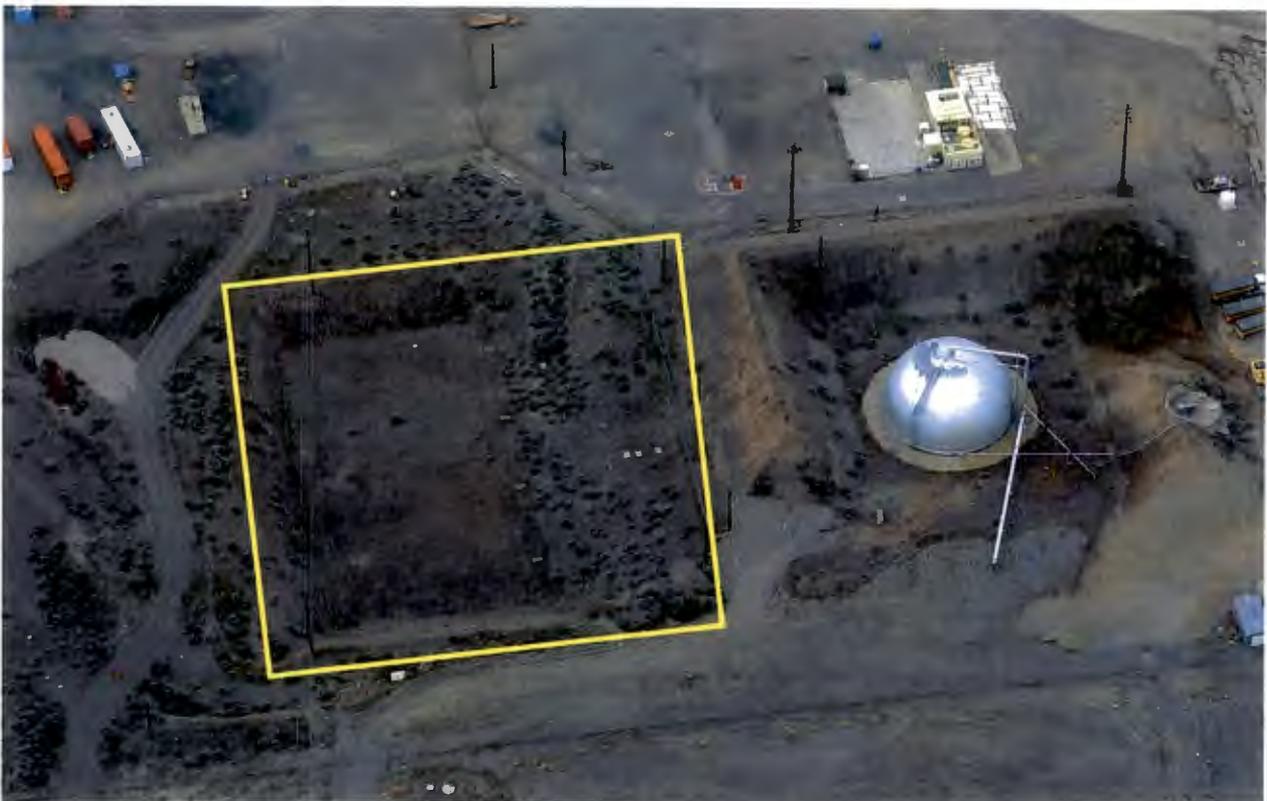
**1903-N Pre-Demolition**

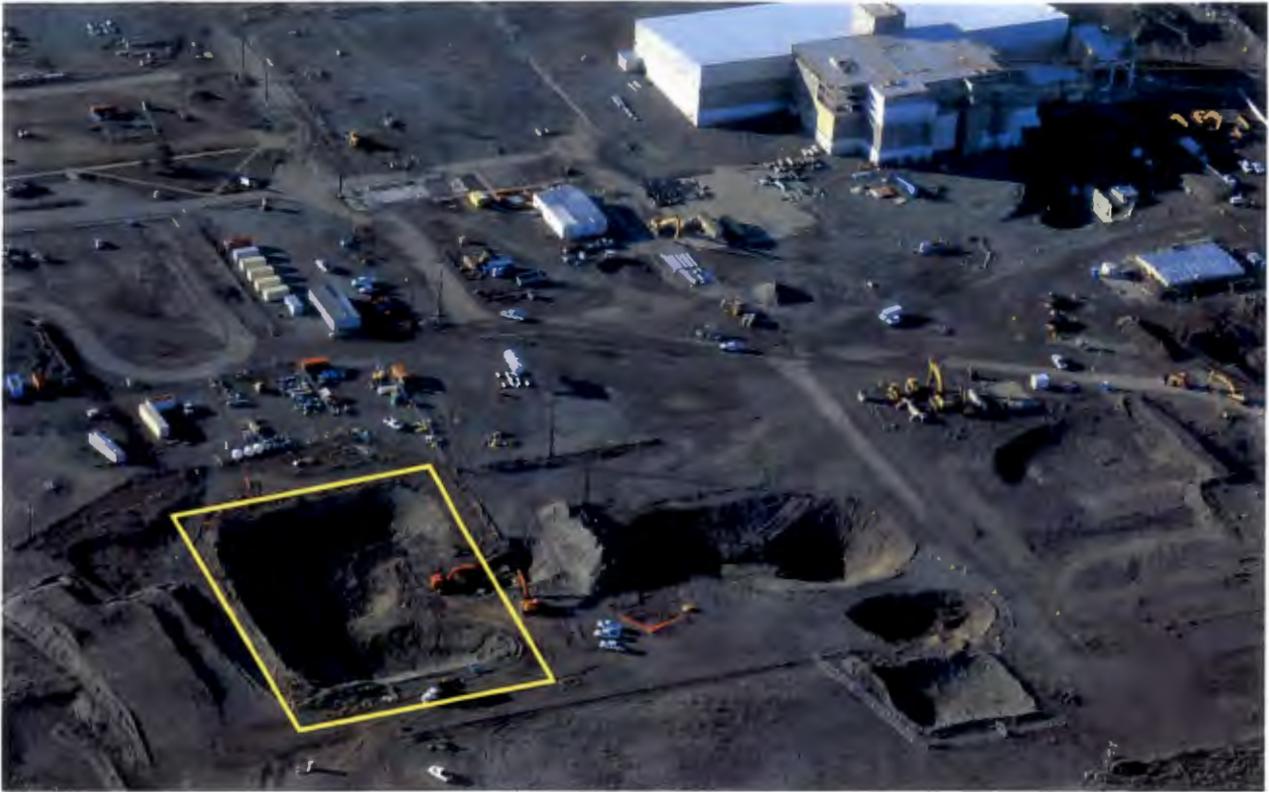
**1903-N During Demolition**

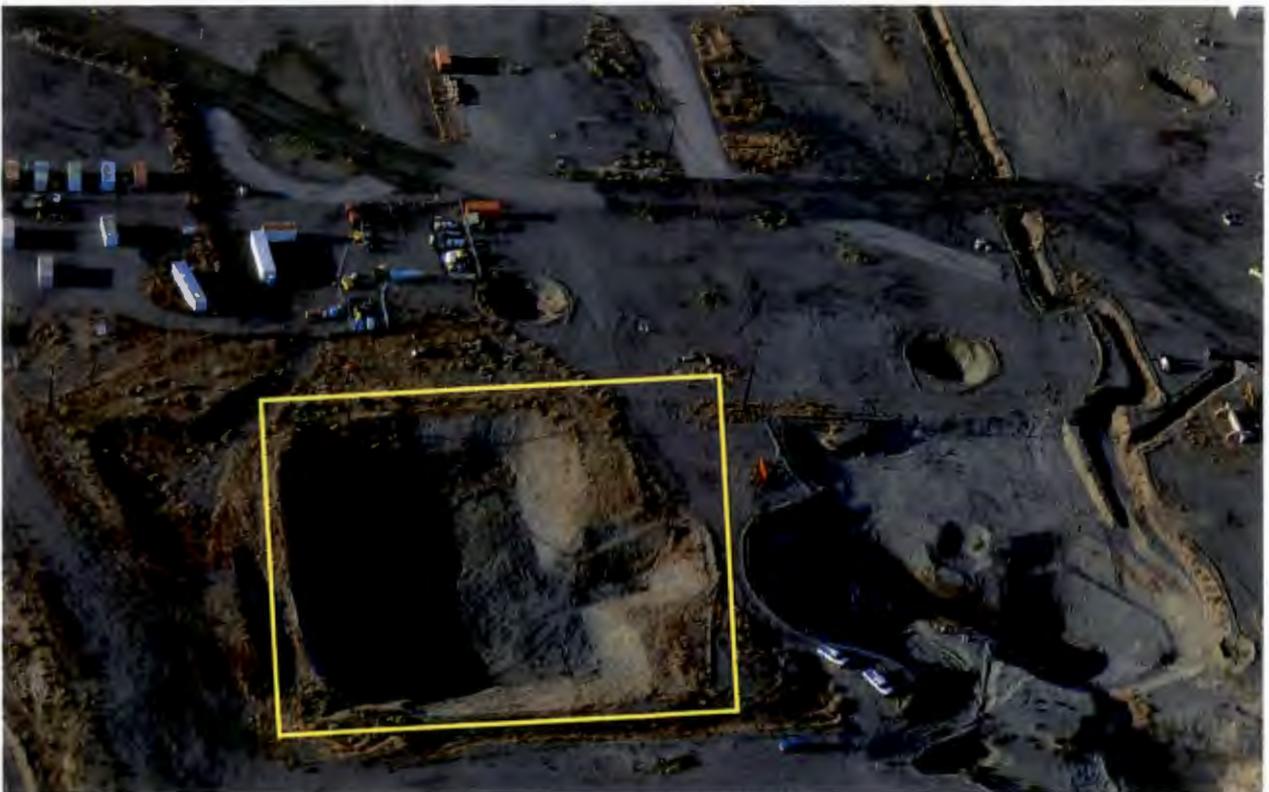
**1903-N Post-Demolition**

The 1903-N excavation has been backfilled and revegetated.

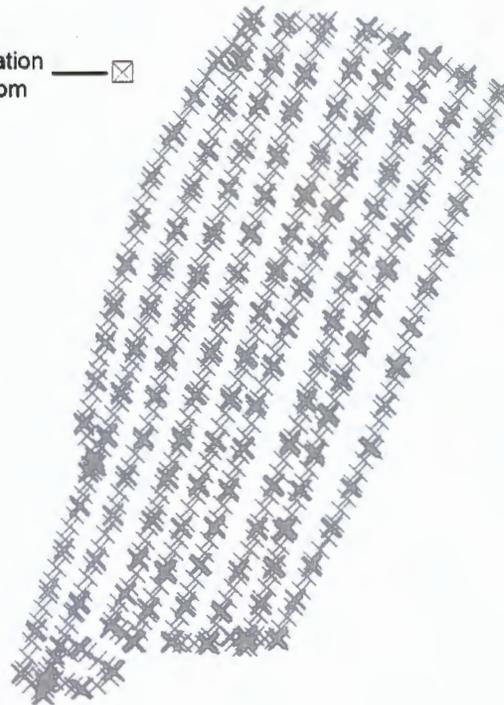
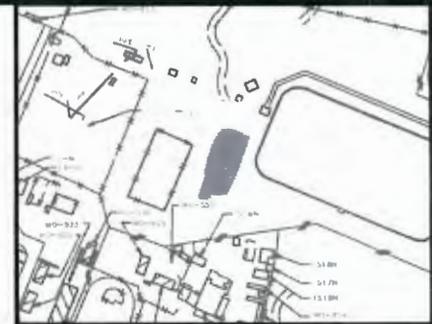
**100N Field Remediation  
 124-N-4 Stockpile  
 GPERs Radiological Survey  
 Gamma Track Map**

Coverage File: N173  
 Number of Data Pnts: 1932  
 Type of Survey: gamma  
 Max GCPM: 1971  
 Avg Bkg CPM: 1288  
 Survey Date: 6/22/2011  
 Area Surveyed: 1416 m<sup>2</sup>  
 Project File: ESRFRM110148G  
 Pdf File: ESRFRM110148GC

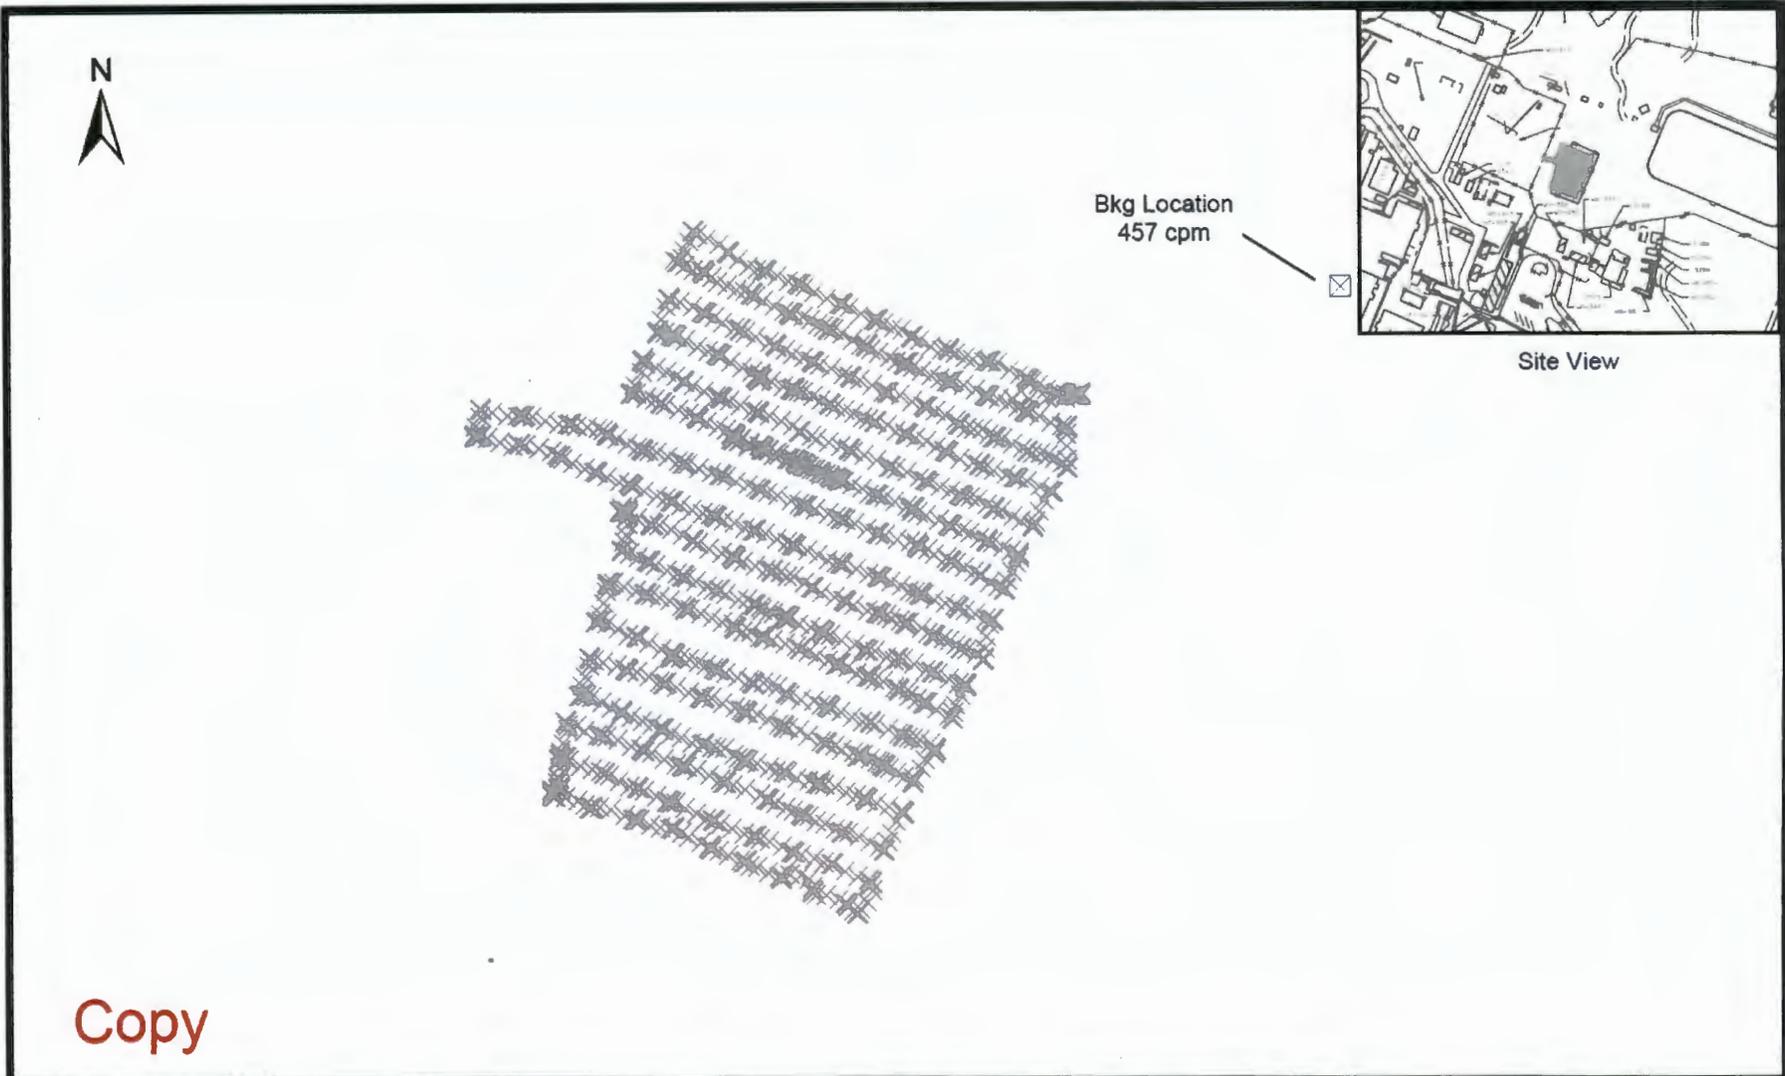
**100N Field Remediation  
124-N-4 Floor Bottom  
GPERS Radiological Survey  
Beta Track Map**

Legend	Summary Statistics
NET CPM	Coverage File: N173A
× <685	Number of Data Pnts: 2735
● 685 - 5000	Type of Survey: beta
● 5000 - 10000	Max GCPM: 653
● 10000 - 25000	Avg Bkg CPM: 457
● 25000	Survey Date: 6/22/2011
	Area Surveyed: 2078 m <sup>2</sup>
	Project File: ESRFRM110149B
	Pdf File: ESRFRM110149BC

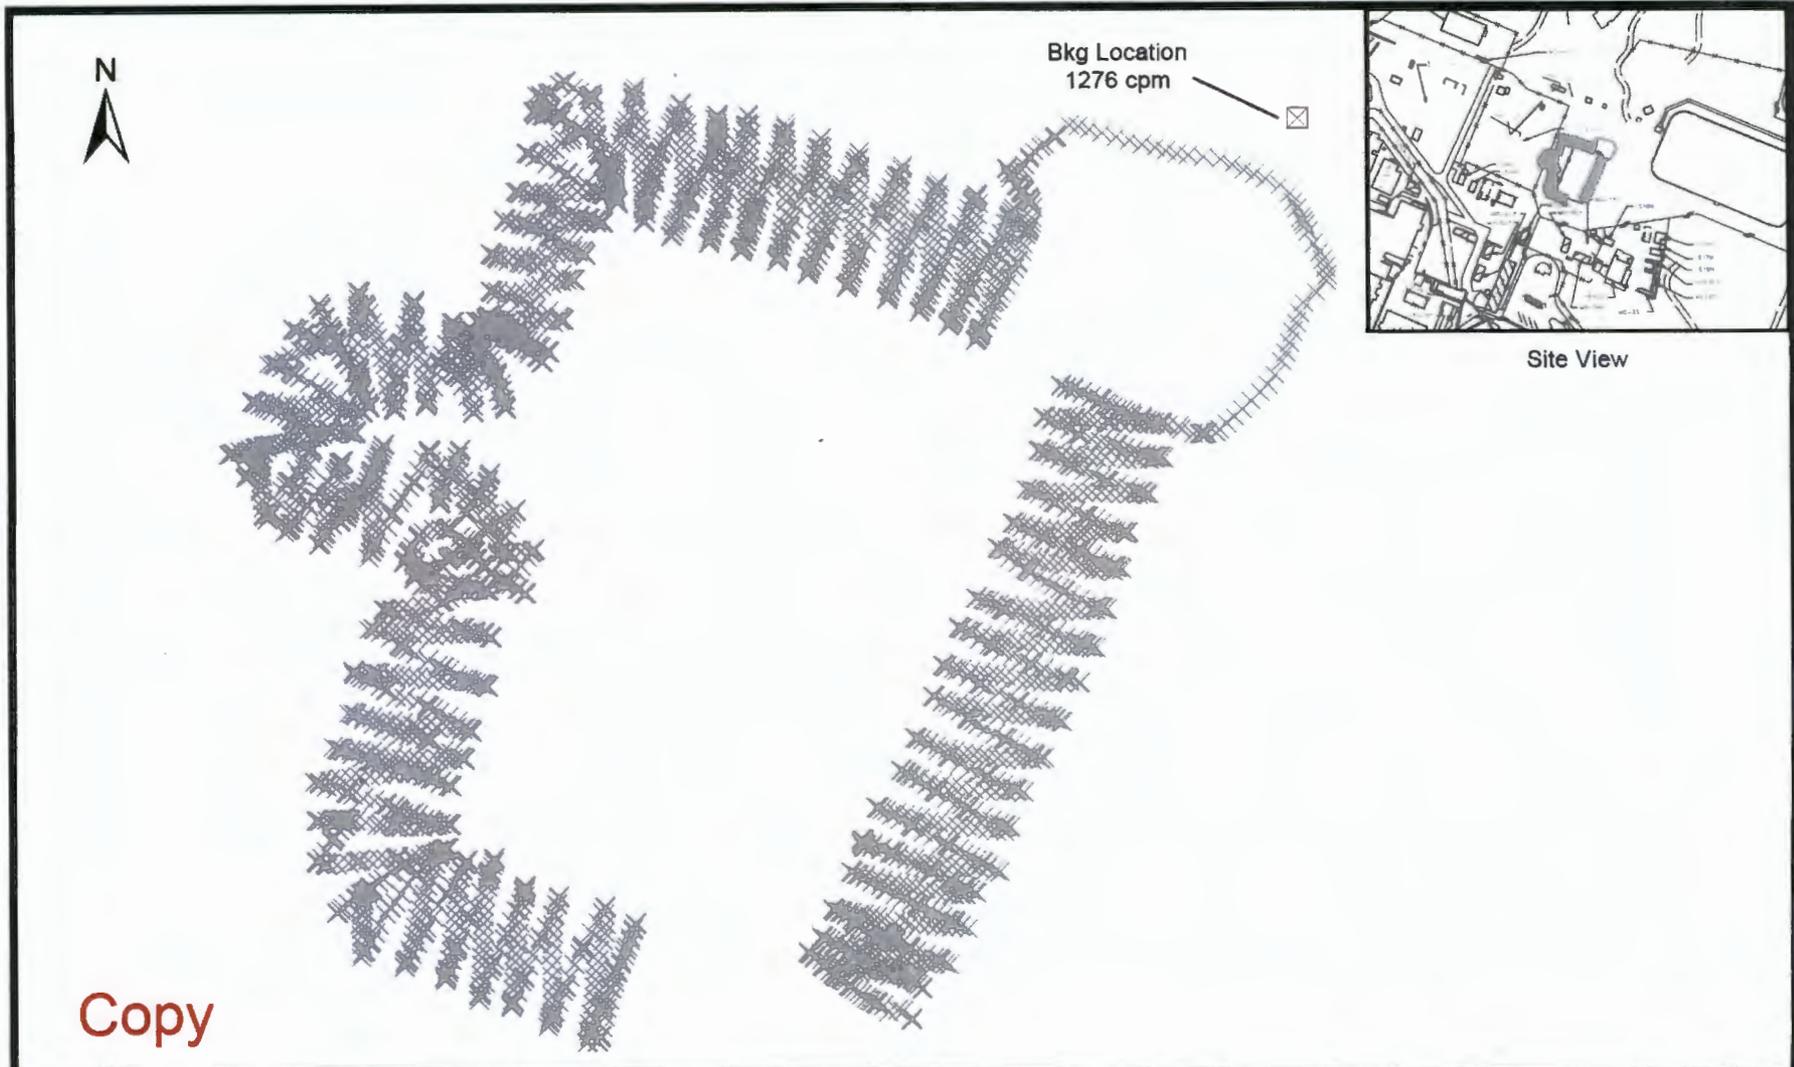
**100N Field Remediation**  
**124-N-4 Slopes**  
**GPERS Radiological Survey**  
**Gamma Track Map**

Legend	Summary Statistics
NET CPM	Coverage File: N174
× <1914	Number of Data Pnts: 6576
● 1914 - 5000	Type of Survey: gamma
● 5000 - 10000	Max GCPM: 3030
● 10000 - 25000	Avg Bkg CPM: 1276
● 25000	Survey Date: 6/23/2011
	Area Surveyed: 2397 m <sup>2</sup>
	Project File: ESRFRM110150G
	Pdf File: ESRFRM110150GC

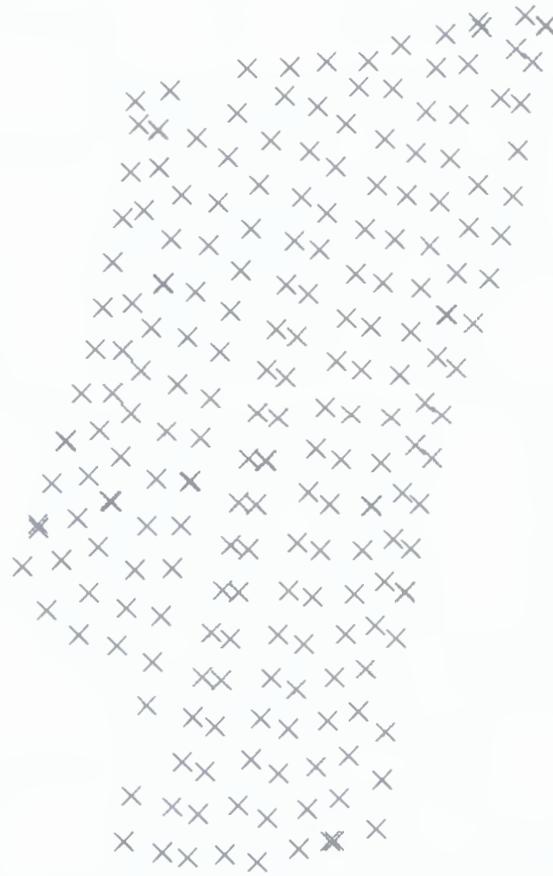
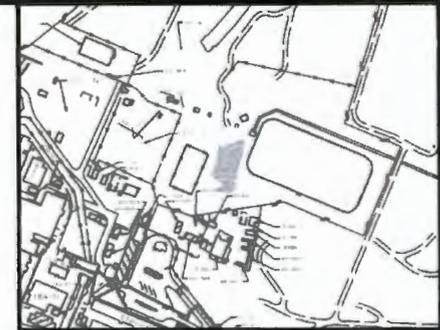
**100N Field Remediation  
 124-N-4  
 GPERS Radiological Survey  
 Beta Track Map**

Coverage File: N231  
 Number of Data Pnts: 215  
 Type of Survey: beta  
 Max GCPM: 849  
 Avg Bkg CPM: 418  
 Survey Date: 8/19/2011  
 Area Surveyed: 418 m<sup>2</sup>  
 Project File: ESRFRM110177B  
 Pdf File: ESRFRM110177BC

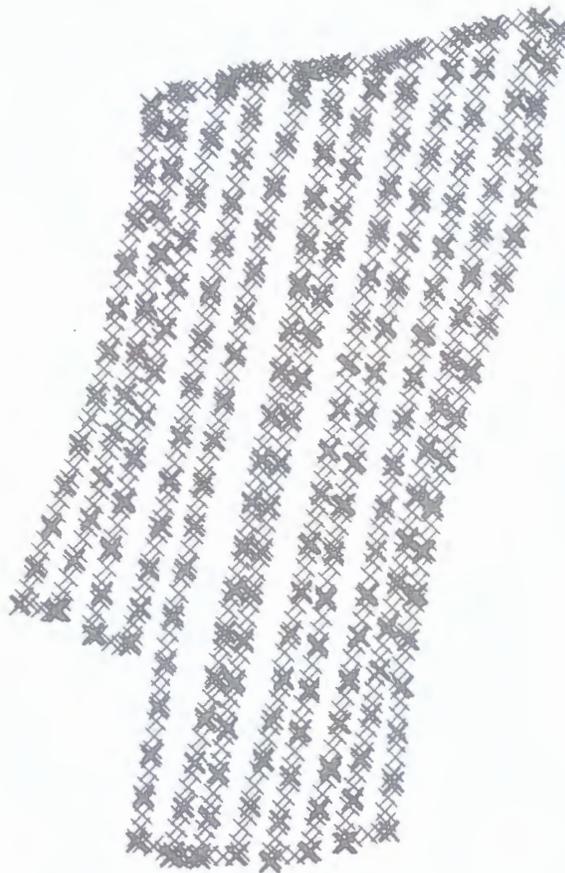
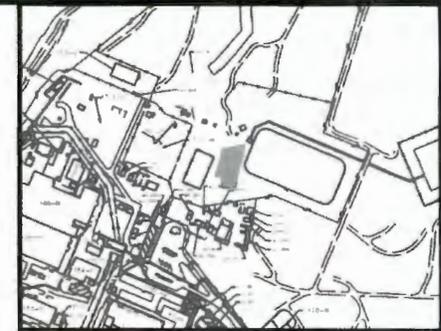
**100N Field Remediation  
124-N-4  
GPERS Radiological Survey  
Gamma Track Map**

Legend	Summary Statistics
NET CPM	Coverage File: N231
	Number of Data Pnts: 2659
	Type of Survey: gamma
x <2463	Max GCPM: 2102
● 2463 - 5000	Avg Bkg CPM: 1642
● 5000 - 10000	Survey Date: 8/19/2011
● 10000 - 25000	Area Surveyed: 2237 m <sup>2</sup>
● 25000	Project File: ESRFRM110177
	Pdf File: ESRFRM110177GC

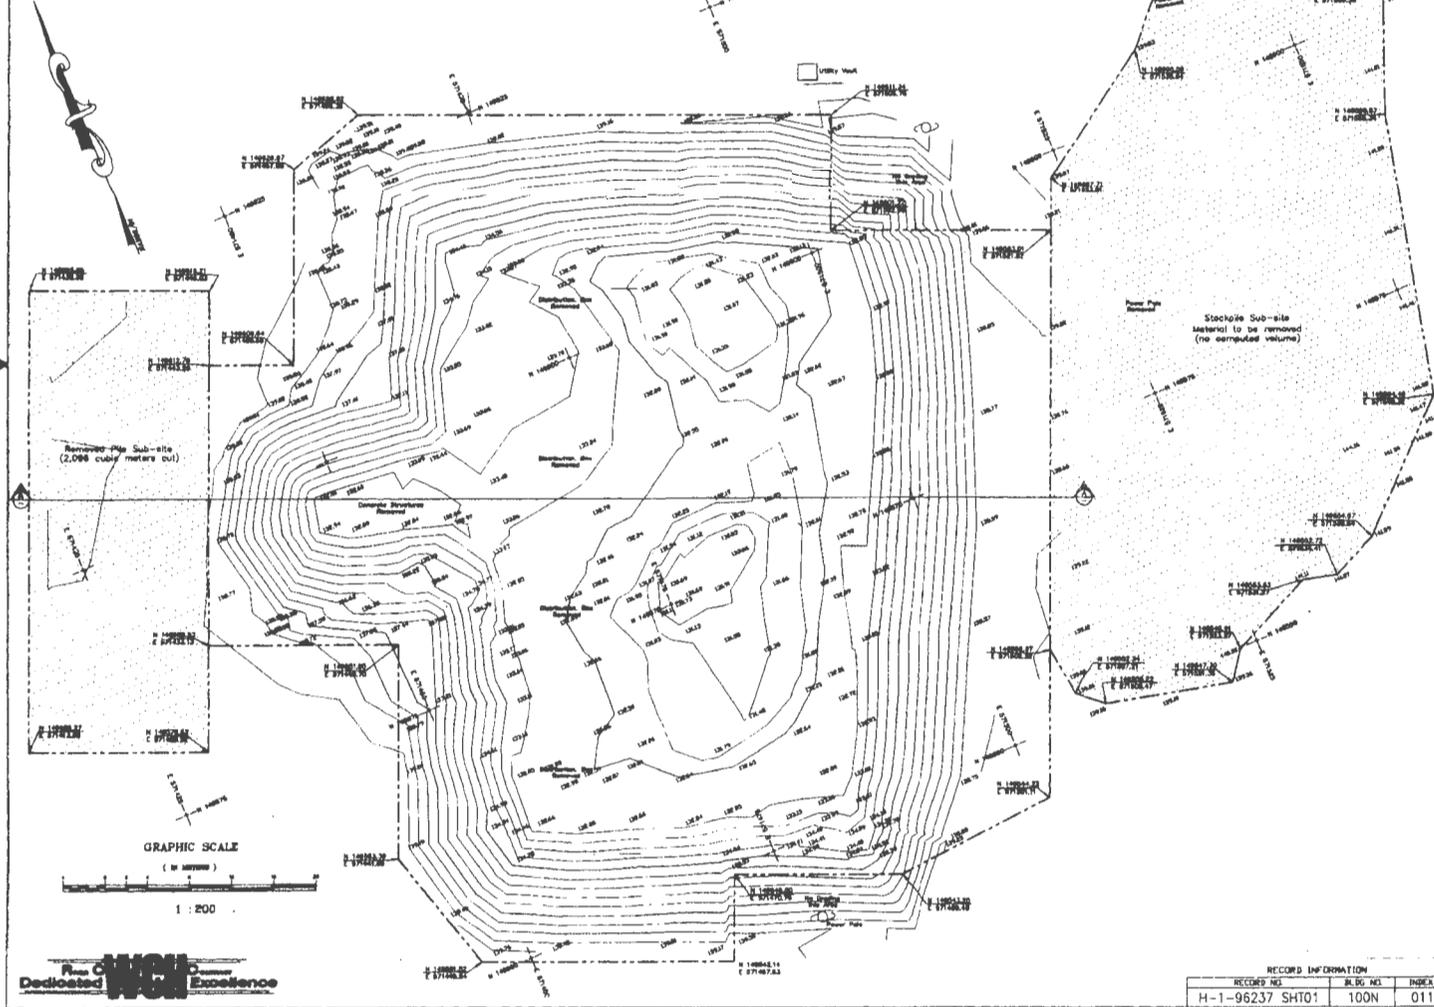
100 N AREA  
100 N WASTE SITE REMEDIATION  
124-N-4 POST EXCAVATION CIVIL SURVEY

THE PURPOSE OF THIS SURVEY WAS TO PROVIDE EXISTING SITE TOPOGRAPHY POST REMEDIATION ACTIVITIES AT THE 124-N-4 SANITARY SEWER SYSTEM. THIS SURVEY OUTLINES THE ASSOCIATED SPILL PILE TO BE REMOVED AND COMPLETE EARTHWORK VOLUMES. FOR THE PURPOSE OF THIS SURVEY THE SITE WAS DIVIDED INTO 3 SUB-SITES.

- 1) STOCKPILE: THE OUTLINE OF THE EXISTING SPILL PILE WAS MEASURED. THE PILE CONTAINED WITHIN THIS SUB-SITE IS PLANNED TO BE REMOVED.
- 2) 124-N-4 EXCAVATION: THE AREA SURROUNDING AND CONTAINING THE EXCAVATED AREA.
- 3) REMOVED PILE: AREA WESTERLY OF THE EXCAVATION WHICH PRIOR TO THE START OF REMEDIATION ACTIVITIES CONTAINED A PILE/BERM WHICH INTERFERED WITH THE PLANNED EXCAVATION SIDE SLOPES.

Sub-site	Out cu.m.	Fill cu.m.	Net cu.m.	Method
124-N-4 EXCAVATION	8718	4	8713 (C)	Grid
124-N-4 REMOVED PILE	2096	0	2096 (C)	Grid

A pre-demolition civil survey was performed at the 1903-N Sanitary Sewer System in March of 2010. A post-demolition civil survey was performed at the 1903-N footprint in April of 2011. Copies of these civil surveys are provided in Attachment 4.
