**CERTIFICATION OF CLEAN CLOSURE FOR THE 331-C STORAGE FACILITY**

OWNER/OPERATOR  
CLEAN CLOSURE CERTIFICATION  
FOR  
331-C HAZARDOUS WASTE STORAGE FACILITY

**RE: CLEAN CLOSURE CERTIFICATION REPORT, 331-C FACILITY, HANFORD SITE, WASHINGTON**

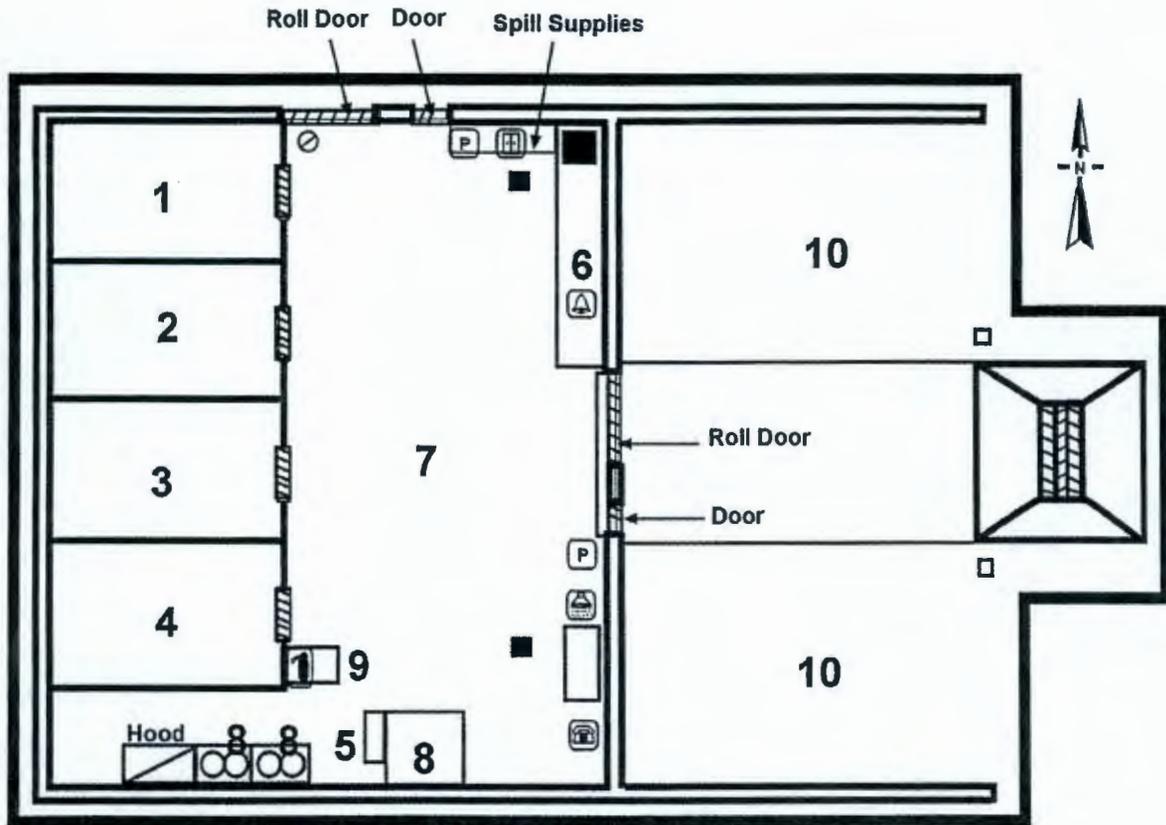
### 331-C Storage Unit

The 331-C Storage Unit is a specific area within Building 331-C. It consists of the building's north room and a fenced area under a canopy located directly east of the north room. The interior area has a metal containment barrier around the room's perimeter, with smaller containment areas for segregation of incompatible wastes (Cells 1 through 4). The floor is sealed with epoxy paint. Collection sumps span the doorways on the north and east sides, and Cells 1 through 4 have individual containment sumps. The exterior area also has a containment barrier, epoxy floor paint, and a collection sump (Cell 10). A figure from the Part III, Operating Unit 15 Unit-Specific Conditions for the 331-C Storage Unit is attached, which shows the Storage Unit and containment area layout.

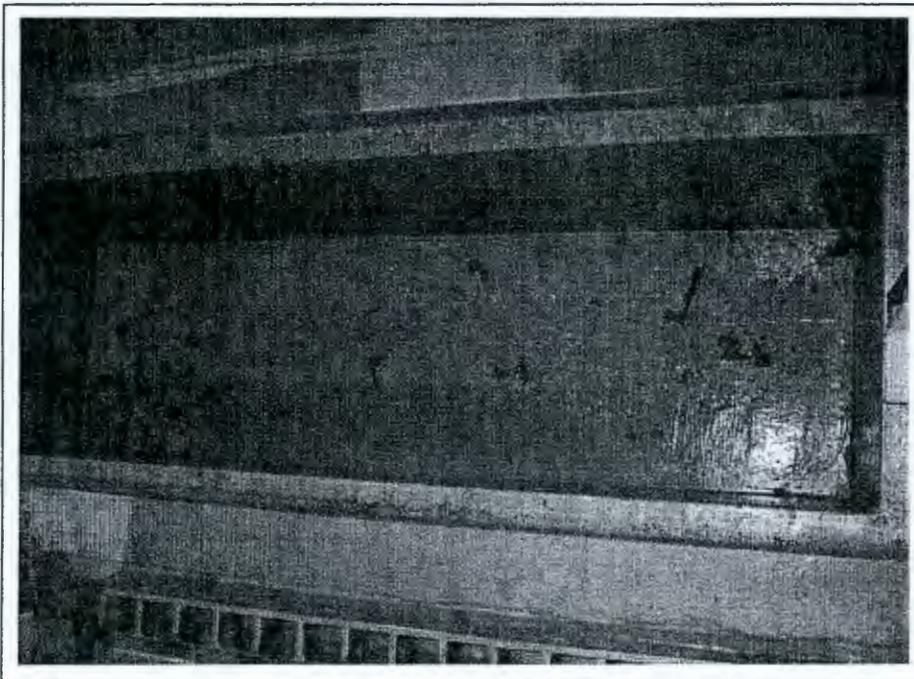
- Collection sumps inside the building were empty at the time of the reconnaissance, and no evidence of cracks were noted (Photo 2).
- The collection sump at Cell 10, which is outside of the building canopy, was full of standing water from precipitation at the time of the reconnaissance (Photo 3). The grate and concrete pad elevation is higher than the surrounding ground elevation, which prevents general site runoff from entering the sump (Photo 4). Even though the pit interior could not be visually assessed, the sump's ability to retain standing water is indicative of its soundness.

Photo 2. Collection sump at entrance of Cell 3; dark spots are loose dirt and cobwebs.

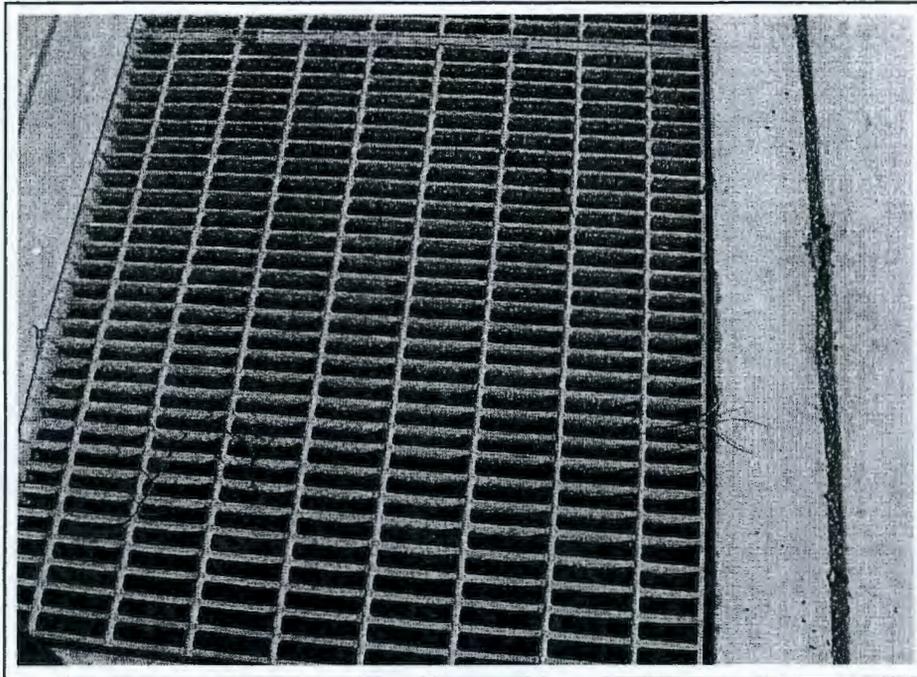
Photo 3. Grate over outdoor collection sump in Cell 10.

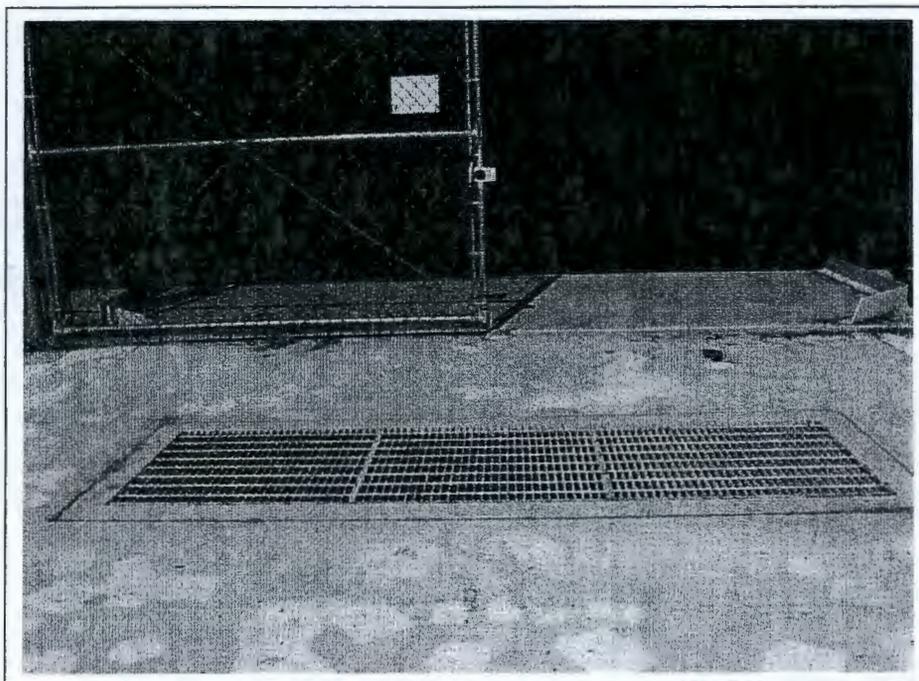
Photo 4. View toward the west showing outdoor collection sump and Cell 10.
