CWR-PFP-00013
Revision 0

Miscellaneous CERCLA Demolitions and Removals

As Left Characterization

Document Type: RPT Program/Project: PFP Closure

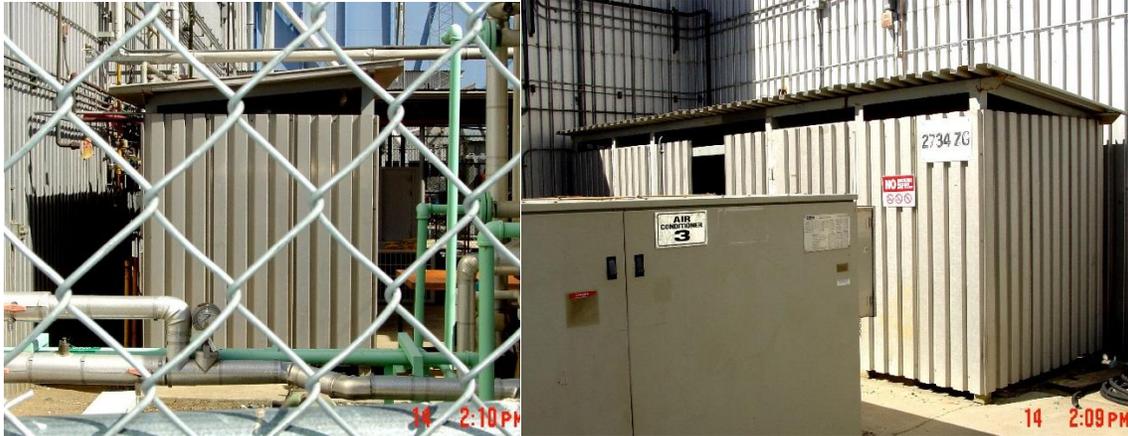
Figure 1. 2734ZF and 2734ZG Gas Bottle Storage

These two similar gas bottle storage areas (Figure 1) were metal structures on a concrete pad located adjacent to PFP on the southwest side. The concrete slabs were left in place.

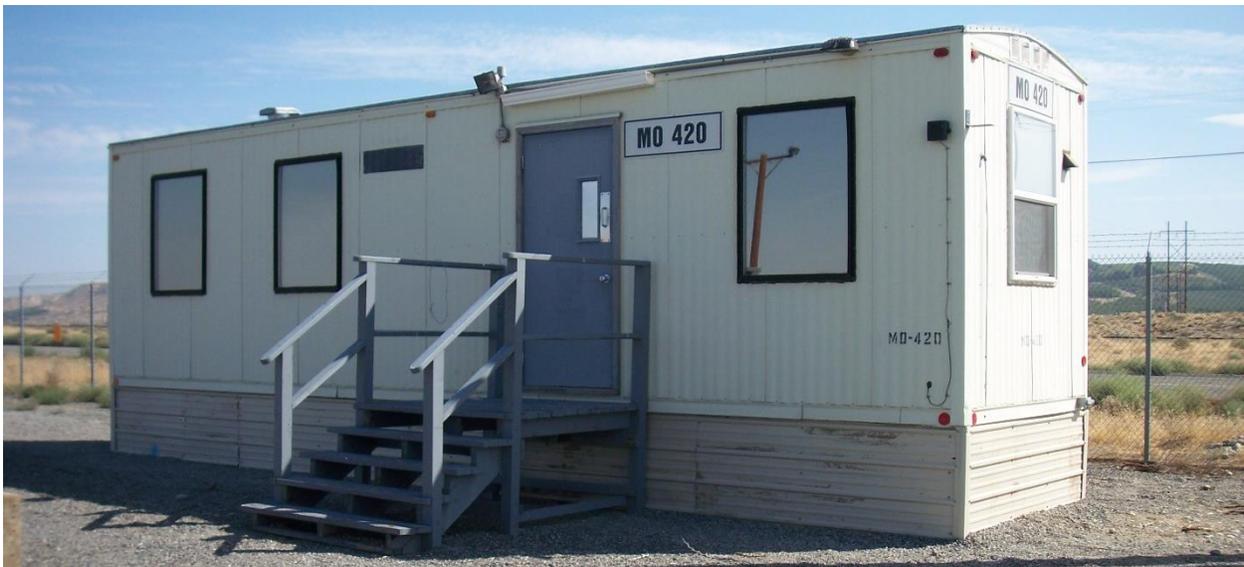
Figure 2. Mobile Office Trailer at Pit 6

MO420 was a mobile trailer used at PFP to support vehicle inspections at 2701ZC, and it was replaced by 2701ZE. The trailer was relocated to Pit 6 (Figure 2).

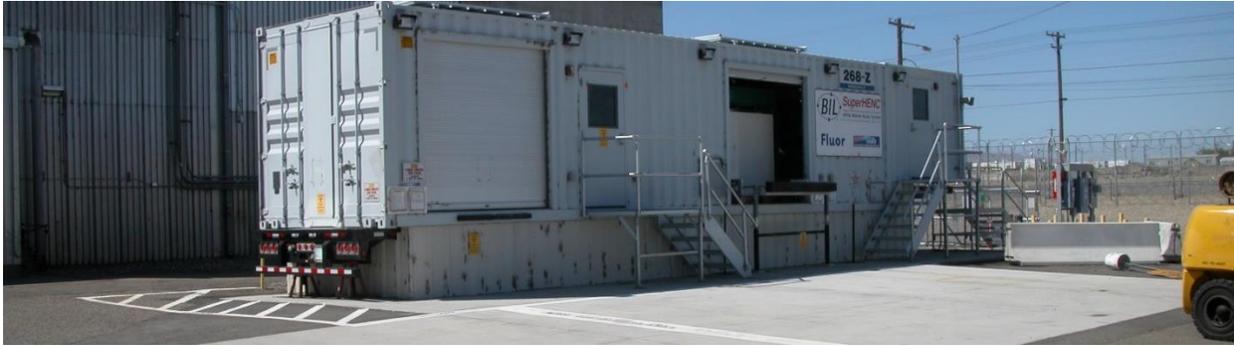
Figure 3. Mobile Box Assay Unit

The Mobile Box Assay Unit (Figure 3) was a Super High Efficiency Neutron Coincidence, also known as the SUPERHENC assay device, that was transferred offsite (Figure 4). The pad and front apron shown in Figure 3 remain.

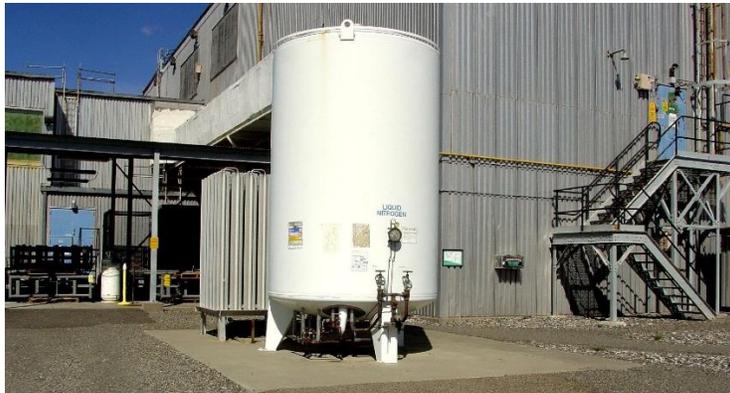
Figure 5. Liquid Nitrogen Tank

The liquid nitrogen storage tank (Figure 5), located at the southwest corner of PFP, and the associated evaporator were leased equipment and returned to the vendor. The concrete pad remains.

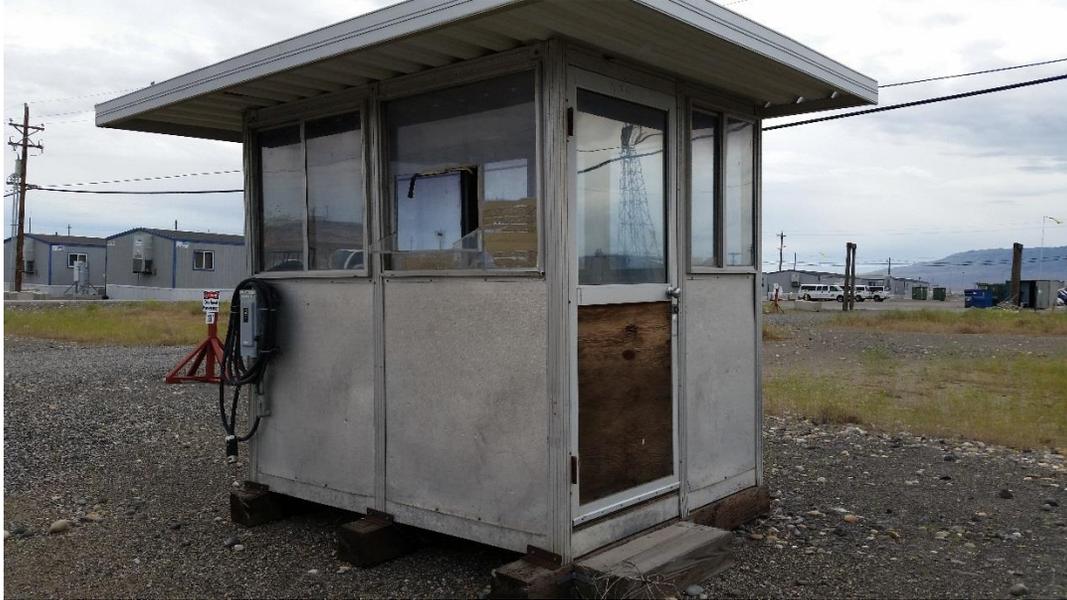
Figure 6. Guard Shack on Display at PFP 2017

The guard shack was located adjacent to 291Z. The modular structure was moved to the 200 East Area in 2009 and renumbered as 6701H; it has subsequently been replaced and returned to PFP as a display item (Figure 6).

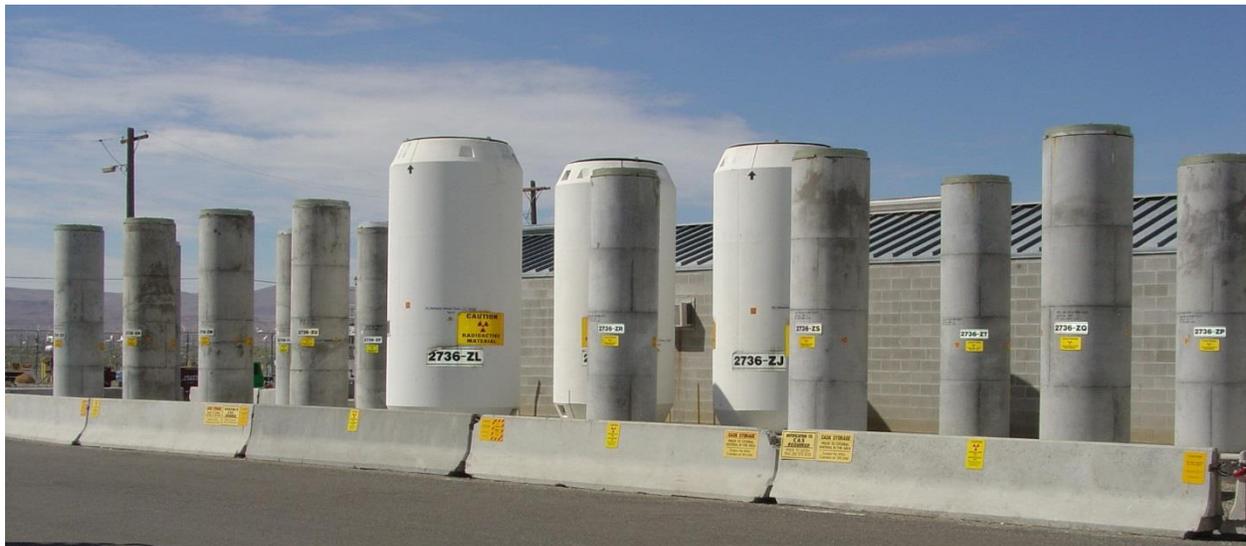
Figure 7. Interim Storage Vaults and Casks

The interim storage vaults (ISVs) and interim storage casks (ISCs) were located at the east side of the 2729Z Building (Figure 7) and consisted of 14 vaults and 3 shippable casks. The ISVs were shipped to ERDF (Figure 8), grout filled, and disposed. The ISCs were relocated to the 200 East Area. The prefabricated support bases associated with the ISVs and ISCs were also removed.

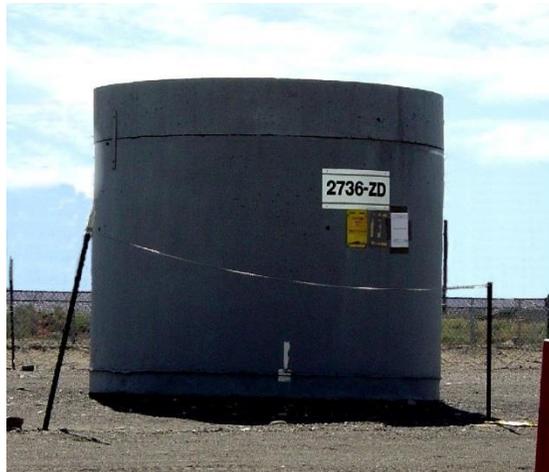
Figure 9. 2736ZD Experimental Breeder Reactor II Cask

The Experimental Breeder Reactor II cask (2736ZD), a reinforced aboveground concrete cylindrical vault (8 ft tall and 9 ft in diameter, with a 1 ft thick interlocking cover and base plate), was located south of 2736ZC (Figure 9). The cask, including the prefabricated support base, was relocated to the 200 East Area.

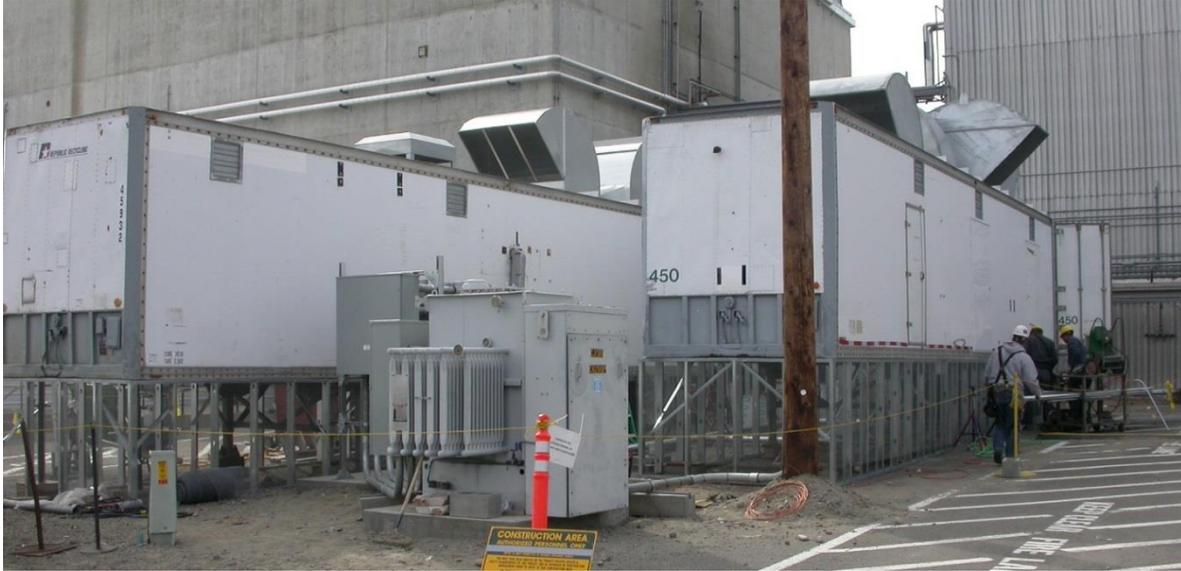
Figure 10. Breathing Air Trailers

These two breathing air trailers (Figure 10) were brought from the Rocky Flats demolition project and installed at PFP but never used. They were removed (Figure 11) and transferred to excess.

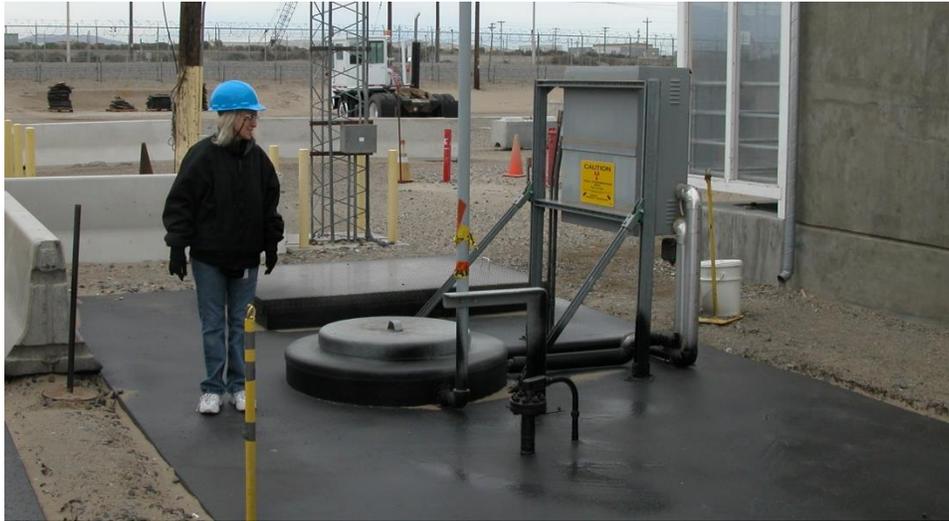
Figure 12. Underground Fuel Tank before Removal

The underground fuel tank (2721Z-2), shown in Figure 12, was located next to the 2736ZB Building and fueled generators in 2721Z. The tank was removed (Figure 13) and assessed in full compliance with WAC 173-360, “Underground Storage Tank Regulations” (MSBA, 2011, “Underground Storage Tank Site Assessment and Closure Report”).

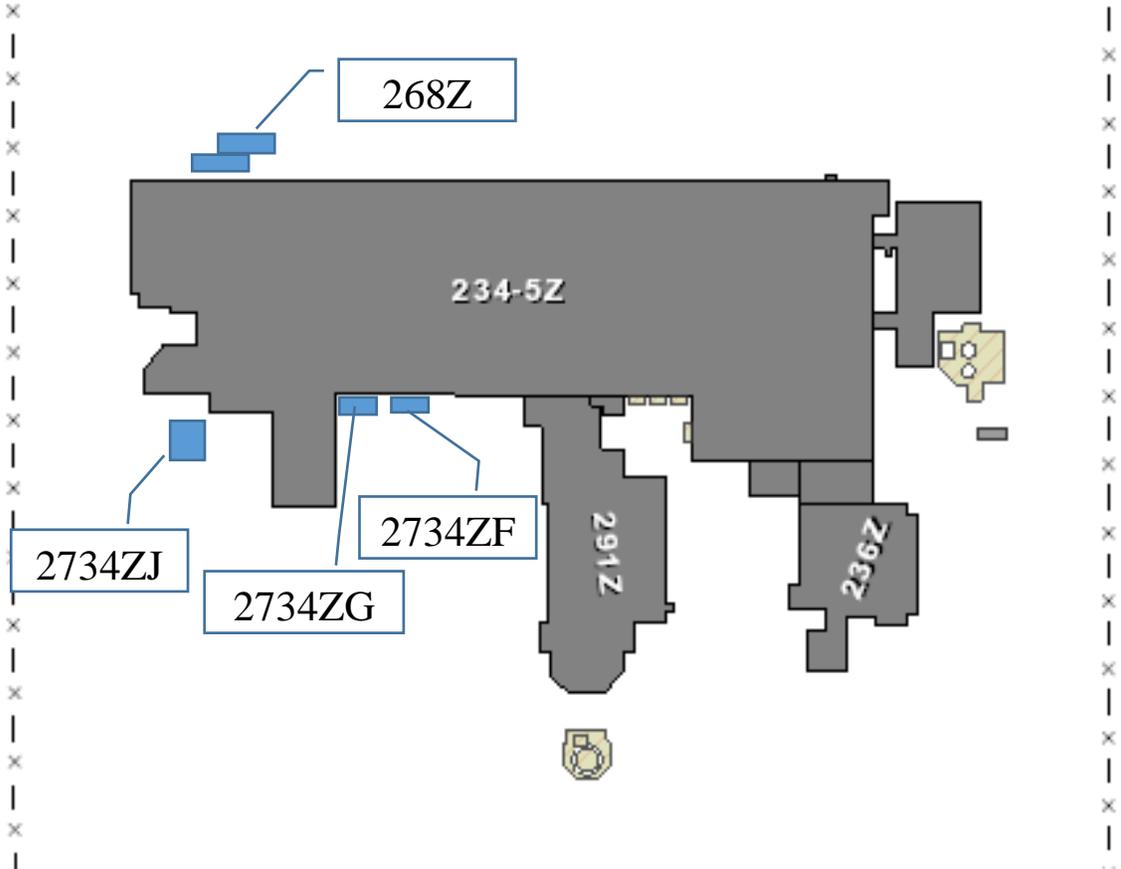
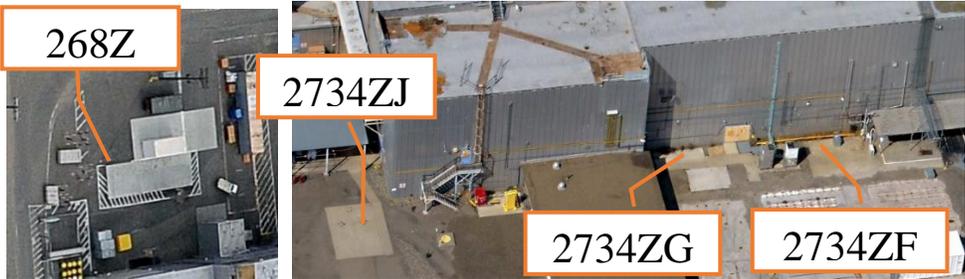
Figure 14. Remaining Slab Locations

Except for MO240, which was located near the intersection of 19th Street and Camden Avenue, all items described in this report were located within the PFP fenced area. Slabs associated with the 268Z Mobile Box Assay Unit, nitrogen tank pad 2734ZJ, and bottle docks 2734ZF and 2734ZG remain (Figure 14). At the time of removal, no detectable radioactive contamination associated with any of these slabs was identified; however, because of their proximity adjacent to the PFP main building, a final status of these slabs must be addressed after demolition of PFP.

No chemical or radiological hazards are known to be associated with any of the slabs. Due to the proximity to PFP where the various items were located, final characterization is deferred until after completion of PFP demolition.
