2736Z Complex Demolitions Report

As Left Characterization

Document Type: RPT Program/Project: PFP Closure

Date Published
July 2017

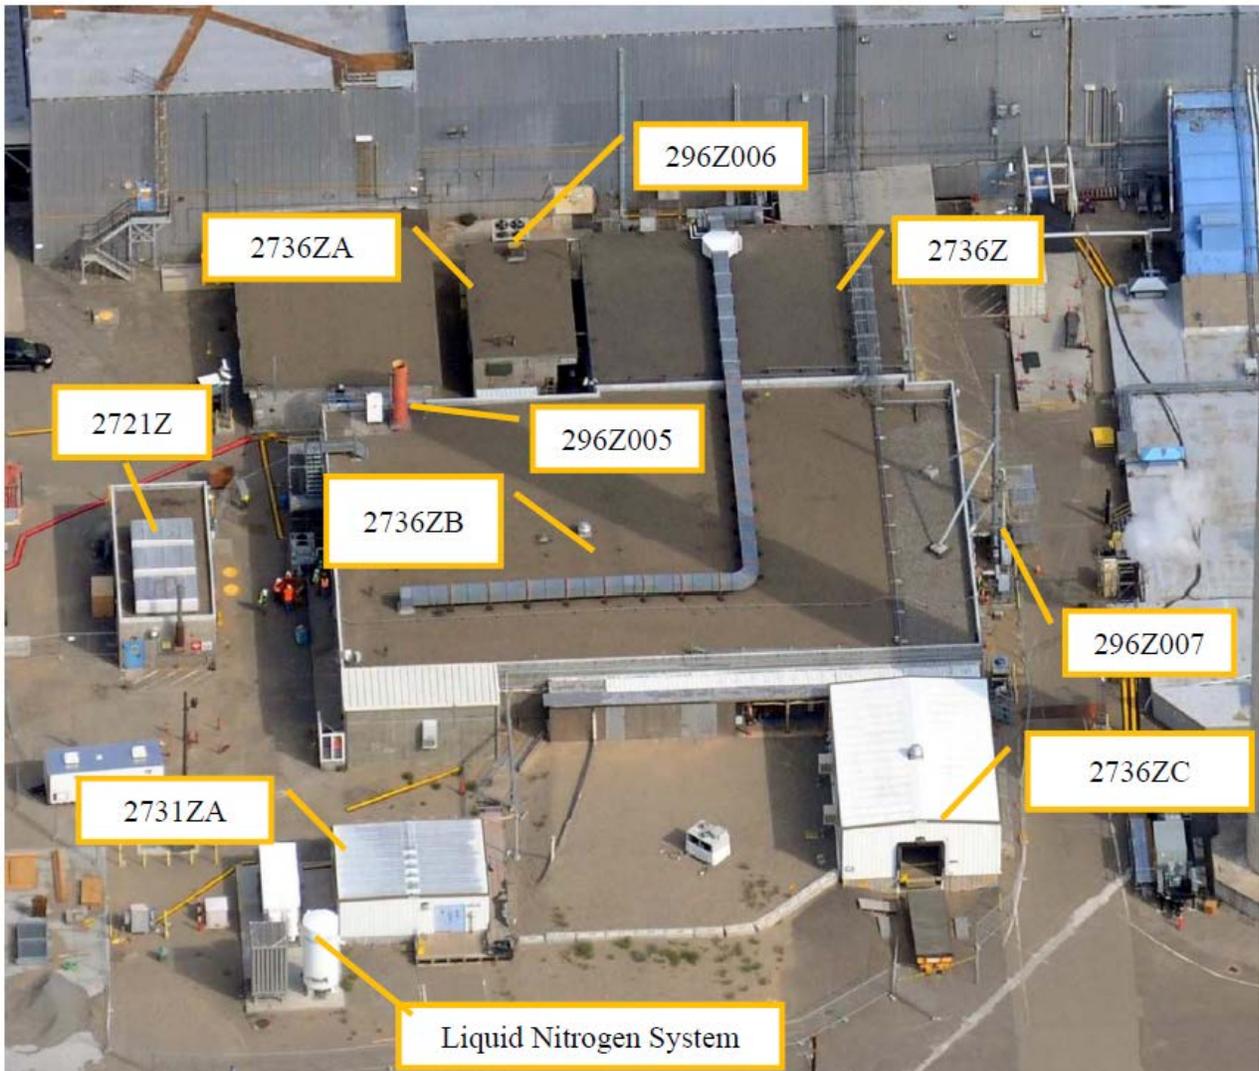
Figure 1. 2736Z Complex

The 2736Z Complex (Figure 1) was located at the southwest area of the PFP Complex and consisted of the Plutonium Storage Building (2736Z), the Plutonium Storage Ventilation Structure (2736ZA), the Plutonium Storage Support Building (2736ZB), the Cargo Restraint Transport Dock (2736ZC), the Emergency Generator Building (2721Z), and the Container Storage Building (2731ZA). Ventilation stack 296Z006 was located in the 2736ZA Building, and the 2736ZB Building had two ventilation stacks, 296Z005 and 296Z007.

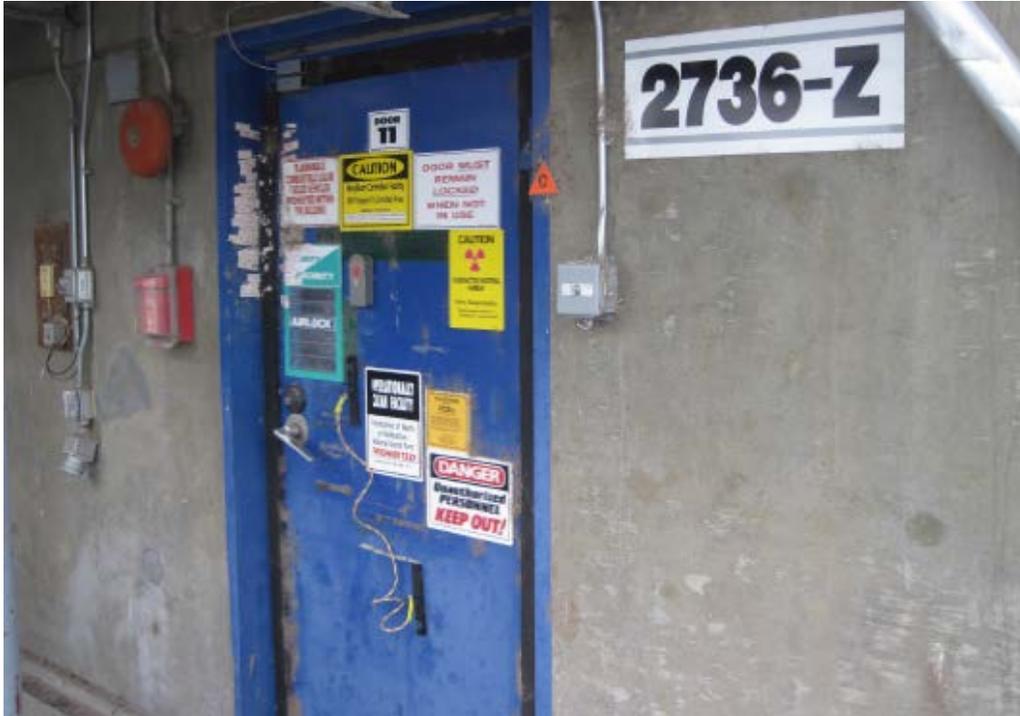
Figure 2. 2736Z Building Entrance

The 2736Z Building (Figure 2) was the primary PFP plutonium storage building and was located on the south side of the 234-5Z Building. The 2736Z Building also abutted the 2736ZB Building. Constructed in 1971, the 2736Z Building was a 65 by 56 ft one-story structure constructed of reinforced concrete. It contained four vaults for storing plutonium product and scrap.

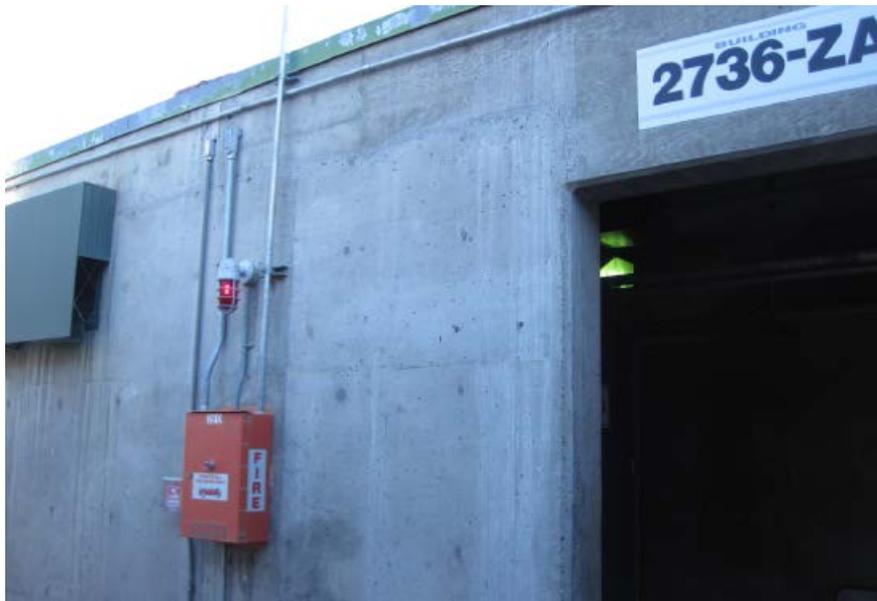
Figure 3. 2736ZA Building Entrance

Constructed in 1971, the 2736ZA Building (Figure 3) housed the ventilation equipment for the 2736Z Building and was a one-story facility ~40 by 22 ft. Ventilation stack 296Z006 was an integral part of the structure (Figure 1).

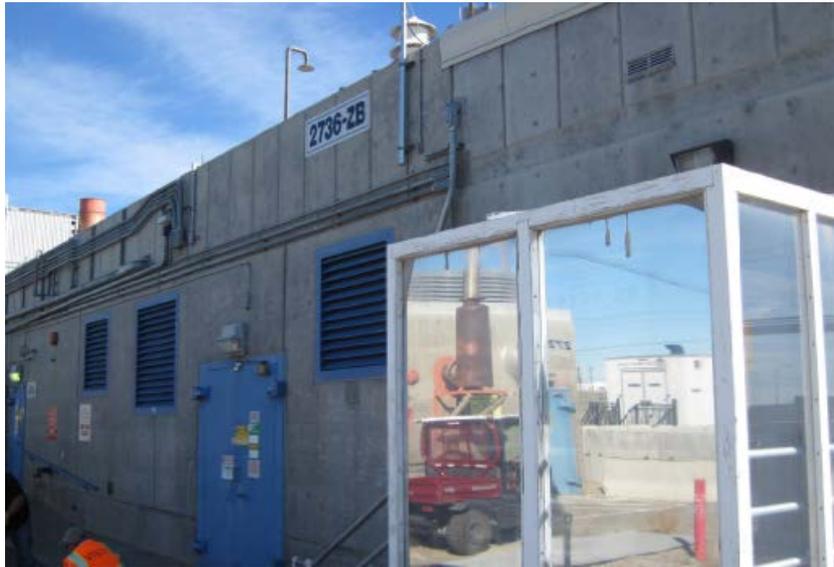
Figure 4. 2736ZB Building

The 2736ZB Building was constructed in 1982 to support 2736Z Building storage vault operations and was connected to the south side of the 2736Z Building. 2736ZB was a one-story building ~132 by 90 ft, primarily constructed of reinforced concrete. Ventilation stack 296Z005 was an integral part of the structure (Figure 4). The building underwent extensive modification in 2001, including the addition of a new ventilation stack (296Z007; Figure 9), to support processing and package fissile residue materials for offsite shipment.

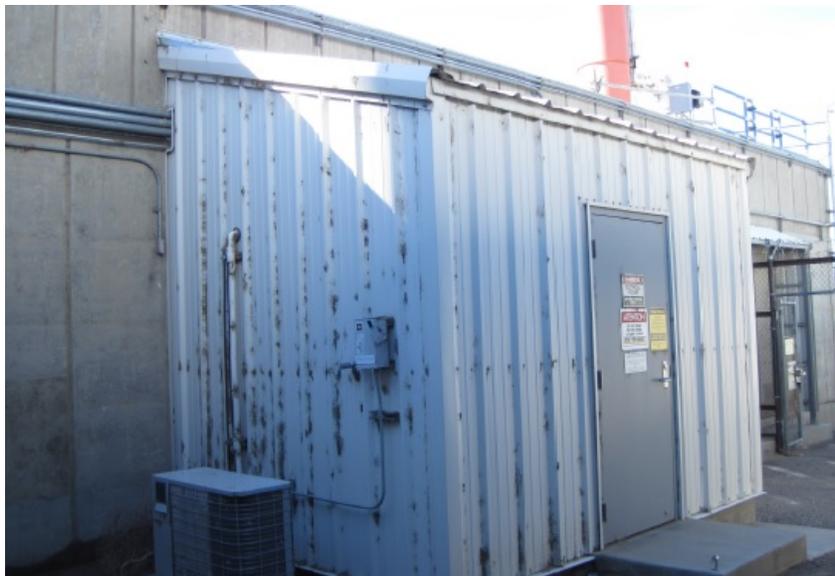
Figure 5. Room 637A Annex to 2736ZB

An annex (Figure 5) on the north wall of room 637 of the 2736ZB Building that housed supporting electrical equipment was referred to as 637A.

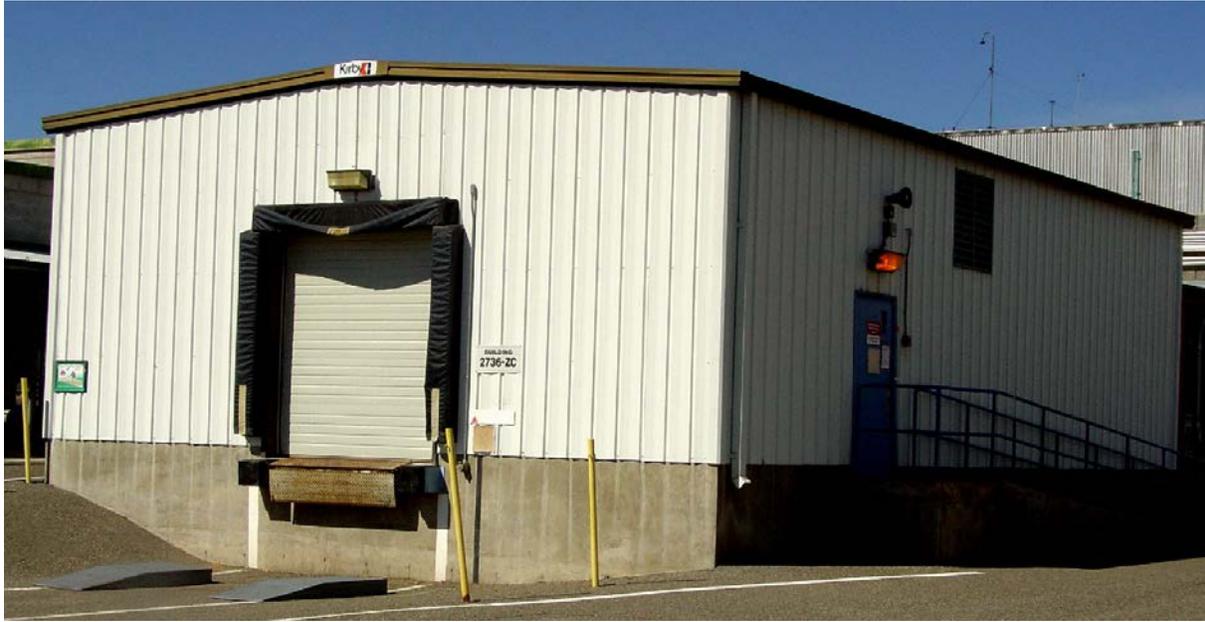
Figure 6. 2736ZC Building

The 2736ZC Cargo Restraint Transport Dock (Figure 6) was constructed in the late 1970s and was an enclosed loading and unloading dock and corridor to the shipping and receiving areas of the 2736ZB Building. The dock was a concrete pad enclosed in a metal building ~48 ft, 6 in. by 32 ft. The 2736ZC provided temporary storage for shipping containers associated with offsite shipping and receiving.

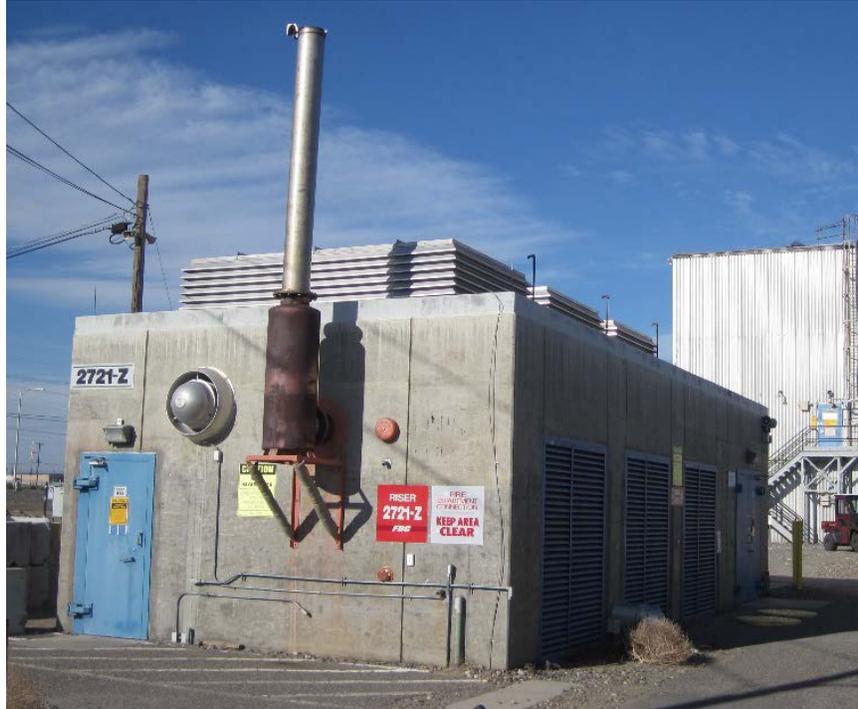
Figure 7. 2721Z Building

The 2721Z Building (Figure 7) was constructed in 1979 to house backup emergency diesel electric generators. 2721Z was located immediately west of the 2736ZB Building. 2721Z was 46 by 19 ft and was constructed of poured reinforced concrete walls and floor. 2721Z housed three diesel-driven generators that were used as backup power for the PFP facilities. Fuel to the 2721Z generators was provided by an underground storage tank (2721Z-2) located south of 2736ZB. Removal of the tank was addressed in CWR-PFP-00013, *Miscellaneous Pre-2014 CERCLA Demolitions and Removals*.

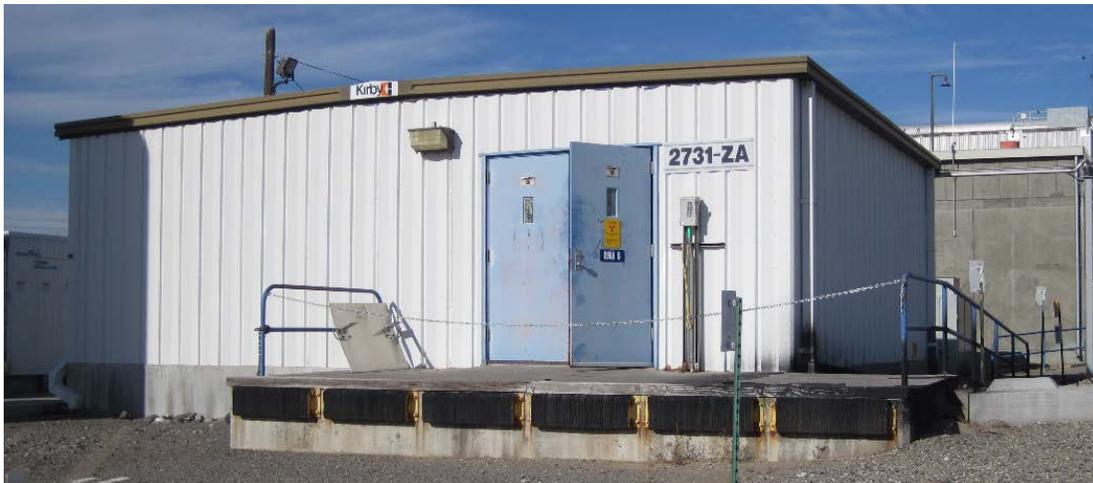
Figure 8. 2731ZA Building

Also known as the Clean Laundry Building (Figure 8), the 2731ZA provided storage for laundry and equipment. The building was an ~93 by 16 ft steel structure erected on a concrete slab located south of the 2736ZB Building. A liquid nitrogen system (Figure 1) located immediately west of the 2731Z Building provided nitrogen to the 2736ZB Building.

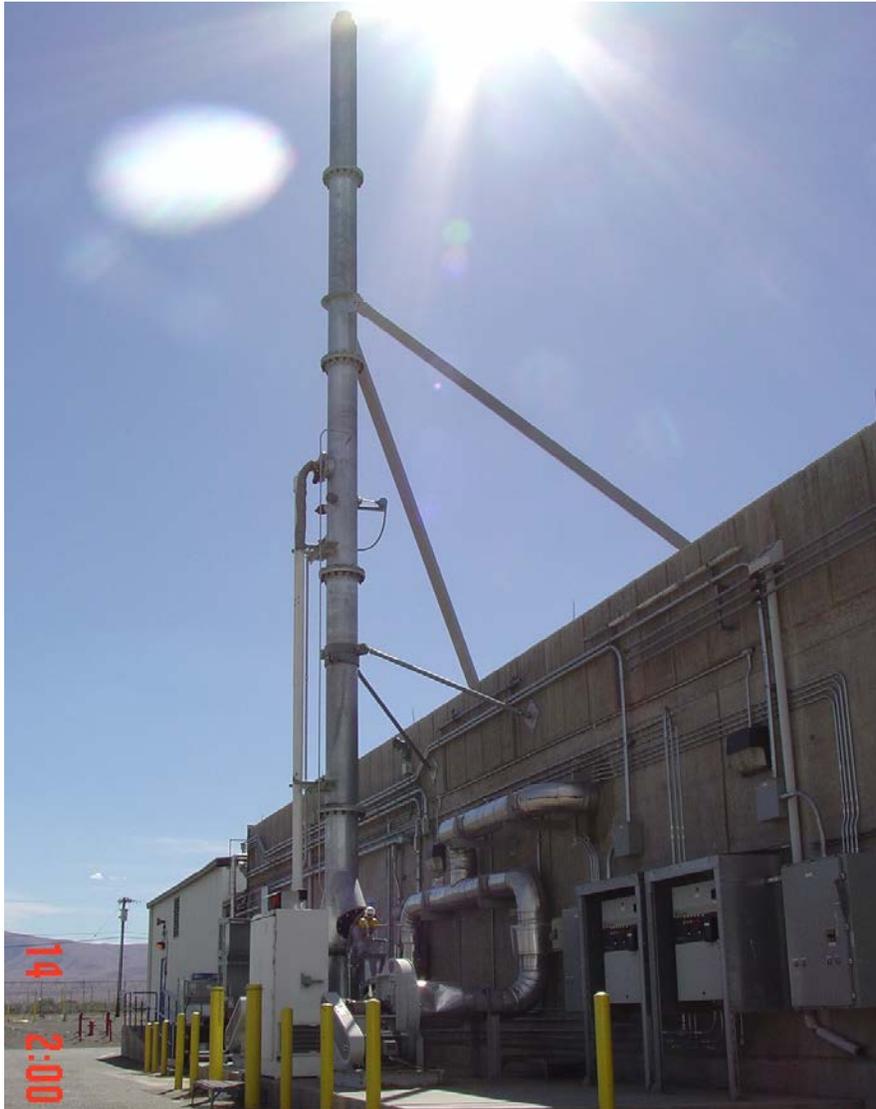
Figure 9. 2731ZA Building

Three emission stacks (296Z005, 296Z006, and 296Z007) were associated with the 2736Z Complex. Stack 296Z005 provided ventilation for the 2736Z Vault and was an integral part of the 2736ZA Building (Figure 1). Stack 296Z006 provided ventilation to and was an integral part of 2736ZB (Figure 1). The 296Z007 stack adjacent to 2736ZB (Figure 9) provided ventilation for the 2736ZB glovebox areas.

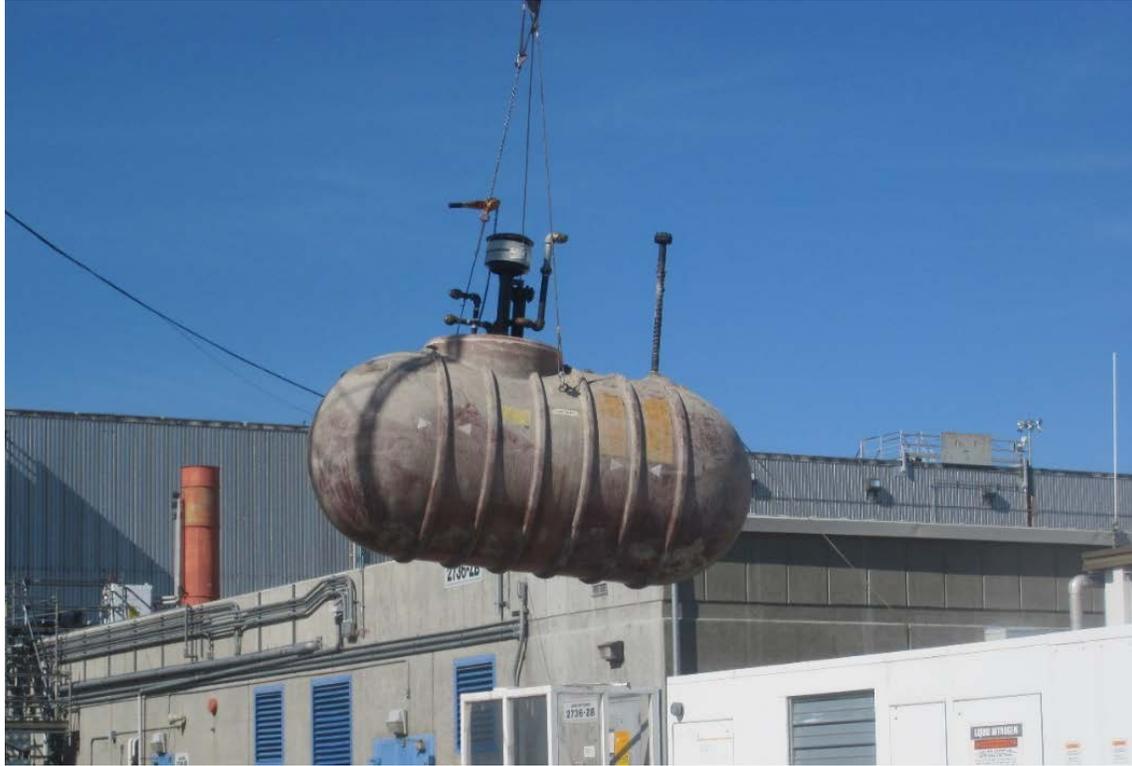
Figure 10. Underground Fuel Tank Removal

Demolition of the 2736Z Complex occurred in two phases. Following decommissioning of the 2736ZB Building, the underground fuel tank (2721Z-2) was removed (Figure 10) in preparation for the demolition of 2721Z. The first phase removed the low-hazard facilities (2721Z, 2731ZA, and 2736ZC), and the final phase addressed the high-hazard facility (2736ZB) and the remainder of the complex (2736Z and 2736ZA, along with stacks 296Z005, 296Z006, and 296Z007).

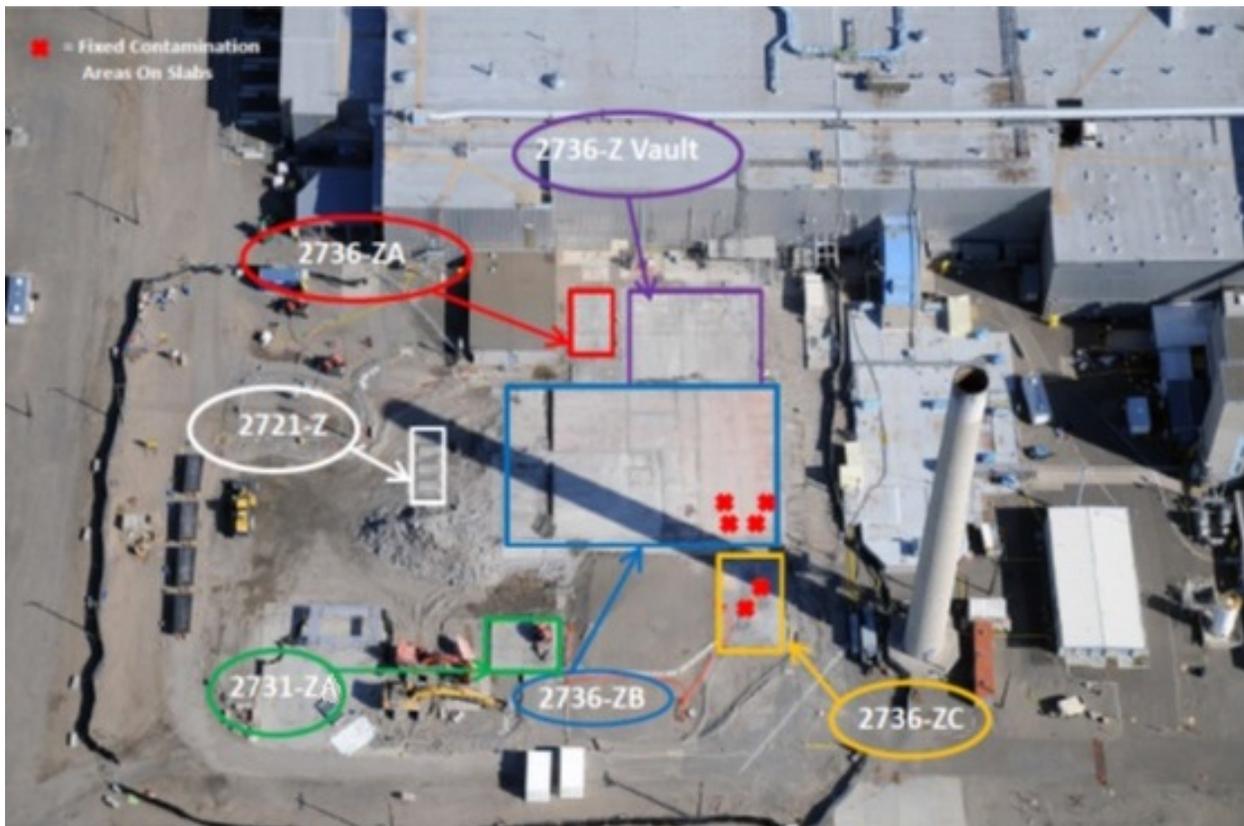
Figure 11. 2736Z Complex Slabs

The facility was left in a clean slab-on-grade condition with all penetrations sealed. Post-demolition, no contamination was identified on the slabs associated with 2721Z, 2731ZA, 2736Z, or 2736ZA. Fixative was applied to areas of contamination on the 2736ZB and 2736ZC slabs, and metal plates were sealed to the slab over the fixed contamination. Figure 11 shows the slabs and location of fixed contamination. Figure 12 shows the as-left condition of the 2721Z and 2736ZB slabs, which were covered with gravel to address walking surface issues.

As shown in Figure 11, small areas of fixed alpha contamination remained on the 2736ZB and 2736ZC slabs. The maximum contamination measured using portable instruments prior to fixing was 4,500 dpm/100 cm² alpha direct and 200 dpm/100 cm² alpha removable (survey BP-1200105).

These areas of fixed contamination were stabilized by painting and were then covered with a steel plate according to work package 2Z-12-05372.

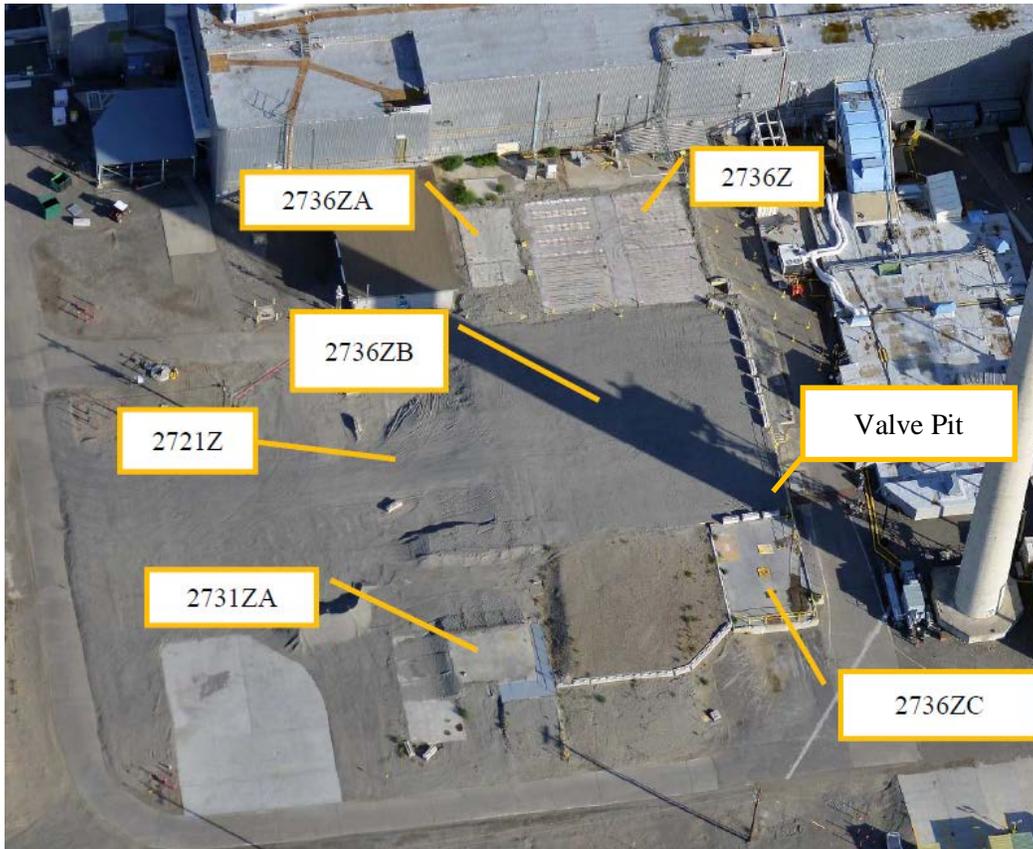
Figure 12. 2736Z Complex As-Left Conditions

One below-grade void space associated with the 2736Z Complex remains: the valve pit on the walkway on the north side of 2736ZB between the 2736ZB and 2736ZC slabs (Figure 12). Details of the void space are shown on drawing H-2-80116. Figure 13 shows the valve pit under construction in the early 1980s. This confined space, CS28, has been eliminated by restricting access with the placement of gravel fill placed over the manhole cover.
