**FACILITY STATUS CHANGE FORM**

<b>Date Submitted:</b> Aug 28, 2012 <b>Originator:</b> John Harrie <b>Phone:</b> 509.308.9935	<b>Area:</b> 300 Area <b>Facility ID:</b> 3229 <b>Action Memorandum:</b> Action Memorandum #1.	<b>Control #:</b> D4-300-070
--	---	---------------------------------

The 3229 Storage Building was a 20' x 20' corrugated steel shed constructed in the 1977 in the northwestern portion of the 300 Area west of the 314 Building and north of the 3704 Building.

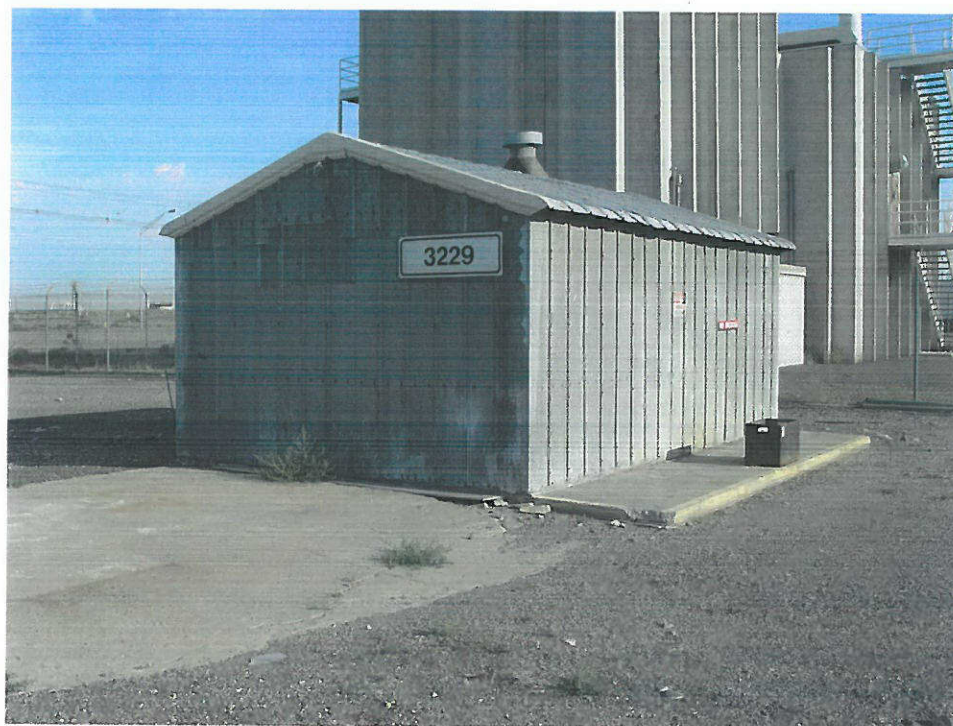
**Photo 1: Looking northwest at the 3229 Building prior to demolition in June of 2004.**

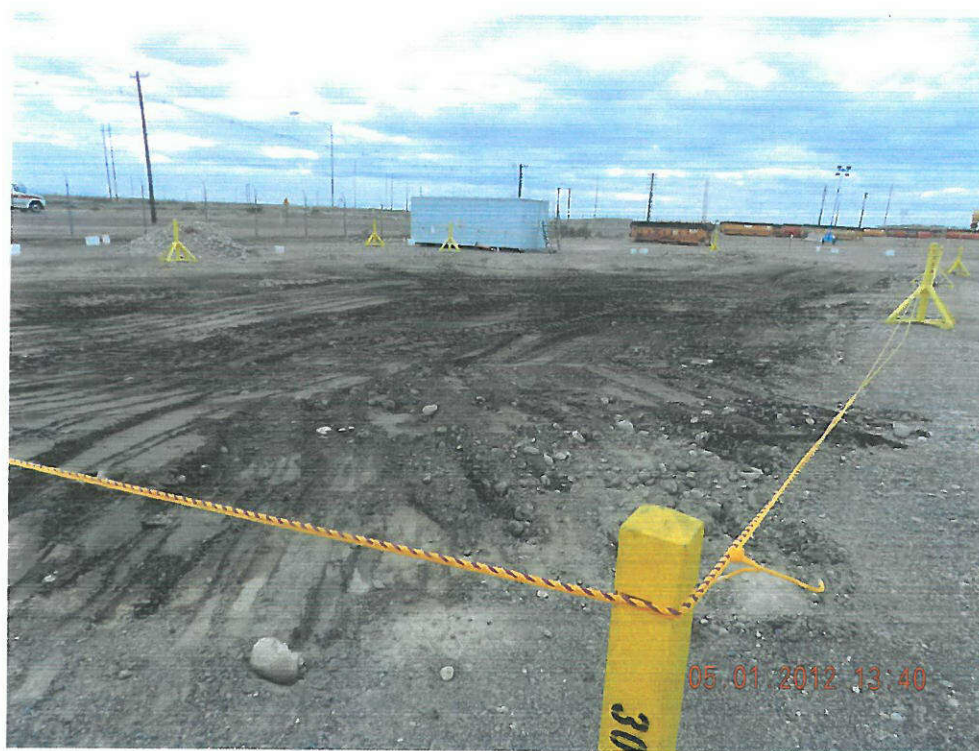
No anomalies were reported during the removal of the 3229 slab. Soils were inspected prior to backfill, no staining or discoloration was observed.

**Photo 2. Looking northwest at 3229 following slab removal in May of 2012.**

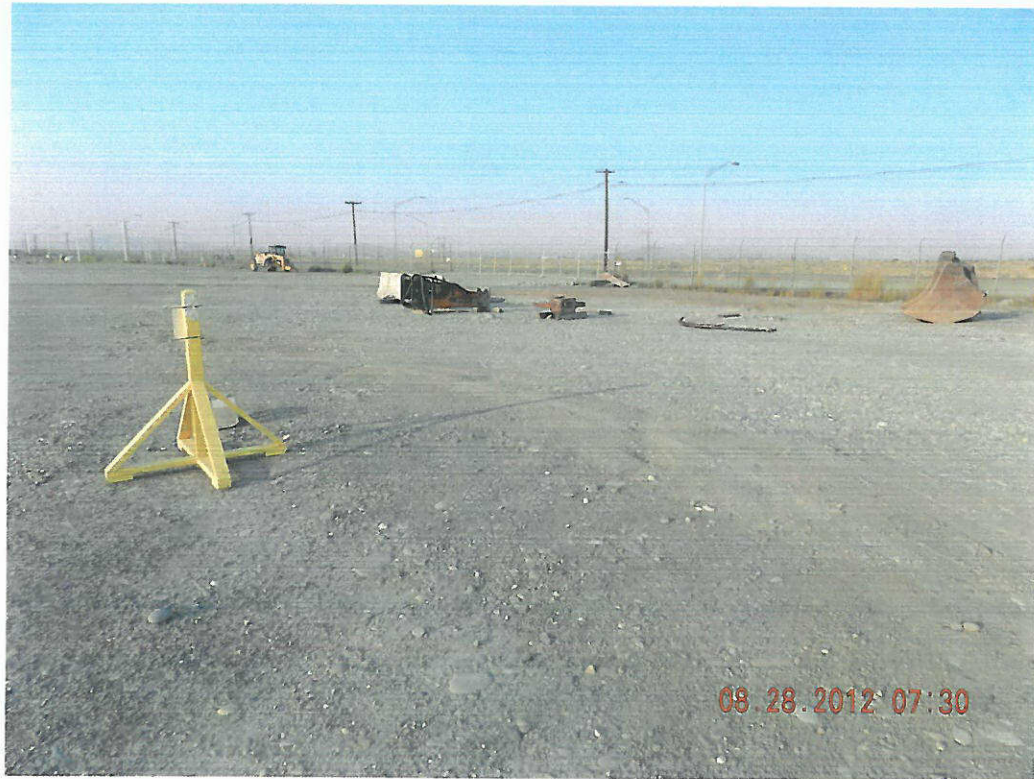
The 3229 Building slab was demolished in August of 2012. The foundation debris were loaded out to EDRF. Approximately 2-feet of soil was removed during slab removal and the excavation was backfilled to grade with clean imported fill. A GPERS survey is included as Attachment 3.

**Photo 3. Looking southwest at the 3229 Building following backfill in August of 2012.**
