FACILITY STATUS CHANGE FORM

Date Submitted: August 8, 2013 Originator: Chris Strand Phone: 554-2720	Area: 300 Area Facility ID: 331H Action Memorandum: Hanford General Decommissioning	Control #: D4-300-088
---	---	---------------------------------

Attachment 1: Facility Information

Building History

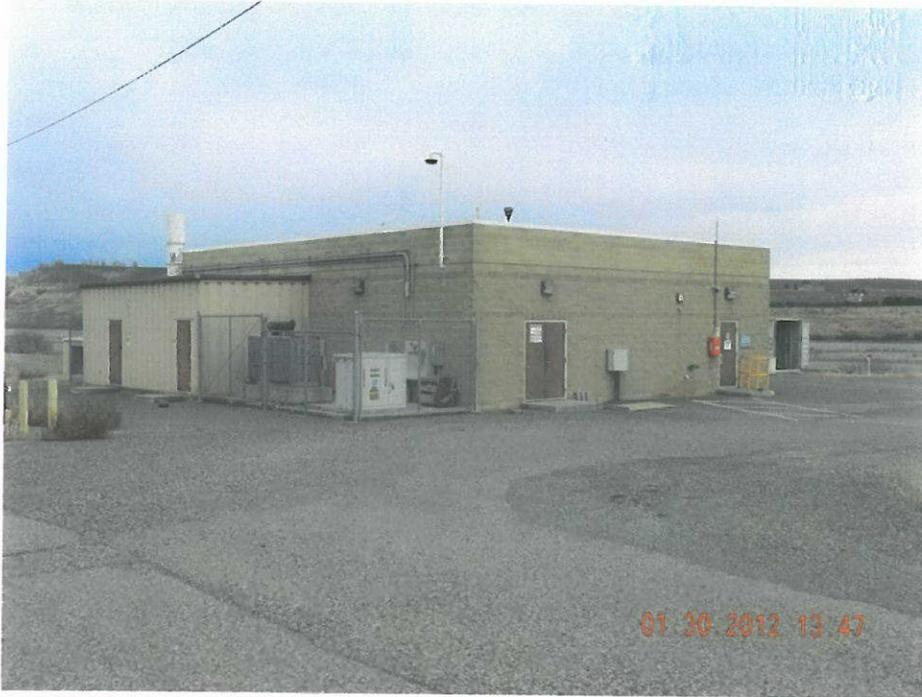
Photograph 1: 331H, looking northeast on January 20, 2012.

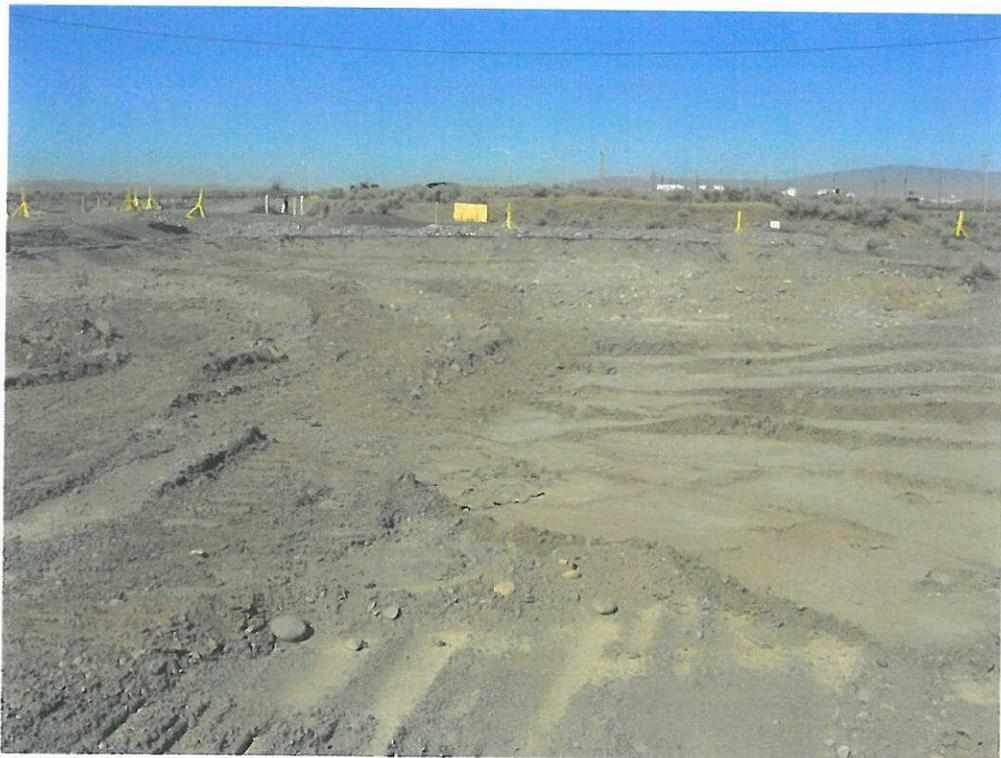
No anomalies were discovered during the below-grade removal of 331H. No soil staining within the excavation was observed and GPERS surveys identified no radiological contamination. The excavation was backfilled with clean fill material.

Photograph 2: 331H excavation following below-grade demolition, looking west on July 22, 2013.

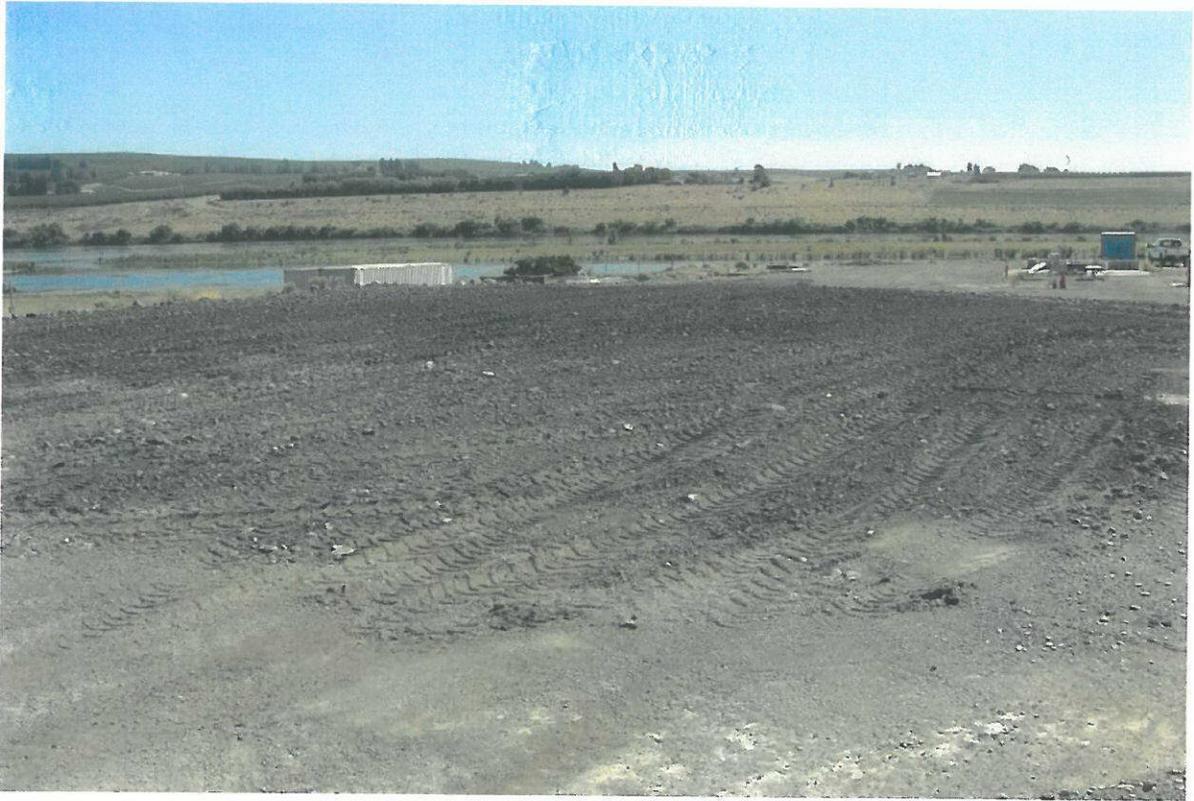
The excavation was backfilled with clean material following GPERS surveys. No radiological or Industrial Hygiene postings remain.

Photograph 3: 331H following backfill, looking east on August 7, 2013

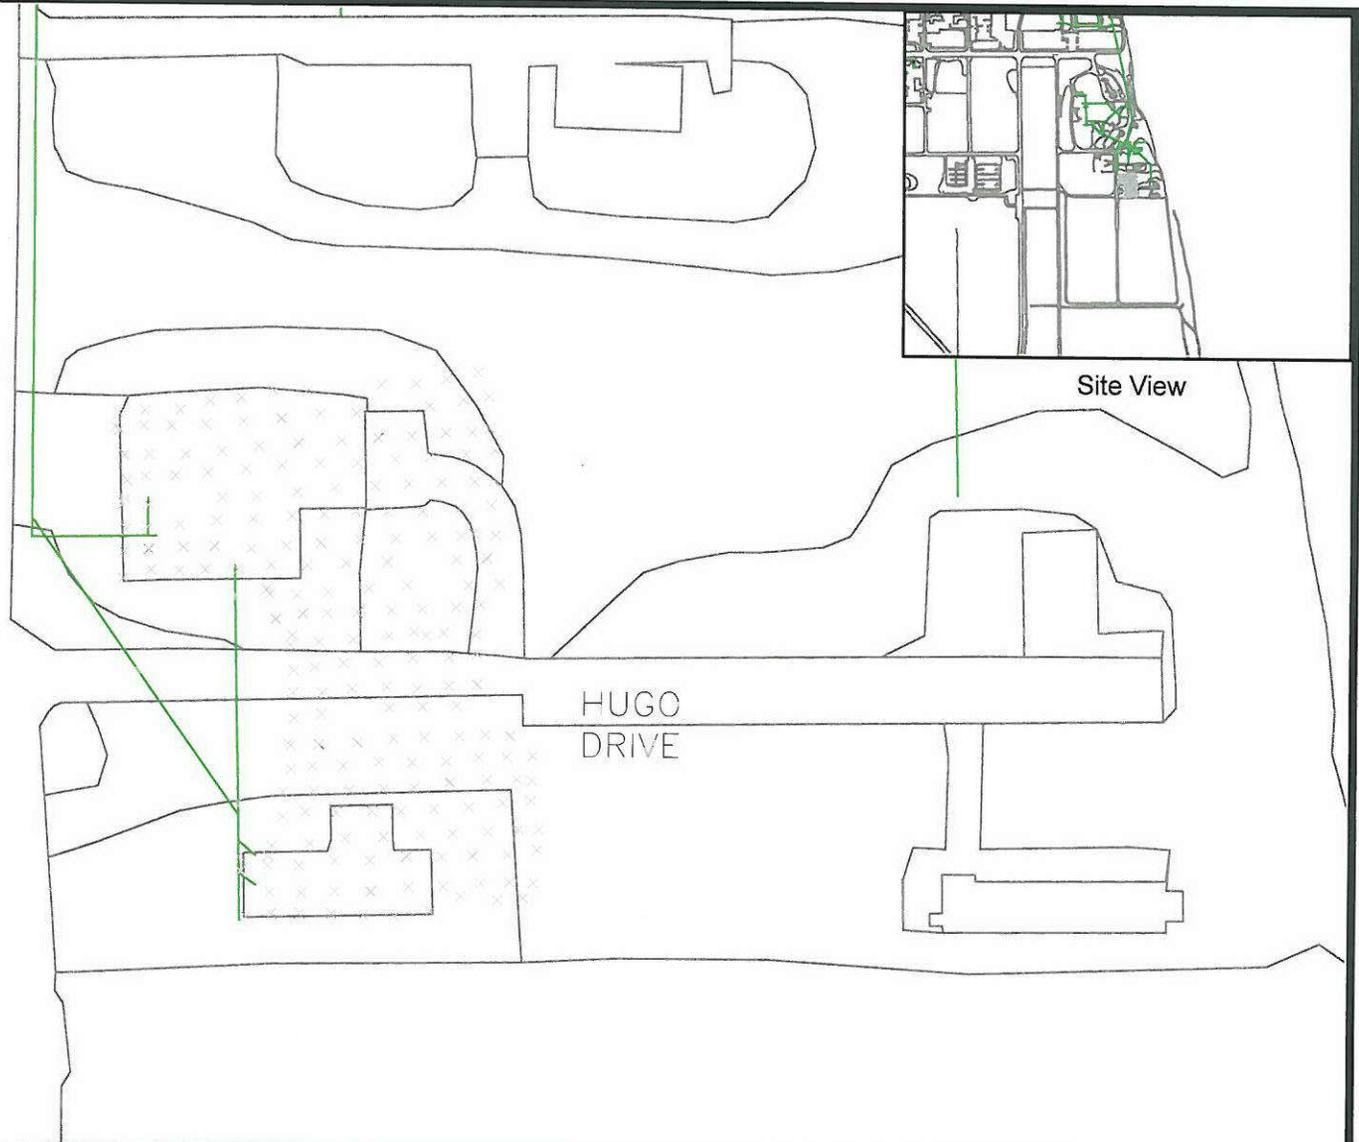
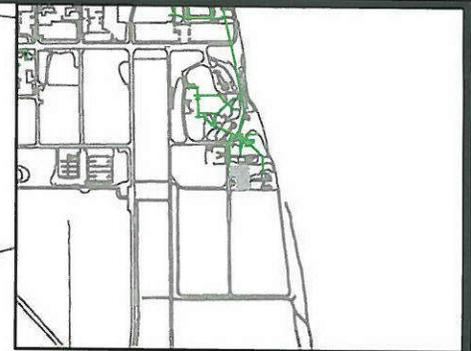
300 D4
331-G, H
GPERS Radiological Survey
Beta Track Map

Bkg Location
1250 m NW
351 cpm

Coverage File: D4_199'
 Number of Data Pnts: 244
 Type of Survey: beta
 Max GCPM: 631
 Avg Bkg CPM: 351
 Survey Date: 7/19/2013
 Area Surveyed: 1600 m²
 Project File: ESRFRM130057B
 Pdf File: ESRFRM130057BC

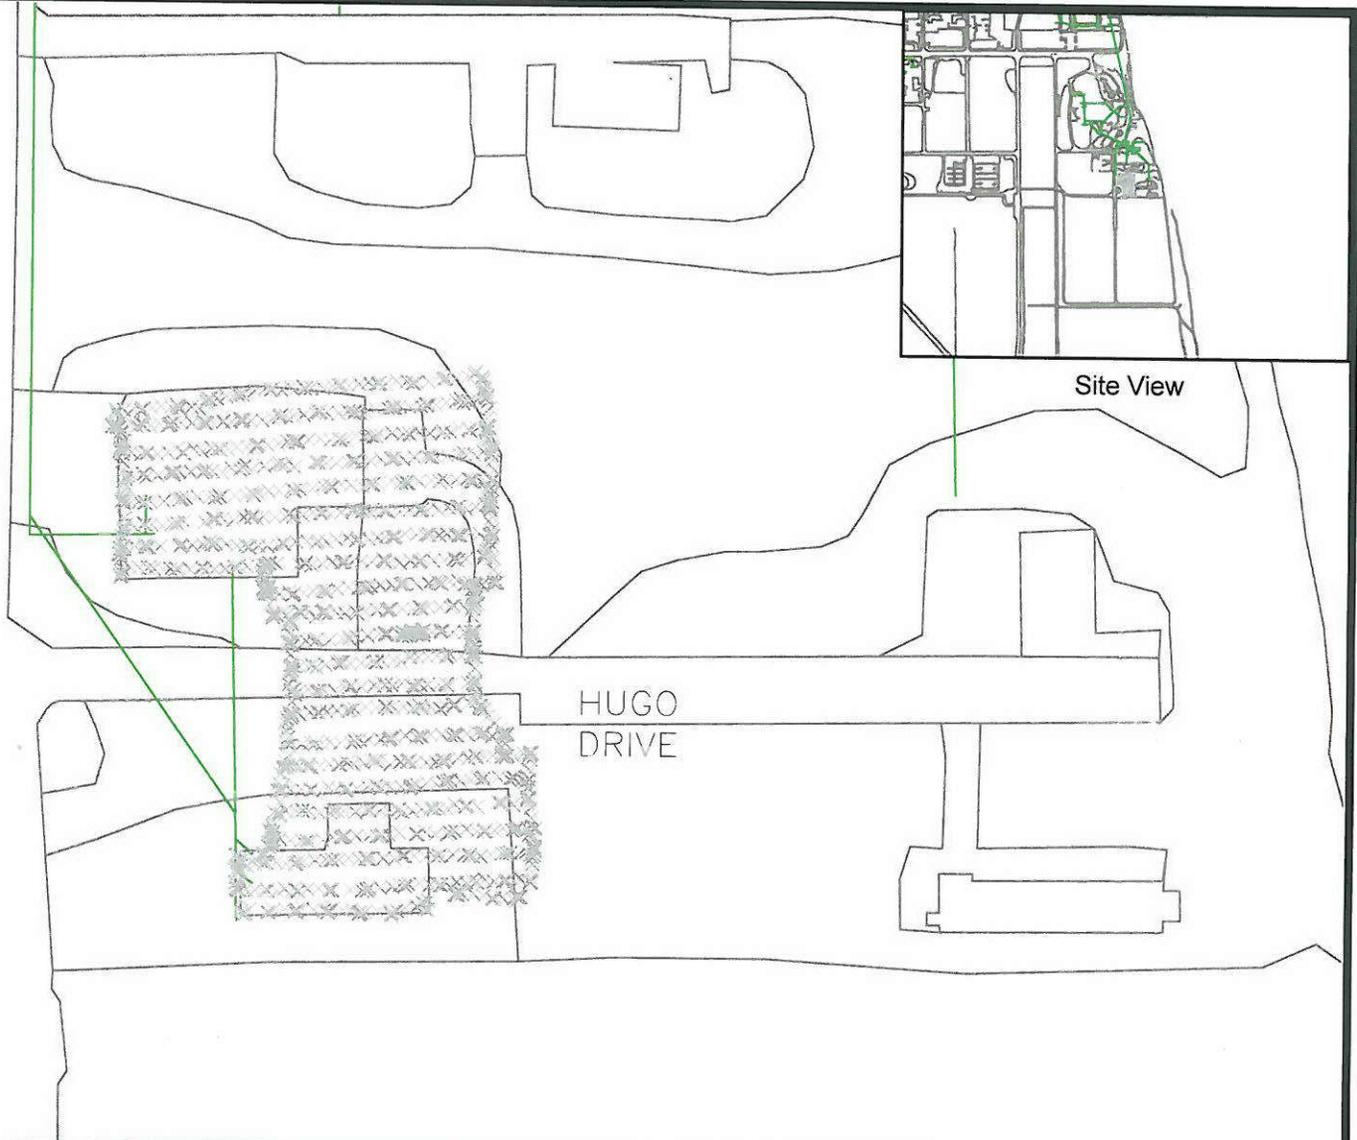
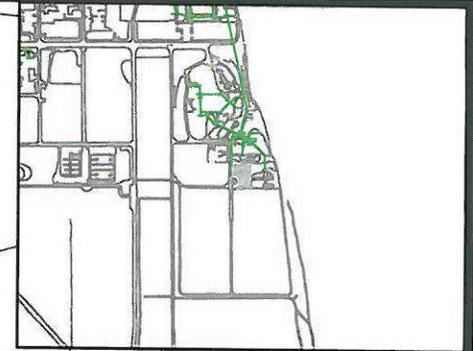
**300 D4
331-G, H
GPERS Radiological Survey
Gamma Track Map**

Bkg Location
1250 m NW
1154 cpm

Coverage File: D4_199
Number of Data Pnts: 3378
Type of Survey: gamma
Max GCPM: 1622
Avg Bkg CPM: 1154
Survey Date: 7/19/2013
Area Surveyed: 1600 m²
Project File: ESRFRM130057G
Pdf File: ESRFRM130057GC
