# OPTIONS FOR RESPONDING TO THE ASSUMED LEAK FROM CATCH TANK 241-UX-302A

This document discusses options for responding to an assumed leak from catch tank 241-UX-302A and recommends a preferred path forward.

**J. G. Propson**  
**G. W. Reddick**  
**R. S. Robinson**  
CH2M HILL Hanford Group, Inc.

**Date Published**  
September 2006

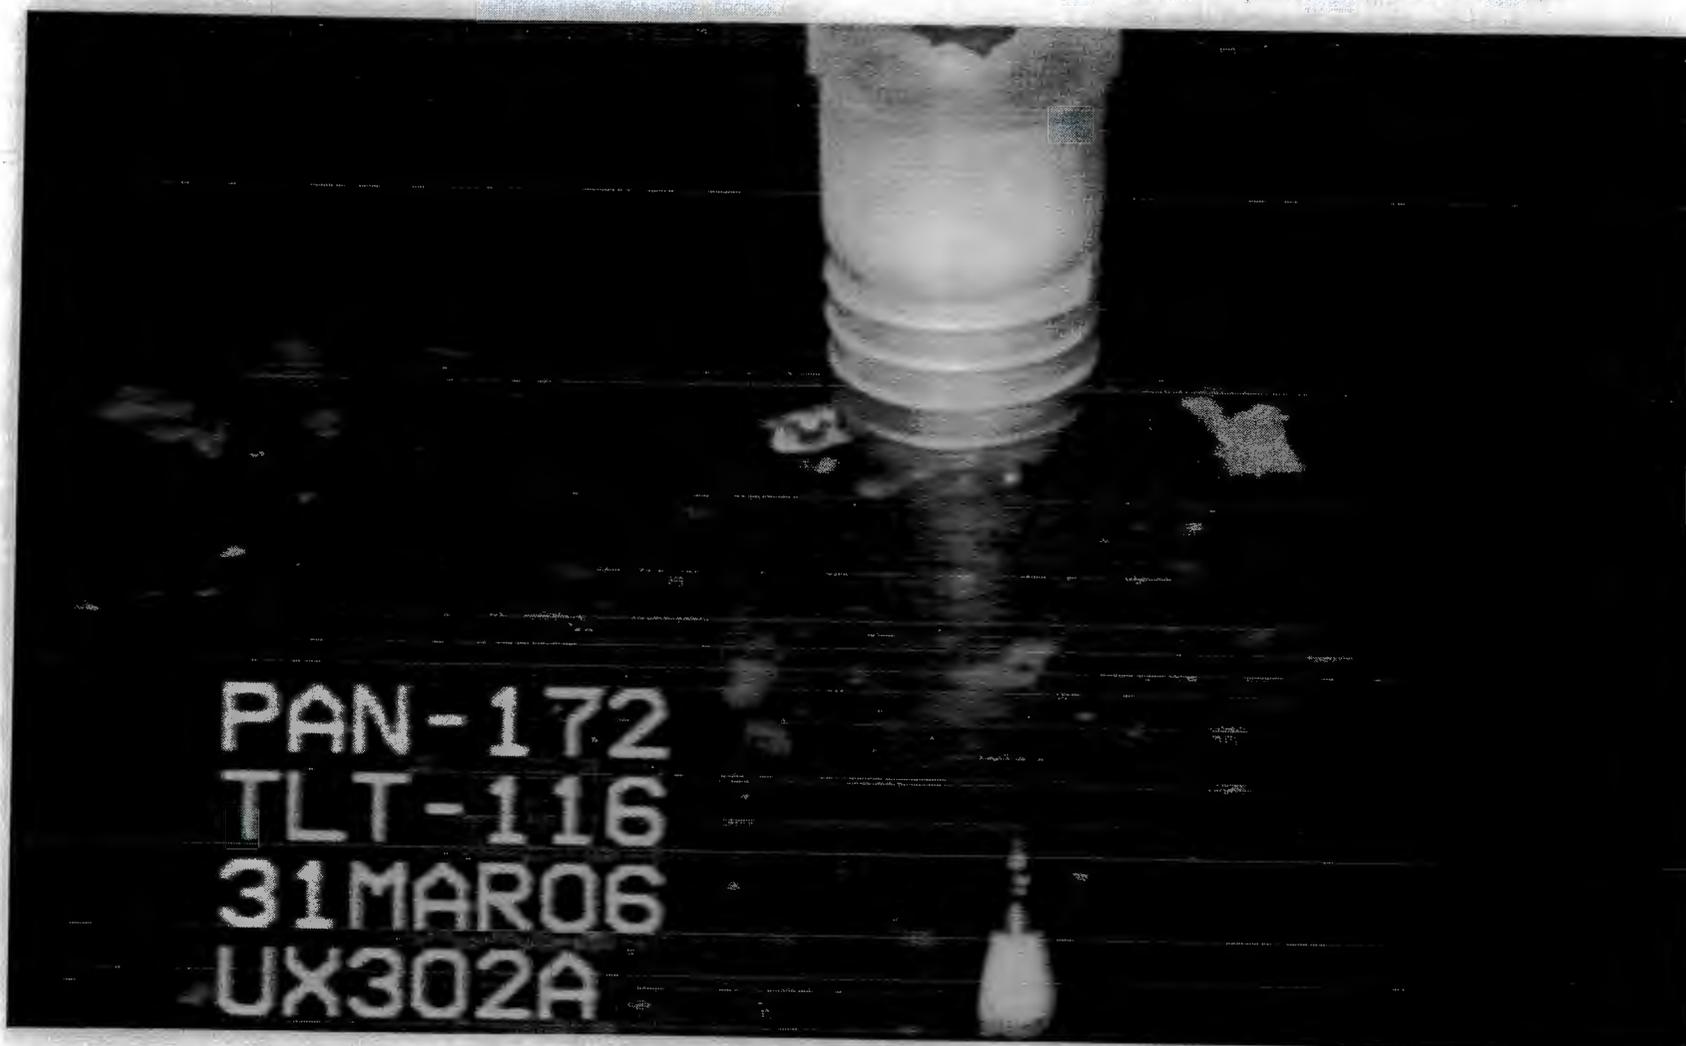
Figure C-3. In-Tank Photo - Installed Pump and ENRAF™ Visible Near Center of Catch Tank 241-UX-302A

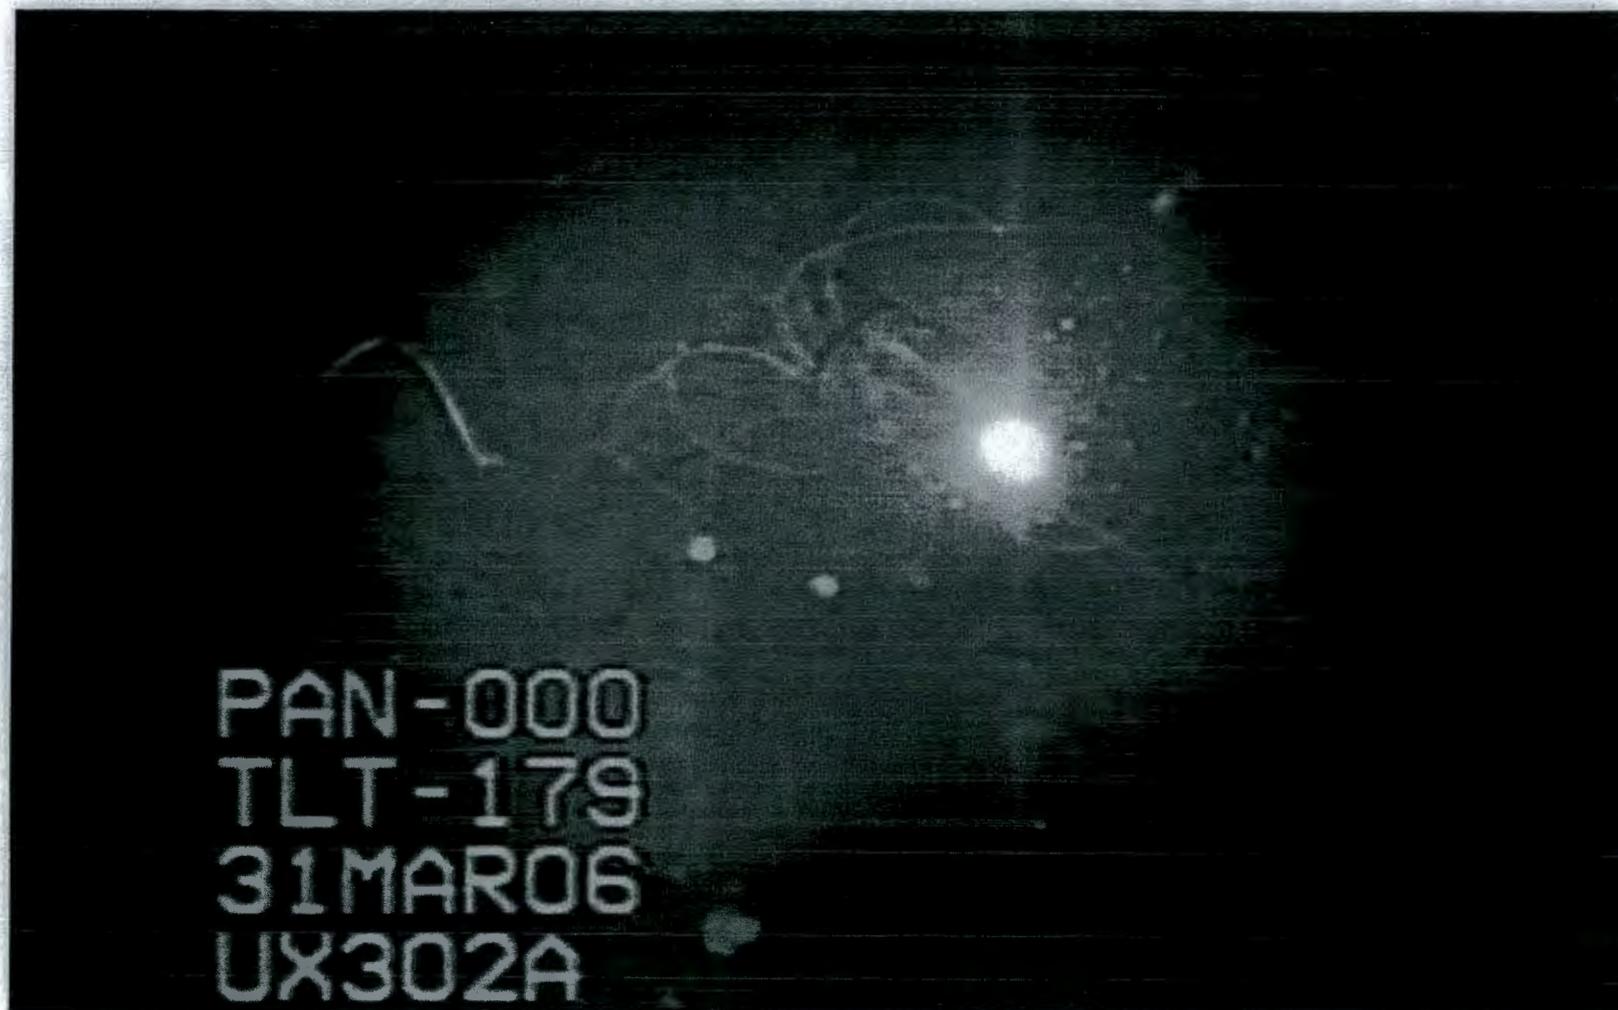
Figure C-5. In-Tank Photo – View Directly Below Riser
