WHC-EP-0535-1

# Annual Surveillance and Maintenance Report for the Retired Hanford Site Facilities Fiscal Year 1992

R. G. Egge

Date Published  
November 1992

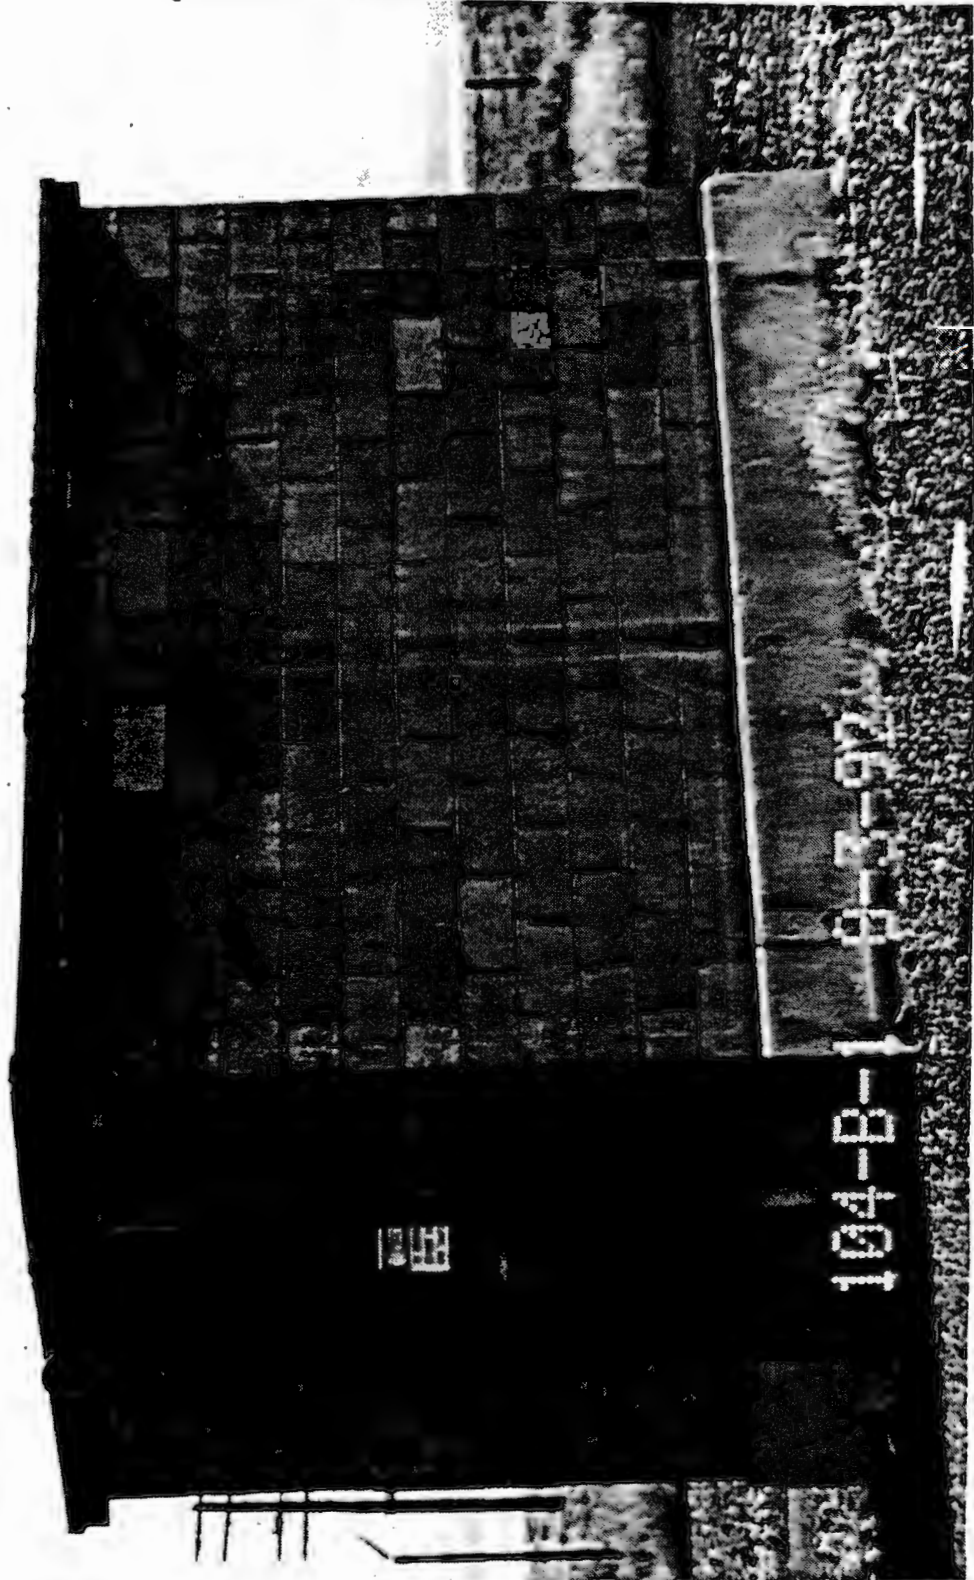
Figure 1-10. 104-B-1 Tritium Vault.

The building's interior is in fair condition, the exterior is in fair to poor condition, and the roof is in poor condition. Presently the building serves no purpose and is scheduled for decommissioning in FY 1998.

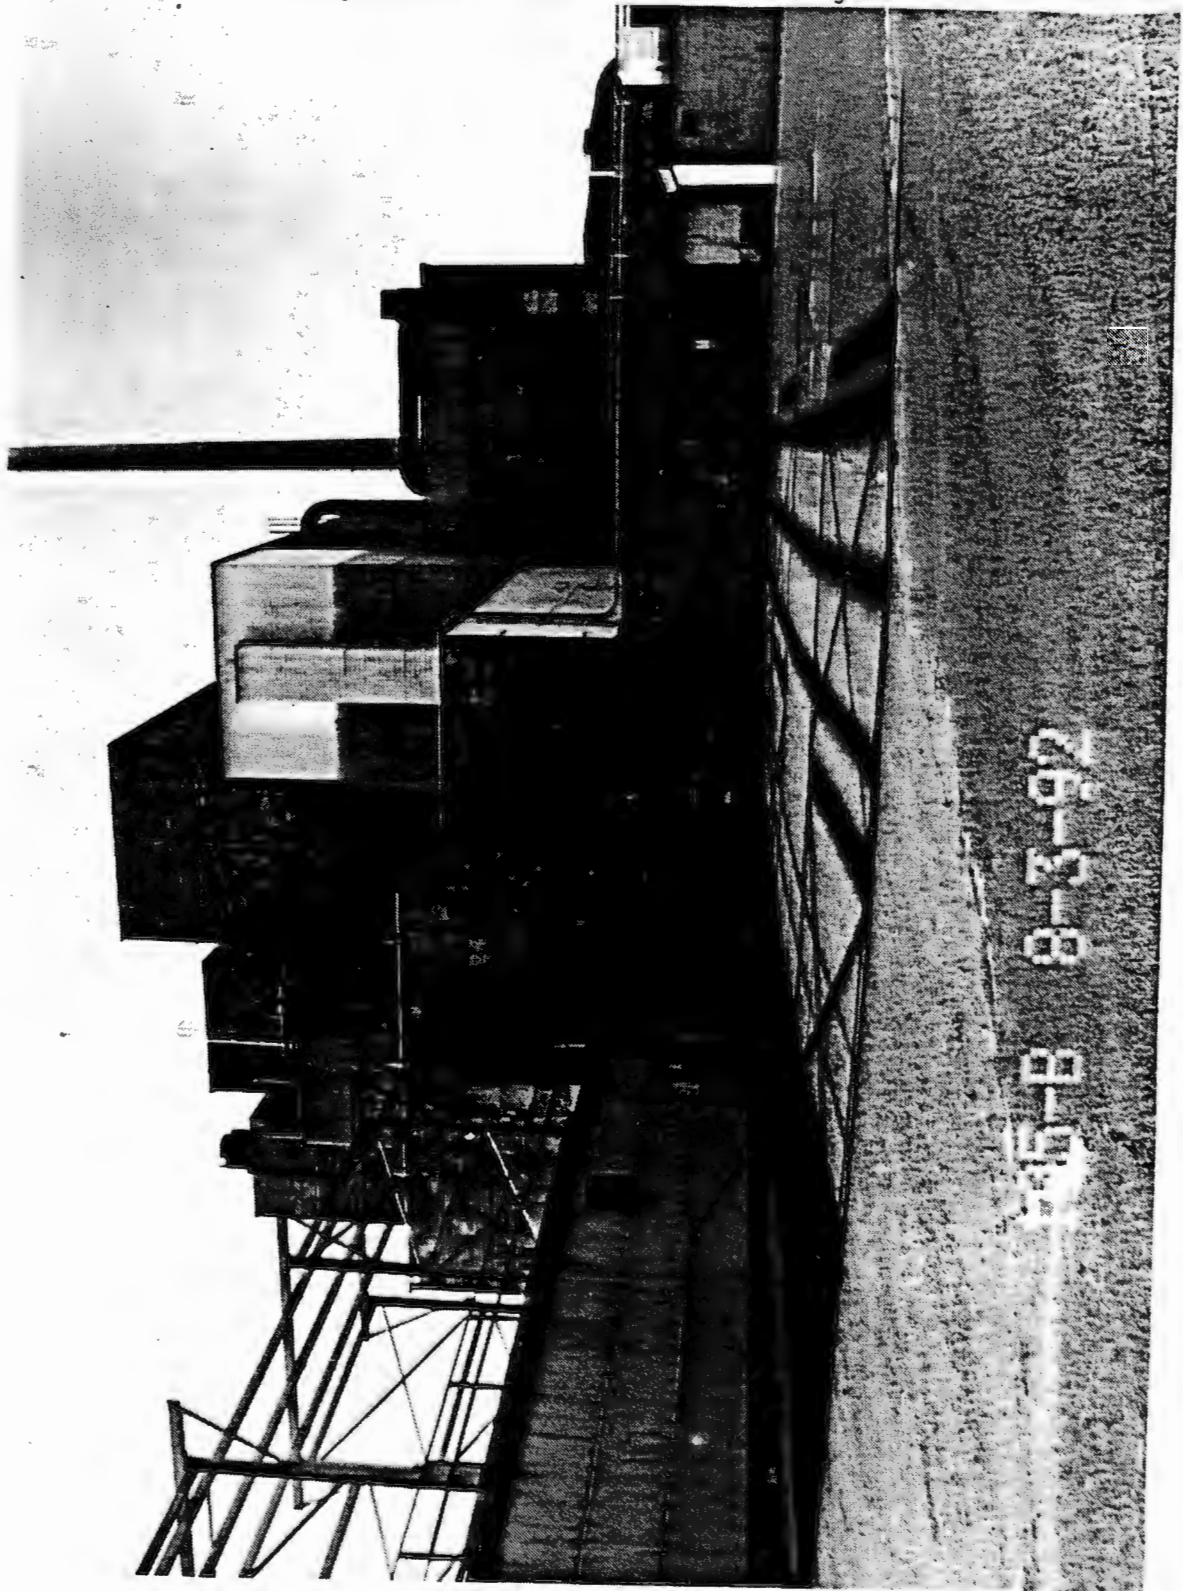
Figure 1-12. 105-B Reactor Building.

The roof is primarily composed of membrane-covered, reinforced, precast concrete panels of the same type as the 105-D, 105-DR, and 105-F Reactors. These panels have endured the past 49 years with a minimum of maintenance and continue to be in good condition because of the initial and continued preventative maintenance the roofs have received since shutdown. Only a few cracked panels need to be replaced in this building.

The building's interior is in good condition and the exterior is in fair condition. The roof is in fair to good condition, but requires annual maintenance and repair to minimize water infiltration. The overall building contains an estimated 13,500 Ci of radionuclides (primarily activation products contained within the graphite core). This is based on the core analysis performed on the 105-D Reactor, which is the same basic size as the 105-B core. In addition, 89.4 metric tons (88 tons) of lead and an unknown quantity of asbestos are contained within the building structure.

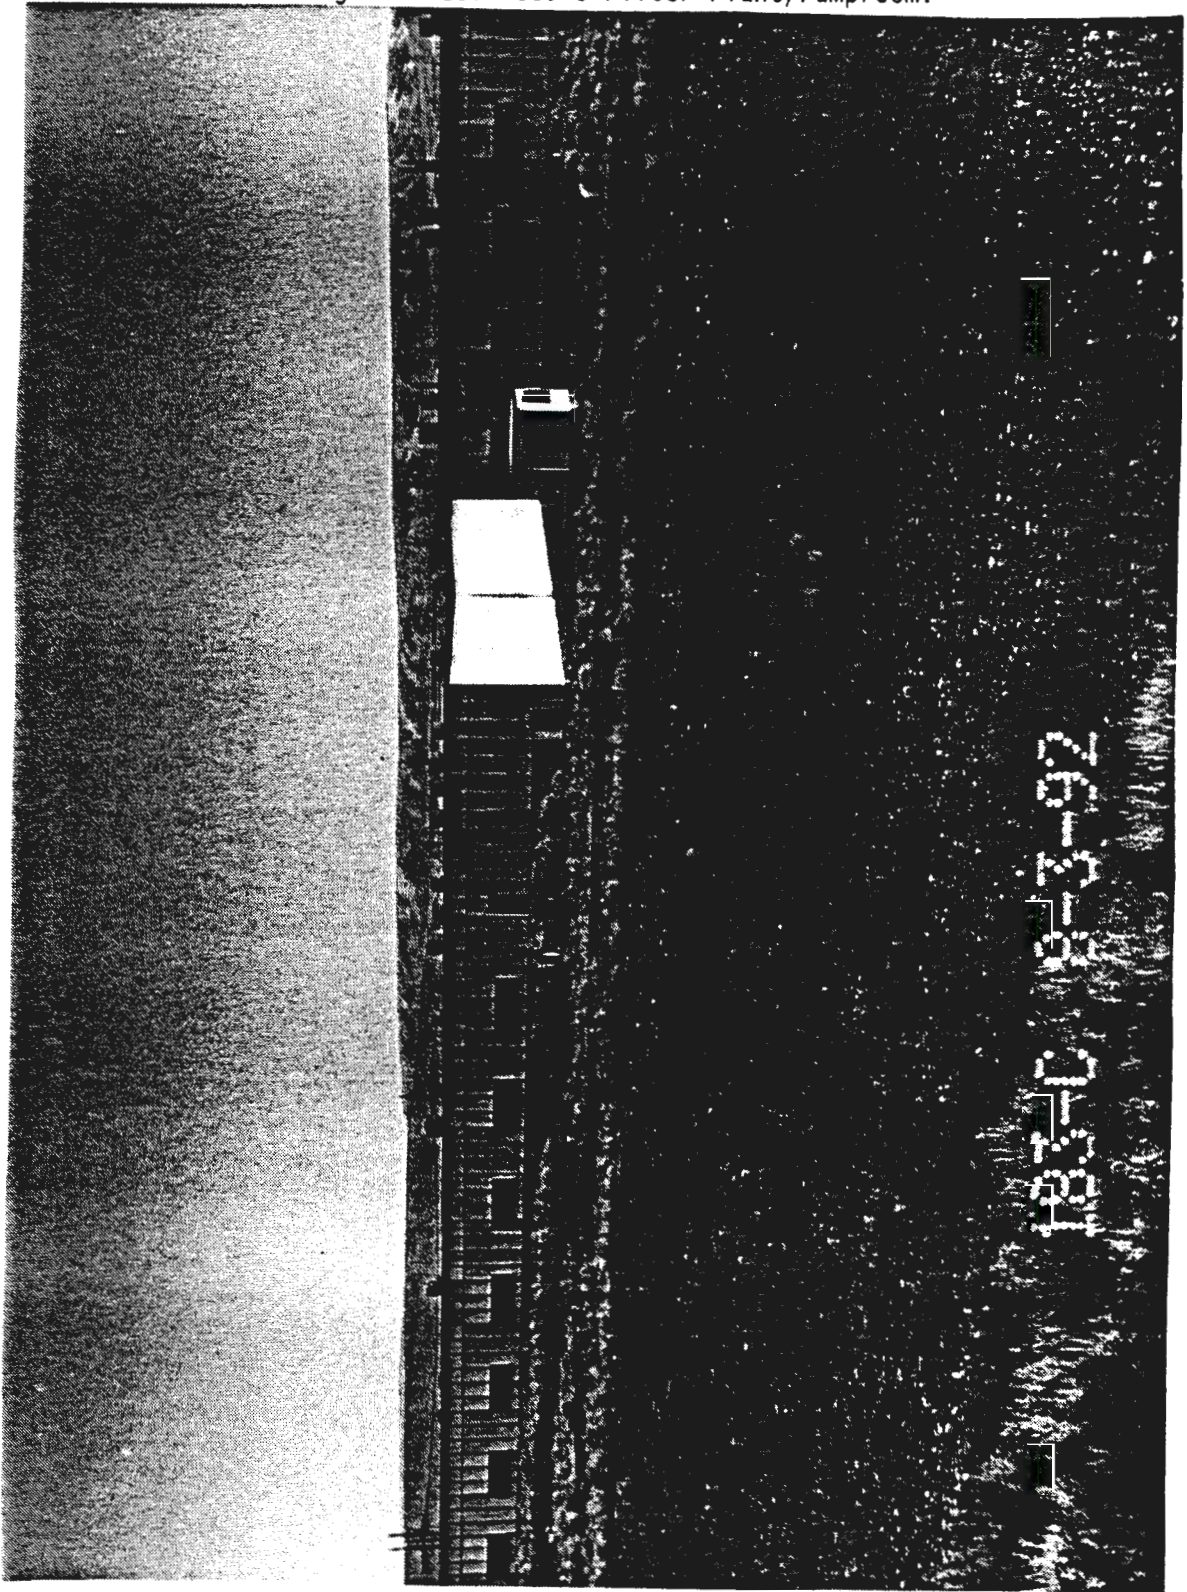
Figure 1-21. 183-C Filter Plant/Pumphoom.

The building's interior is in fair condition, the exterior is in poor condition, and the asphalt-covered metal roof is in very poor condition. Figure 1-22 shows a portion of the roof's exterior that was blown off by the wind. Figure 1-23 shows the internal roof trusses, which are deteriorating as

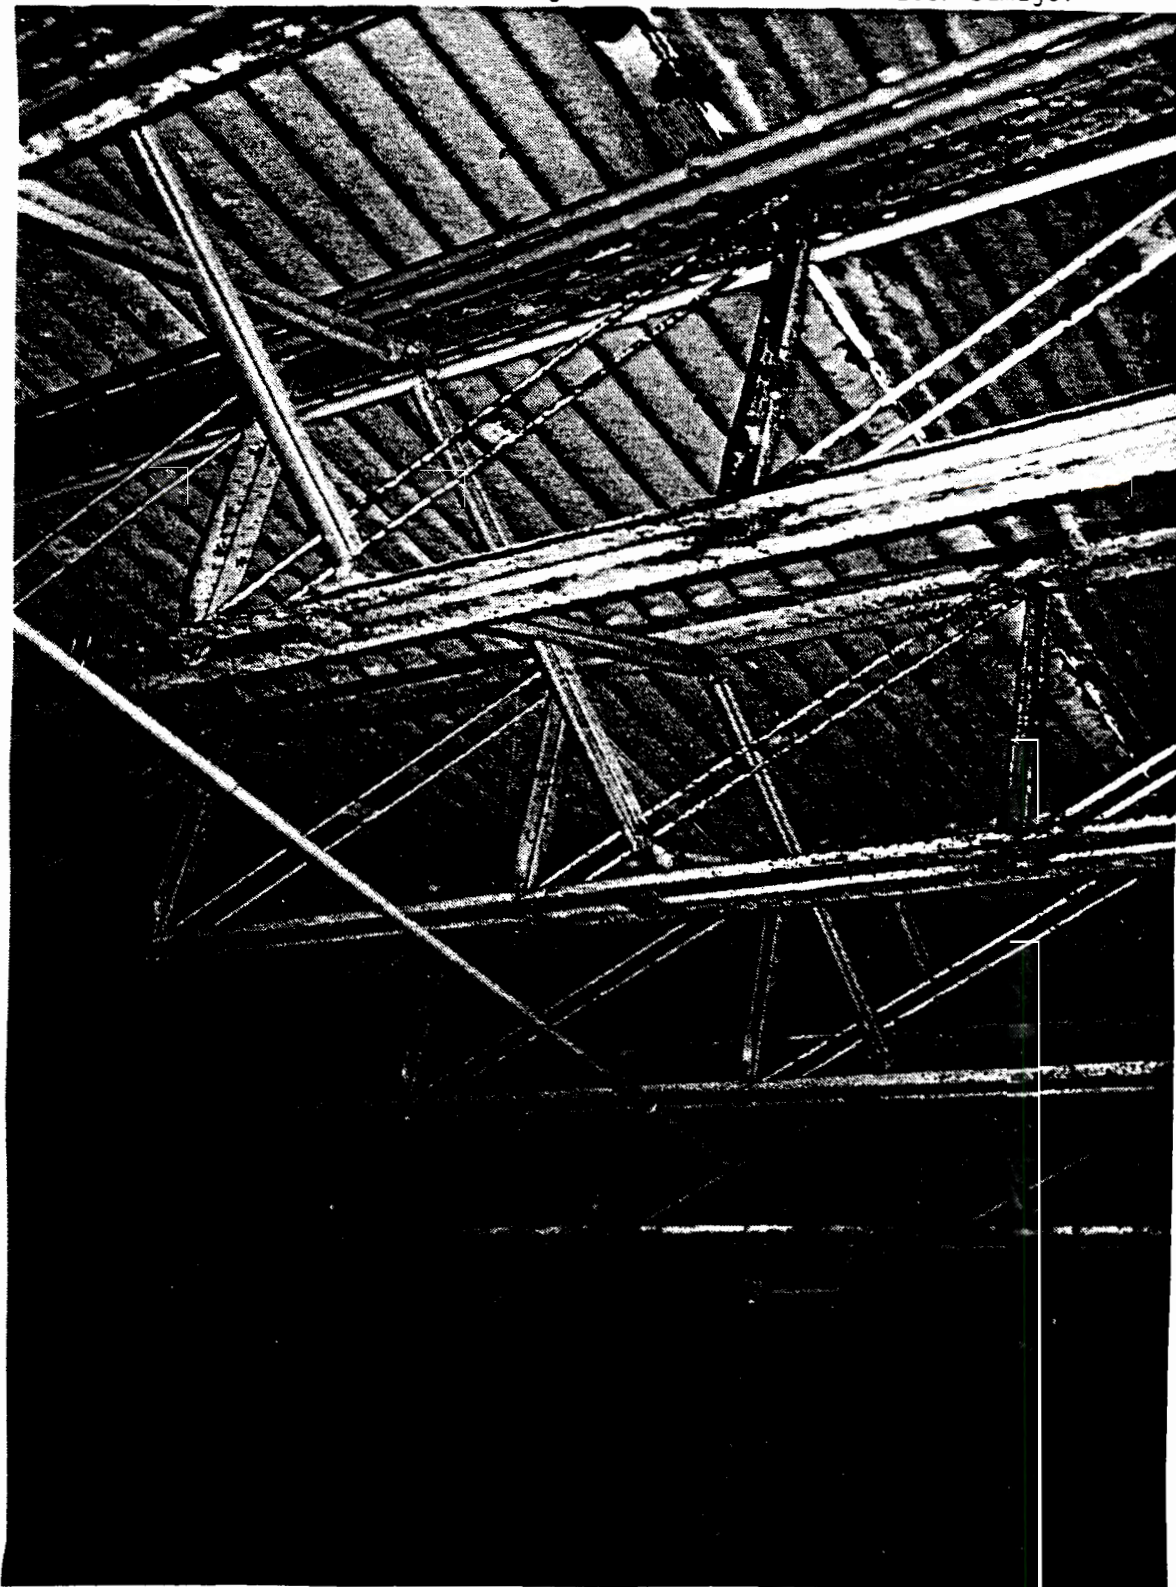
Figure 1-23. 183-C Building Internal Roof Truss Water Damage.

a result of the infiltration of rain water. The water that infiltrated the building has collected in a belowgrade basin and will be pumped out in FY 1993. Presently the building serves no purpose and is scheduled for decommissioning in FY 2003.

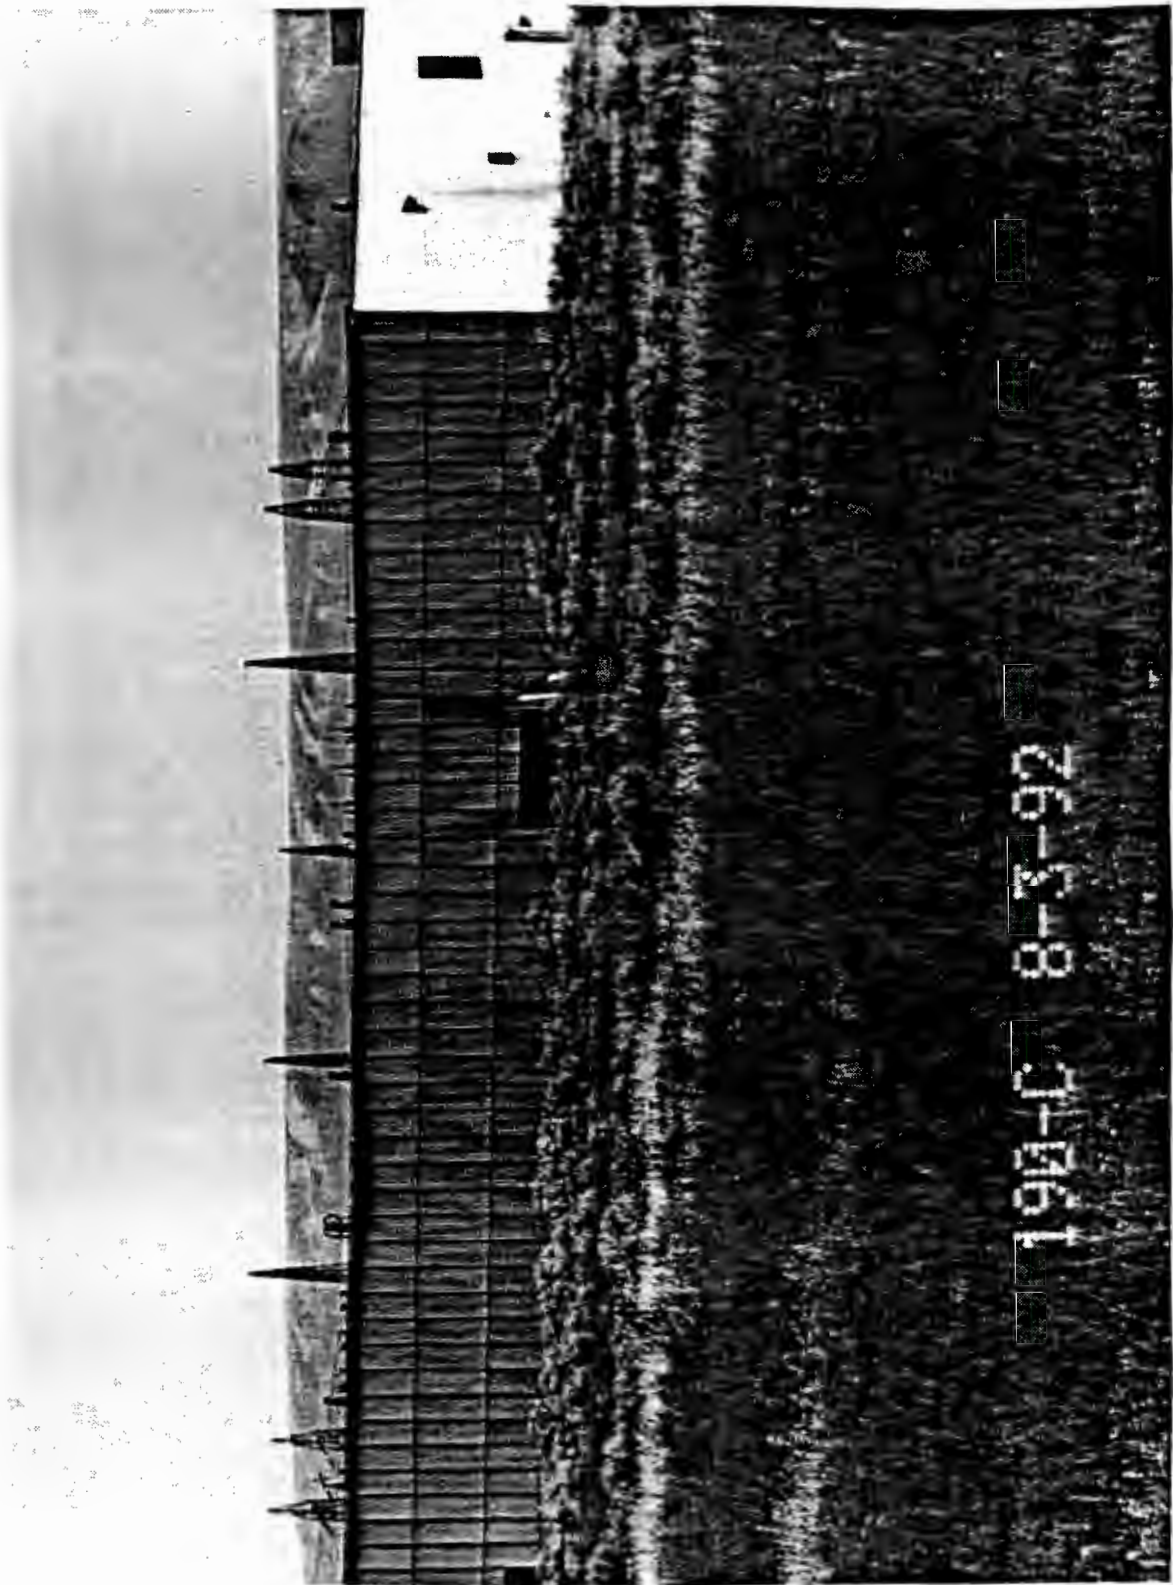
Figure 1-24, 190-C Main Pump House.

The building's interior is in poor condition, the exterior is in fair condition, and the asphalt-covered metal roof is in extremely poor condition. Presently the building is assigned to N Reactor under a Letter of Understanding for storage of radiologically contaminated filters. The internal equipment has been removed in preparation for decommissioning in FY 1999.

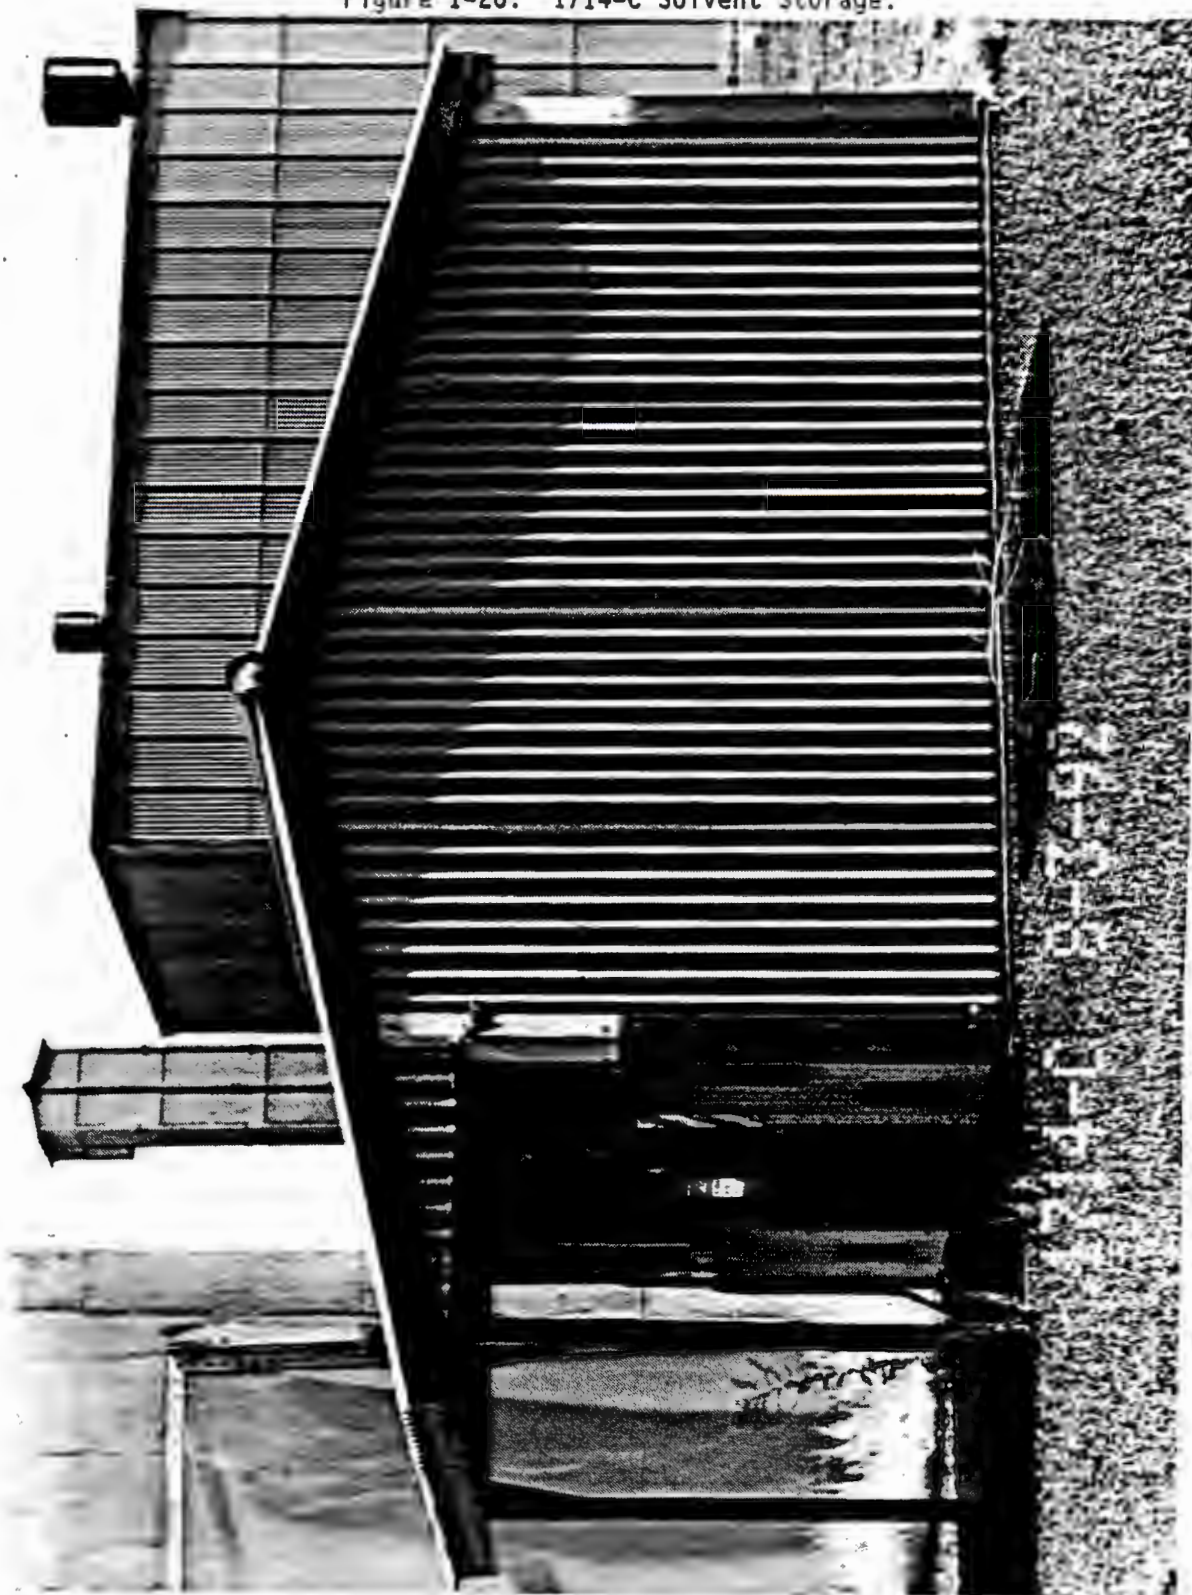
Figure 1-26. 1714-C Solvent Storage.

The 1714-C Building is located south of 105-C Reactor and was used for miscellaneous oil and solvent storage. This facility is a steel-framed, transite structure on a concrete foundation, approximately  $14.5 \text{ m}^2$  ( $156 \text{ ft}^2$ ).

The building's interior, exterior, and roof are all in poor condition. Presently the building serves no purpose and is scheduled for decommissioning in FY 2008.

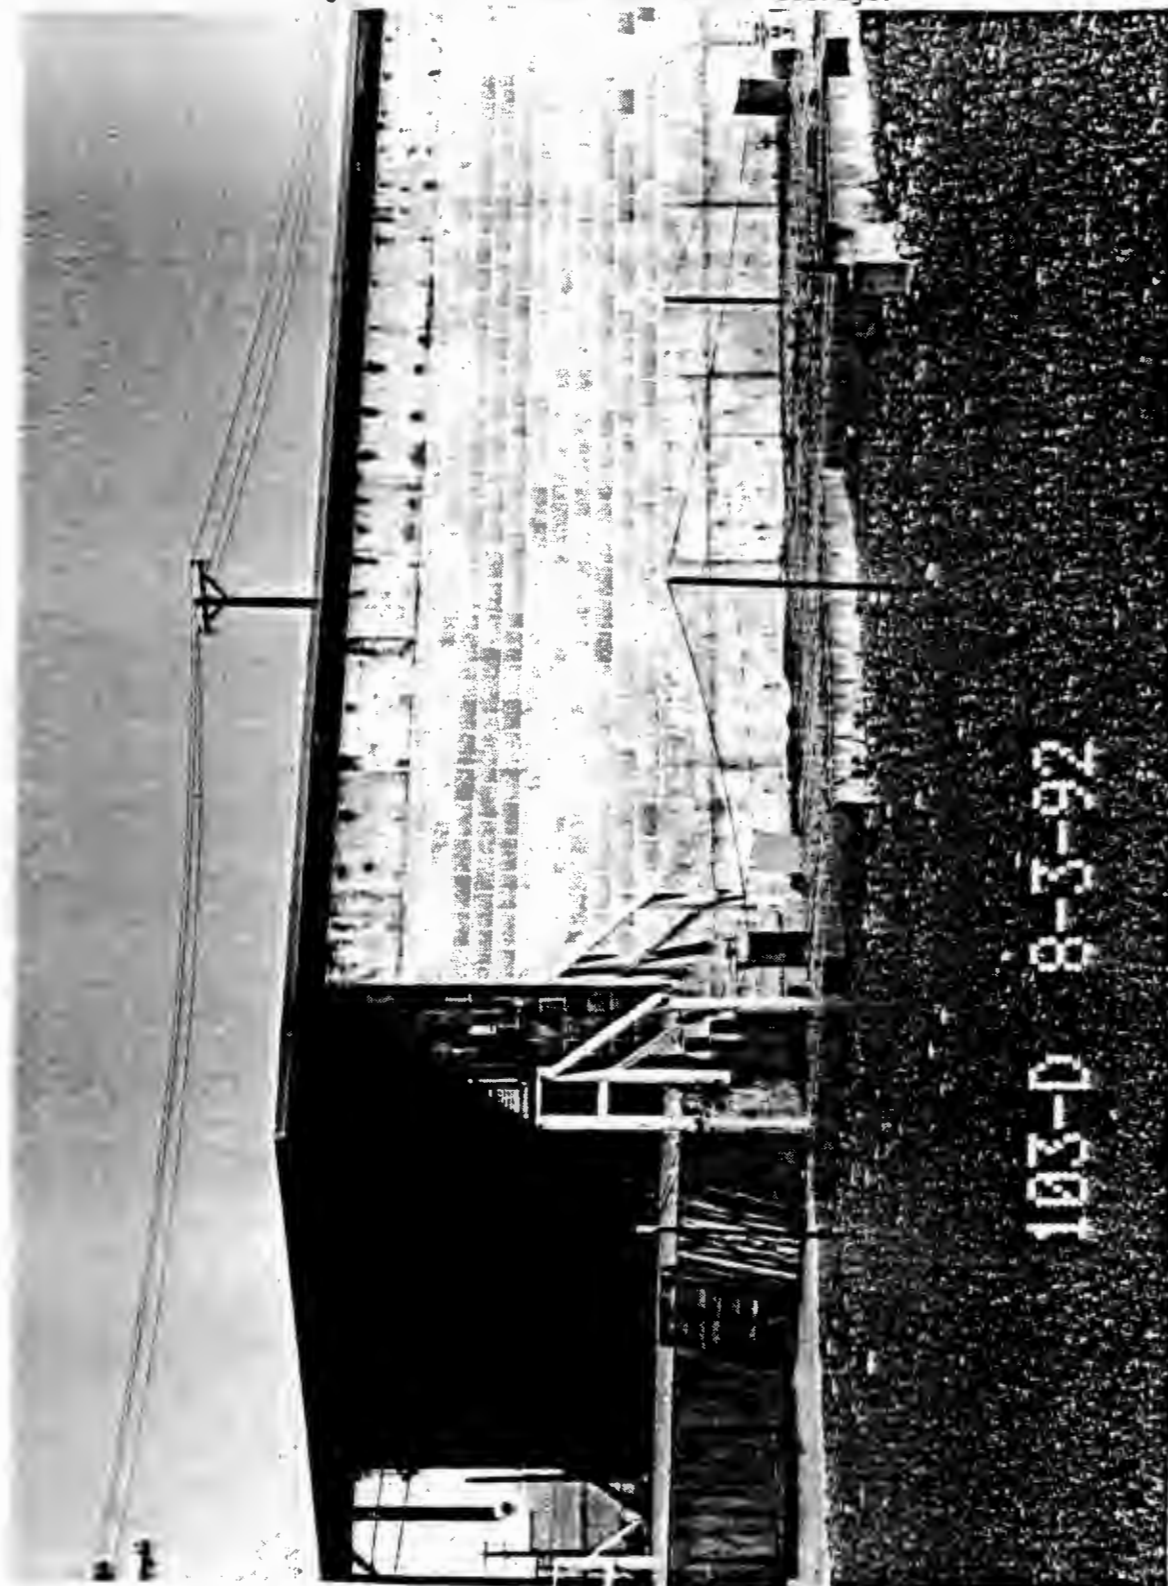
Figure 1-27. 103-D Fresh Metal Storage.

The building's interior and exterior are in fair condition. The asphalt-covered roof is in poor condition. Presently the building serves no purpose and is scheduled for decommissioning in FY 1996.

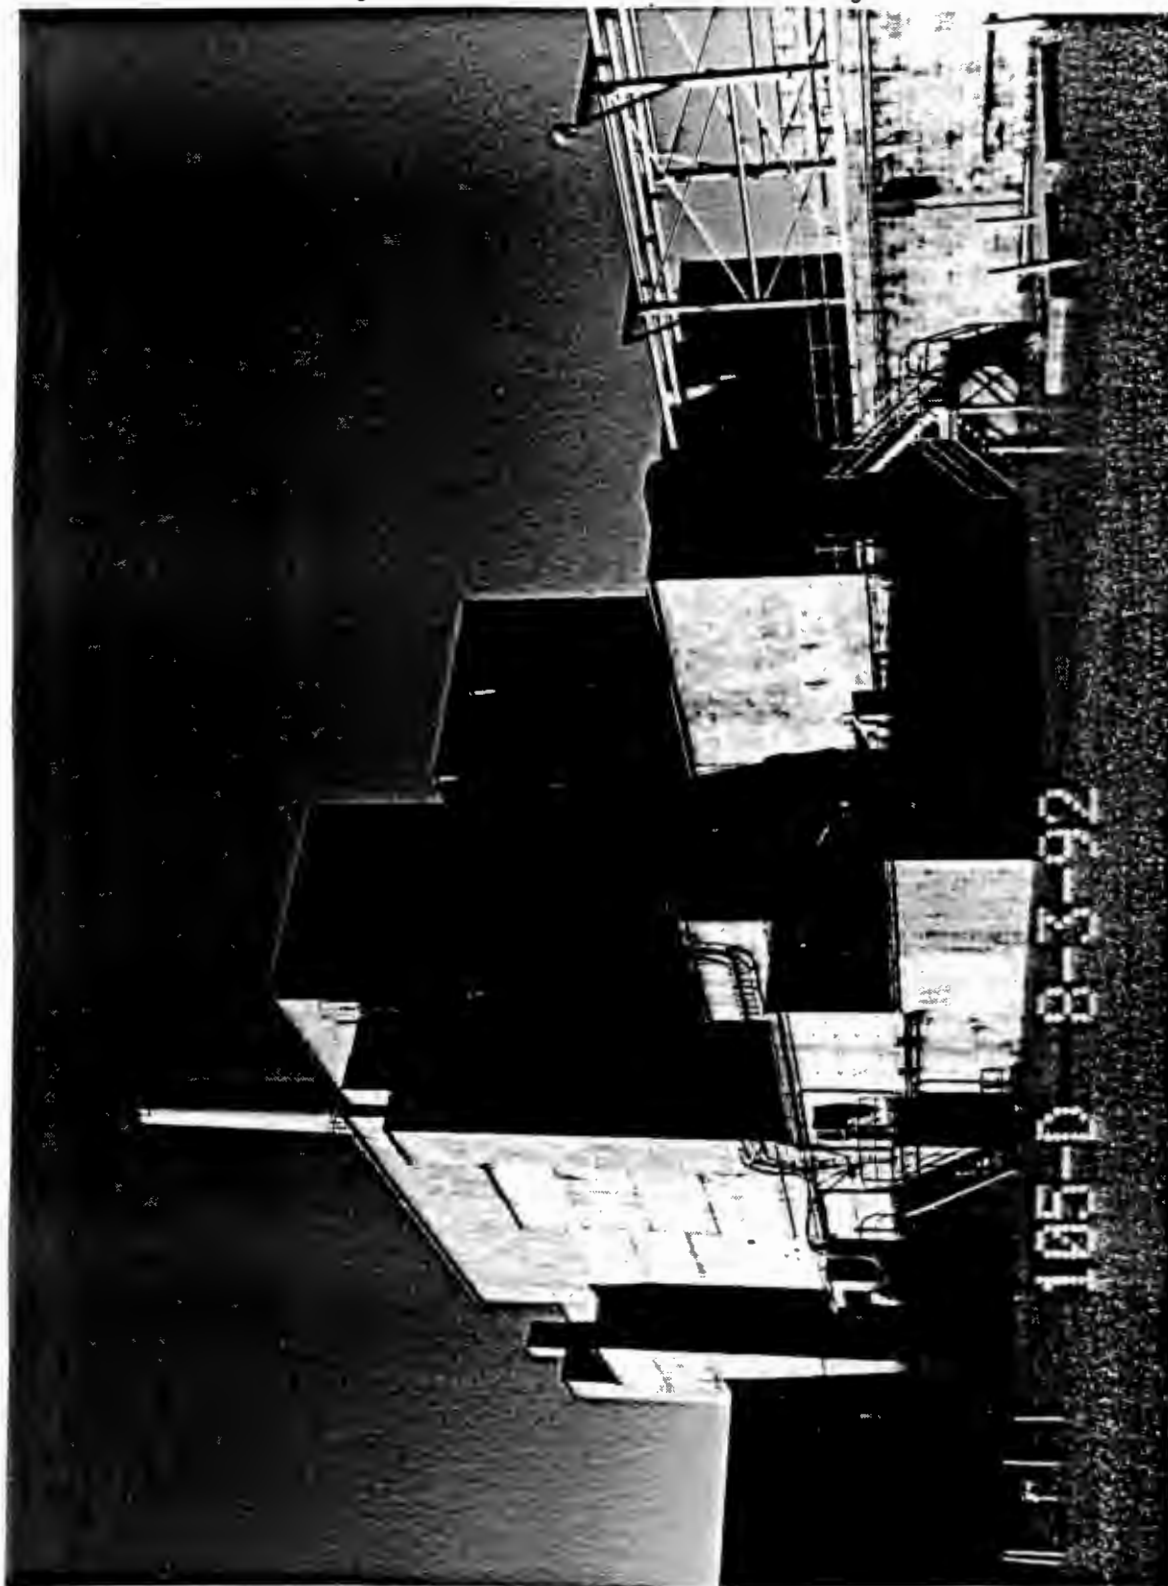
Figure 1-28. 105-D Reactor Building.

The roof is primarily composed of asphalt-covered, reinforced, precast concrete panels of the same type as the 105-B and 105-F Reactors. These panels have endured the past 49 years with a minimum of maintenance, but they are beginning to show severe signs of deterioration in numerous locations. Complete panel replacement will be required in approximately 50 locations.

The building's interior is in poor condition, with numerous friable asbestos locations in radiologically contaminated areas; the exterior is in poor condition, with numerous friable asbestos problems; and the roof is in poor condition in several locations. The overall building contains an estimated 13,500 Ci of radionuclides (primarily activation products contained within the graphite core). In addition, 96.5 metric tons (95 tons) of lead and 2.83 m<sup>3</sup> (100 ft<sup>3</sup>) of asbestos are contained within the facility.

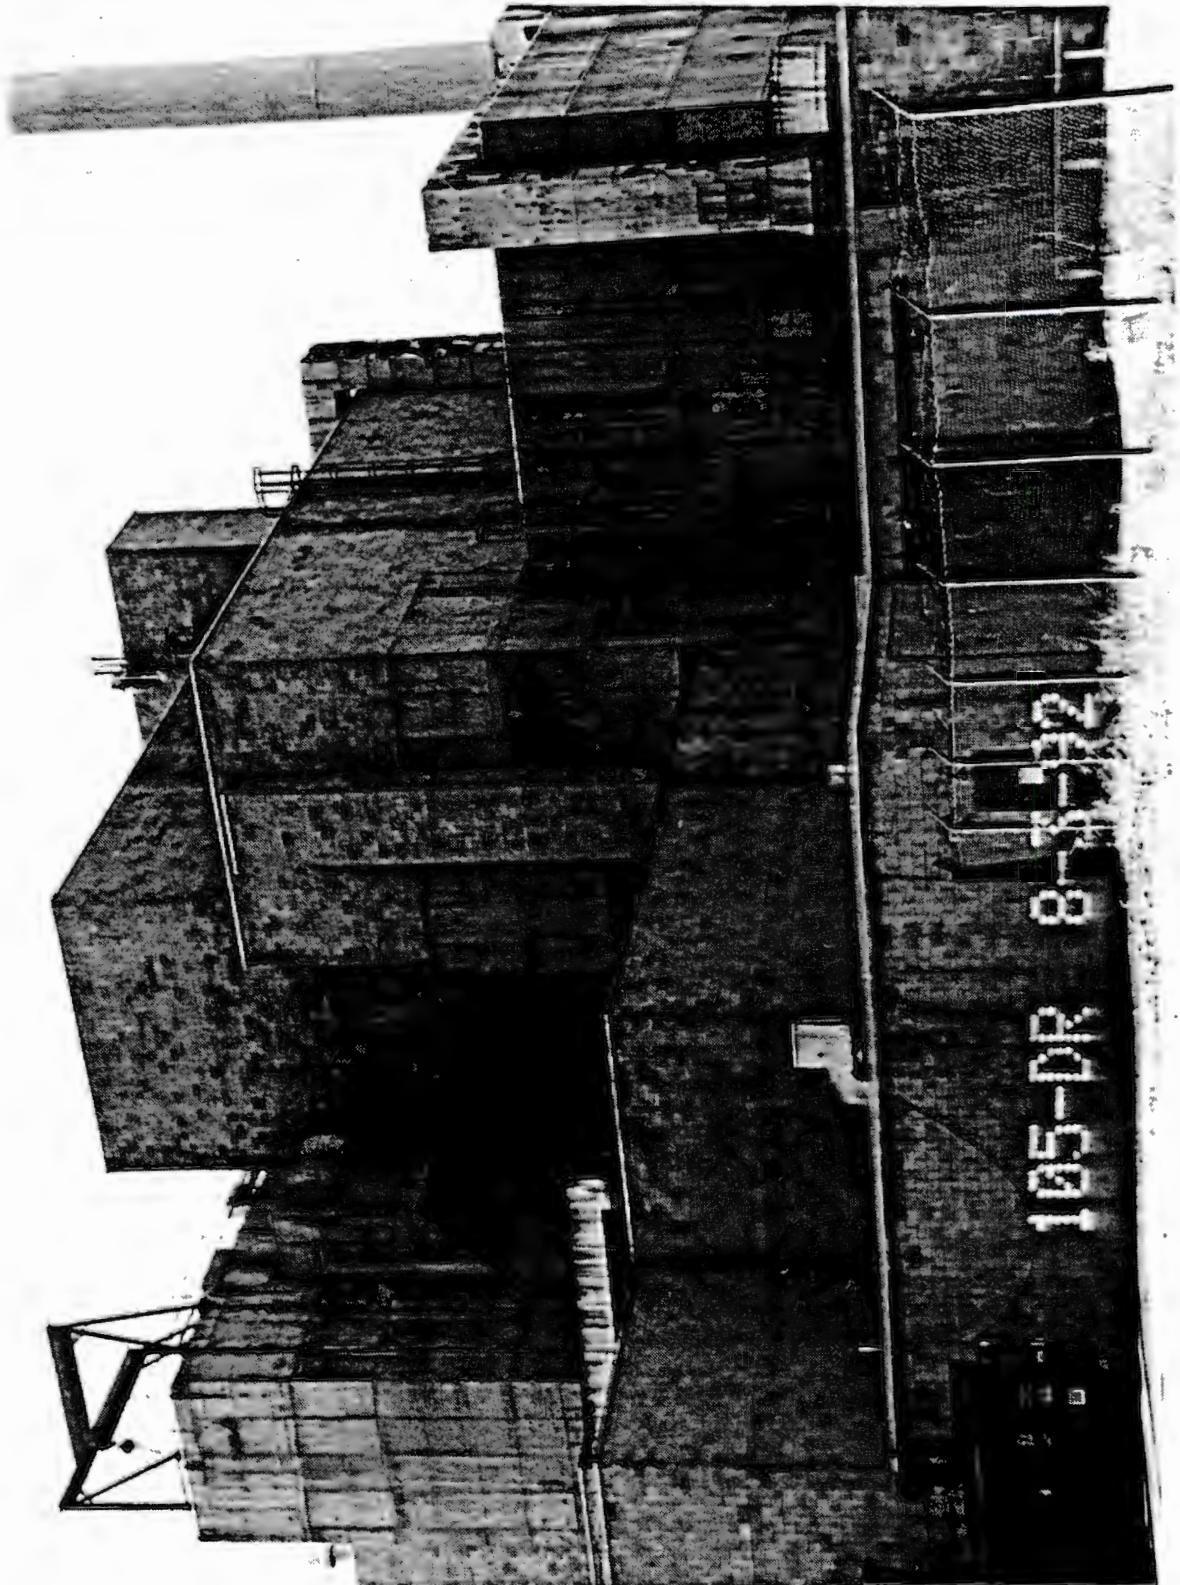
Figure 1-30. 105-DR Reactor Building.

The roof is primarily composed of asphalt-covered, reinforced, precast concrete panels of the same type as the 105-B, 105-D, and 105-F Reactors. These panels have endured the past 45 years with a minimum of maintenance, but they have deteriorated past the point of corrective maintenance in numerous locations. Complete panel replacement is required in approximately 45 of these roof panels.

The building's interior and exterior are in poor condition, with numerous friable asbestos locations, and the roof is in poor condition in several locations. The overall building contains an estimated 13,500 Ci of radionuclides (primarily activation products contained within the graphite core). This is based on the core analysis performed on the 105-D Reactor, which is the same basic size as the 105-DR core. In addition, 96.5 metric tons (95 tons) of lead and an unknown quantity of asbestos are contained within the facility. However, the core radionuclide loading may be slightly less than the 105-D core because the procurement specification for the graphite in the second group of reactors constructed at the Hanford Site, those being the 105-C, 105-DR and 105-H, did not allow the graphite to contain as many impurities as the original specification. The net result should be a lowering of the activation products.

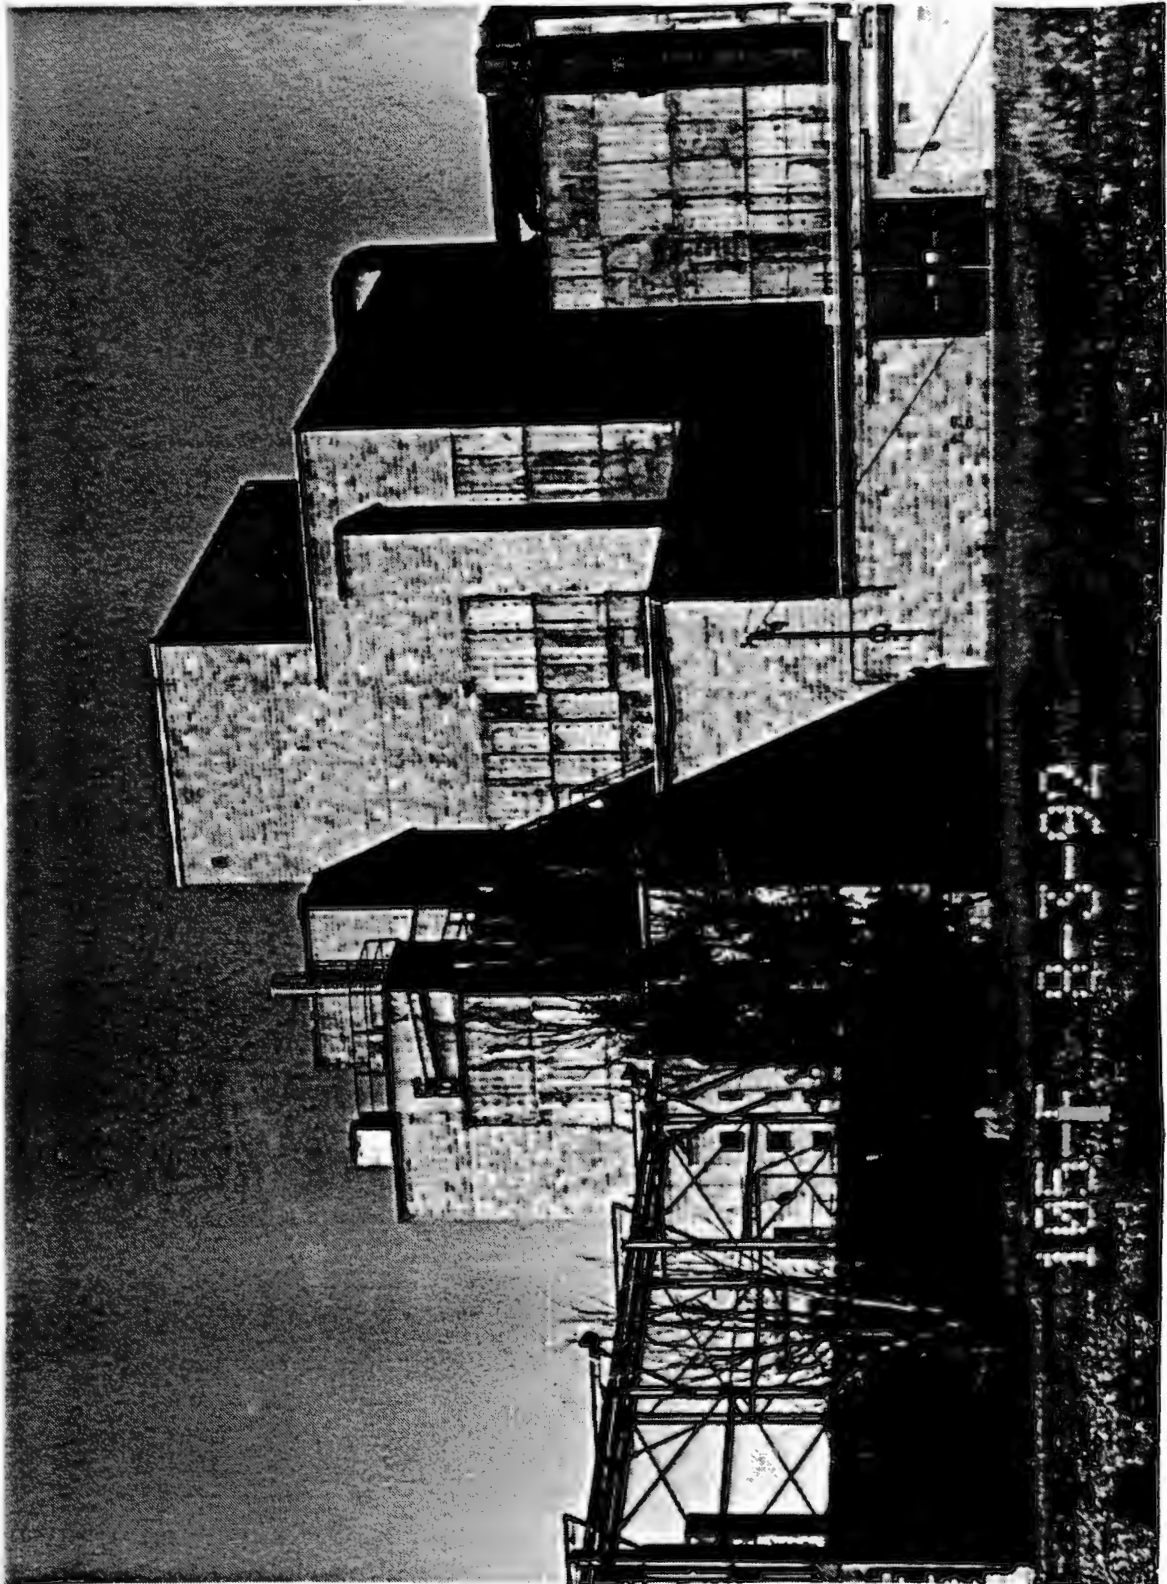
Figure 1-35. 105-F Reactor Building.

The fuel storage basin served as an underwater collection, storage, and transfer facility for the irradiated fuel elements discharged from the reactor. It consists of a fuel element pickup area, storage area, and transfer area. The basin is 6.7 m (22 ft) deep and contained 6.1 m (20 ft) of water during operation. It has since been partially drained and backfilled with soil and rock.

The roof is primarily composed of asphalt-covered, reinforced, precast concrete panels of the same type as the 105-B, 105-D, and 105-DR Reactors. These panels have endured the past 49 years with a minimum of maintenance, but they now show severe signs of deterioration in approximately 30 percent of the overall building. Complete panel replacement will be required in approximately 350 to 500 locations.

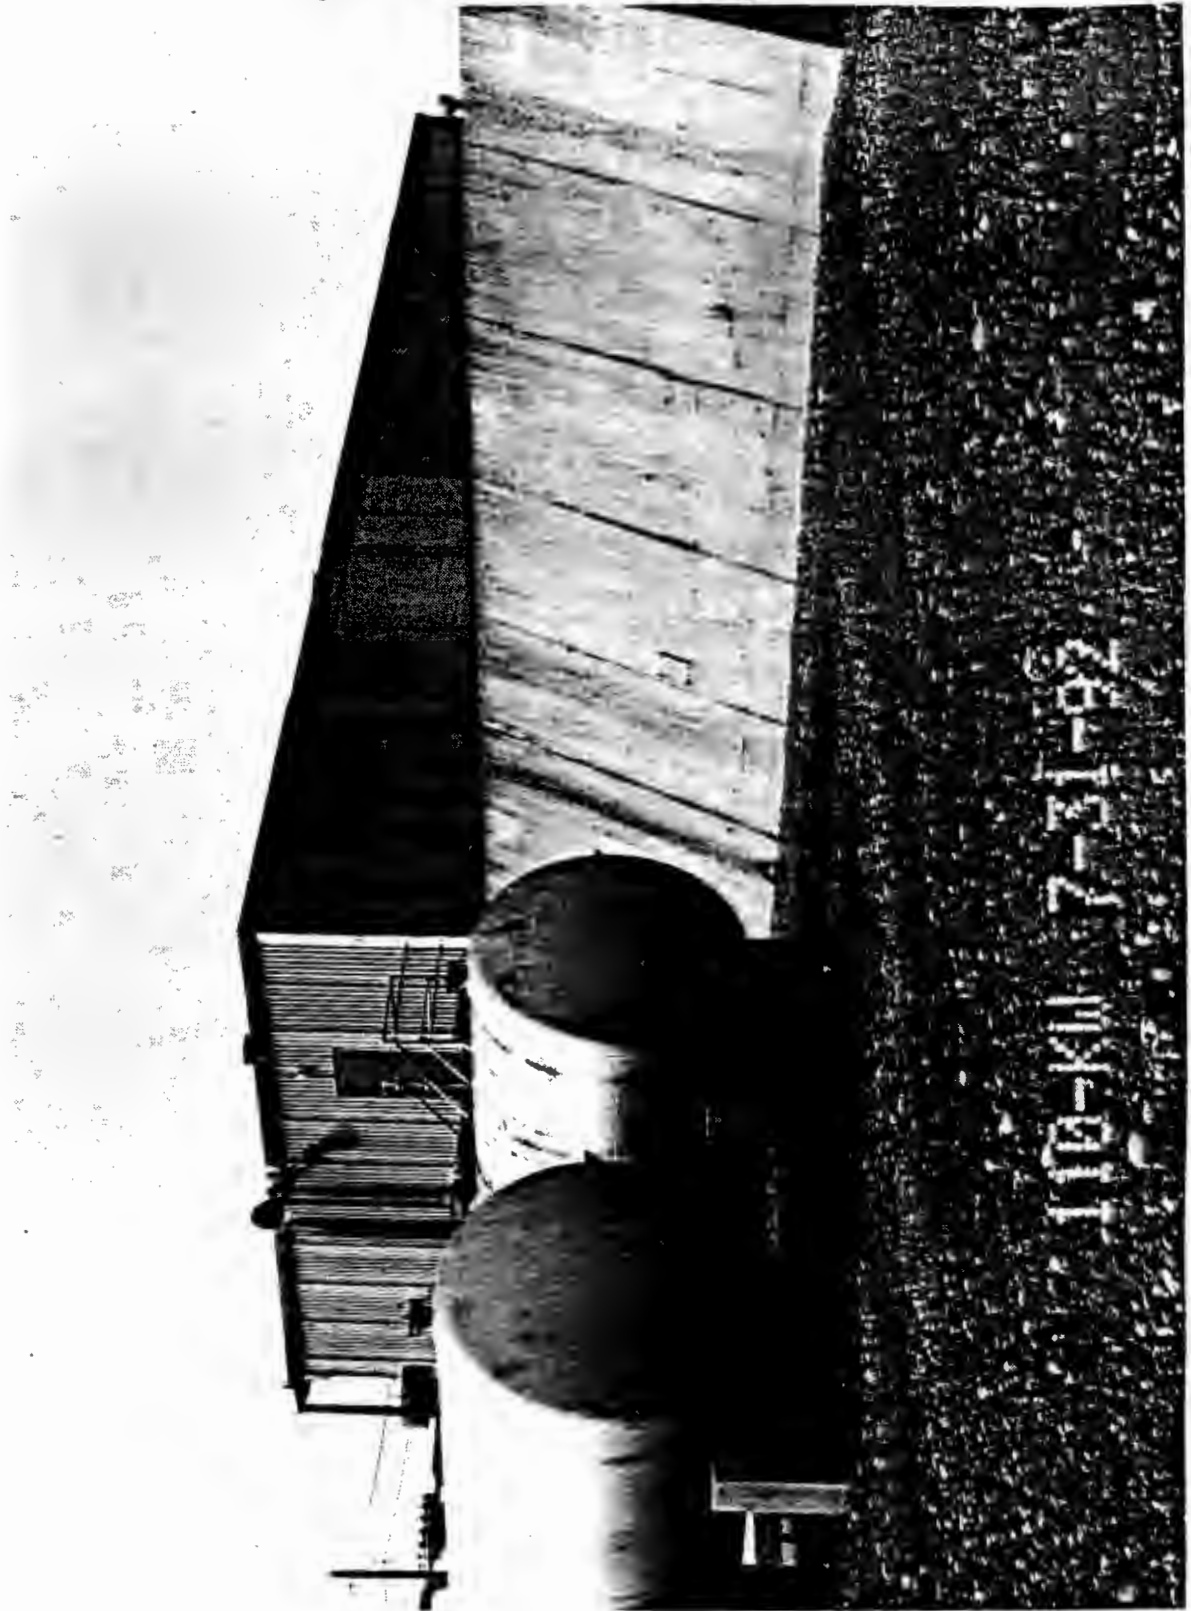
Figure 1-57. 110-KW Gas Storage Facility.

The bunker building's interior, exterior, and roof are in fair condition. Presently the building serves no purpose and is scheduled for decommissioning in FY 2006.
