WHC-EP-0535-1

# Annual Surveillance and Maintenance Report for the Retired Hanford Site Facilities Fiscal Year 1992

R. G. Egge

Date Published  
November 1992

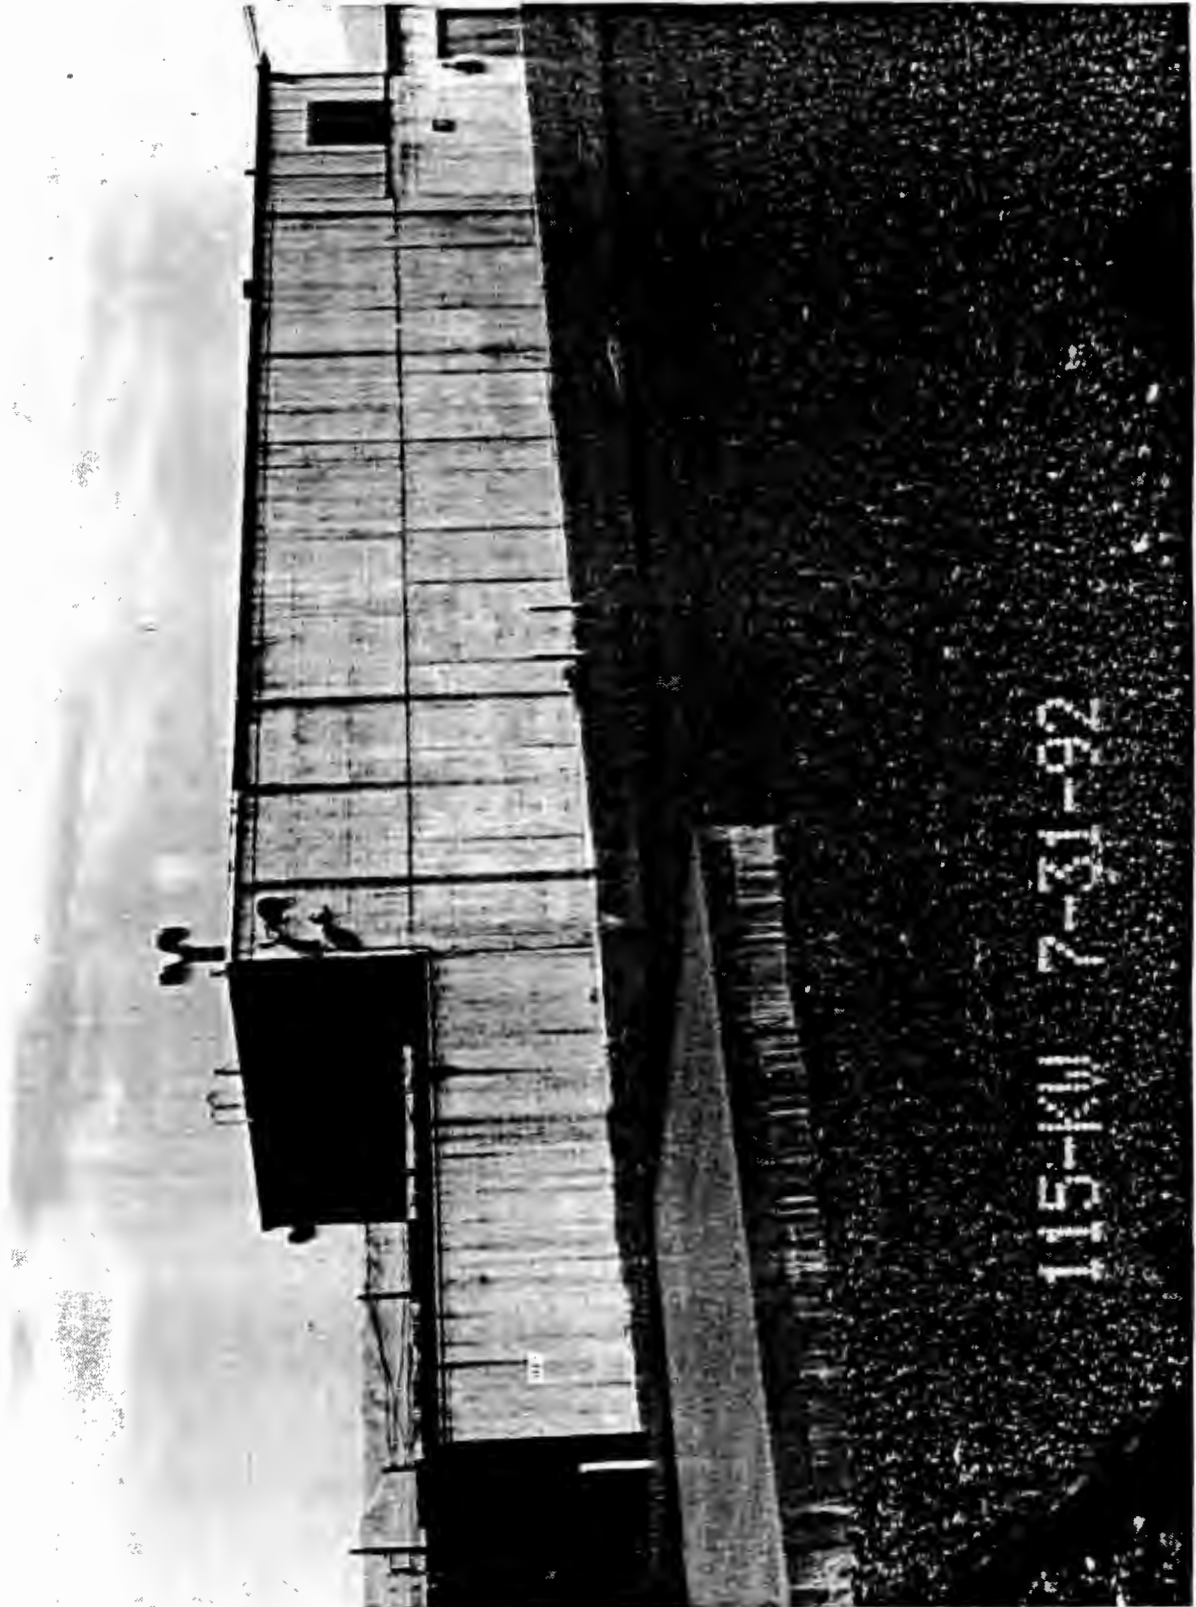
Figure 1-58. 115-KW Gas Recirculation Building.

The 115-KW Facility housed the gas circulating pumps and associated equipment for the Reactor Gas Coolant System. The building is a single-story, reinforced concrete structure, 34.6 m by 10.4 m (113.5 ft by 34 ft), with 6.1 m (20 ft) abovegrade and 6.1 m (20 ft) belowgrade.

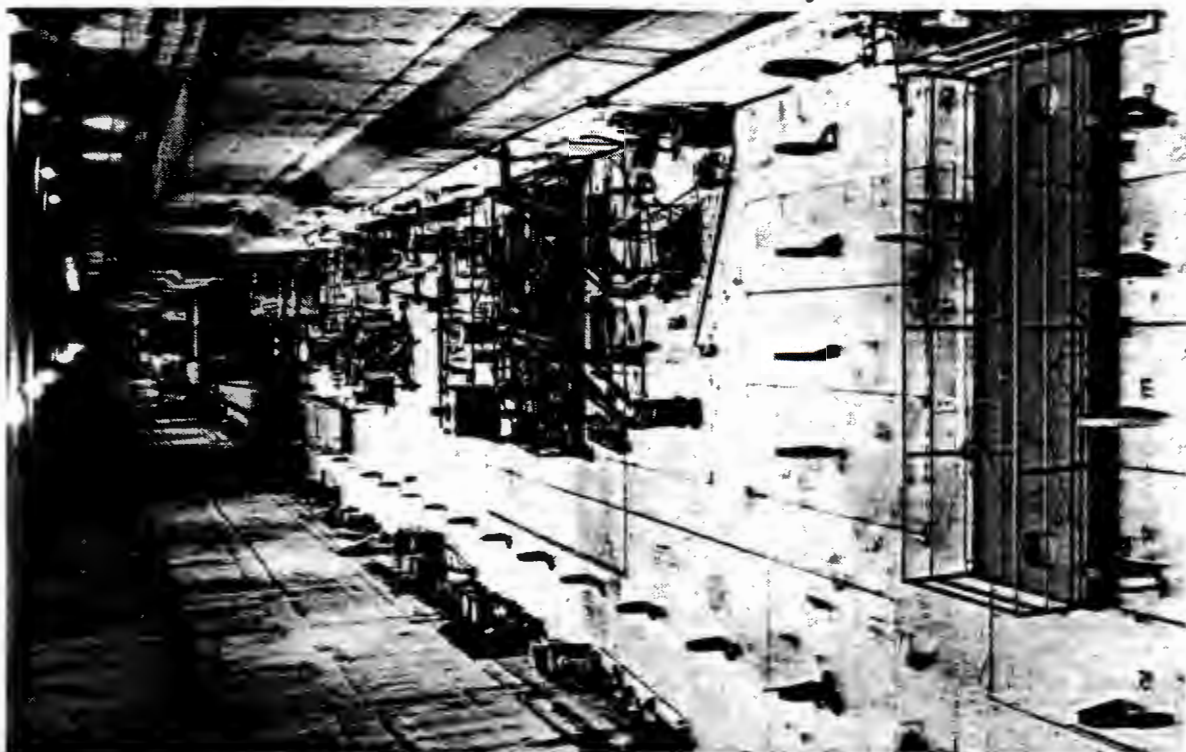
Figure 2-2. U Plant Facility.

The U Plant Facility is located in the 200 West Area of the Hanford Site (Figure 2-1). Figure 2-2 shows an aerial photograph of the 221-U Plant Facility exterior. The reinforced concrete canyon building (221-U) was originally constructed between 1944 and 1945 as an integral part of the U Plant fuel separation facility, but was never used for that purpose. From 1950 to 1952, the U Plant Facility was extensively modified for a uranium metal recovery program. Modification included all new cell process equipment in the canyon building.

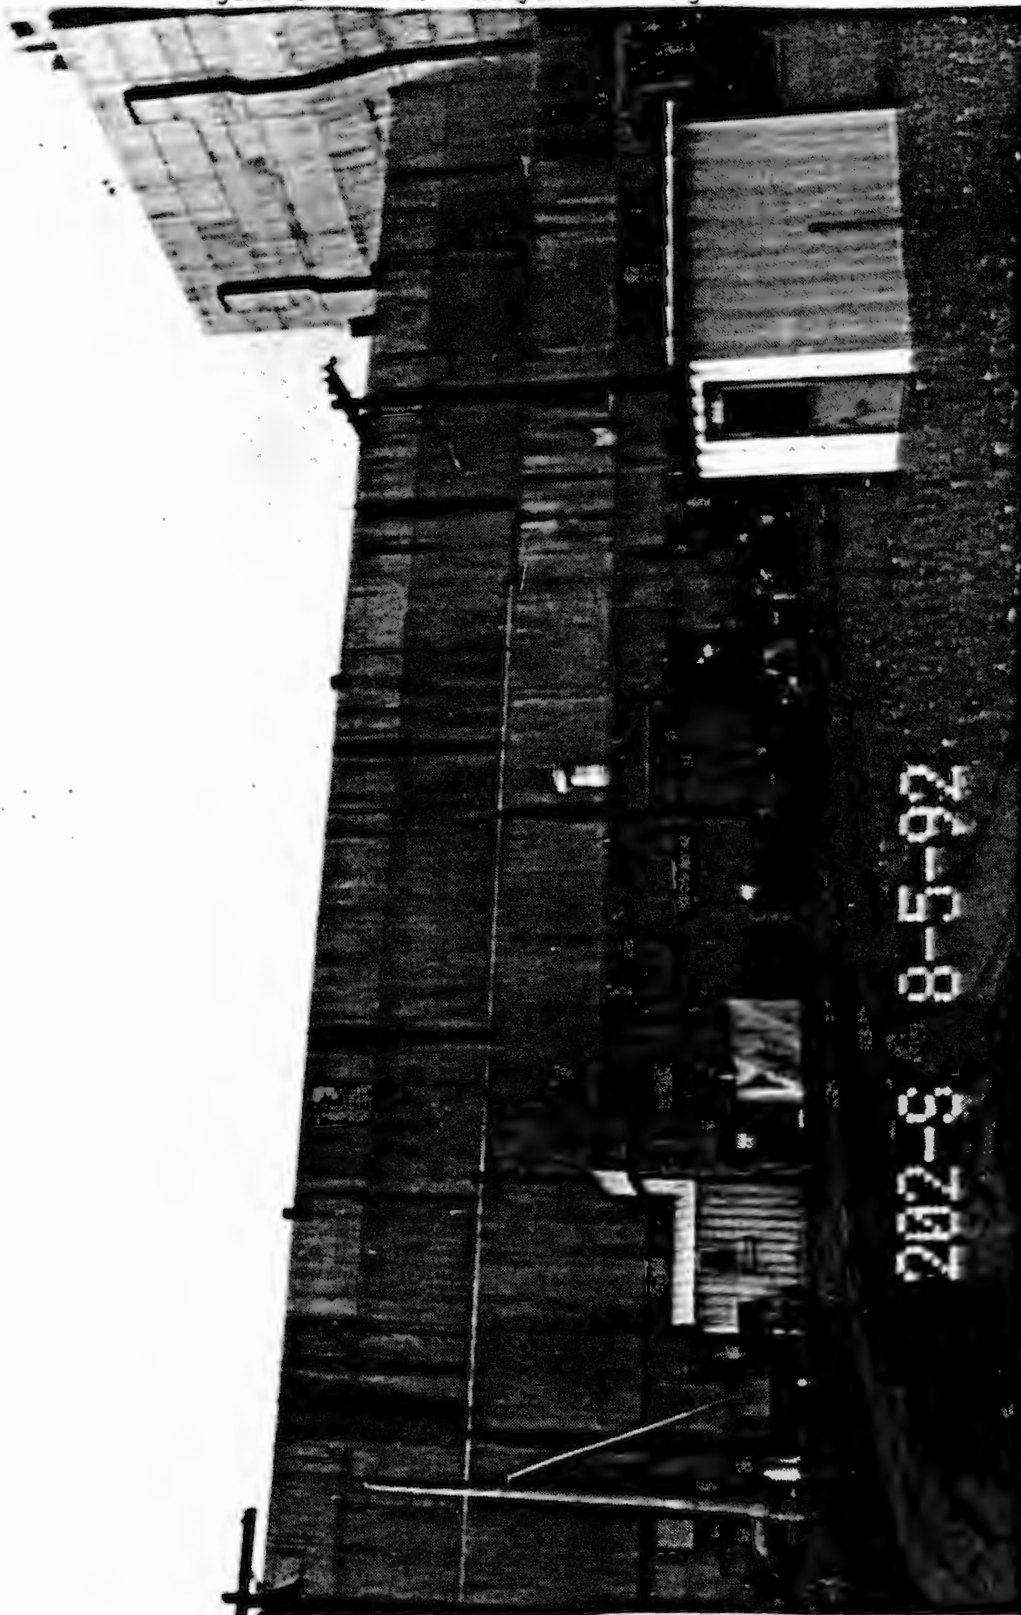
Figure 2-9. 202-S Canyon Building.

The 202-S Building is a reinforced concrete structure consisting of two main architectural features, the canyon and silo areas (see Figure 2-10). The building is 142.6 m (468 ft) long and 49.1 m (161 ft) wide. The canyon portion contains all the equipment for handling radioactive materials such as fuel dissolution, feed preparation, solvent distillation, and waste concentration and neutralization. The silo area, located at the west end of the canyon, houses the solvent extraction columns and aqueous makeup vessels.

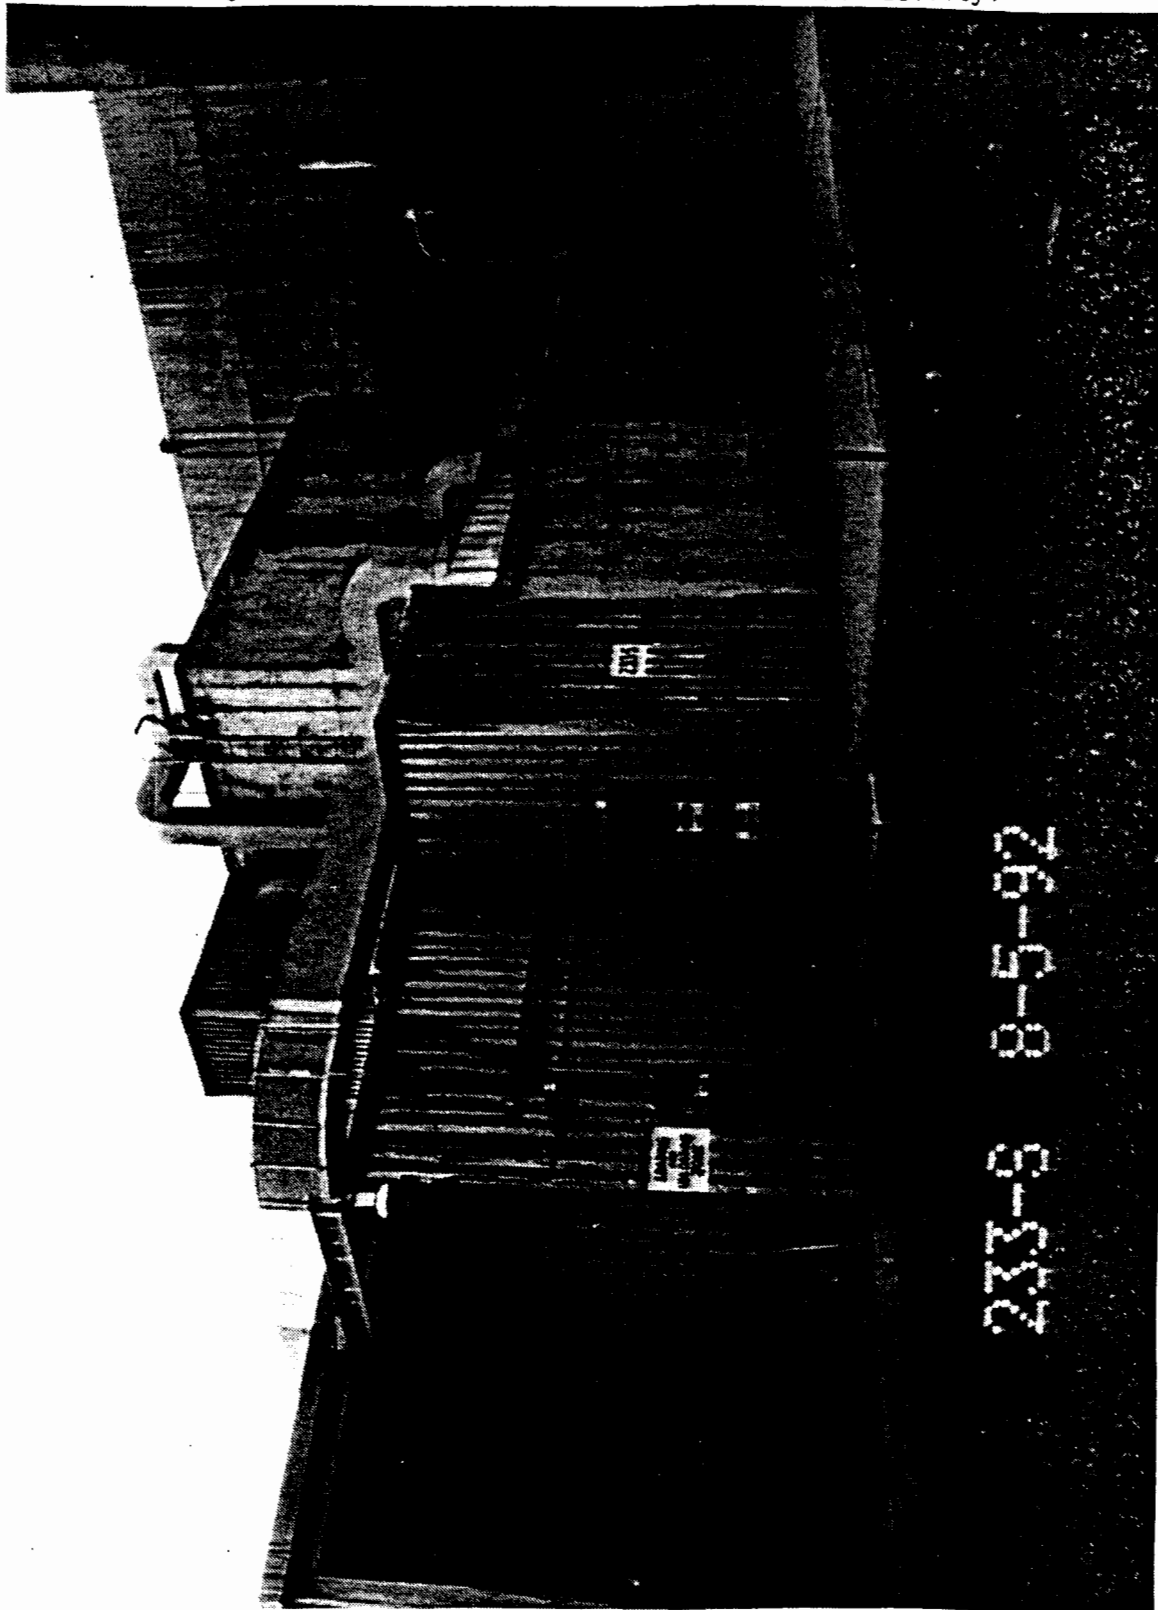
Figure 2-11. 233-S Plutonium Concentration Facility.

The 233-S Plutonium Concentration Facility, located directly north of the 202-S Building, was built in 1954 and 1955 and was placed into operation in March 1955. During the initial process, a dilute plutonium nitrate solution was transferred from the 202-S Building to the 233-S Building. Within the 233-S Building, the plutonium solution was concentrated and loaded into product removal cans for transportation to other facilities for further processing. The facility is a reinforced concrete and corrugated metal structure consisting of eight rooms plus five airlocks. A 9.7-m (32-ft) high bay area is divided into two sections: a process zone and a viewing bay, partitioned by vertical transparent plastic panels.

These panels offered very little shielding in the event of a criticality incident; therefore, all the process vessels were designed with a critically safe geometry. In 1962, the operations of the facility were expanded to include neptunium concentration and loadout process, along with an ion exchange purification process.

The building's interior and exterior are in poor condition. The urethane-covered, poured concrete roof is in poor condition because of water infiltration and radiological contamination problems. Presently, the building serves no purpose. Decommissioning was originally scheduled in FY 1992 but has been extended to FY 1996, pending demolition design and funding.

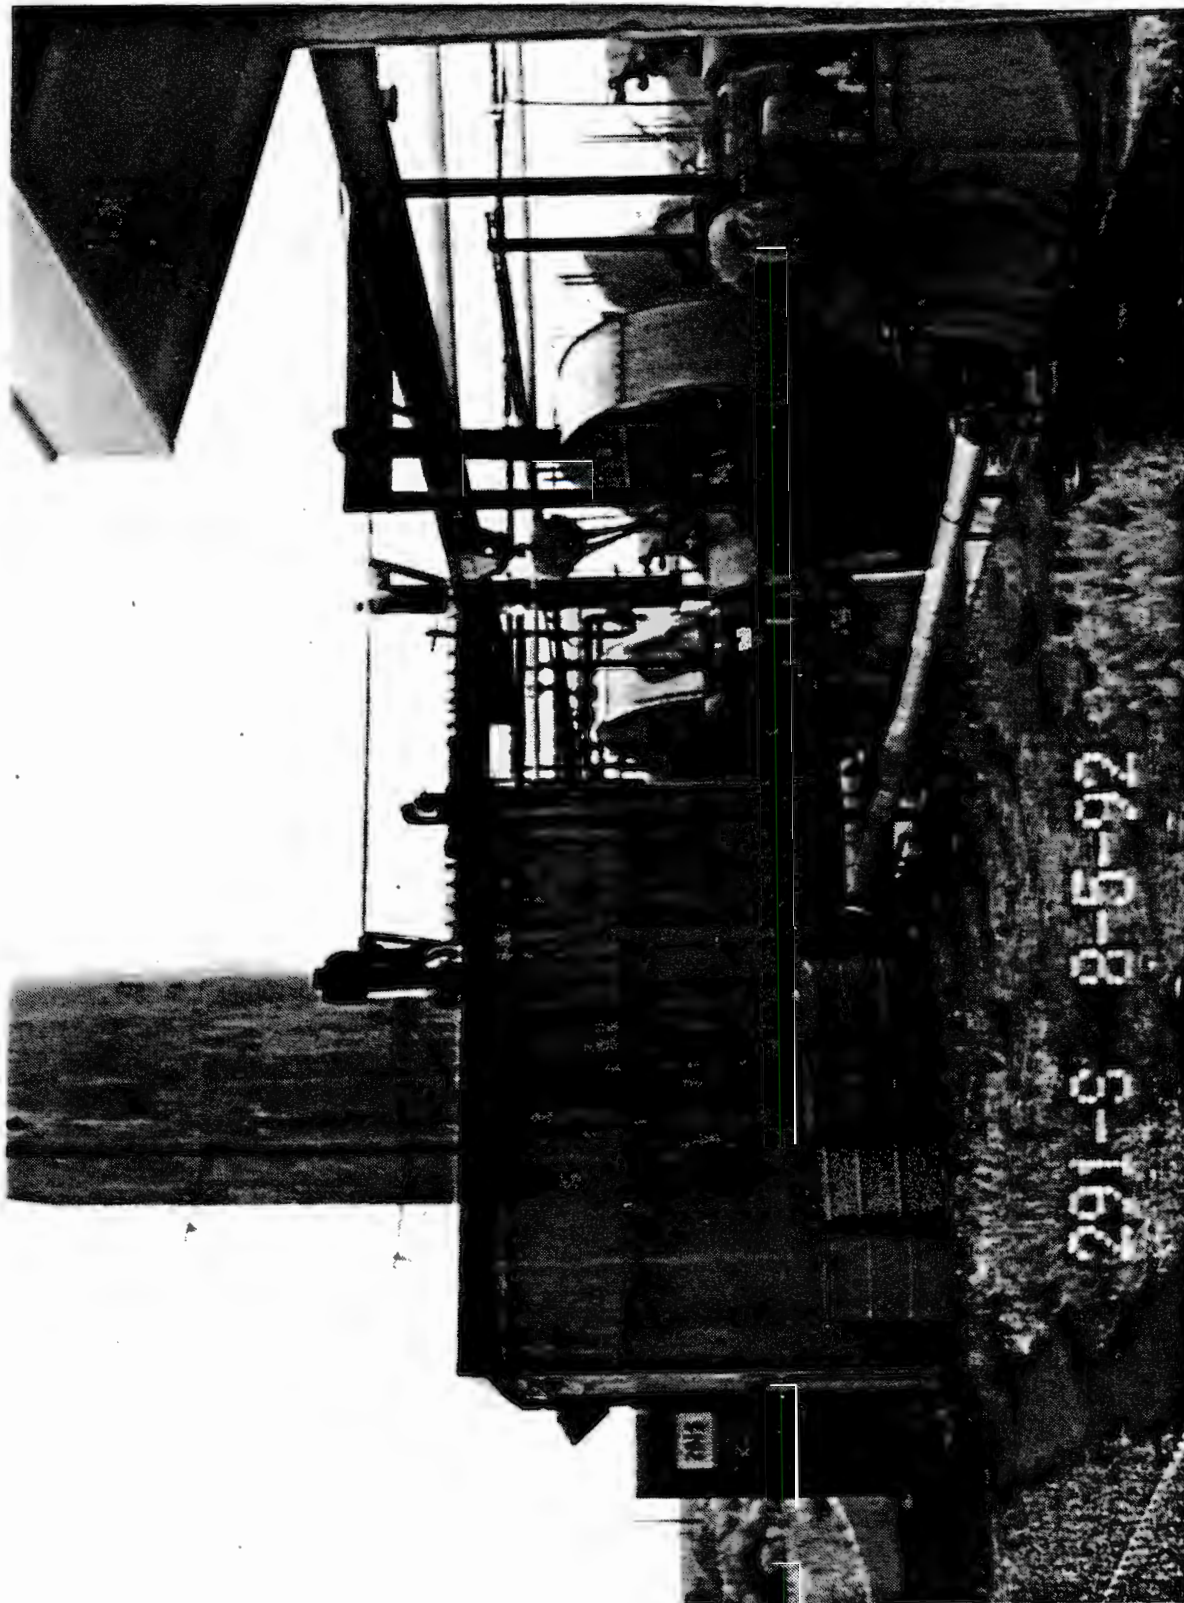
Figure 2-13. 291-S Exhaust Fan Facility.

The general condition of the filter is fair. The building's interior is in fair condition, the exterior is in good condition, and the asphalt-covered, poured concrete roof is in fair condition. The filter roof was recovered with urethane in 1991, thus eliminating the potential for water infiltration. Presently the sand filter removes particulate from the canyon ventilated air before discharge up the stack and will remain in operation until the entire REDOX Facility is demolished.

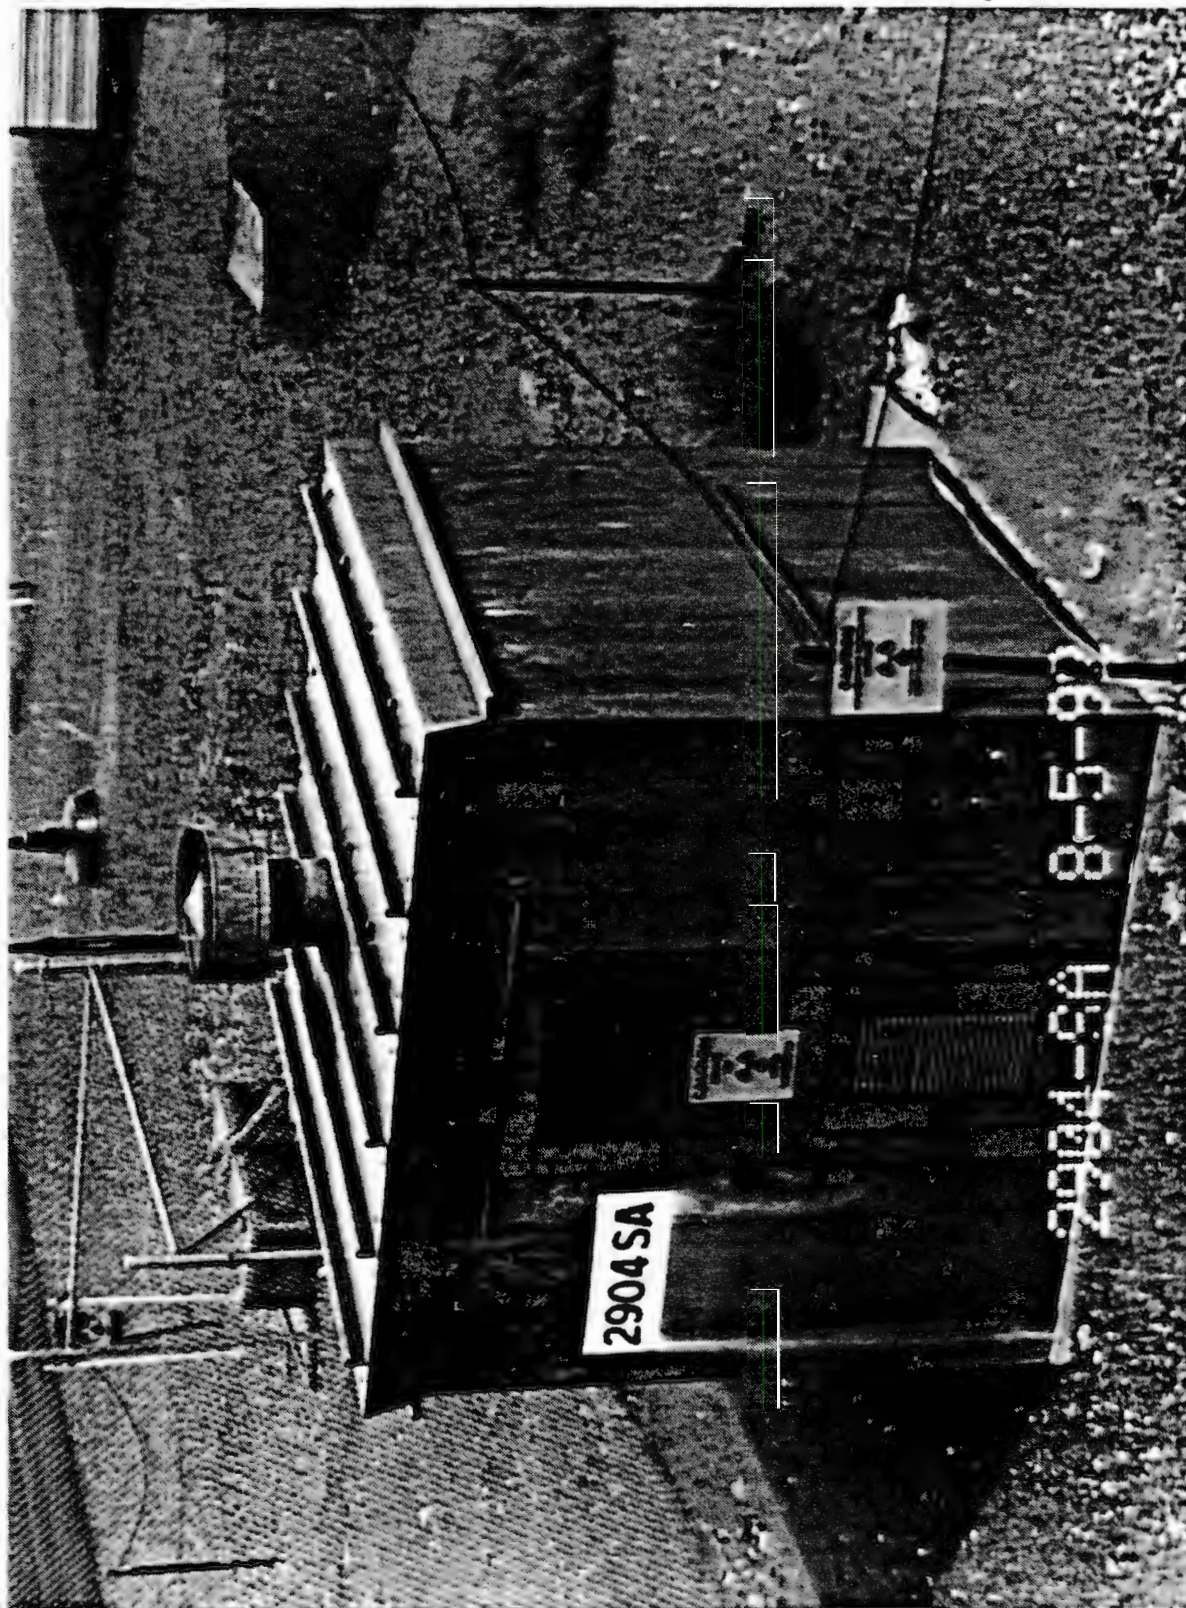
Figure 2-19. 2904-SA Cooling Water Sampler Building.

The 2904-SA Building is a prefabricated metal building resting on a concrete foundation, with outside dimensions of 2.4 m by 2.4 m by 2.1 m (8 ft by 8 ft by 7 ft). The building's interior is in fair condition. The exterior and the roof are in poor condition.

Sample equipment inside the building consists of a pump and a 0.6-m (2-ft) diameter, 0.9 m (3 ft) high stainless steel tank belowgrade, with a sample riser protruding up through the building floor and associated piping.
