**FACILITY STATUS CHANGE FORM**

<b>Date Submitted:</b> Sep 21, 2009	<b>Area:</b> 100-N	<b>Control #:</b> D4-100N-0019
<b>Originator:</b> Bob Cathel	<b>Facility ID:</b> MO-013 Mobile Office (1158-N)	
<b>Phone:</b> (509) 845-6146	<b>Action Memorandum:</b> 100-N Ancillary Facilities

# GPS Survey Data Report for Job 947- MO013, MO425, MO426, MO427, Pre Demolition

# Post Demolition GPS Survey Report for MO-013

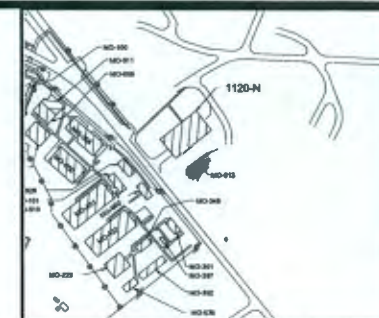
**100N Field Remediation  
MO-013 Site Pad  
GPERS Radiological Survey  
Gamma Track Map**

- Coverage File: N041  
Number of Data Pnts: 930  
Type of Survey: 'Gamma'  
Max GCPM: 1255  
Avg Bkg CPM: 1234  
Survey Date: 02/10/2009  
Area Surveyed: 455 m2  
Project File: N041  
Pdf File: ESRFRM090023C

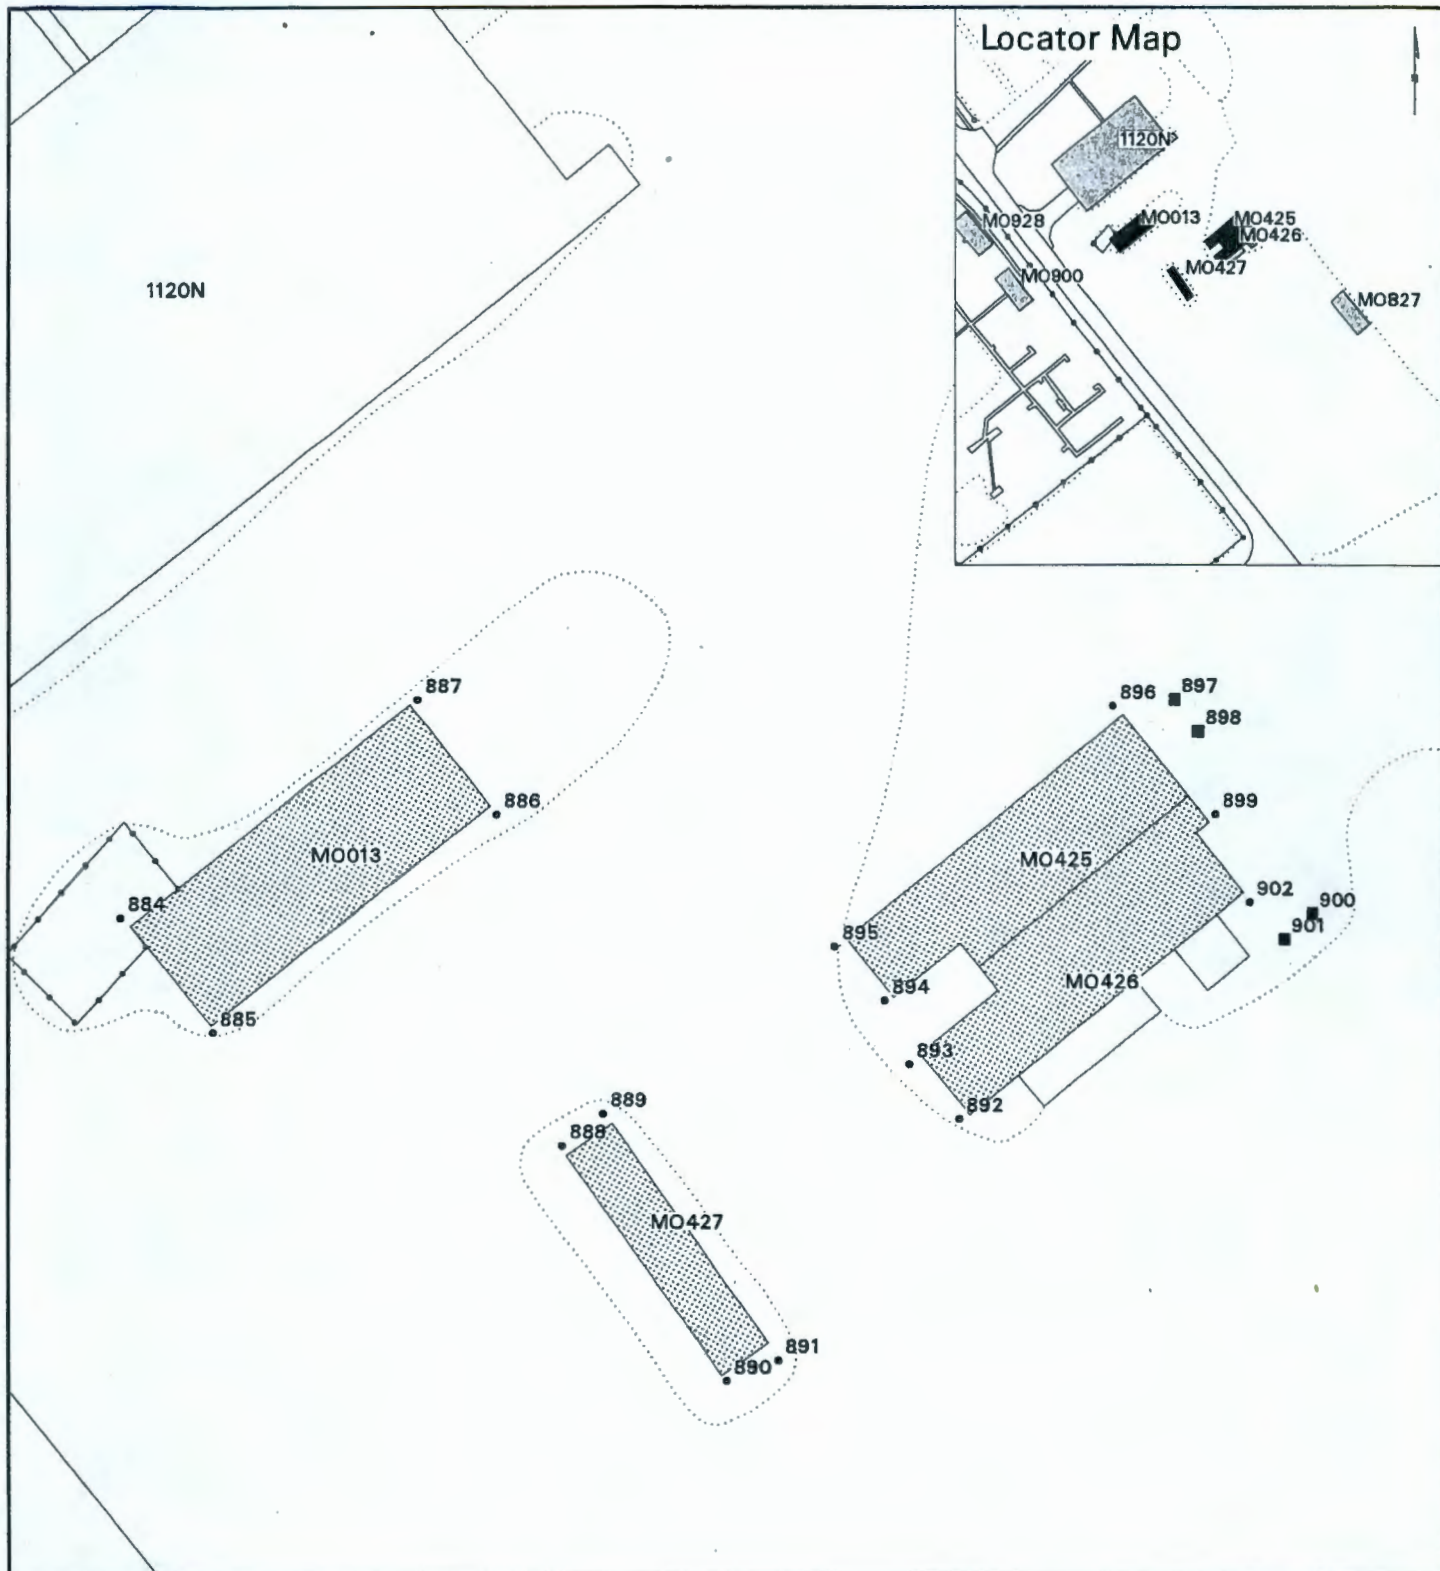
## Pre Demolition Survey for MO-013, MO-425, MO-426, and MO-427

Building Locations for MO-013,  
MO-425, MO-426, and MO-427  
Prior to Demolition

- GPS Building Corner Locations for  
MO-013, MO-425, MO-426, MO-427  
Prior to Demolition
- GPS Locations for Surrounding Features  
See Survey Report for Point Details

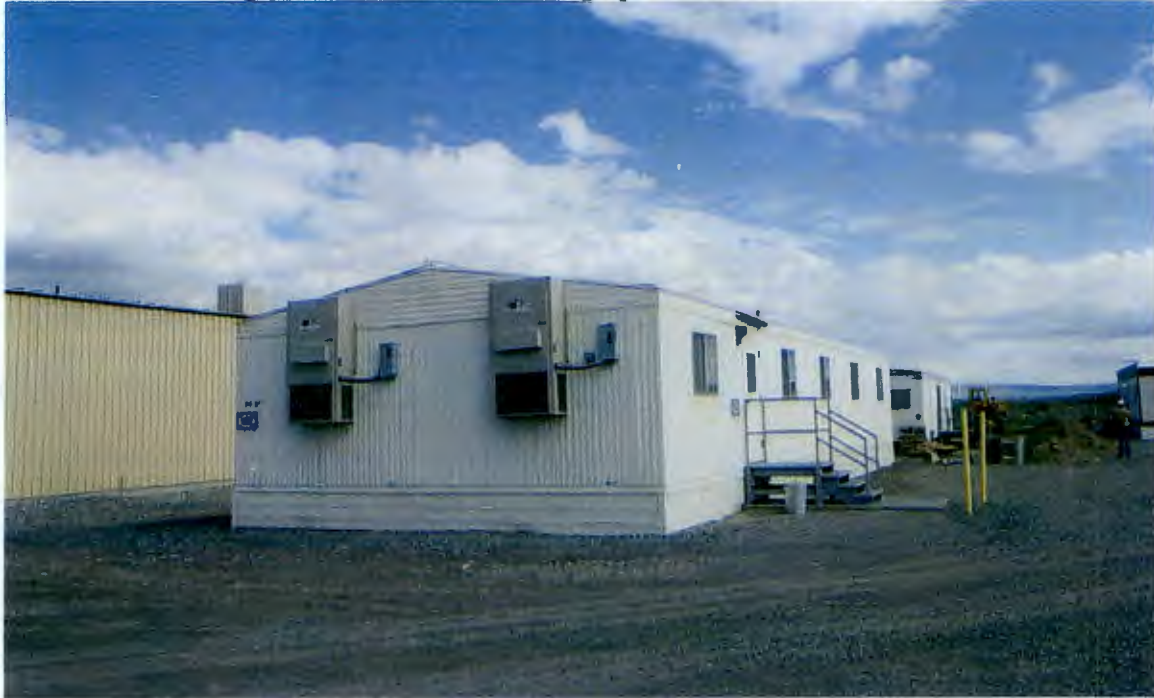
**Figure 1. Pre-demolition Photograph of MO-013 Mobile Office**

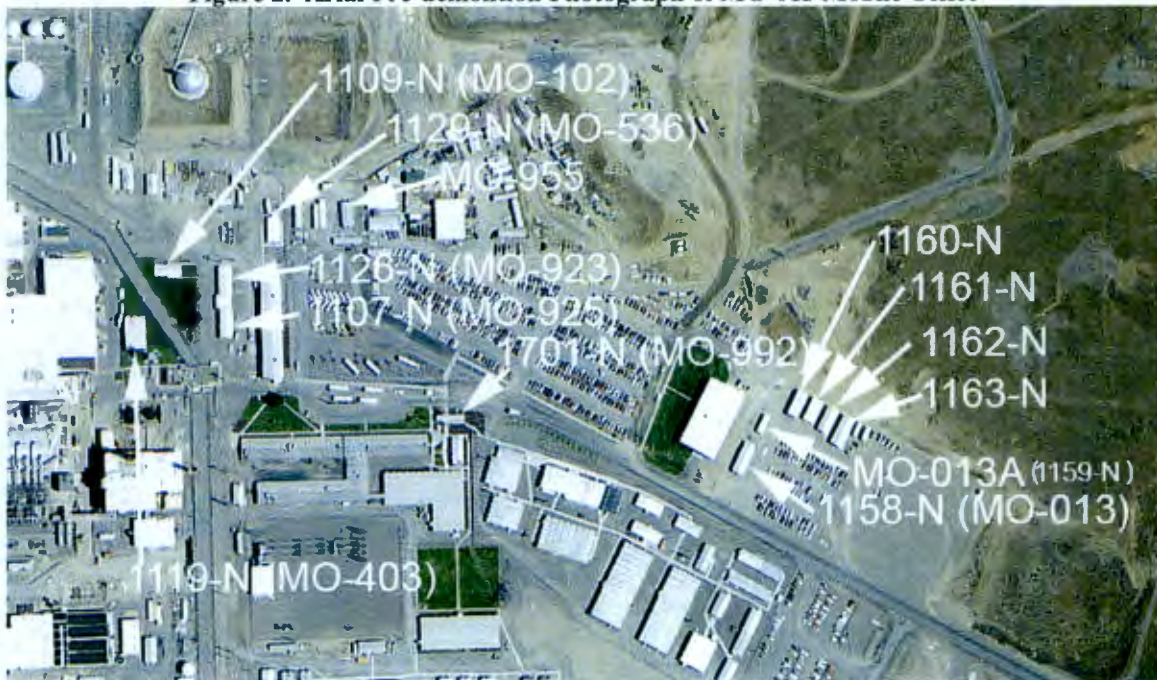
**Figure 2. Aerial Pre-demolition Photograph of MO-013 Mobile Office**

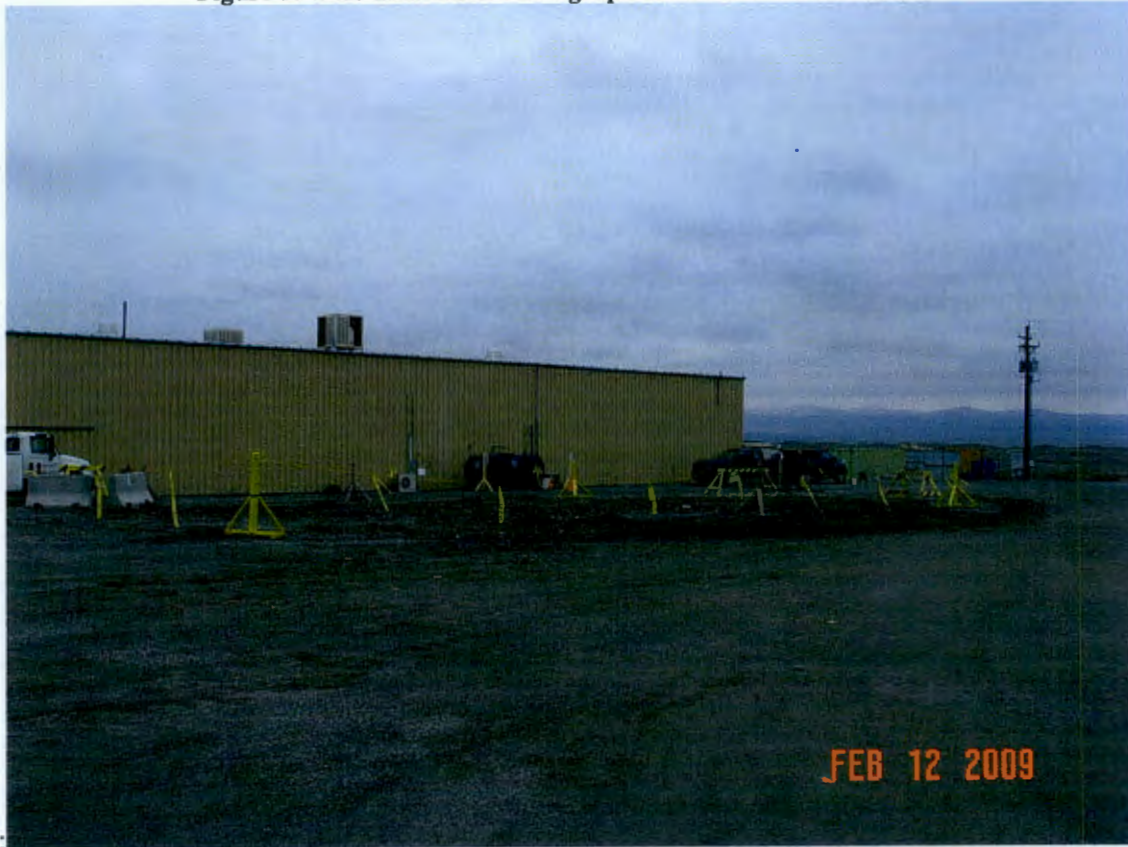
The MO-013 Mobile Office facility was demolished and removed. A minimal amount of soil was removed along with the building debris. No backfill material was needed to regrade the site.

**Figure 3. Post-demolition Photograph of MO-013 Mobile Office**
