## FACILITY STATUS CHANGE FORM

## D4 Project Soils and/or Below Grade Structures Completion Form 1723N Warehouse, 1723NX Laydown Yard, and MO-913 Change Trailer

**WASHINGTON CLOSURE HANFORD D4 FACILITY CHARACTERIZATION  
HISTORICAL SITE ASSESSMENT FOR THE 1723-N WAREHOUSE AND 1723-NX  
LAYDOWN YARD**

# **Post Demolition Summary Report for the 1723N Warehouse, 1723NX Laydown Yard and MO-913 Change Trailer**

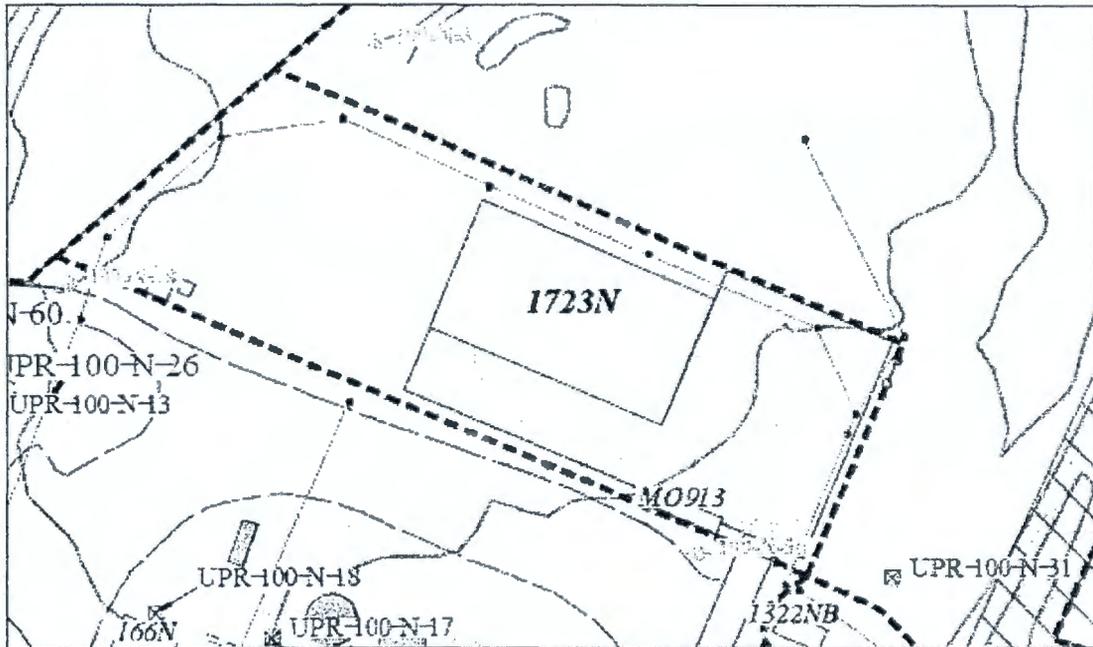
**WIDS Sites and Monitoring Wells**

There is one WIDS site and three monitoring wells in relative proximity to 1723-N and 1723-NX.

- 6.1. 199-N-3: Monitoring well, located north of 1723-NX, still in use.
- 6.2. 199-N-56: Monitoring well, located near the south east side of the 1723-N perimeter, still in use.

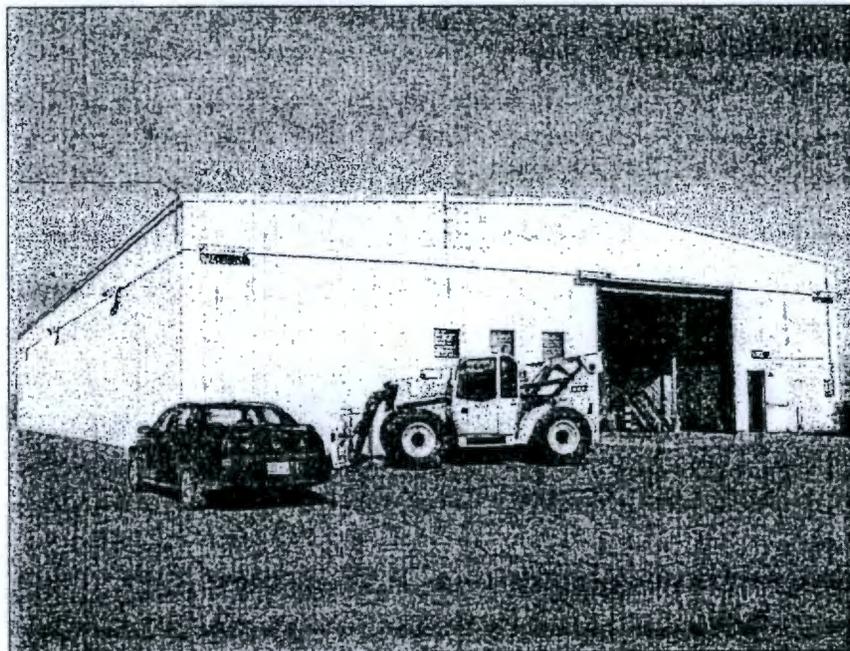
**Figure 9.1 - 1723-N Warehouse**

The 1723-N Warehouse is a warehouse and storage area, constructed of metal siding, and steel beams and metal roof. The building measures 154 feet by 80 feet. There are two roll-up doors, one each at the east and west sides of the building, each measuring 20 feet wide and 16 feet high.

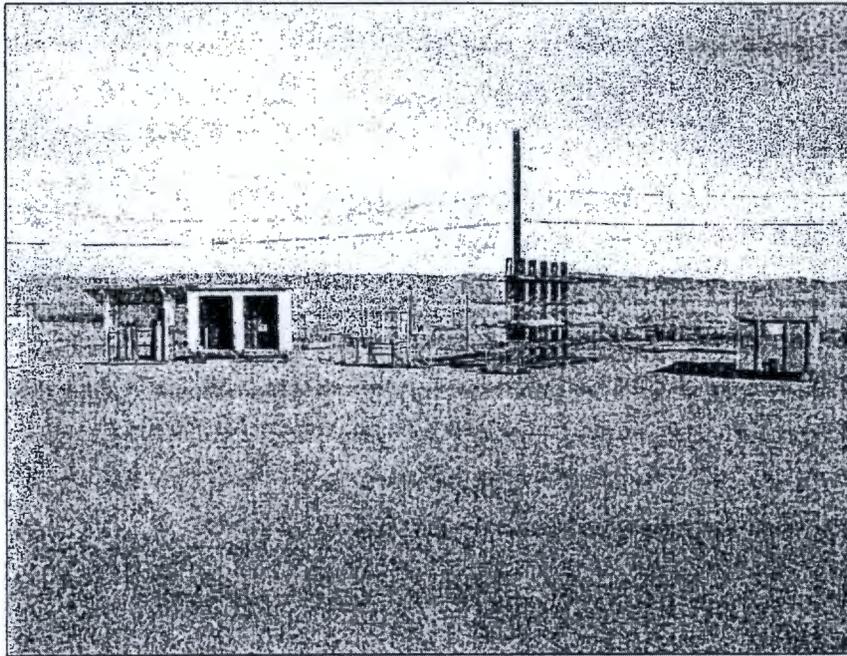
**Figure 9.2 – 1723-NX Laydown Yard**

The 1723-NX Laydown Yard is a flat, gravel covered, fenced area on the west and south west sides of 1723-N (refer to facility floor plan). A compressed gas cylinder shed is present in the north west corner near the fence, and another covered, open air shed is present at the south west corner used to store propane tanks. A large, horizontally oriented cylindrical propane tank rests on the ground in the 1723-NX Laydown Yard, to the south west corner of 1723-N.

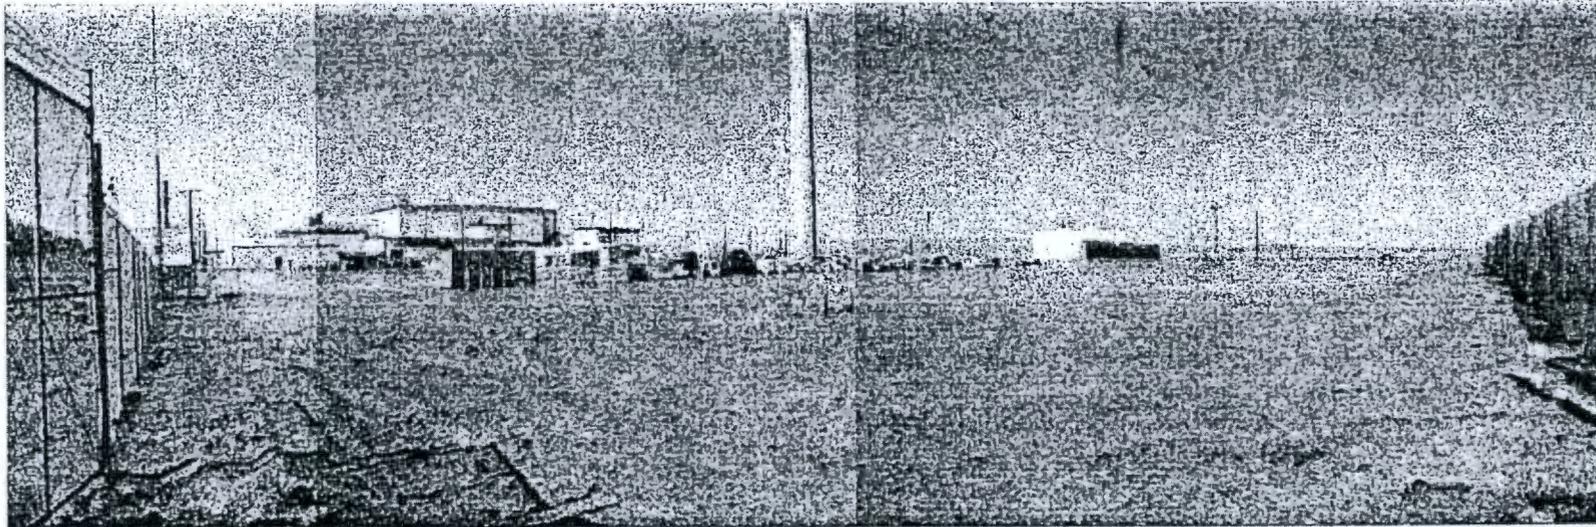
**Figure 2 - 1723N Warehouse, 1723NX Laydown Yard, and MO-913 After Demo (Facing South-West)**

The soil in the vicinity of these facilities was re-graded to fill in uneven ground to minimize tripping hazards.

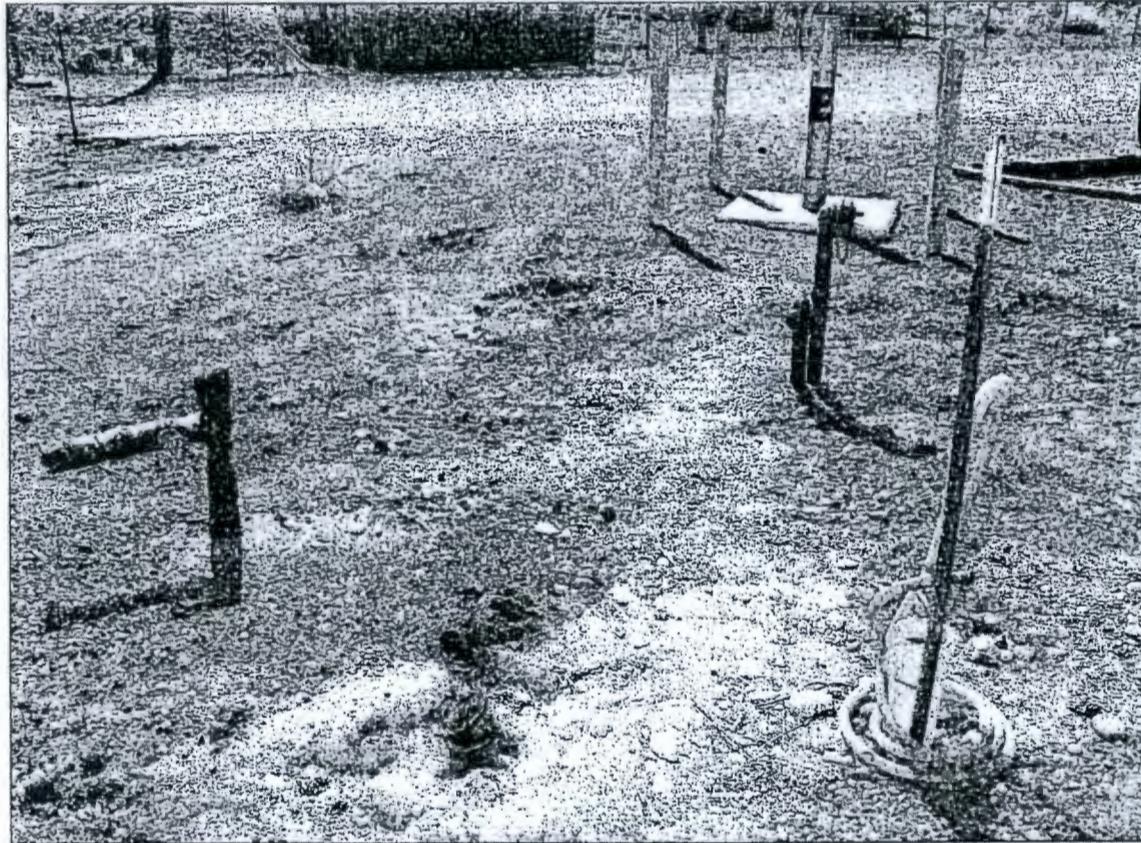
**Figure 3 – Pipes Left In Place at MO-913**

Pipes left in place include one domestic water line and one sewer line. These extend vertically from the ground and are located at the south-west corner of the previous location of MO-913 (see attached civil survey and picture).

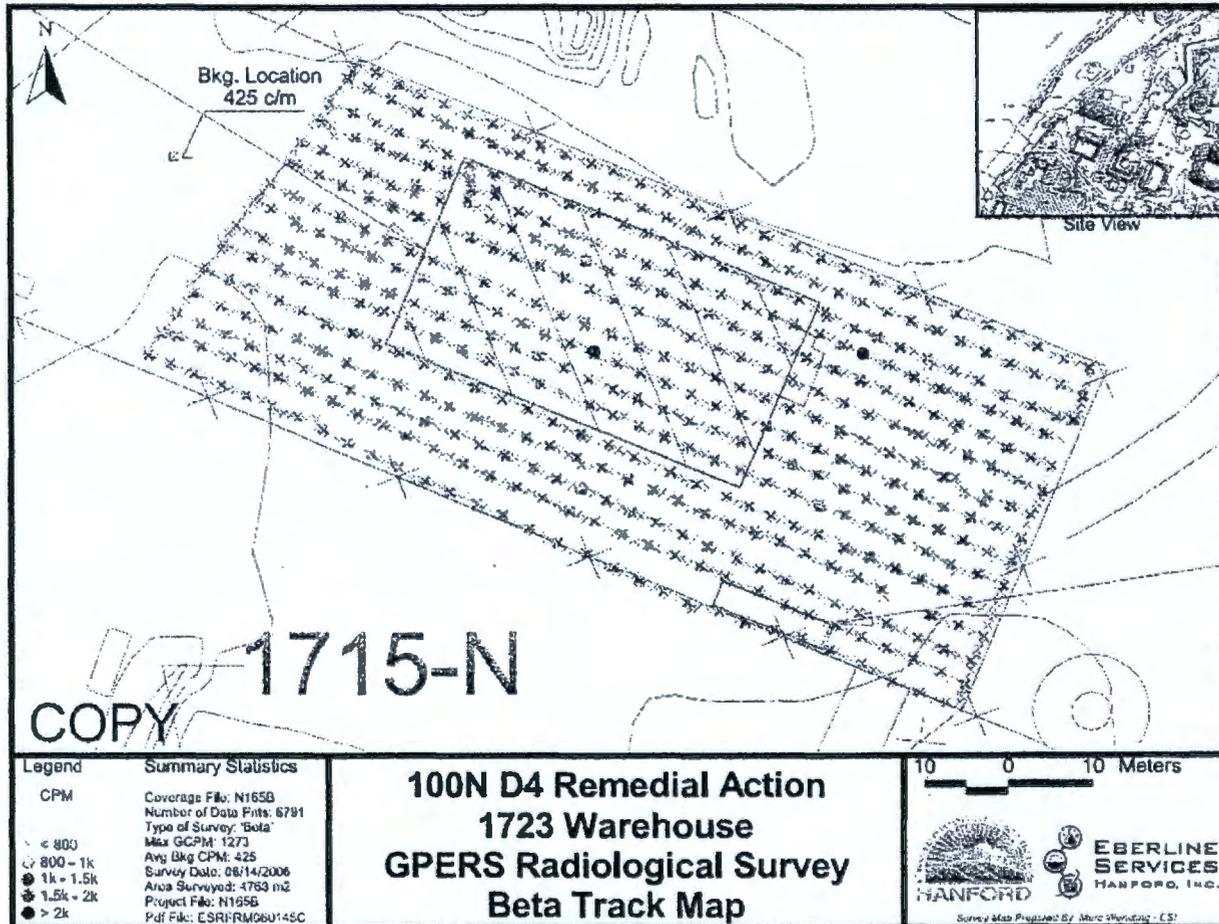
**Figure 4 – Initial GPERS Beta Survey with Anomalous Points**

GPERS surveys were completed at each of these facilities. Note that the original GPERS survey of the 1723N demolition site showed a number of readings above background for both beta and gamma tracks. The site was re-surveyed with the GPERS instruments, and the beta tracks were determined to be anomalous readings. However, the gamma track showed one valid spot of gamma contamination, which was subsequently cleaned up and re-surveyed (see RSR-IFSM-06-0089). See attached GPERS surveys at the end of this report as attachments. The final down posting performed at the site to down post from an SCA to a non-radiologically posted are was covered by radiological survey RSR-IFSM1-06-0109.

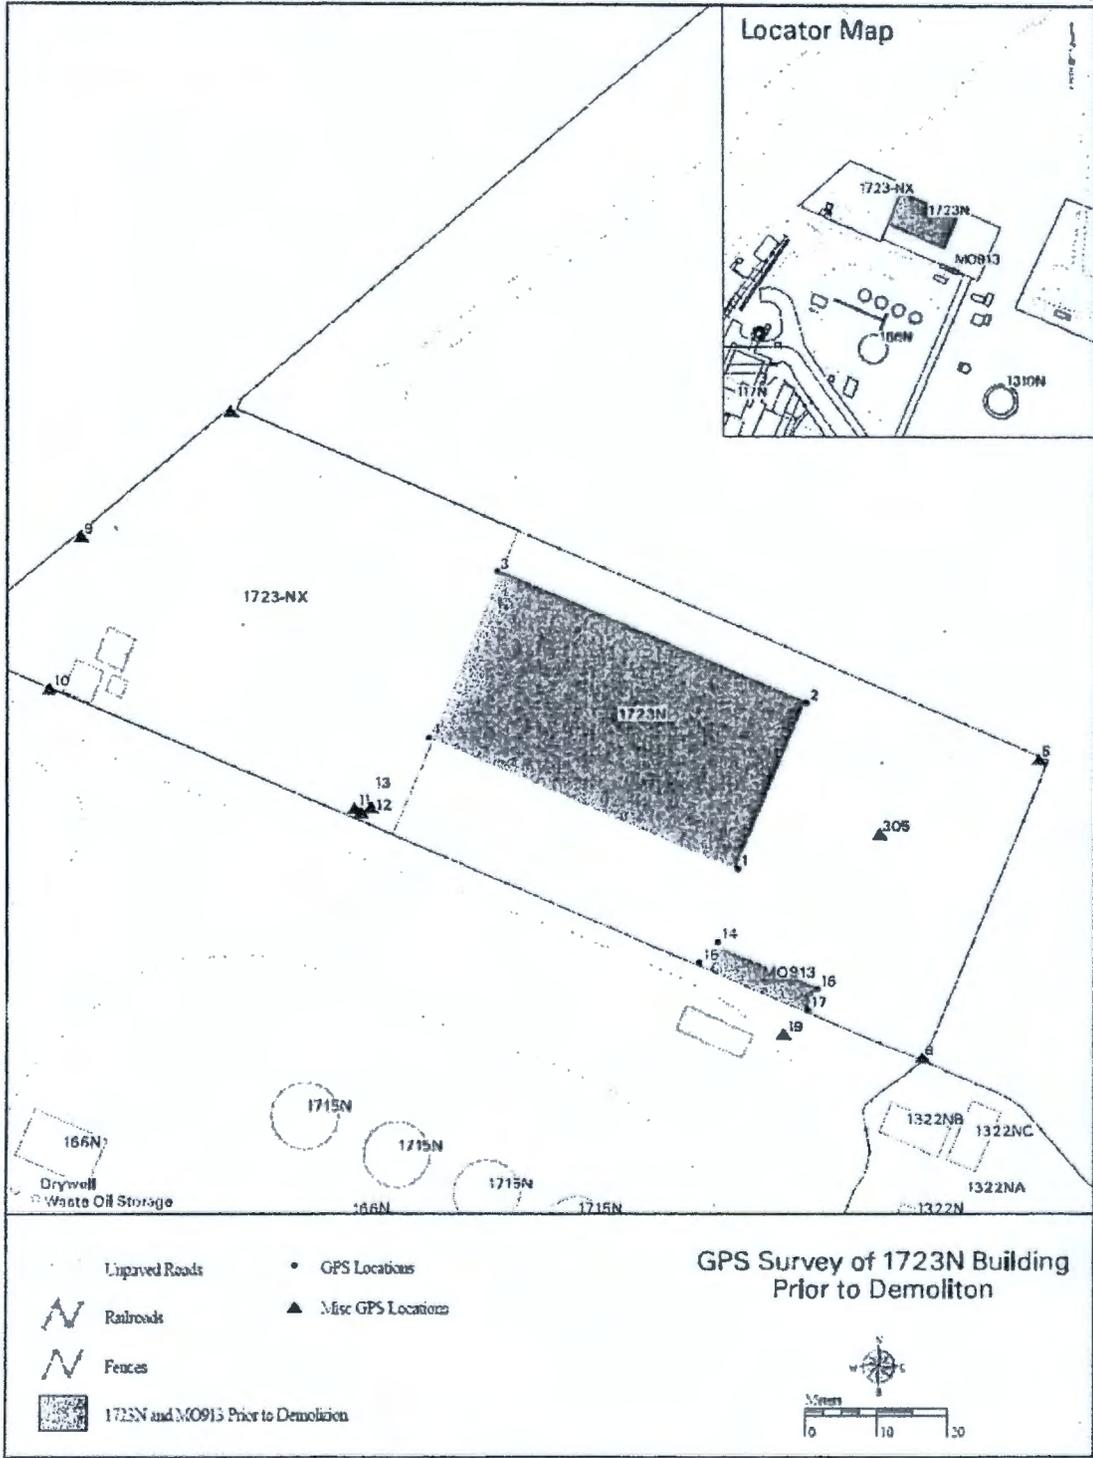
**Survey Data Report – 1723N Pre-Demo**

GPS civil surveys were performed on the 1723-N, 1723-NX, and MO-913 facilities. Copies of these surveys are provided as attachments at the end of this report.

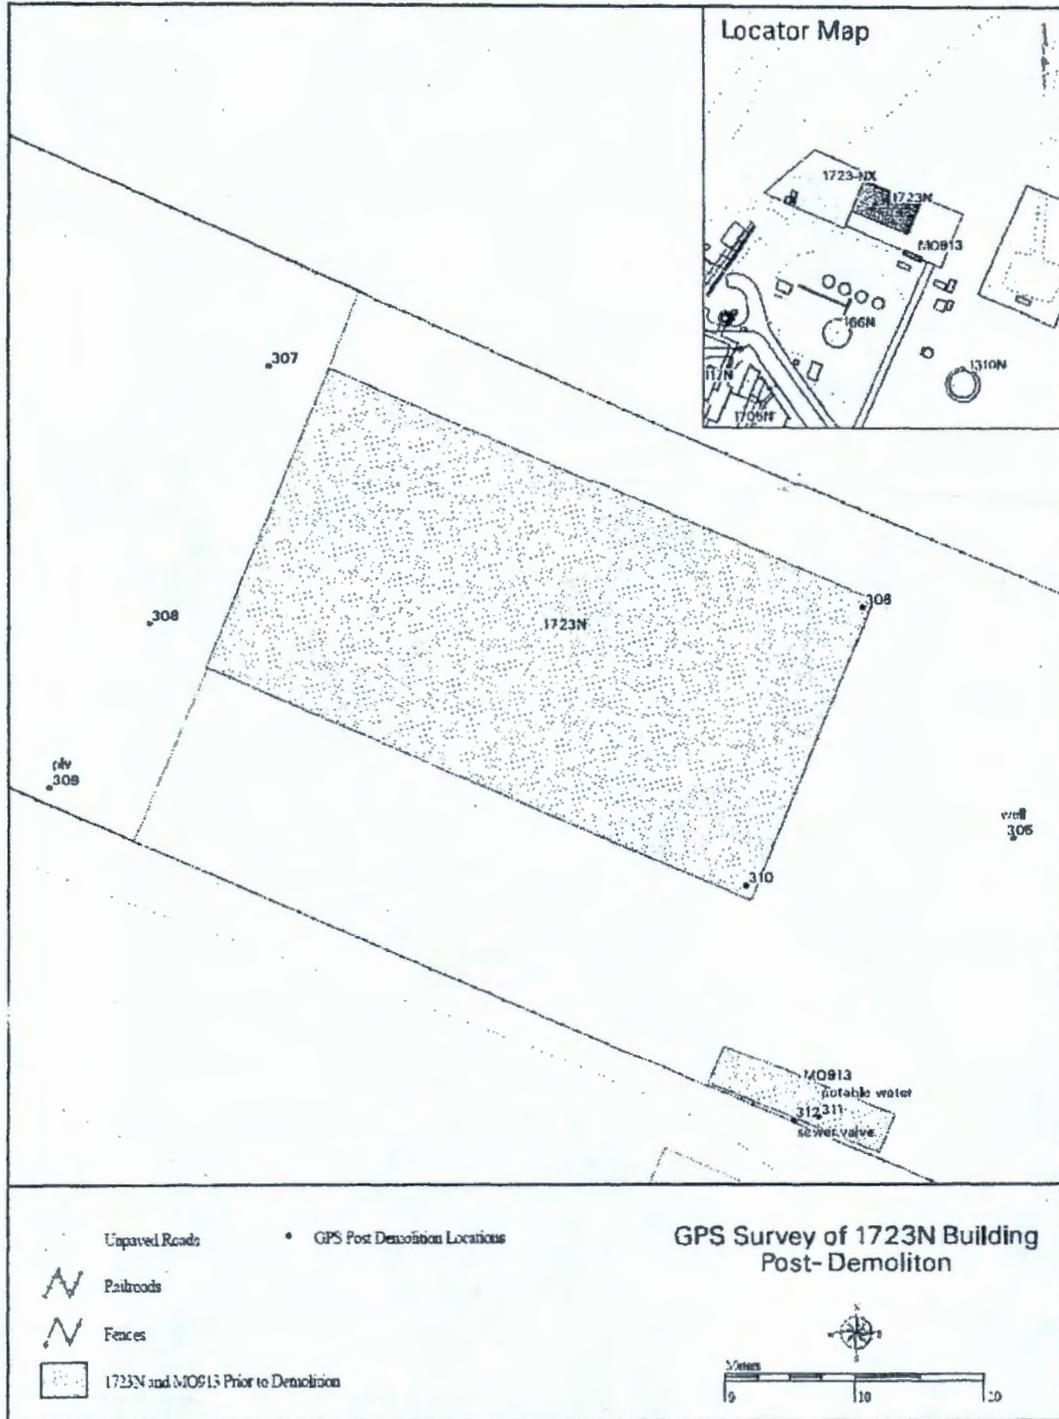
**Survey Data Report – 1723N Post-Demo**

Monitoring well 199-N-1 was uncovered when the asphalt parking area was taken up. The Fluor Hanford ground water organization was contacted, and subsequently inspected the well head. The area was staked, clearly marked with fence posts, left in place, and is now a candidate for decommissioning. The GPS coordinates for this well are shown in the post demolition civil survey included as an attachment.
