**U.S. Department of Energy
Hanford Site**

**SUMMARY OF CALENDAR YEAR 2018 AND 2019 BIOREMEDIATION AT THE
UPR-100-N-17 WASTE SITE**

This technical memorandum provides a summary of bioremediation and monitoring activities performed at the UPR-100-N-17 waste site in 2018 and 2019 and includes the results of the low river stage respirometry test conducted in November 2019.

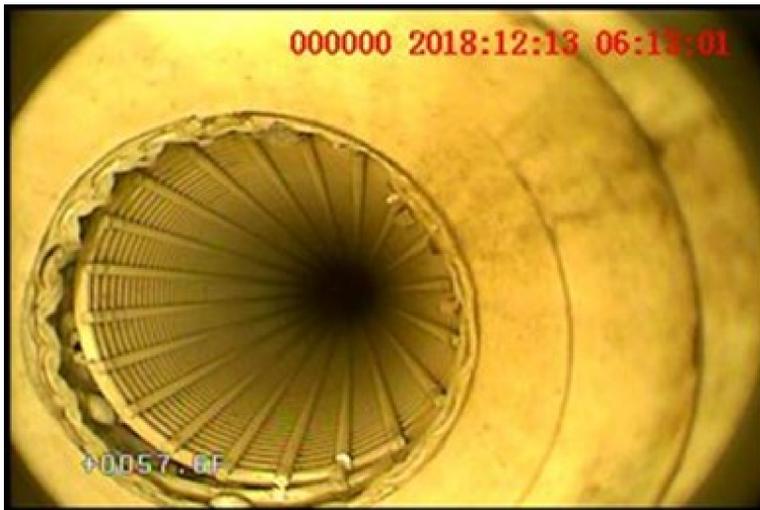
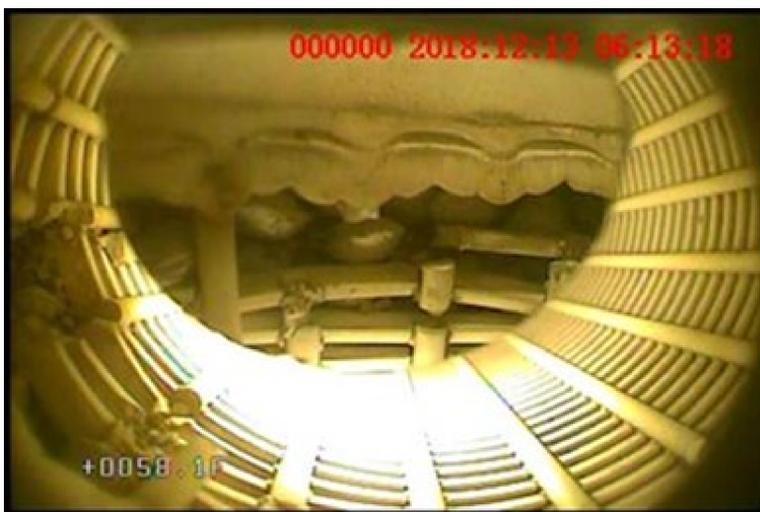
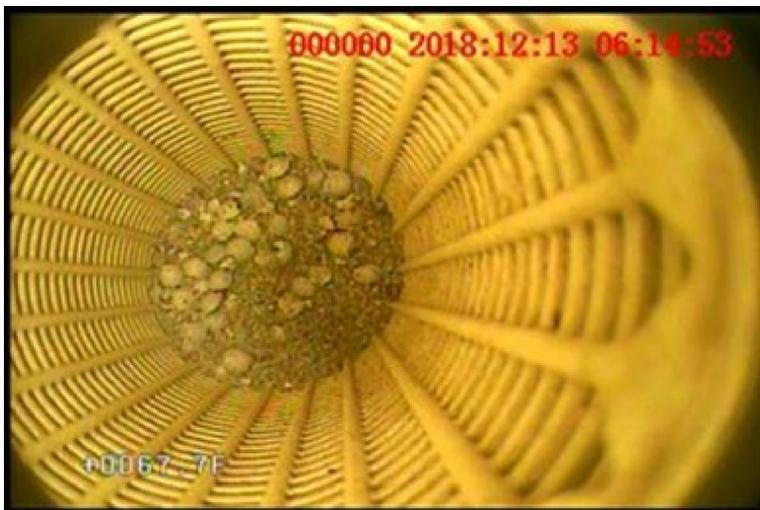
CHPRC	wood.	100-N AREA BIOVENTING SYSTEM	DATE MAY 2020
		WELL 199-N-172 WELL SCREEN SEPARATION PHOTOS	SCALE NOT TO SCALE
Wood Environment & Infrastructure Solutions, Inc. 15862 SW 72nd Ave., Suite 150 Portland, OR 97224			PROJECT NO. 661M120343
			FIGURE 2

Figure 2 - Well 199-N-172 – Well Screen Separation Photos

Images obtained from Art Lee of Jacobs on May 17, 2020.

The last groundwater sample at well 199-N-172 was collected in January 2018. The well was found dry when sampling was attempted in June 2019. Water levels in surrounding wells indicated water should have been present in the well 199-N-172. A camera survey found that the top of the well screen had separated from the well casing causing filter pack material to fall into the well to an elevation above the water level (see Figure 2). The cause of screen separation was likely the result of PVC fatigue from thermal expansion/contraction over its 10-year life (the well was constructed in January 2009) due to cold air injection in winter and hot air injection in summer. Well 199-N-172 still functions for air injection to the vadose zone and repair of the well is being evaluated.
