DOE/RL-99-11

200-BP-1 Prototype Barrier Treatability Test Report

August 1999

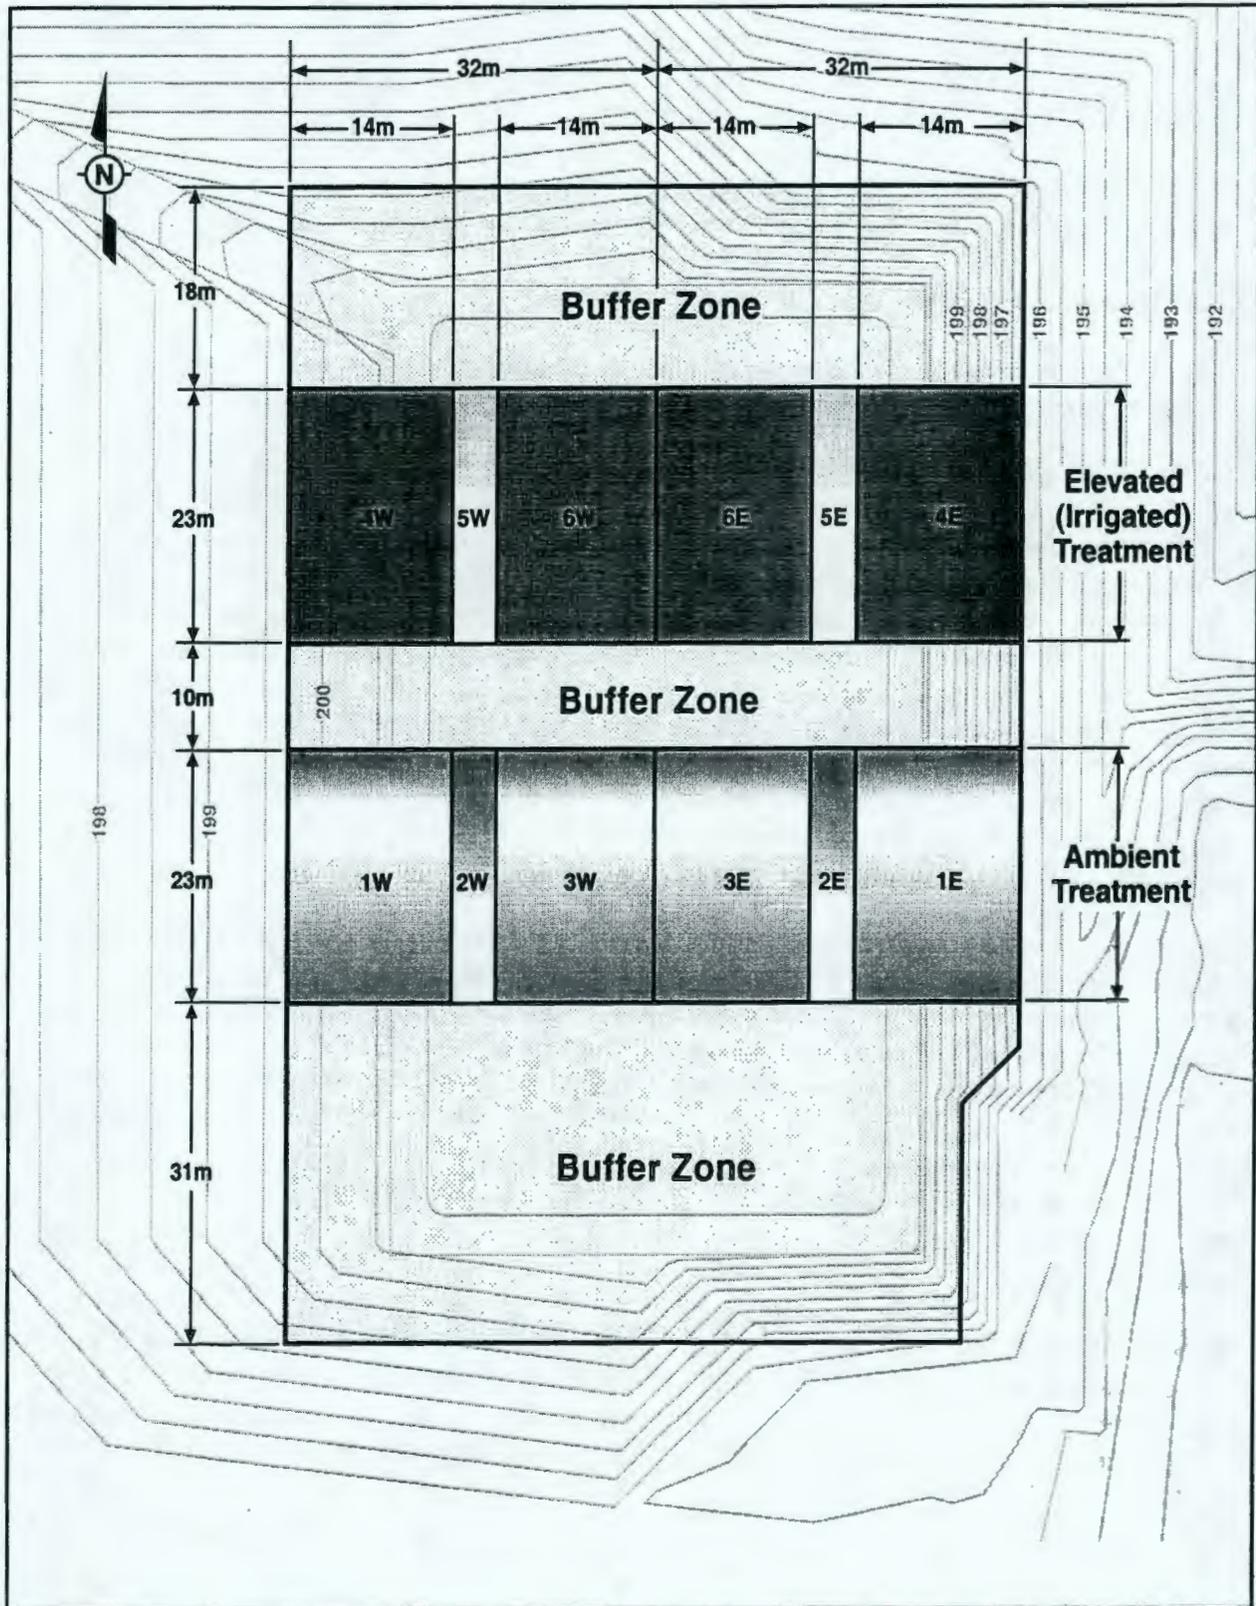
Figure 2-1. Plan View of the Prototype Hanford Barrier Showing Layout of the 2 Precipitation Treatments, the 3 Buffer Zones, and the 12 Surface Soil Plots (1W-6W and 1E-6E).

2.2.2.1 Experimental Design. For monitoring purposes, the surface of the barrier is divided into two treatments or sections (elevated and ambient), one to the north and the other to the south. The north section was designated to receive an elevated amount of precipitation (natural precipitation plus supplemental irrigation) to simulate extreme climatic conditions (three times the long-term annual precipitation), while the south section received only natural (i.e., ambient) precipitation. To minimize edge effects and interaction between the precipitation treatments, the two sections are separated from each other and from the north and south edges of the barrier by buffer zones. The north section is separated from the south by a 10-m buffer zone. To minimize the impact that the edges could have on monitored processes, the north section is separated from the northern edge by an 18-m buffer zone, whereas a 31-m zone separates the south section from the southern edge. Figure 2-1 is a plan view of the prototype Hanford Barrier showing the layout of the two precipitation treatments.

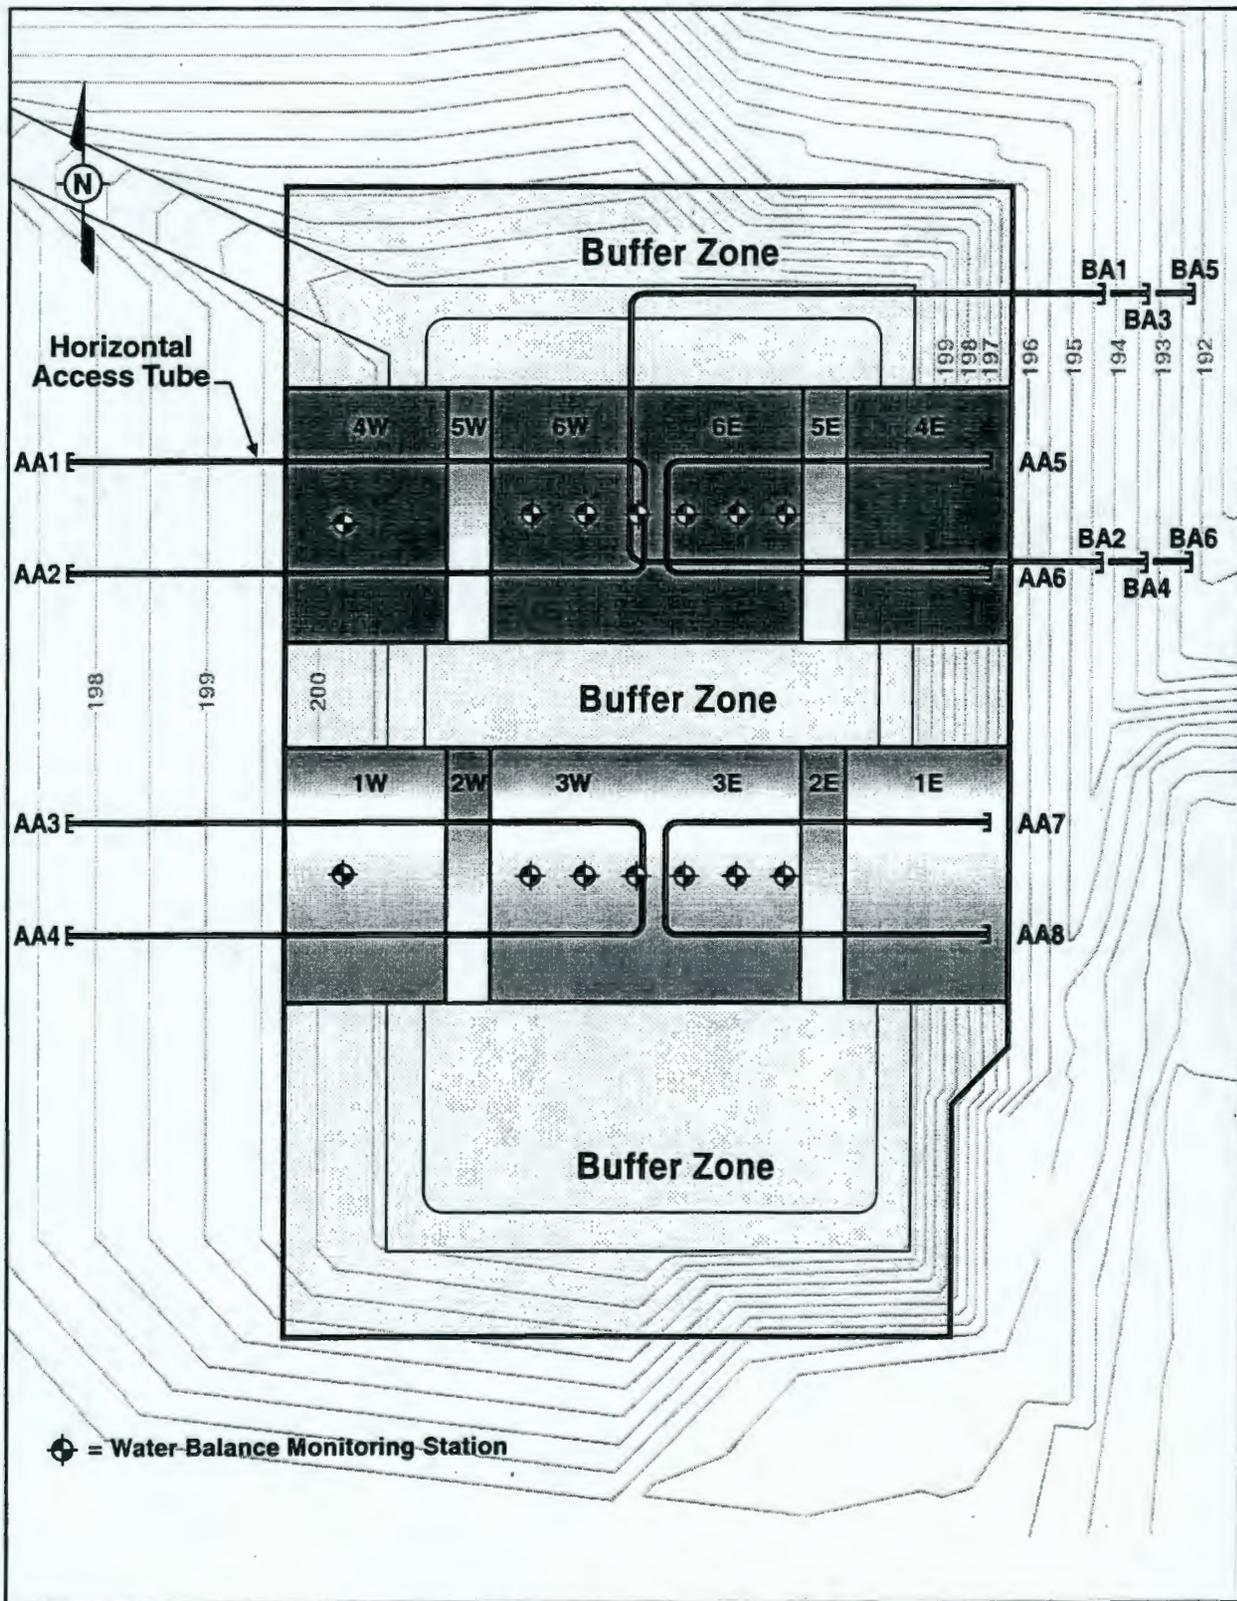
Figure 2-2. Plan View of the Barrier's Surface Showing the Location of the 14 Water Balance Monitoring Stations and Horizontal Neutron Access Tubes.

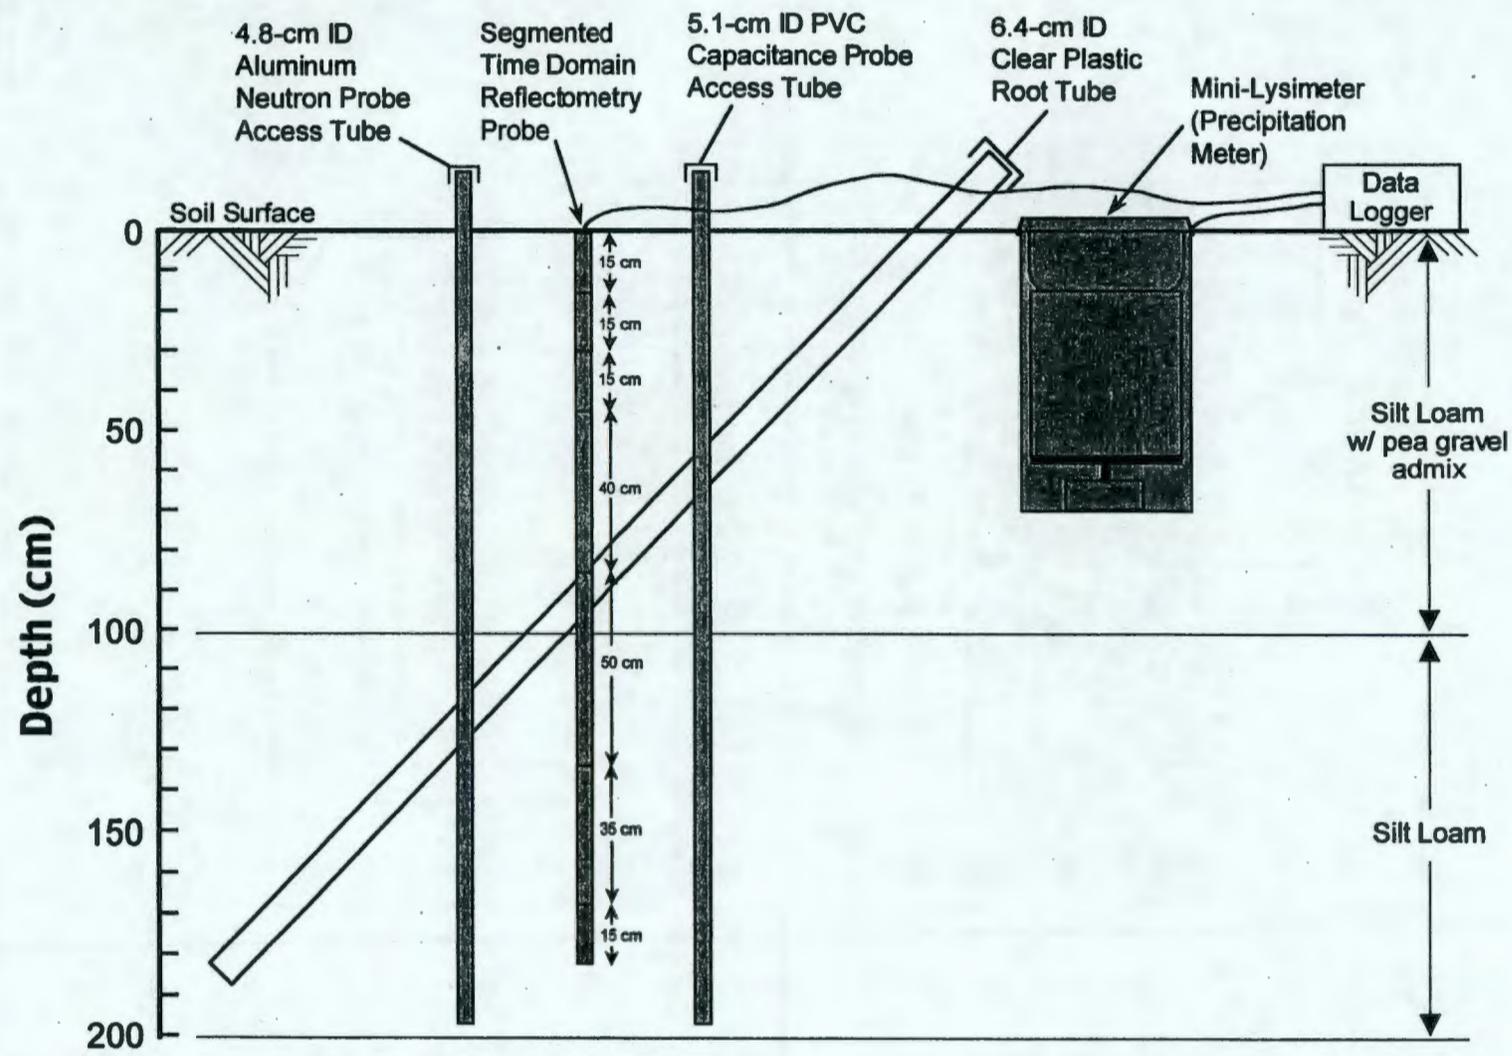
Figure 2-3. Cross Section of a Typical Water Balance Monitoring Station.

To measure water content profiles in the top 2-m-thick silt-loam layer, each monitoring station was fitted with a vertical aluminum access tube for measurements with a neutron probe, a polyvinyl chloride (PVC) access tube for capacitance probe, and a 1.85-m segmented time domain reflectometry (TDR) probe (Figure 2-3). Each surface plot is associated with a water collection system (with boundaries on the asphalt layer) to permit measurement of drainage out of the upper soil layers (Appendix A). Below each treatment, U-shaped horizontal neutron probe access tubes permit measurement of water content above and below the asphalt layer (Figure 2-2 and Appendix A). A pan lysimeter was also installed under the asphalt pad at the northeastern corner of the riprap slope (plot 4E) to permit evaluation of the performance of the asphalt layer (Appendix A).

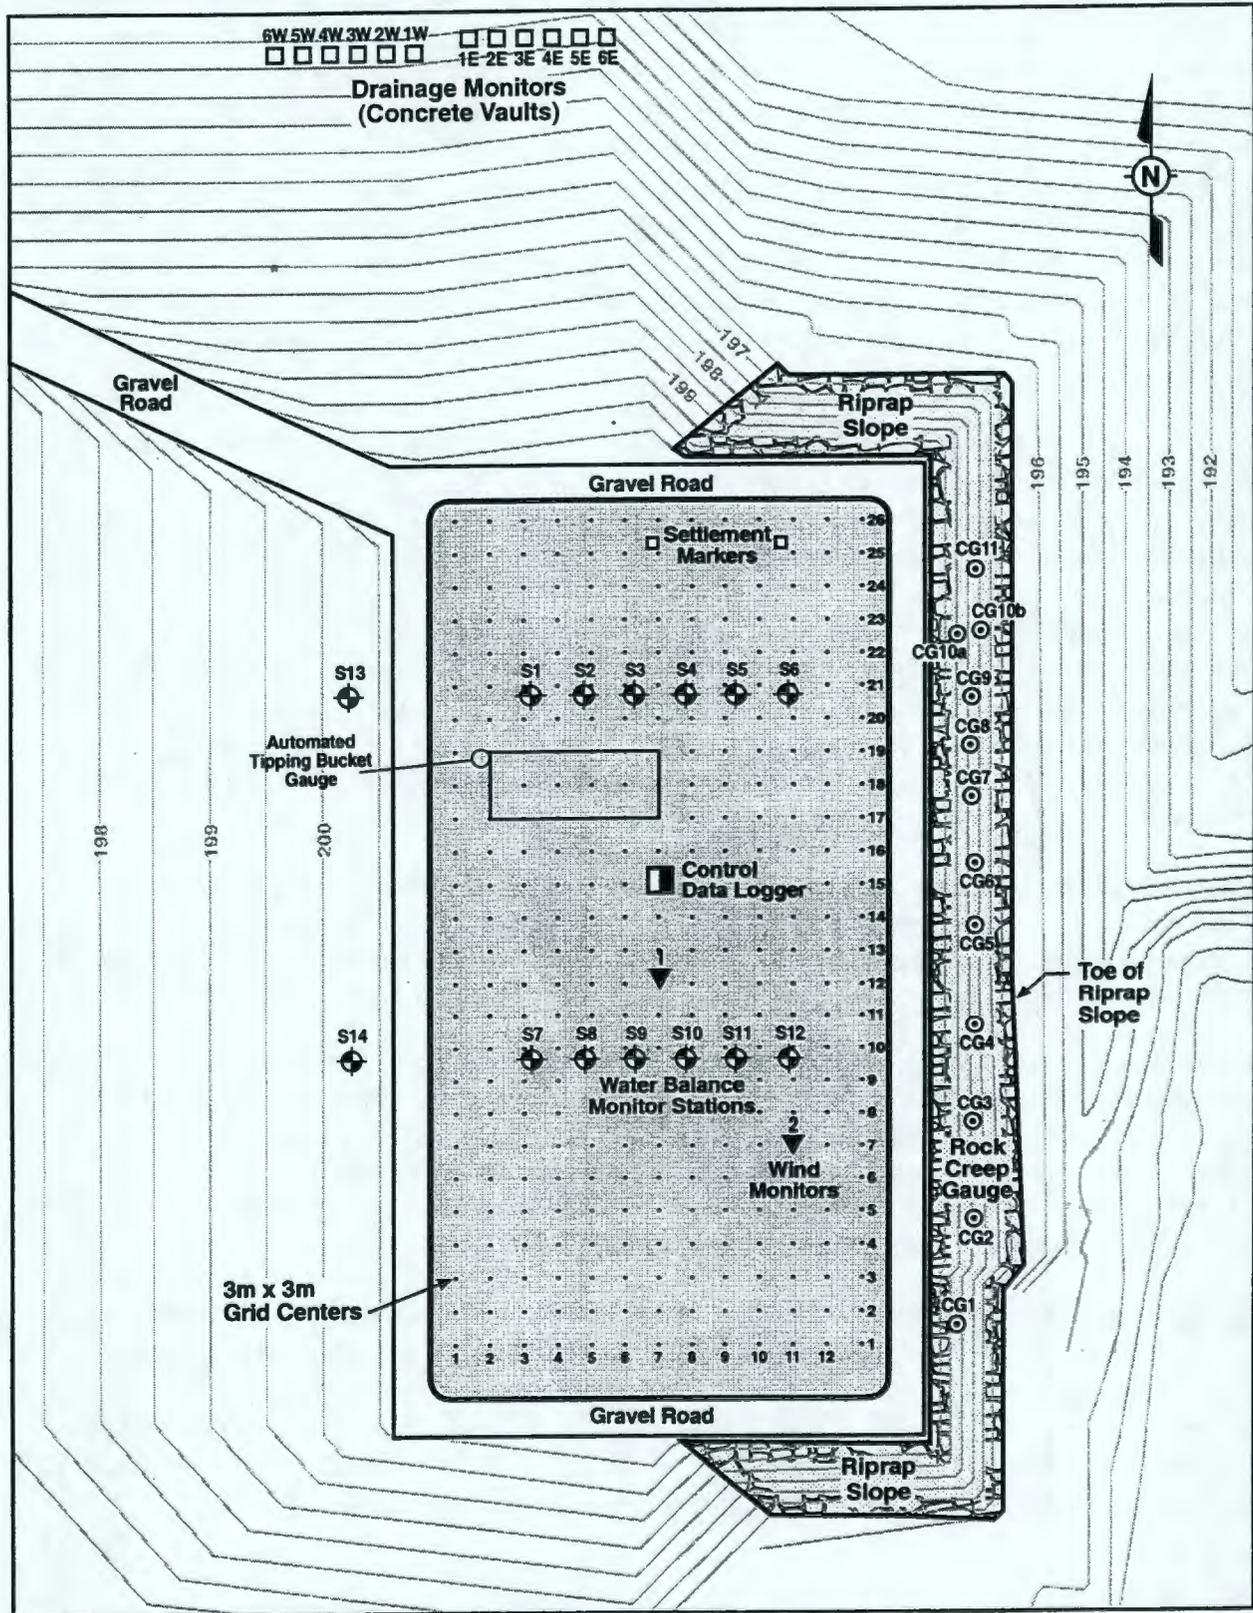
Figure 2-4. Plan View of the Barrier's Surface Showing the 3-m x 3-m Grid and Relative Positions of the Water Balance Monitoring Stations (S1 Through S14).

The drainage monitoring system is composed of 12 concrete vaults (Figures 2-4 and 2-5 and Appendix A). The vaults were installed to the north and downgradient from the asphalt layer to allow the movement of water by gravity. Drainage water flows into each vault via a datalogger-controlled tipping-bucket raingauge, which allows monitoring of low flows. Each vault is also fitted with a submersed Druck[®] pressure transducer that continuously monitors the intermediate to high flow rates by recording hydrostatic pressure, which is a function of water height. Measurements are made at intervals ranging from 10 minutes to 1 hour. Also included in each vault is an Orenco[®] dosing siphon, a passive device for monitoring large flows. The siphon is fitted with a dose counter connected to a datalogger to record dosing events. Each dose is equivalent to $591 \pm 40 \text{ L}$ of water, or 1.8 mm from the full-sized plots and 6.4 mm from the transition plots. Each vault is also fitted with an evaporimeter to monitor the amount of water evaporating from the vault. The measurement precision of the instruments is presented in Table 2-2. Detailed instructions on the measuring procedure are provided in PNL-PSB-4.0.

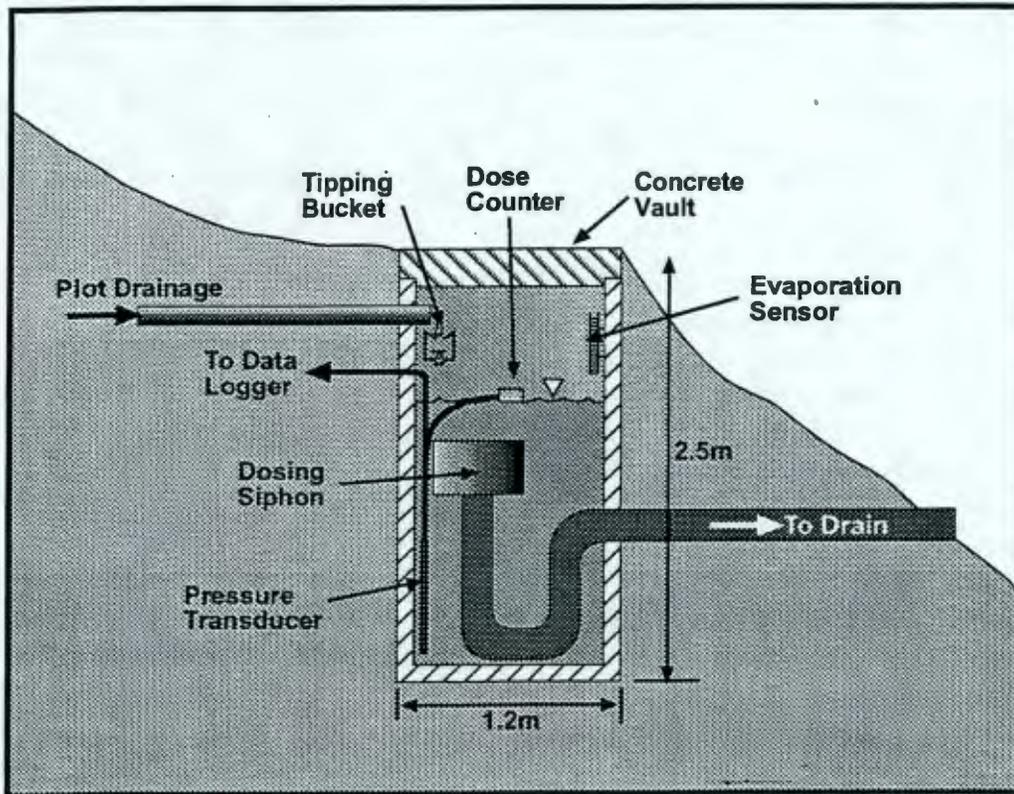
Figure 2-5. Schematic of Drainage Monitoring System Showing the Siphon Vault and Associated Monitoring Instruments.

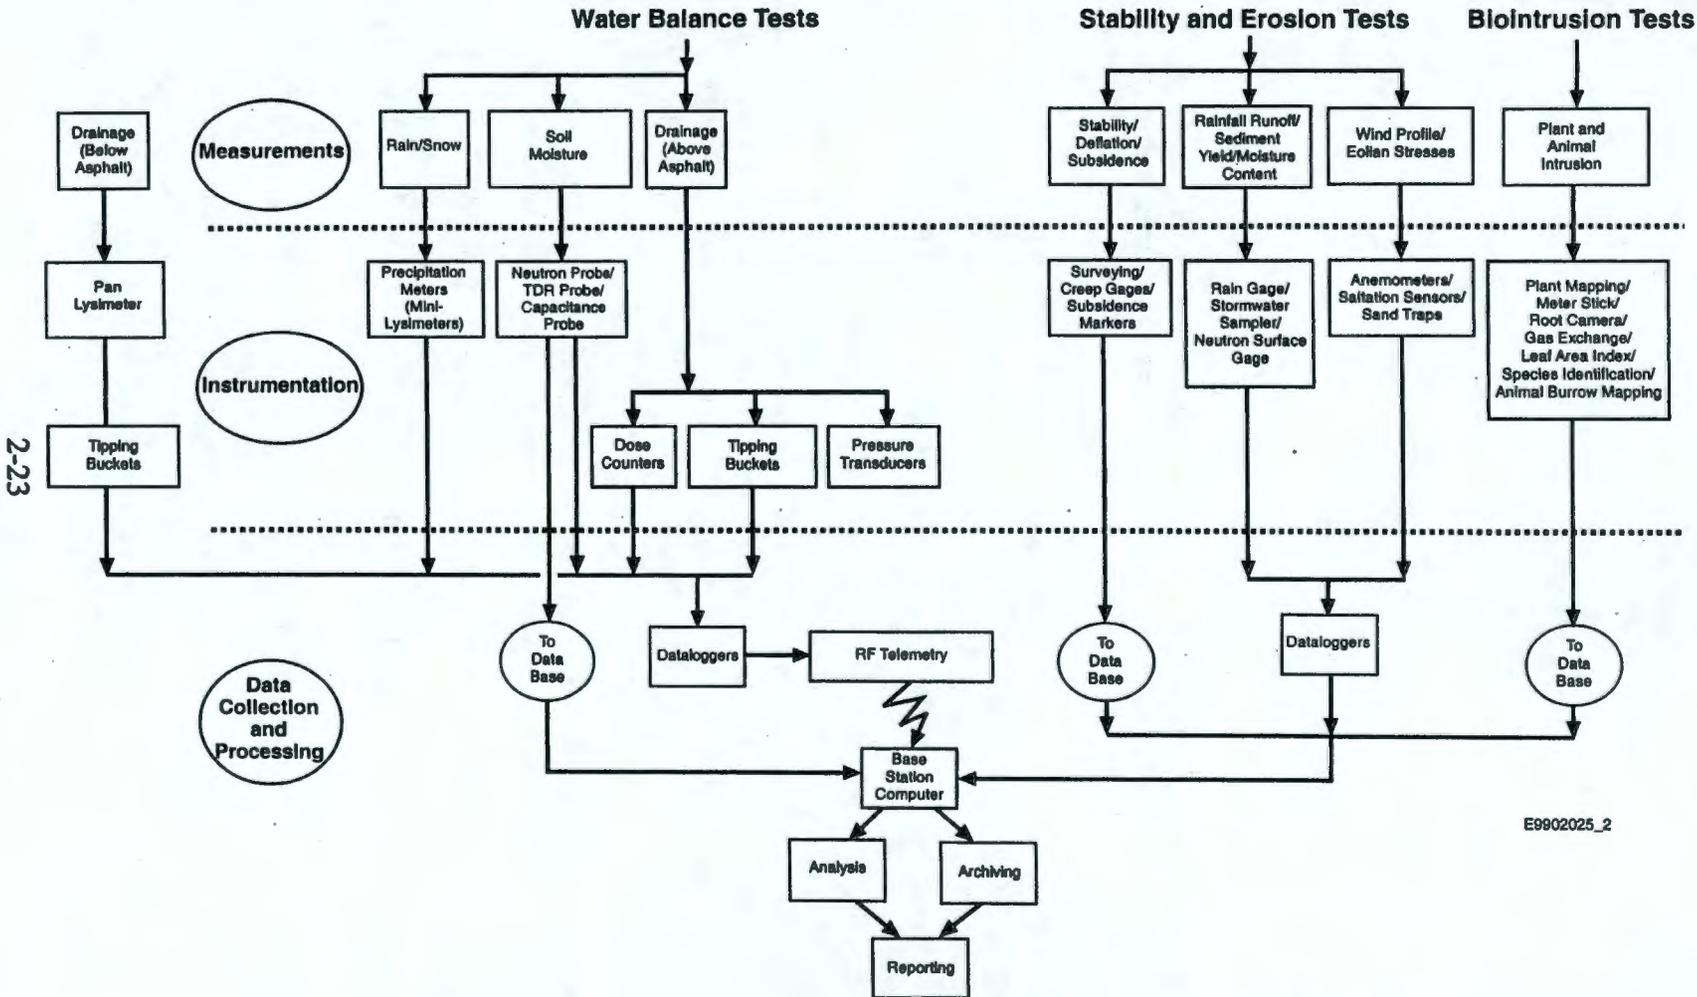
Figure 2-7. Measurement, Instrumentation, and Data Collection Flow Diagram for the Prototype Surface Barrier.

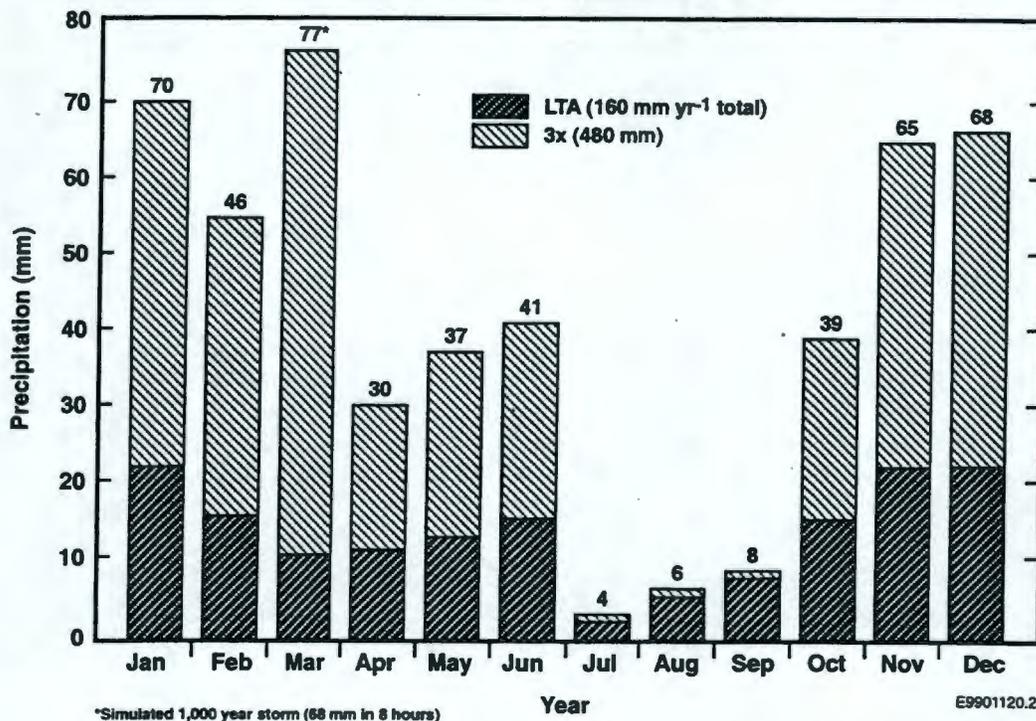
Figure 3-1. Scheduled Monthly Irrigation Water Application Followed During the First 3 Years of the Treatability Test.

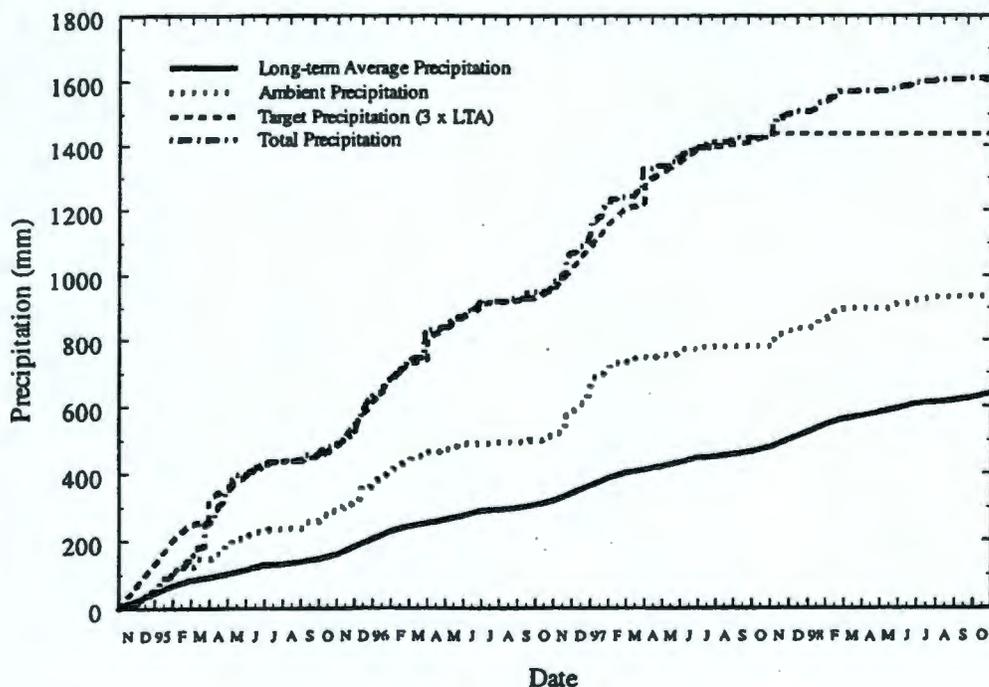
Figure 3-2. Cumulative 4-Year Precipitation Data for the Prototype Barrier. Total Precipitation Includes both Natural Precipitation and Applied Irrigation.

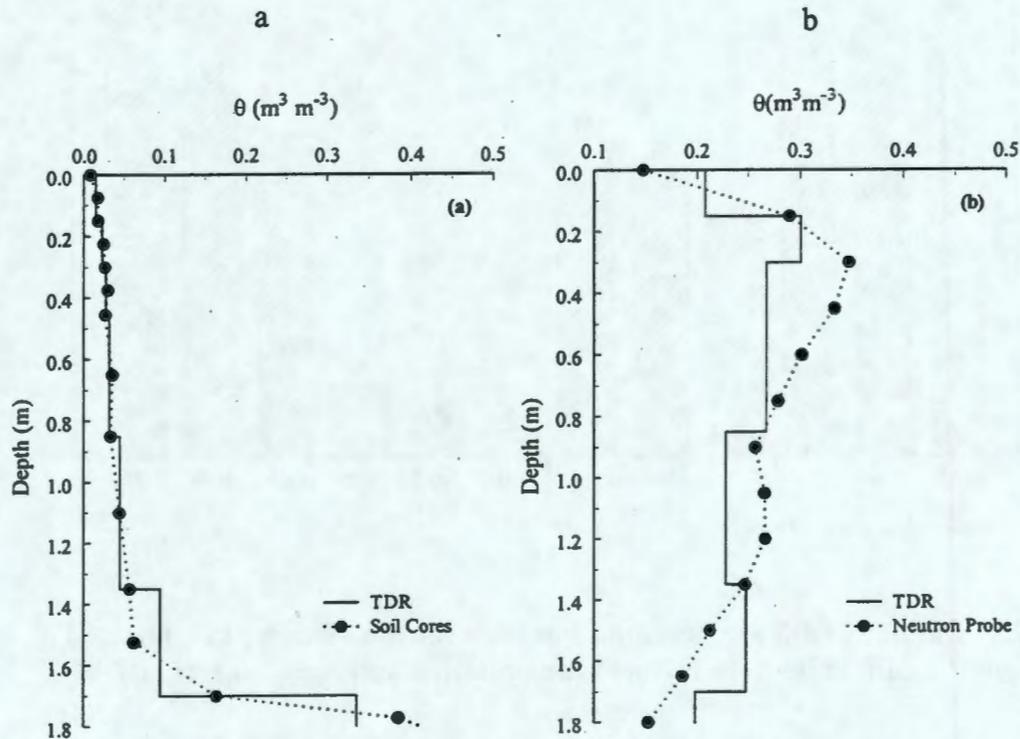
Figure 3-3. Comparison of Water Content $\theta(z)$ Measured with a Seven-Segment Remote Shorting TDR Probe with (a) θ Determined by Gravimetry in a Draining Sand Column, and (b) Field Measurements of θ (by Neutron Probe) in the Silt Loam.

(After applying 70 mm of irrigation over 8 hours, the change in storage was 55 mm by TDR measurements compared to 69 mm by neutron probe.)

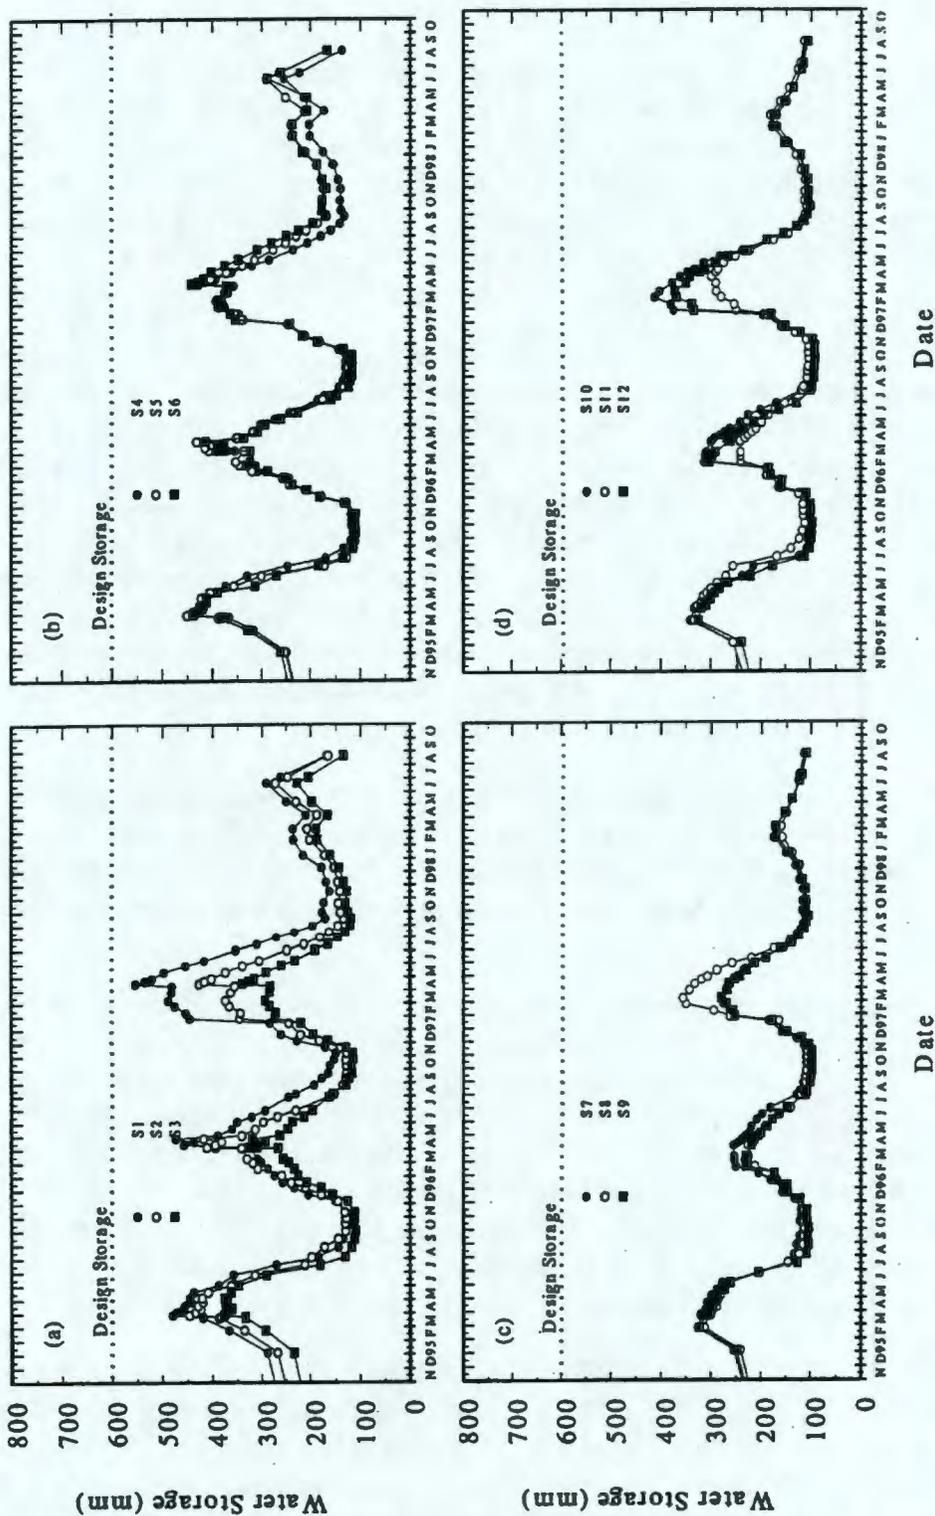
Figure 3-4. Temporal Variation in Soil Water Storage at the Barrier, for Each of the Silt-Loam Plots, from November 1, 1994 through September 30, 1998. ([a] northwest, 6W; [b] northeast, 6E; [c] southwest, 3W; [d] southeast, 3E).

Figure 3-4 shows unusually small peaks in water storage in the winter of WY 1998. There are two explanations: (1) irrigation events were discontinued in September 1997 and briefly resumed in May 1998 to facilitate validation of water storage measurements, and (2) the winter of WY 1998 was unusually dry because of El Niño effects. Precipitation recorded at the barrier in the winter of WY 1998 was 69 mm, compared to 106 mm in WY 1995, 126 mm in WY 1996, and 140 mm in WY 1997. The winter LTA is 60 mm.

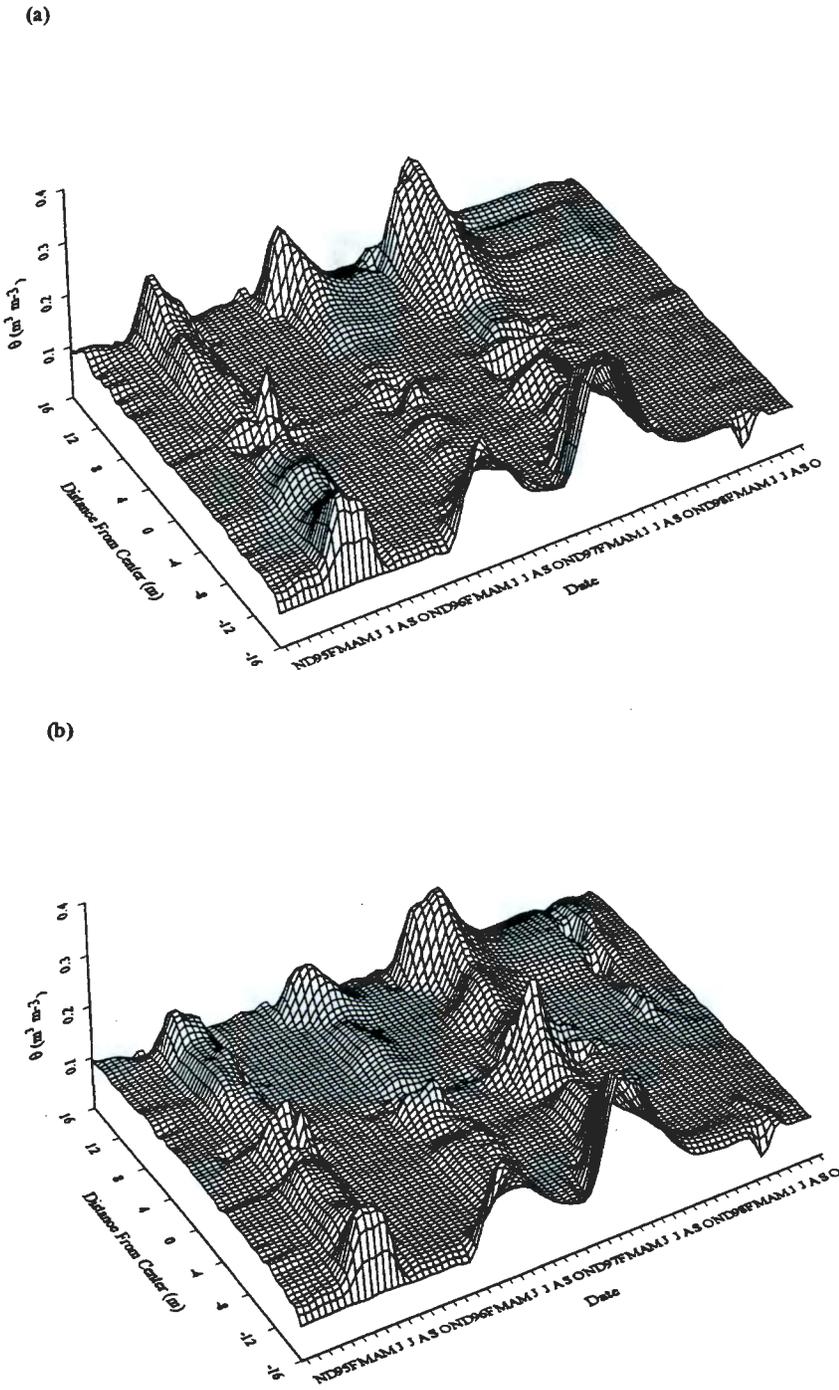
Figure 3-5. Spatiotemporal Variations in Soil Water Content at the Bottom of the Silt-Loam Layer of the Irrigated Treatment of the Barrier.

([a] northern end of treatment, tube AA1 + AA5, and [b] southern end of treatment, tube AA2 + AA6).

In general, accumulation of water was greatest at the northwest and northeast edges of the irrigated plots (tubes AA1 and AA5) and usually peaked by early May. These data also show that the decline in θ at the capillary break usually starts shortly after reaching its maximum value. There also appears to be a difference in the arrival time of the wetting front at tubes in the north and south ends of each plot, as well as a difference between the value of θ on the western (Figure 3-7a) and eastern (Figure 3-7b) plots. These differences are most likely due to differences in the snow and water accumulation during the winter and spring.

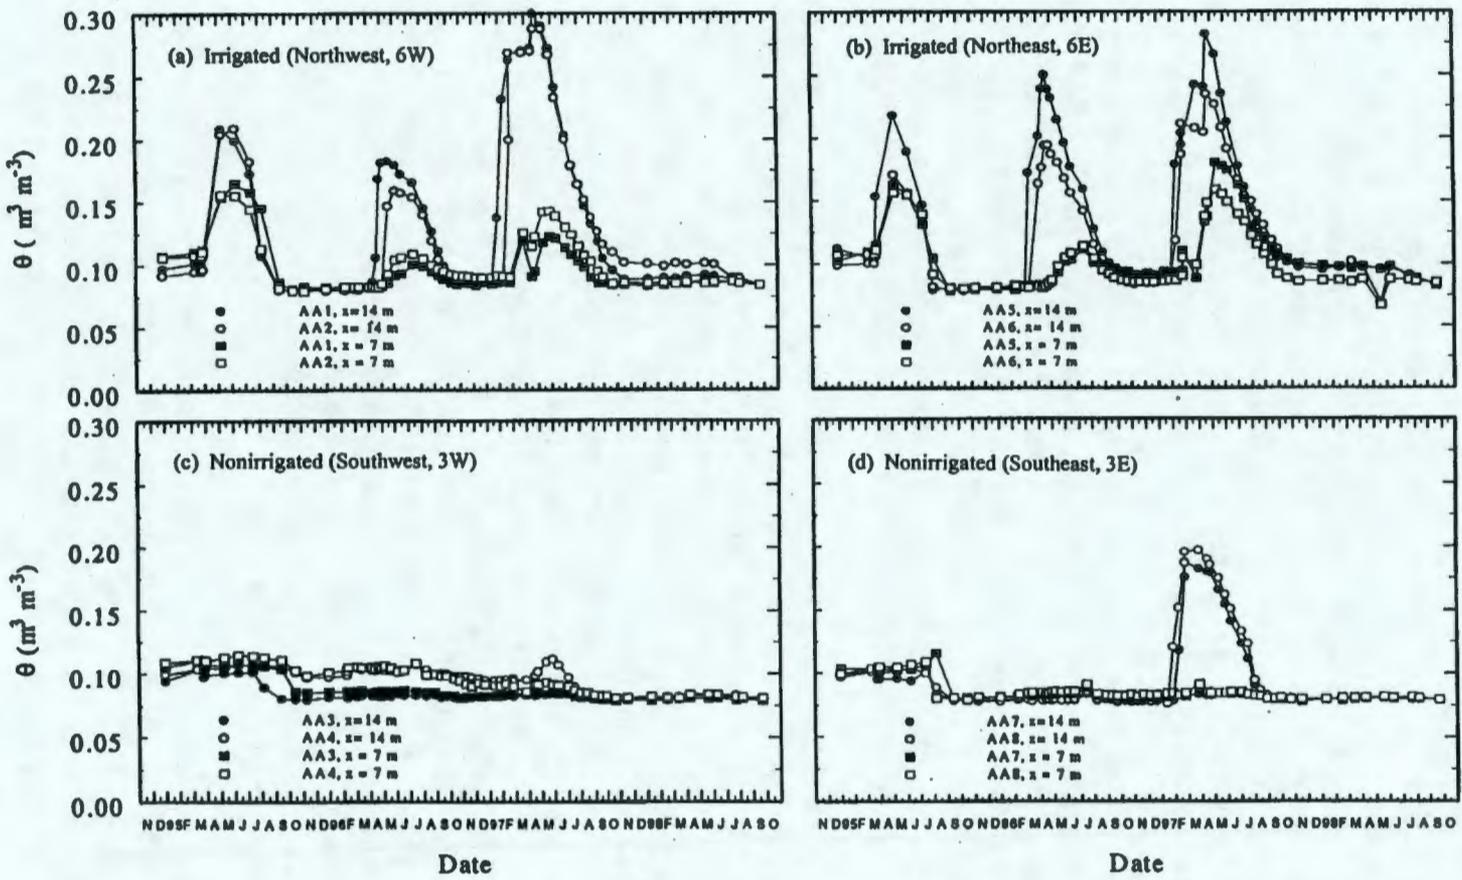
Figure 3-7. A Comparison of Temporal Variations in Soil Water Content Along Two Transects at the Bottom of Silt-Loam Layer of the Barrier. (Data represent water content θ (t) at 7 m and 14 m from the center of each plot.)

A better visual perspective of the temporal change in θ is obtained from two-dimensional plots of $\theta(t)$ along a transect of interest. Figure 3-7 shows a plot of $\theta(t)$ at 7 m (midpoint of the plot) and 14 m (outer edge of the plot) in each treatment. In November 1994, initial θ on the four plots was relatively similar, with a mean of $0.10 \text{ m}^3 \text{ m}^{-3}$ over all plots. Despite regular irrigations, no significant increase in θ was observed at the capillary break until just after the first simulated 1,000-year storm on March 26, 1995.

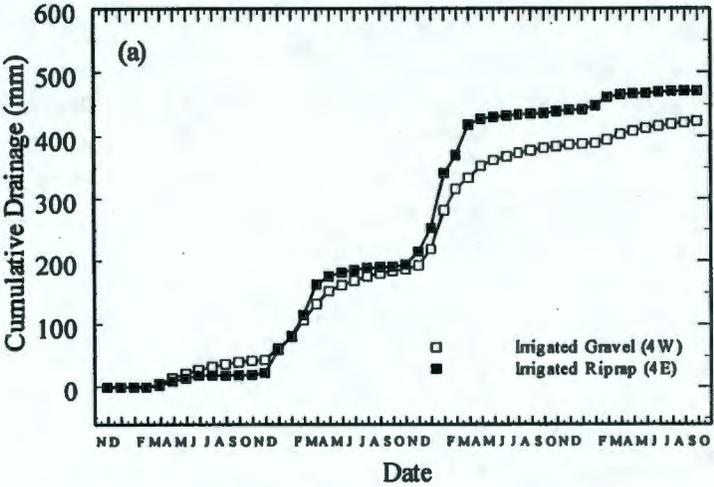
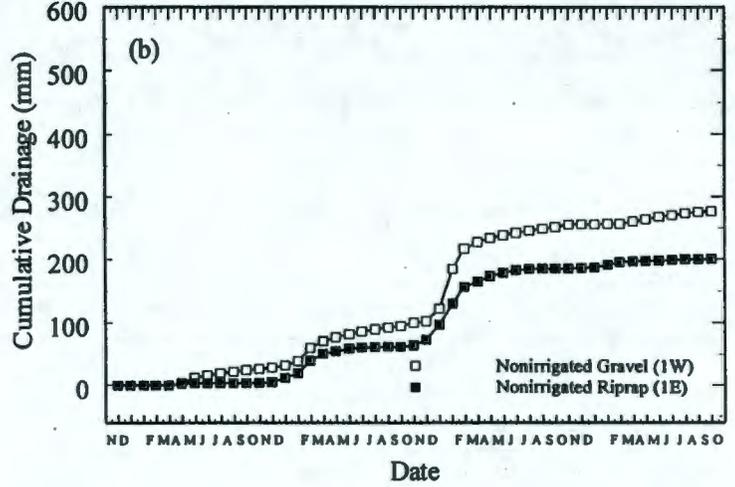
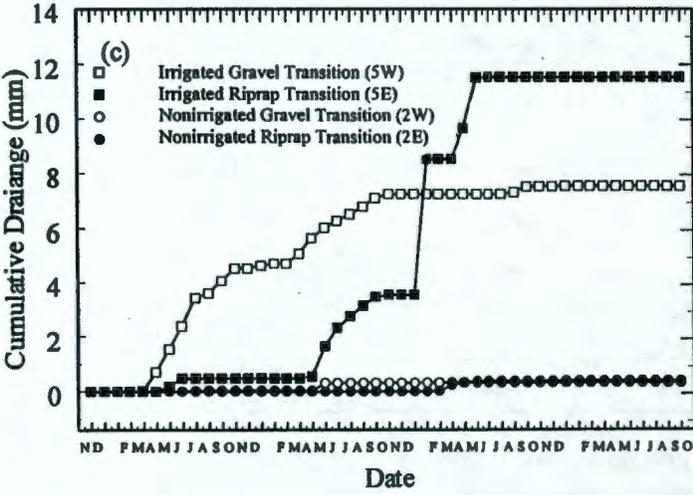
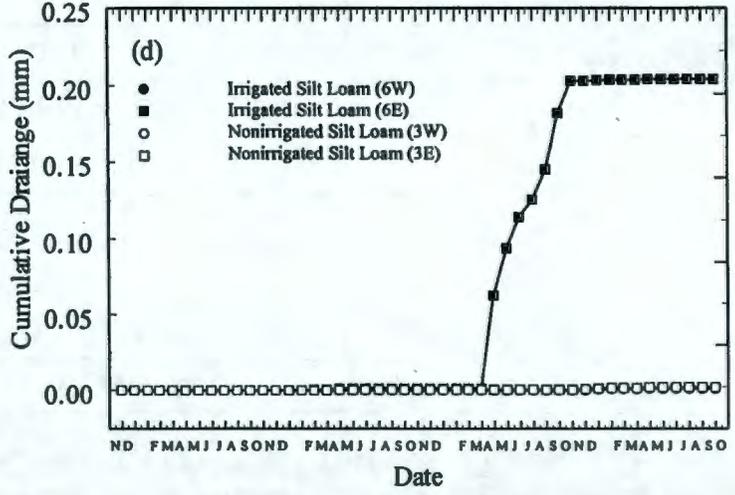
Figure 3-8. Cumulative Drainage from the 12 Collection Zones on the Asphalt Pad.
 (a) irrigated side-slope plots, 4W, 4E; (b) nonirrigated side-slope plots, 1W, 1E;
 (c) transition plots 5W, 5E, 2W, 2E; and (d) silt-loam plots 6W, 6E, 3W, 3E.)

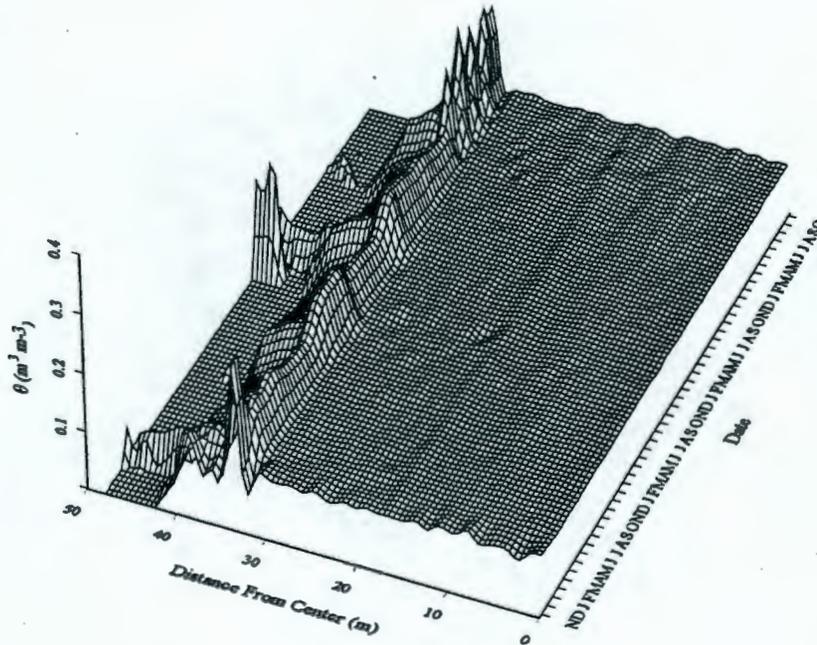
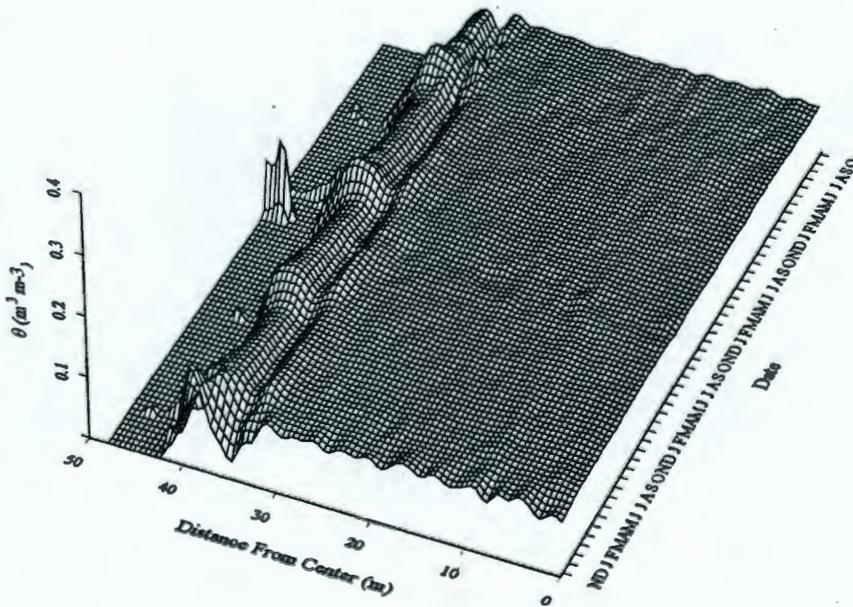
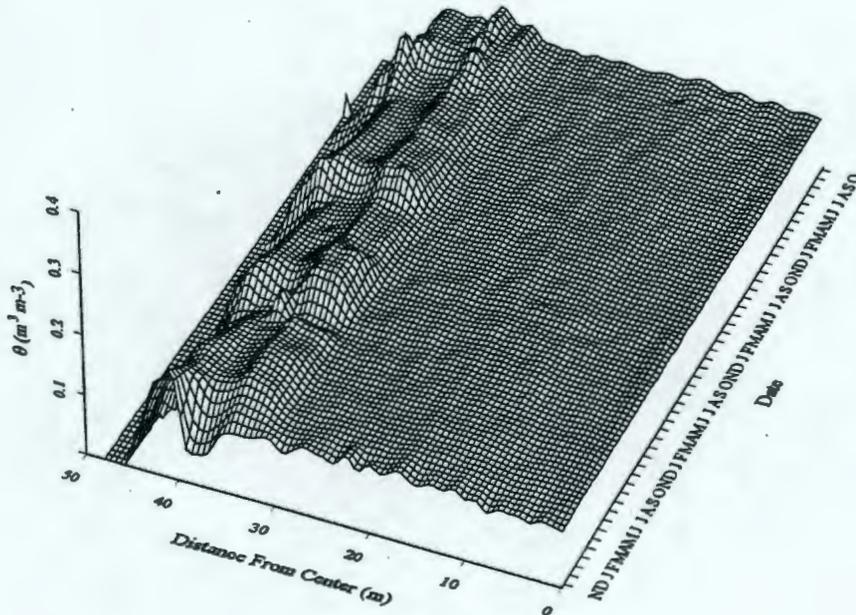
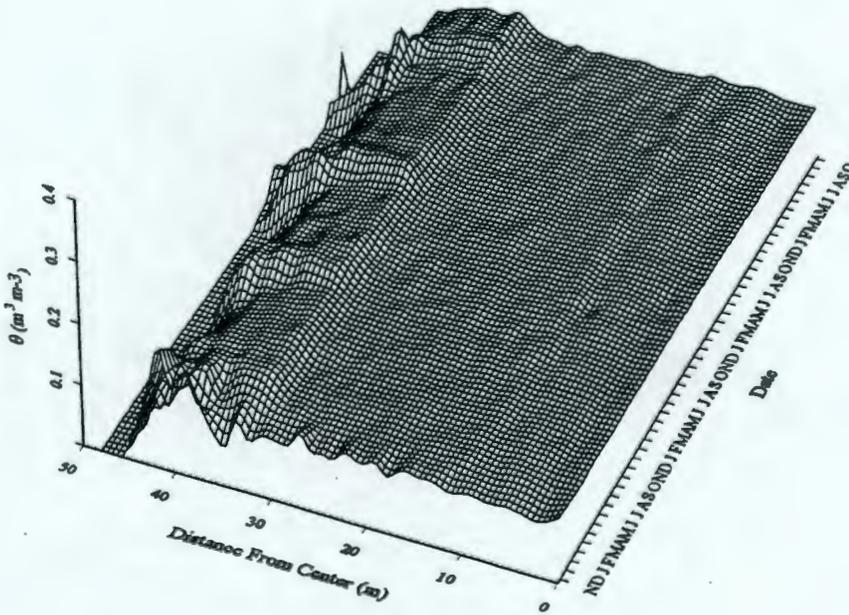
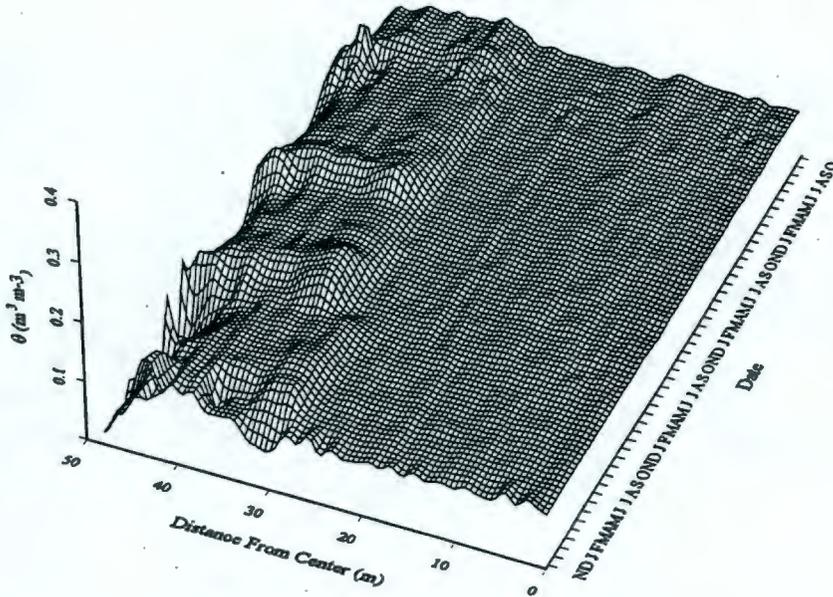
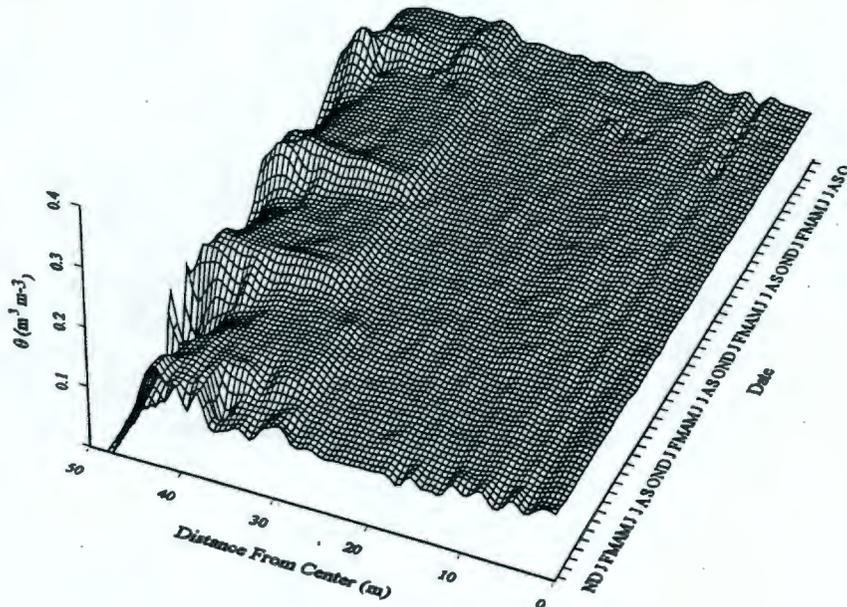
Figure 3-9. Spatiotemporal Variations in Soil Water Content Under the Asphalt Layer.
(Page 2)

(Uncurbed asphalt tube [c] BA3 at 2 m and curbed asphalt tube [d] BA4 at 2 m.)

(Uncurbed asphalt tube [e] BA5 at 3 m and curbed asphalt tube [f] BA6 at 3 m.)

to the east where the water is shed, these changes have not extended very far under the asphalt. At all three depths, changes in θ have not extended more than 2 m under the asphalt, and even then θ has never increased beyond $0.15 \text{ m}^3 \text{ m}^{-3}$.
