DOE/RL-99-11

200-BP-1 Prototype Barrier Treatability Test Report

August 1999

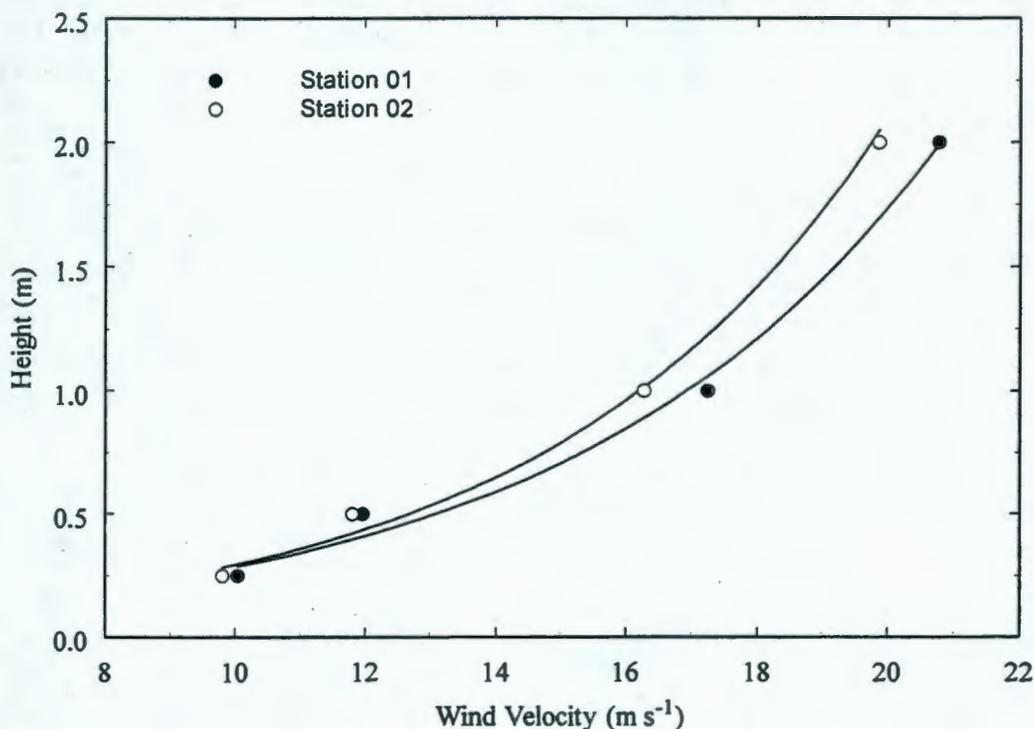
Figure 3-10. Peak Gust Wind Profiles Measured over the Elevated Surface of the Hanford Barrier on March 30, 1997.

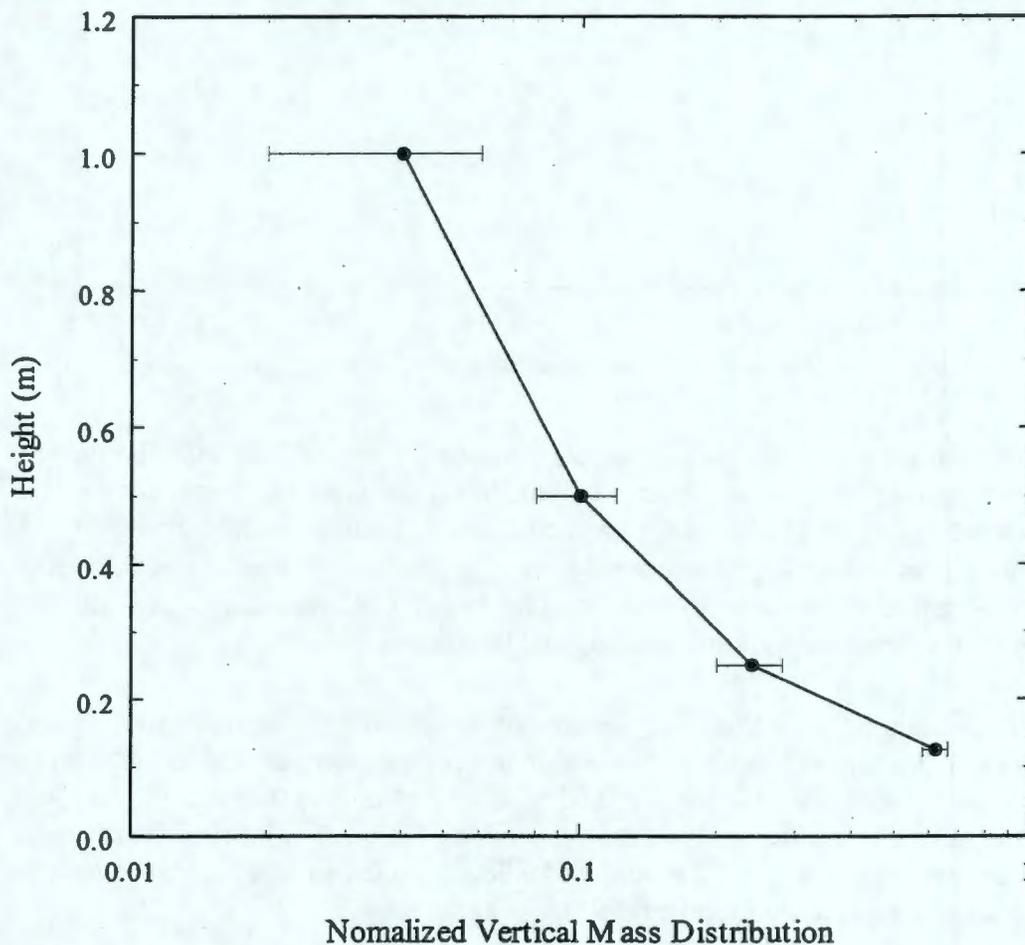
Figure 3-11. Normalized Vertical Profile of Soil Mass Blowing Across the Barrier's Surface Between September 29, 1994 and November 1, 1994.

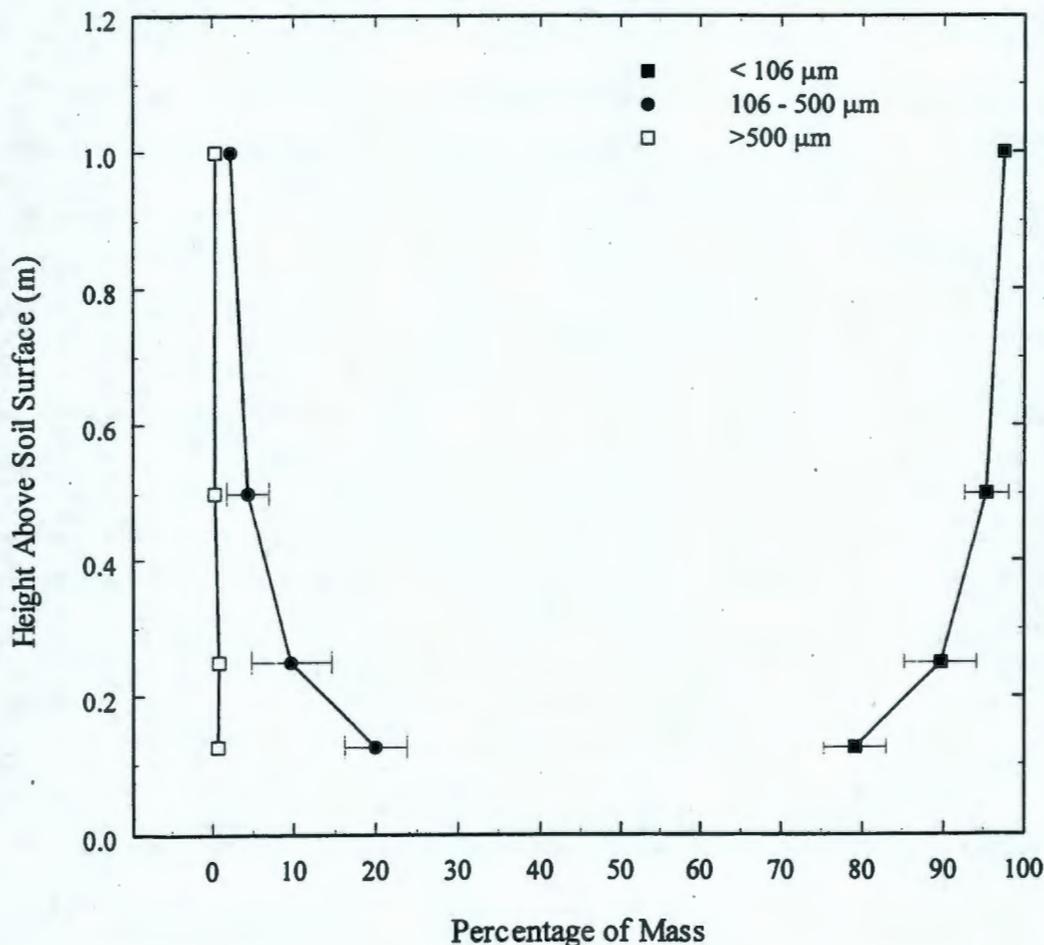
Figure 3-12. Particle Size Distribution of Soil Material Collected in Dust Traps at the Barrier in WY 1995.

Figure 3-12 shows that the composition of the material collected in the dust traps was dominated by very fine sand and silt particles with a mean diameter smaller than $106 \mu\text{m}$. Because of their small sizes, such particles have the greatest tendency to remain suspended once they are removed from the surface by wind. These particles pose little threat to causing further erosion. About 20% of the soil collected consisted of fine sand particles with diameters ranging from 106 to $500 \mu\text{m}$. The greatest quantities were found at a height of 0.5 m above the surface. This size of particle is most likely to be transported by wind in saltation, traveling short distances with low-angle terminal impacts causing smaller silt-sized particles to be ejected from the surface. Therefore, this size of particle poses the greatest threat for causing wind erosion. In contrast, very small quantities ($<1\%$) of sand grains with diameters greater than $500 \mu\text{m}$ were observed. This size of particle is generally transported by wind during creep sliding and rolling at or near the surface. Overall, the size distribution of the soil removed by wind was $89 \pm 4\%$ with diameters less than $106 \mu\text{m}$; $10 \pm 4\%$ between 106 and $500 \mu\text{m}$; and $<1\%$ greater than $500 \mu\text{m}$.

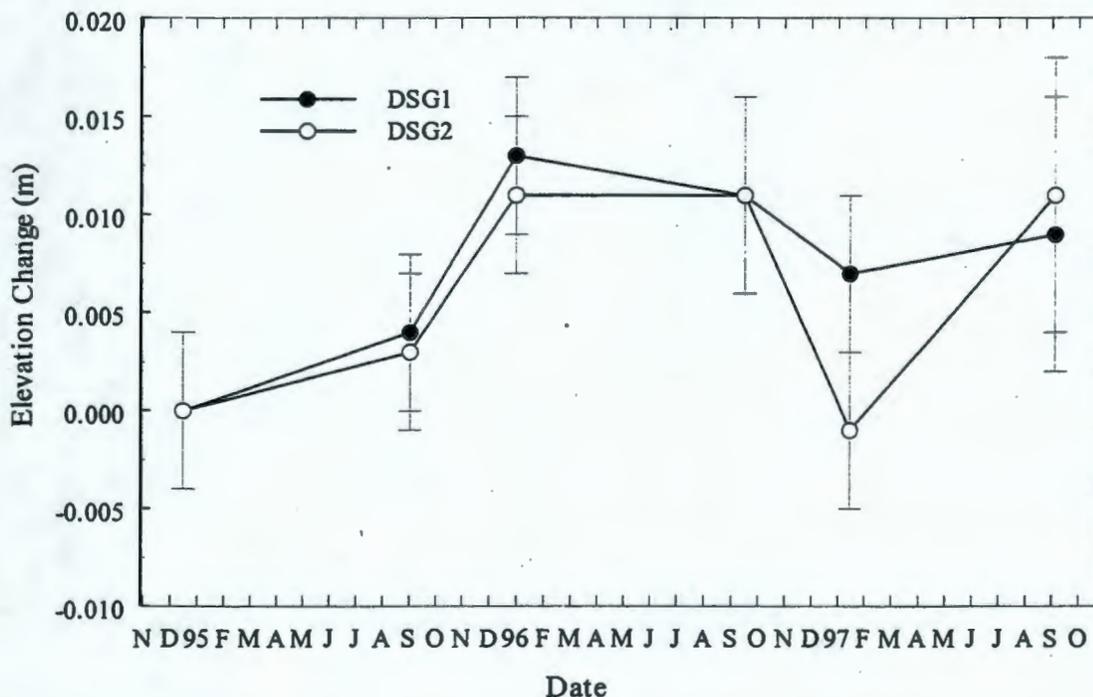
**Figure 3-14. Summary of Changes in Settlement Gauge Elevation
Between November 1, 1994 and September 1997.**
(Error bars represent the total measurement error;
DSG2 is located 14 m east of DSG1.)

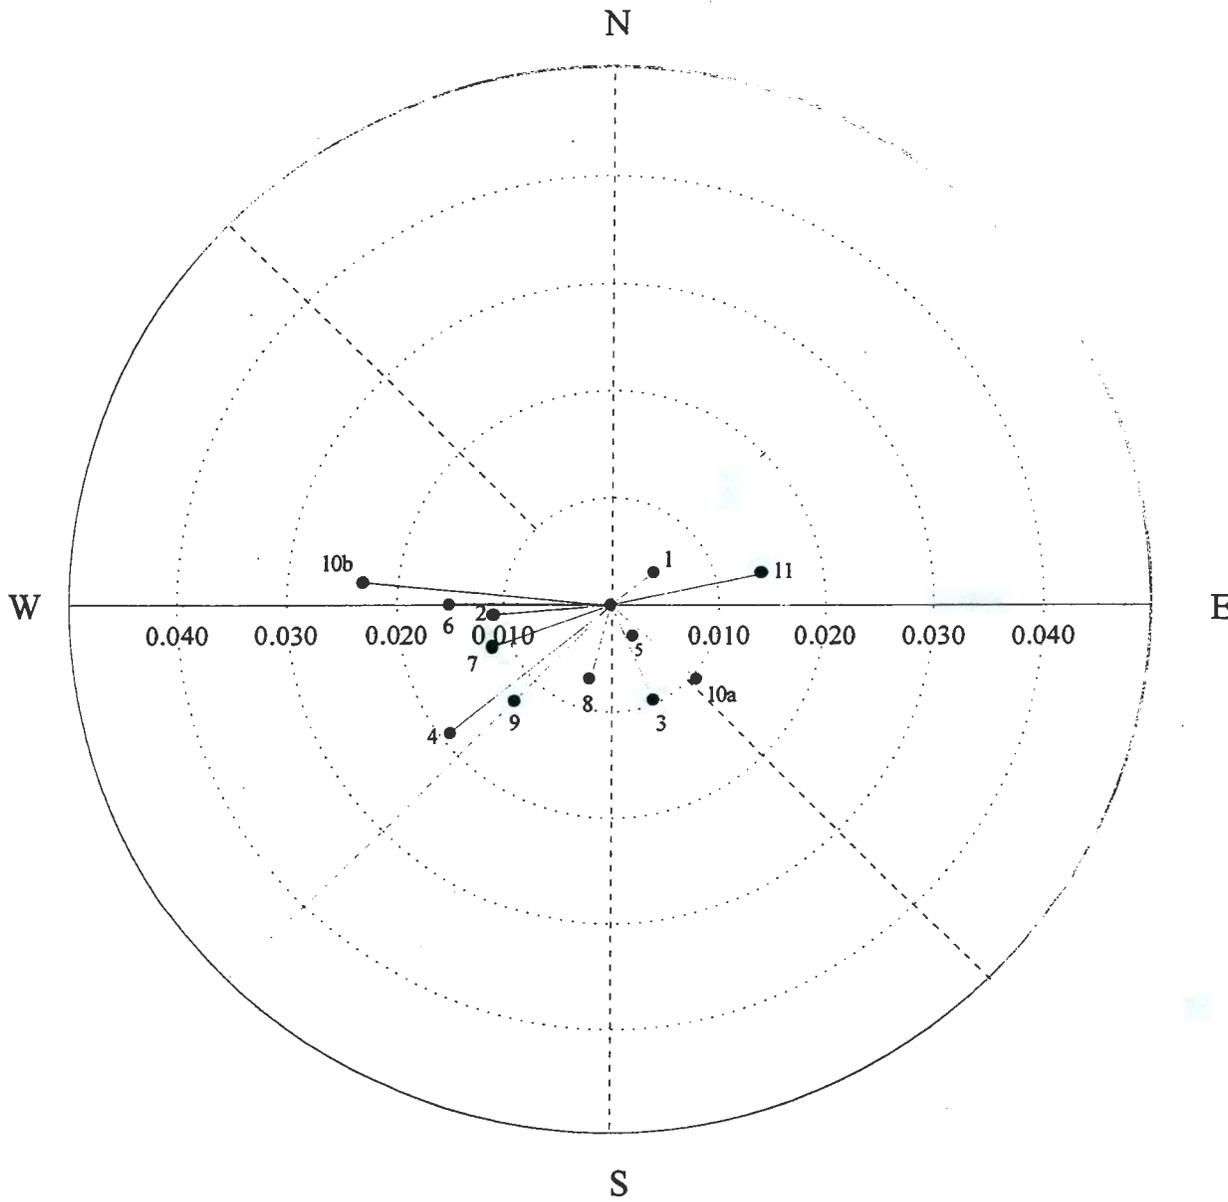
Figure 3-15. Creep Gauge Movement Between December 1994 and September 1995.
(Elevation was measured by EDM; the resultant is in meters and the bearing is in radians).

3.2.3.3 Creep Gauge Movement. As shown in Figure 3-15, the change in location and elevation between the first survey in December 1994 and the second survey in September 1995 showed no clear pattern. This is indicative of random settling of the riprap slope (Ward et al. 1997). This sort of movement was usually observed between surveys. However, a plot of the total change between December 1994 and September 1997 shows a more clearly defined result.

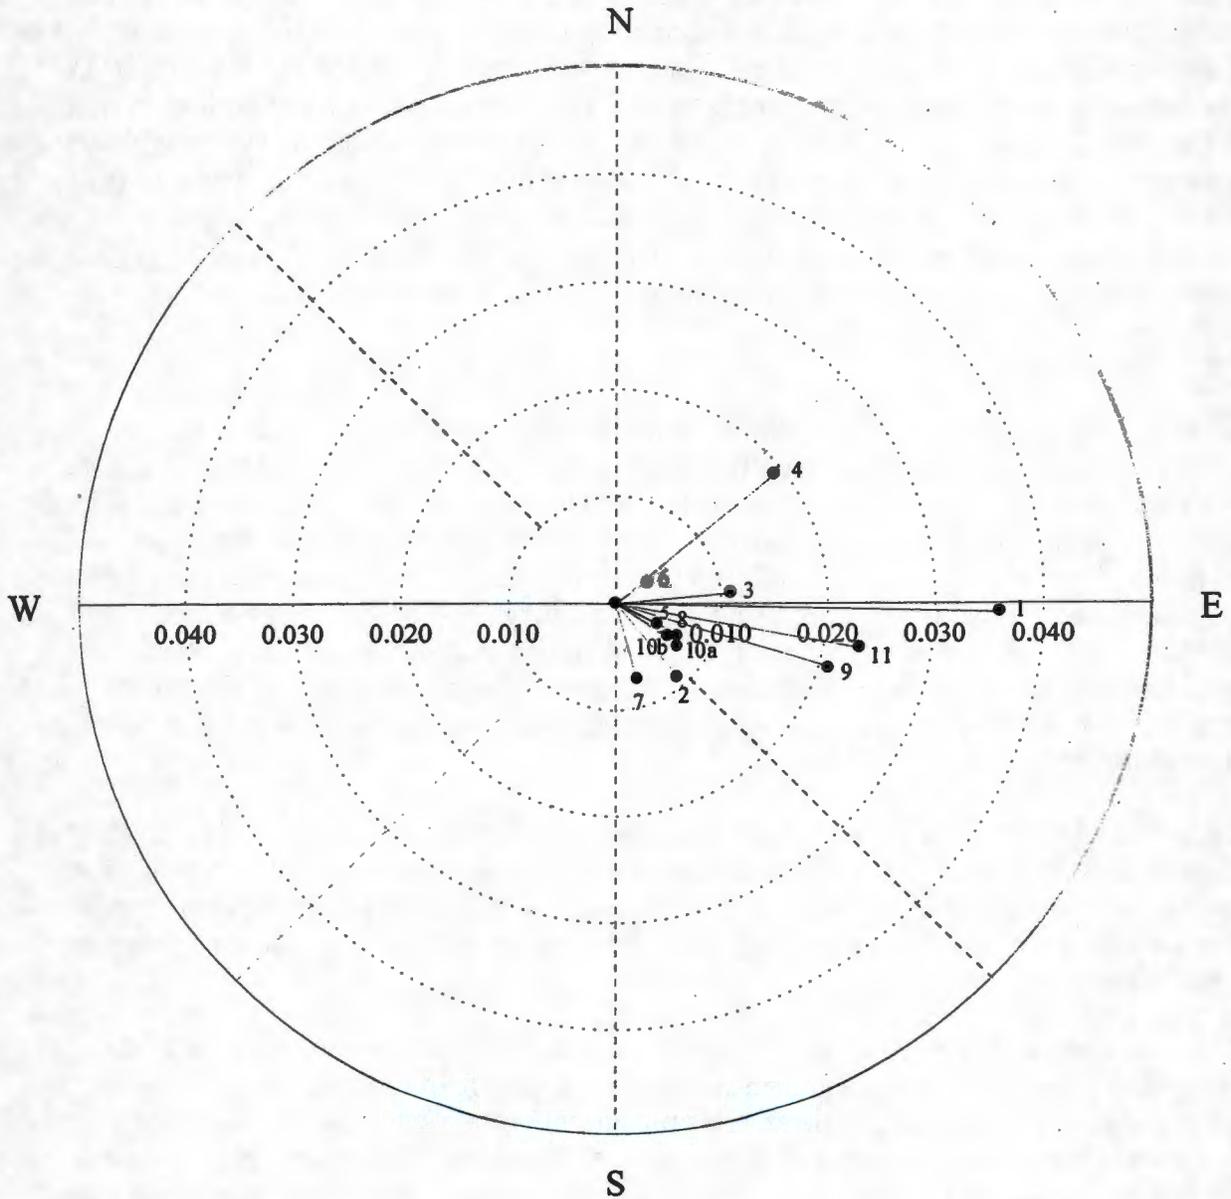
Figure 3-16. Creep Gauge Movement Between December 1994 and September 1997.
(Elevation was measured by EDM; the resultant is in meters and the bearing is in radians).

An analysis of the time course of creep gauge movement over the last 3 years shows a decrease in both the resultant and bearing between the first and second surveys (Ward et al. 1997). After the initial decline, they both increased and remained relatively constant. The variance in the resultant data was also relatively high, suggesting some randomness to the movement. However, the decrease in variance of the bearing estimates between the first and last surveys suggest a preferred easterly movement. Movement in an easterly direction is consistent with an outward and downward movement of the rock slope. However, visual observation and the magnitude of the measured changes show no evidence of side-slope failure. Thus, the small amount of displacement observed between December 1994 and September 1997 is probably due to settlement of the side slope into a more stable and compact arrangement. As with the settlement gauges, additional monitoring would be required to confirm or eliminate slope failure.

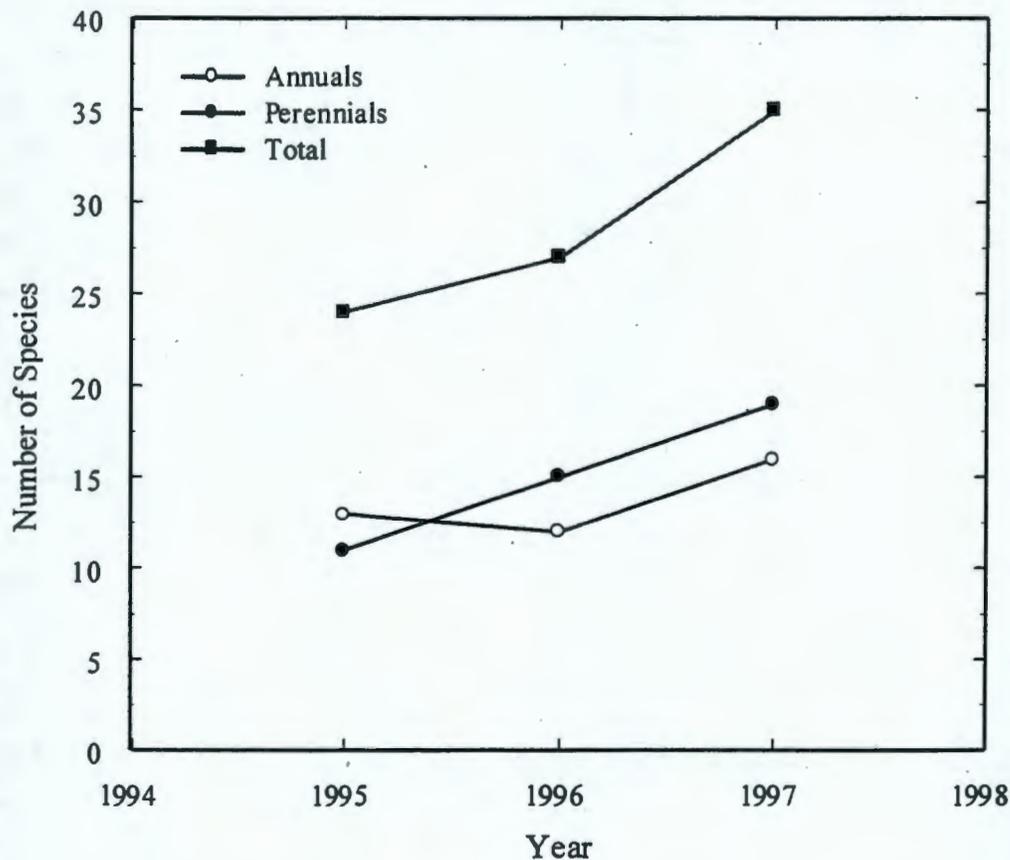
Figure 3-17. Number of Annual and Perennial Species Including Total Species on the Barrier's Surface.

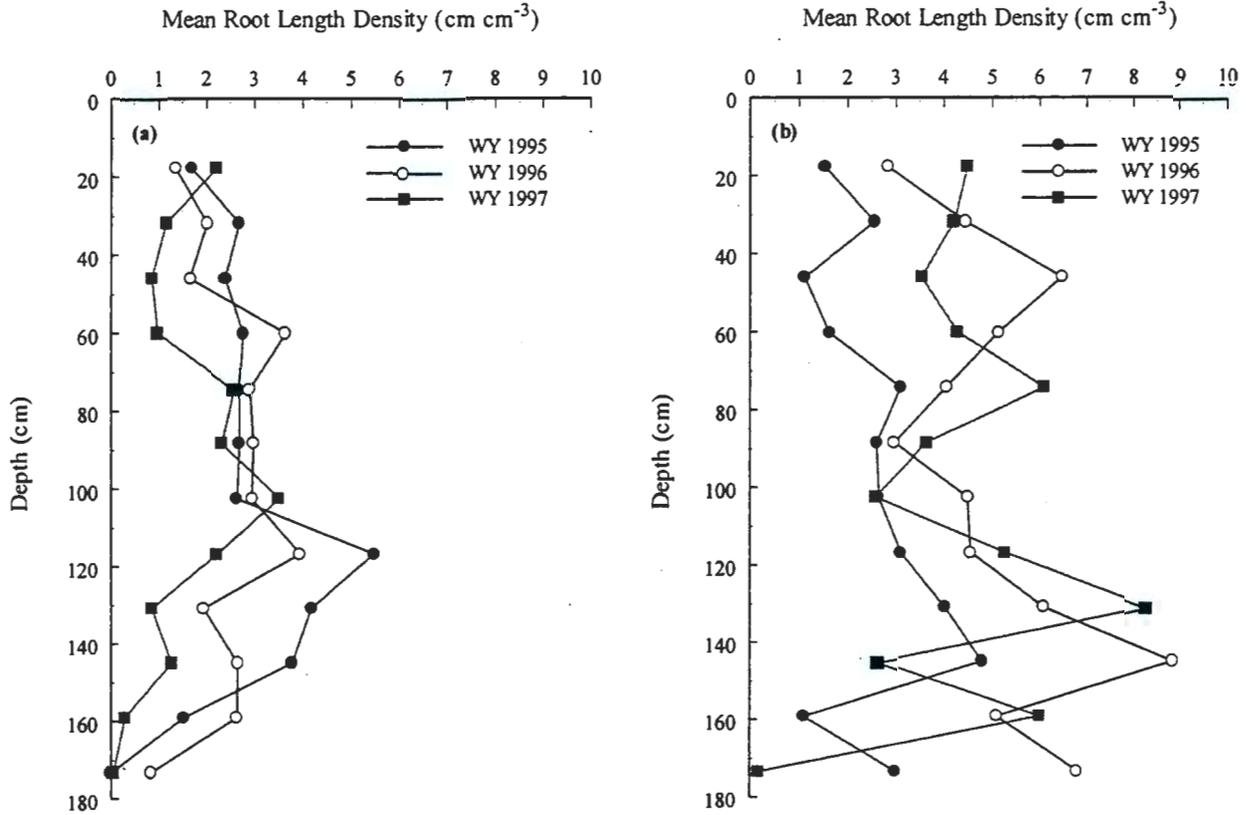
Figure 3-18. Mean Root Length Density as a Function of Depth in WY 1995, WY 1996, and WY 1997. ([a] nonirrigated treatment, and [b] irrigated treatment.)

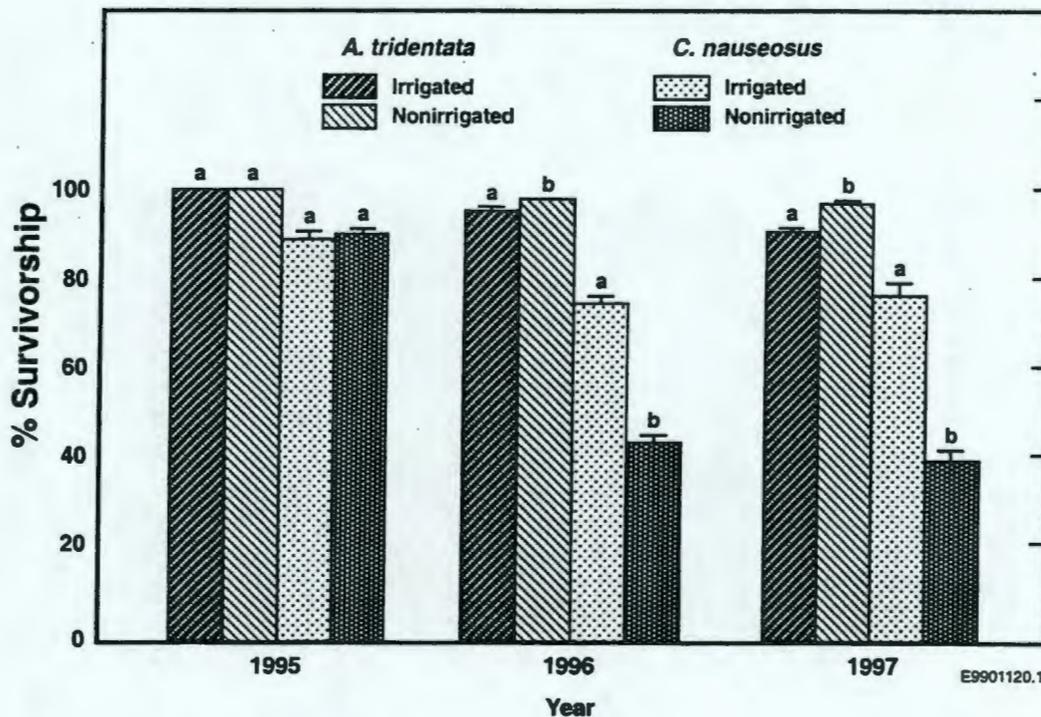
Figure 3-19. Mean Survivorship for *Artemisia tridentata* and *Chrysothamnus nauseosus* in WY 1995, WY 1996, and WY 1997 for the Nonirrigated and Irrigated Treatments. (Error bars are one standard error of the mean. Means with differing letters within years and species are significantly different.)

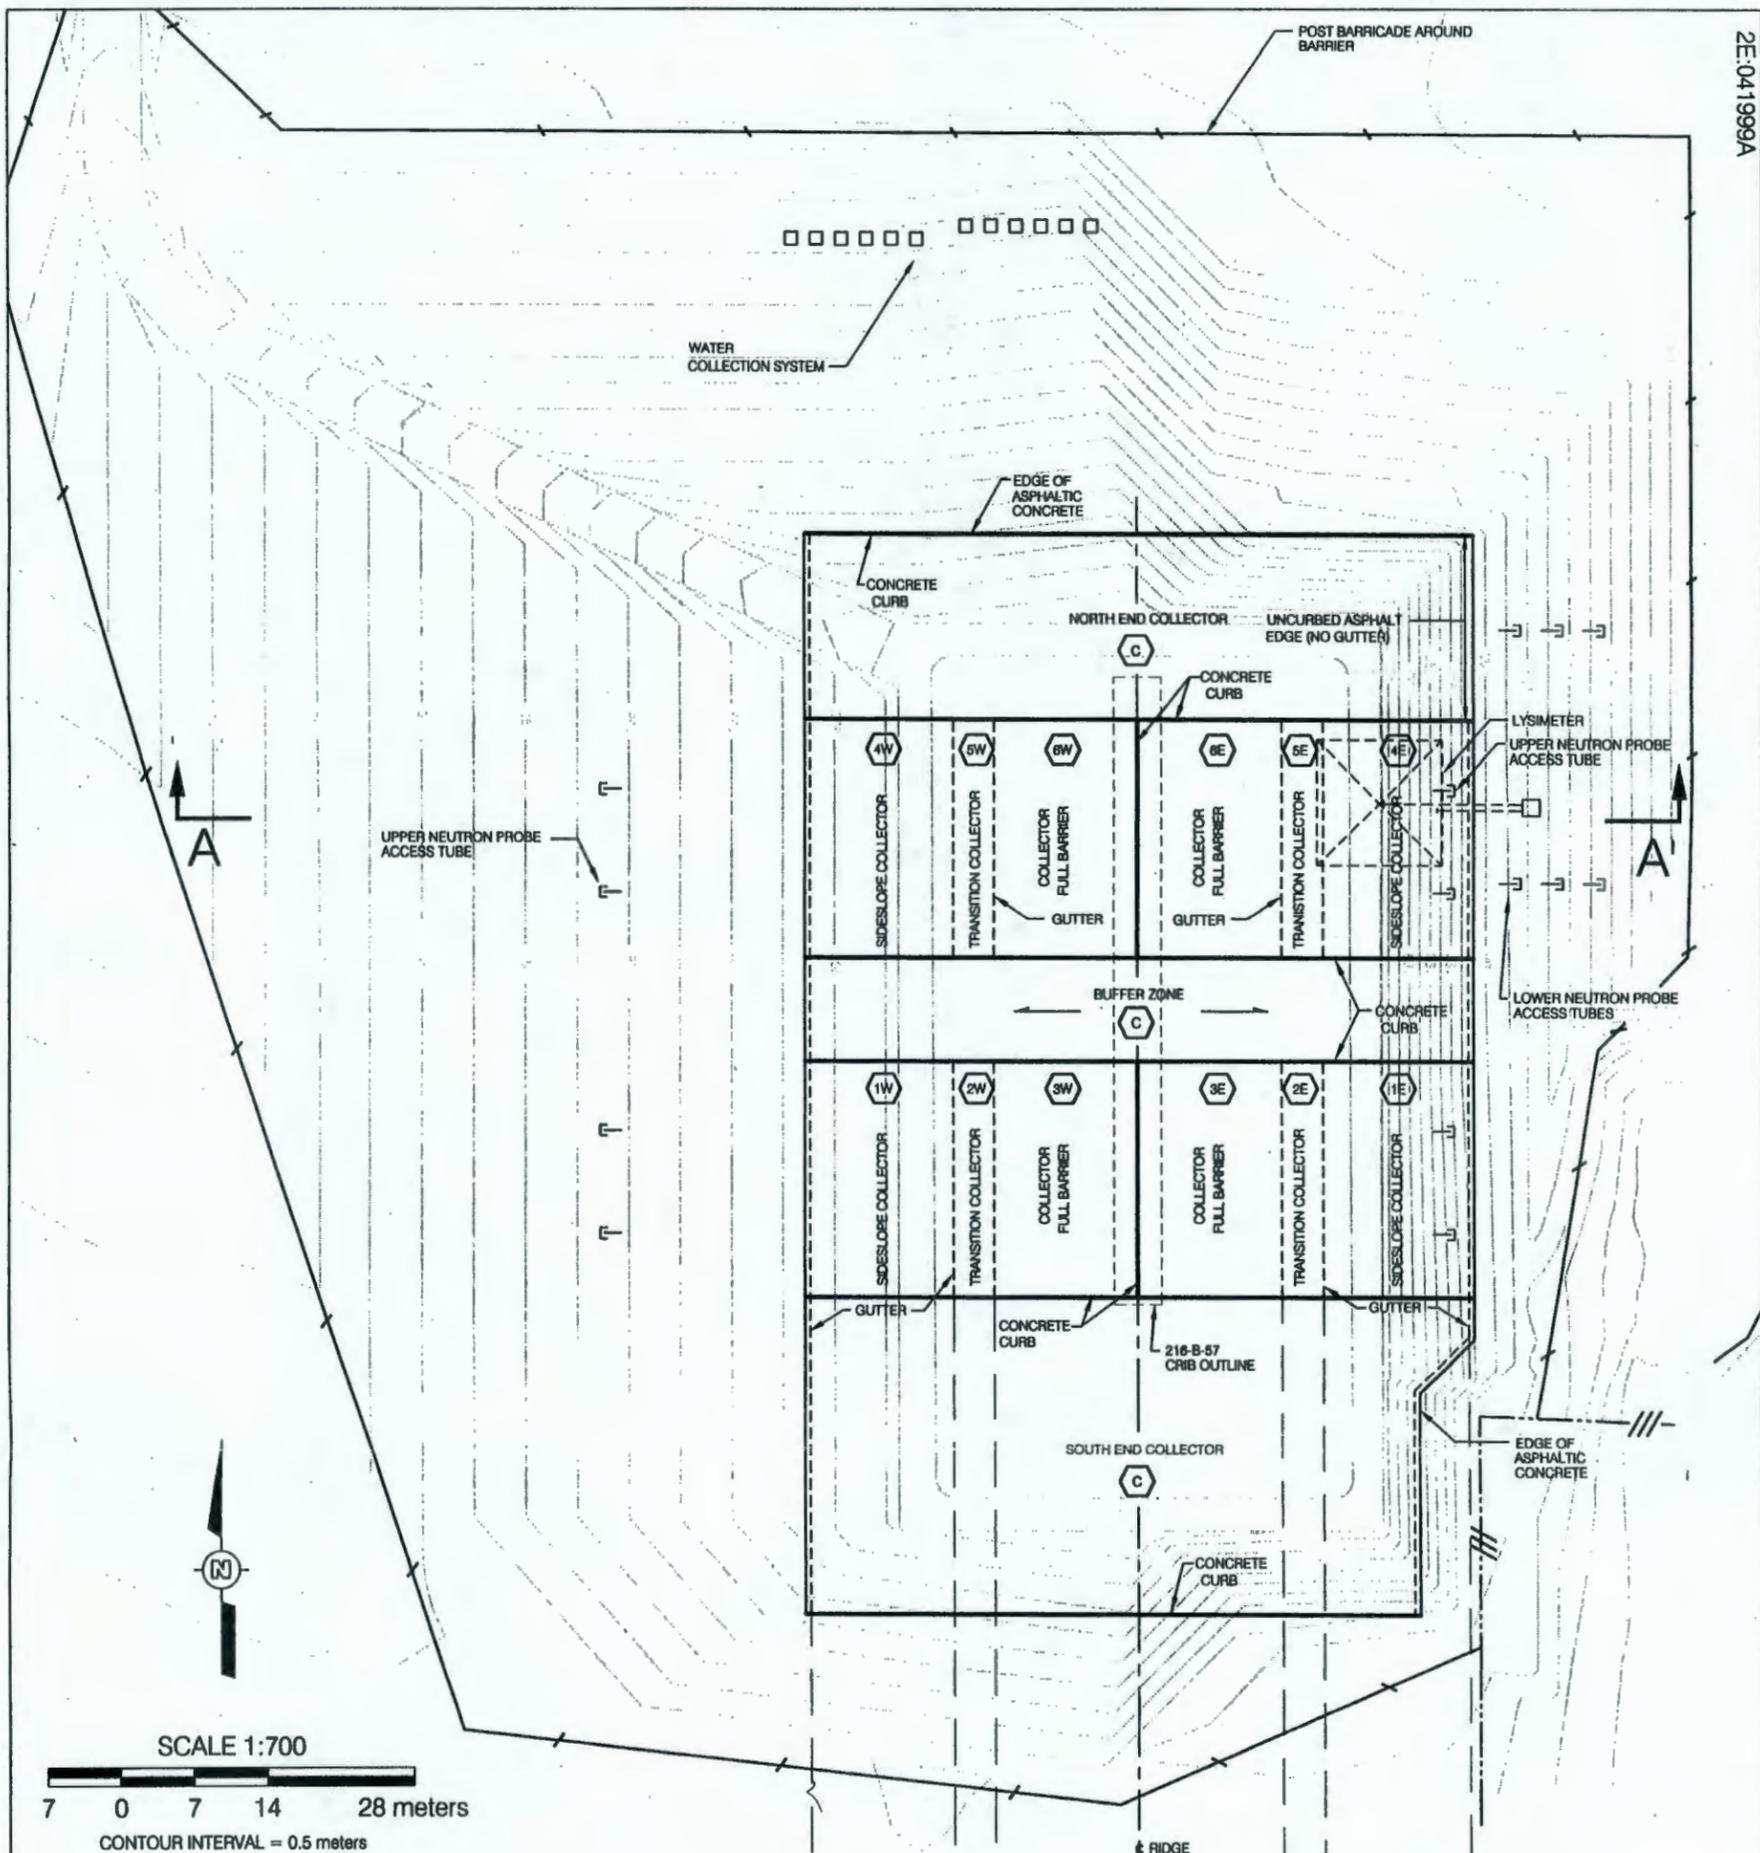
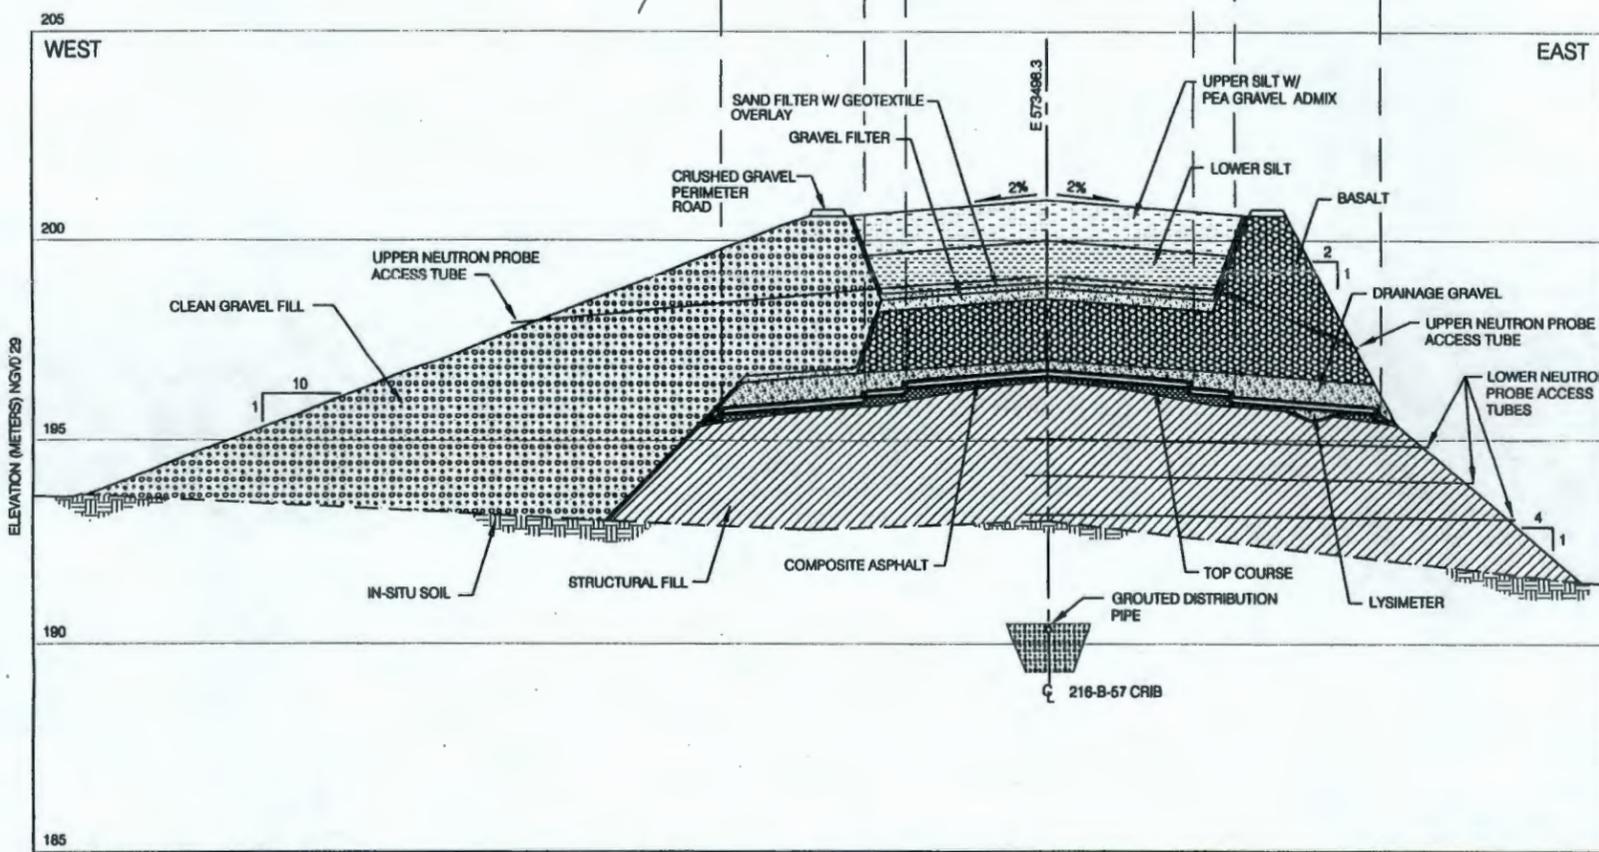
Figure A-1. Plan and West-East Cross Section of the Prototype Hanford Barrier Highlighting the Asphalt Layer Water Collection Zones.

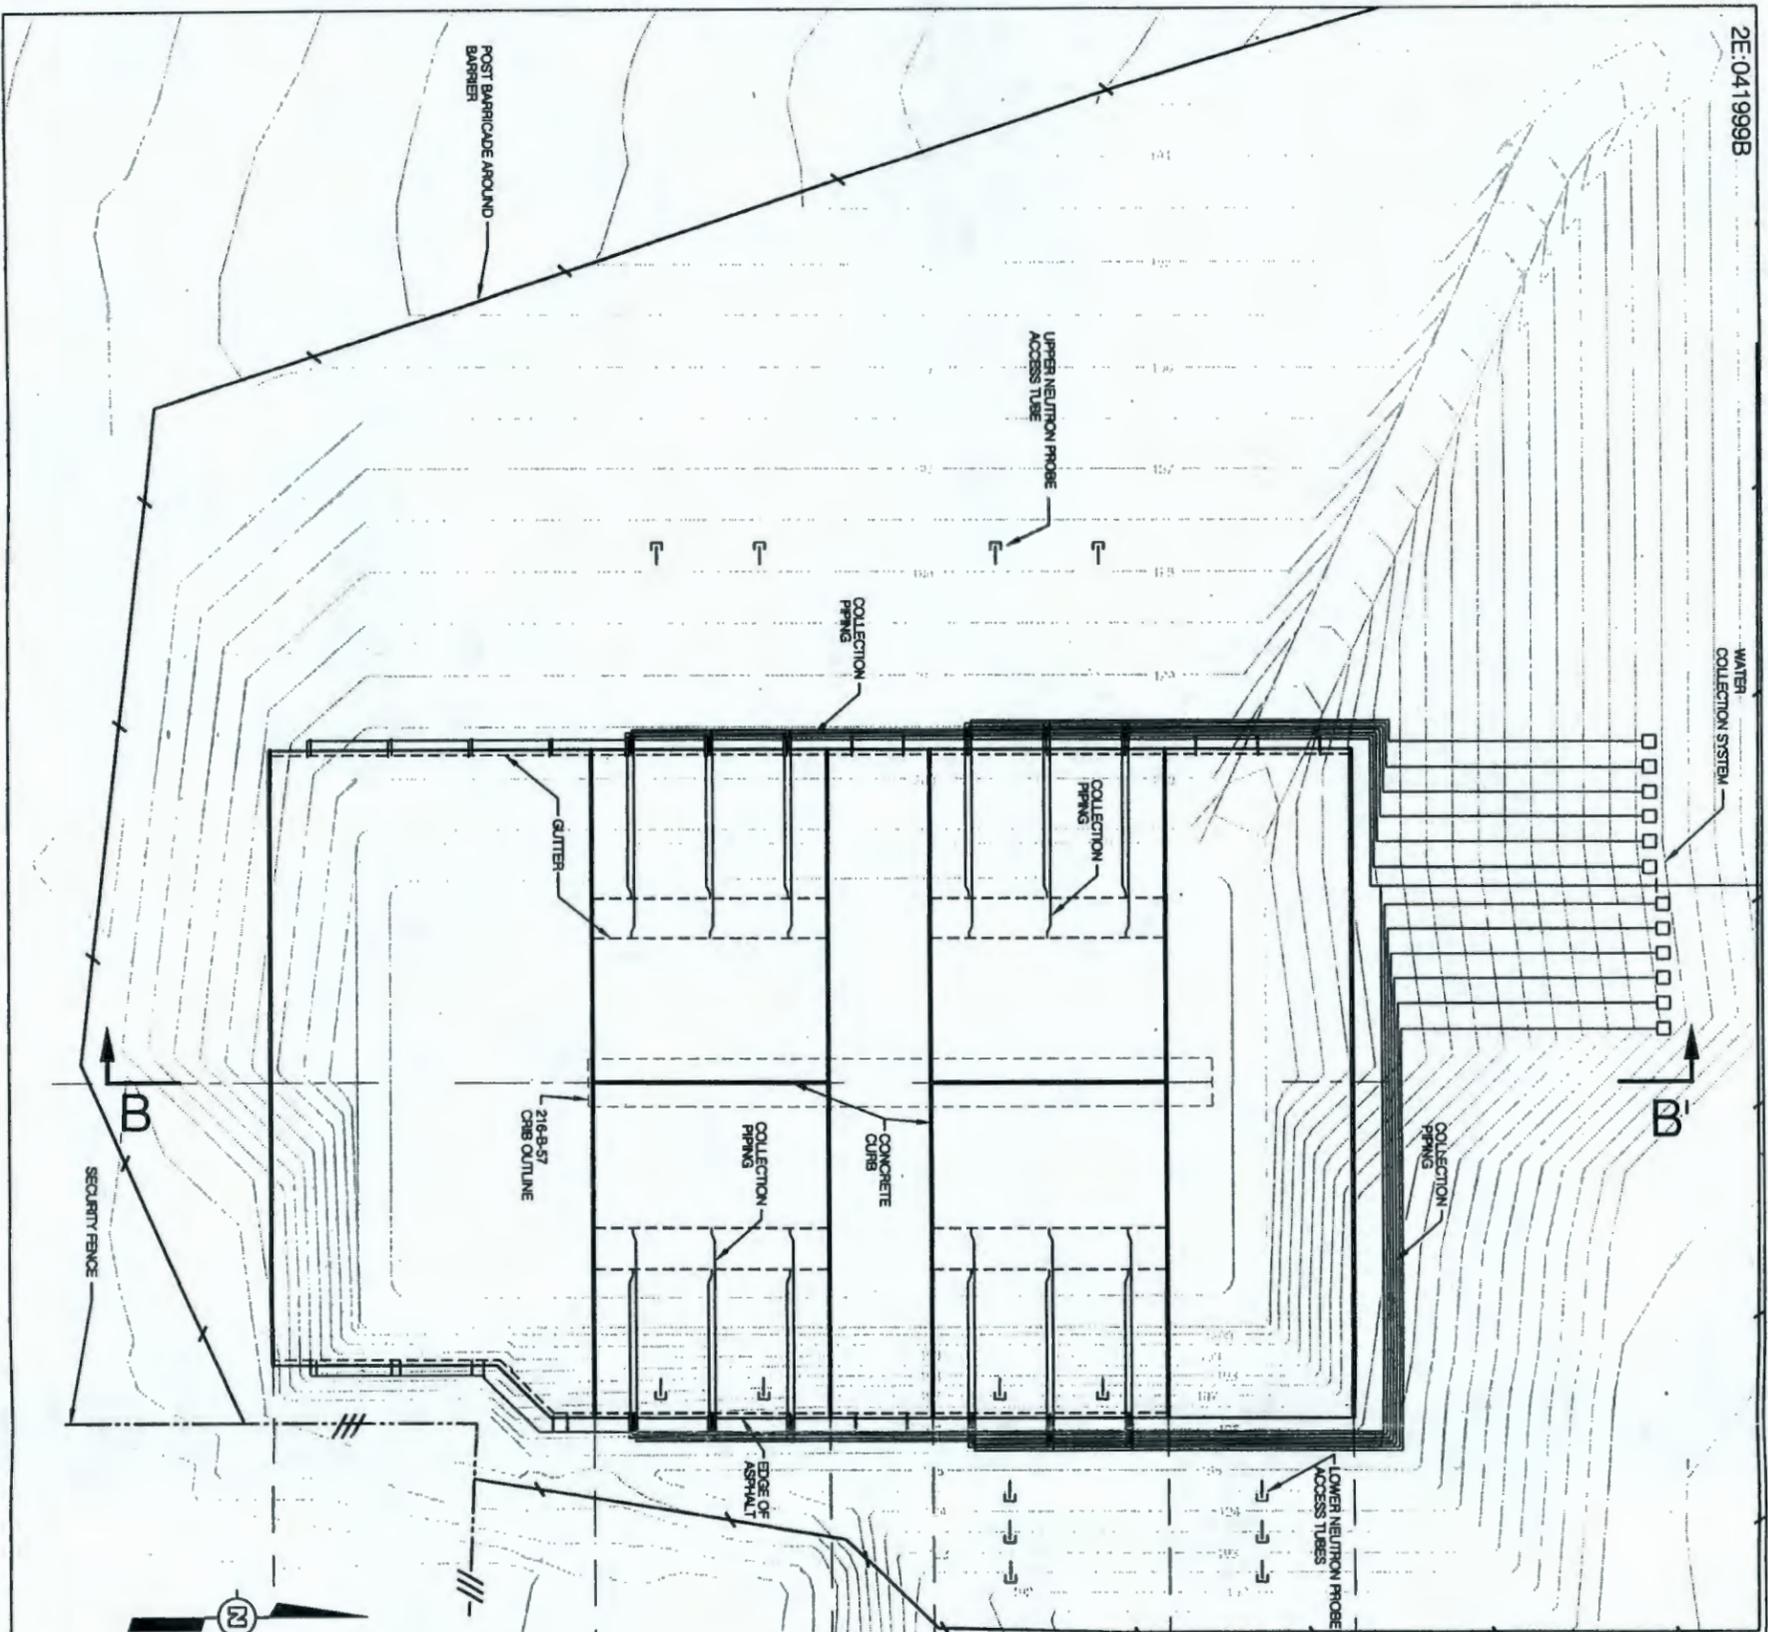
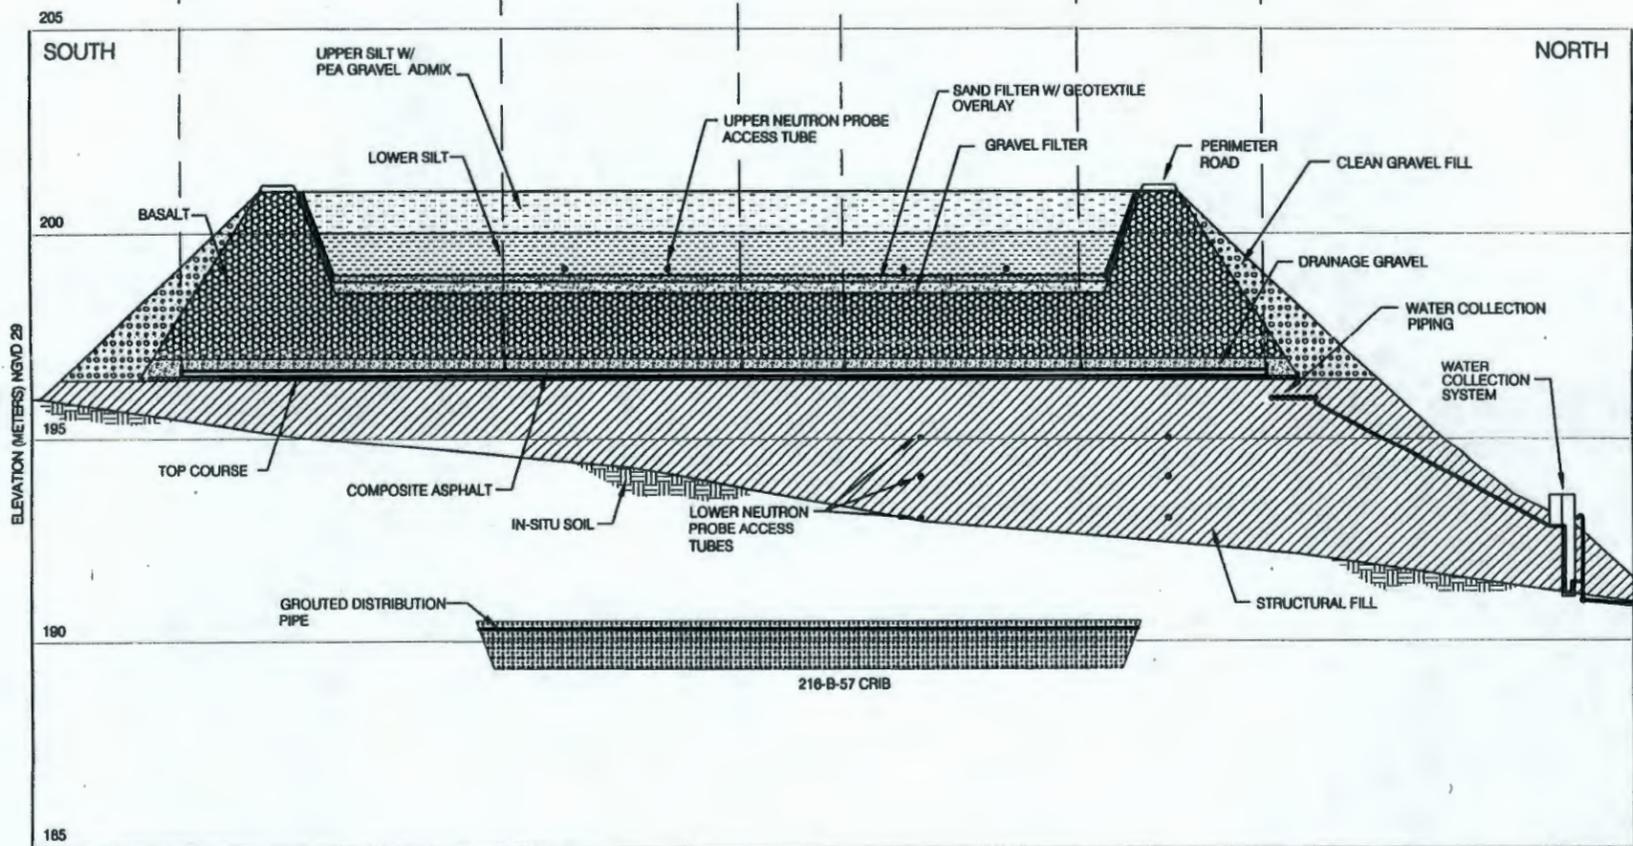
Figure A-2. Plan and North-South Cross Section of the Prototype Hanford Barrier Highlighting the Asphalt Drainage Collection System.
