DOE/RL-99-11

200-BP-1 Prototype Barrier Treatability Test Report

August 1999

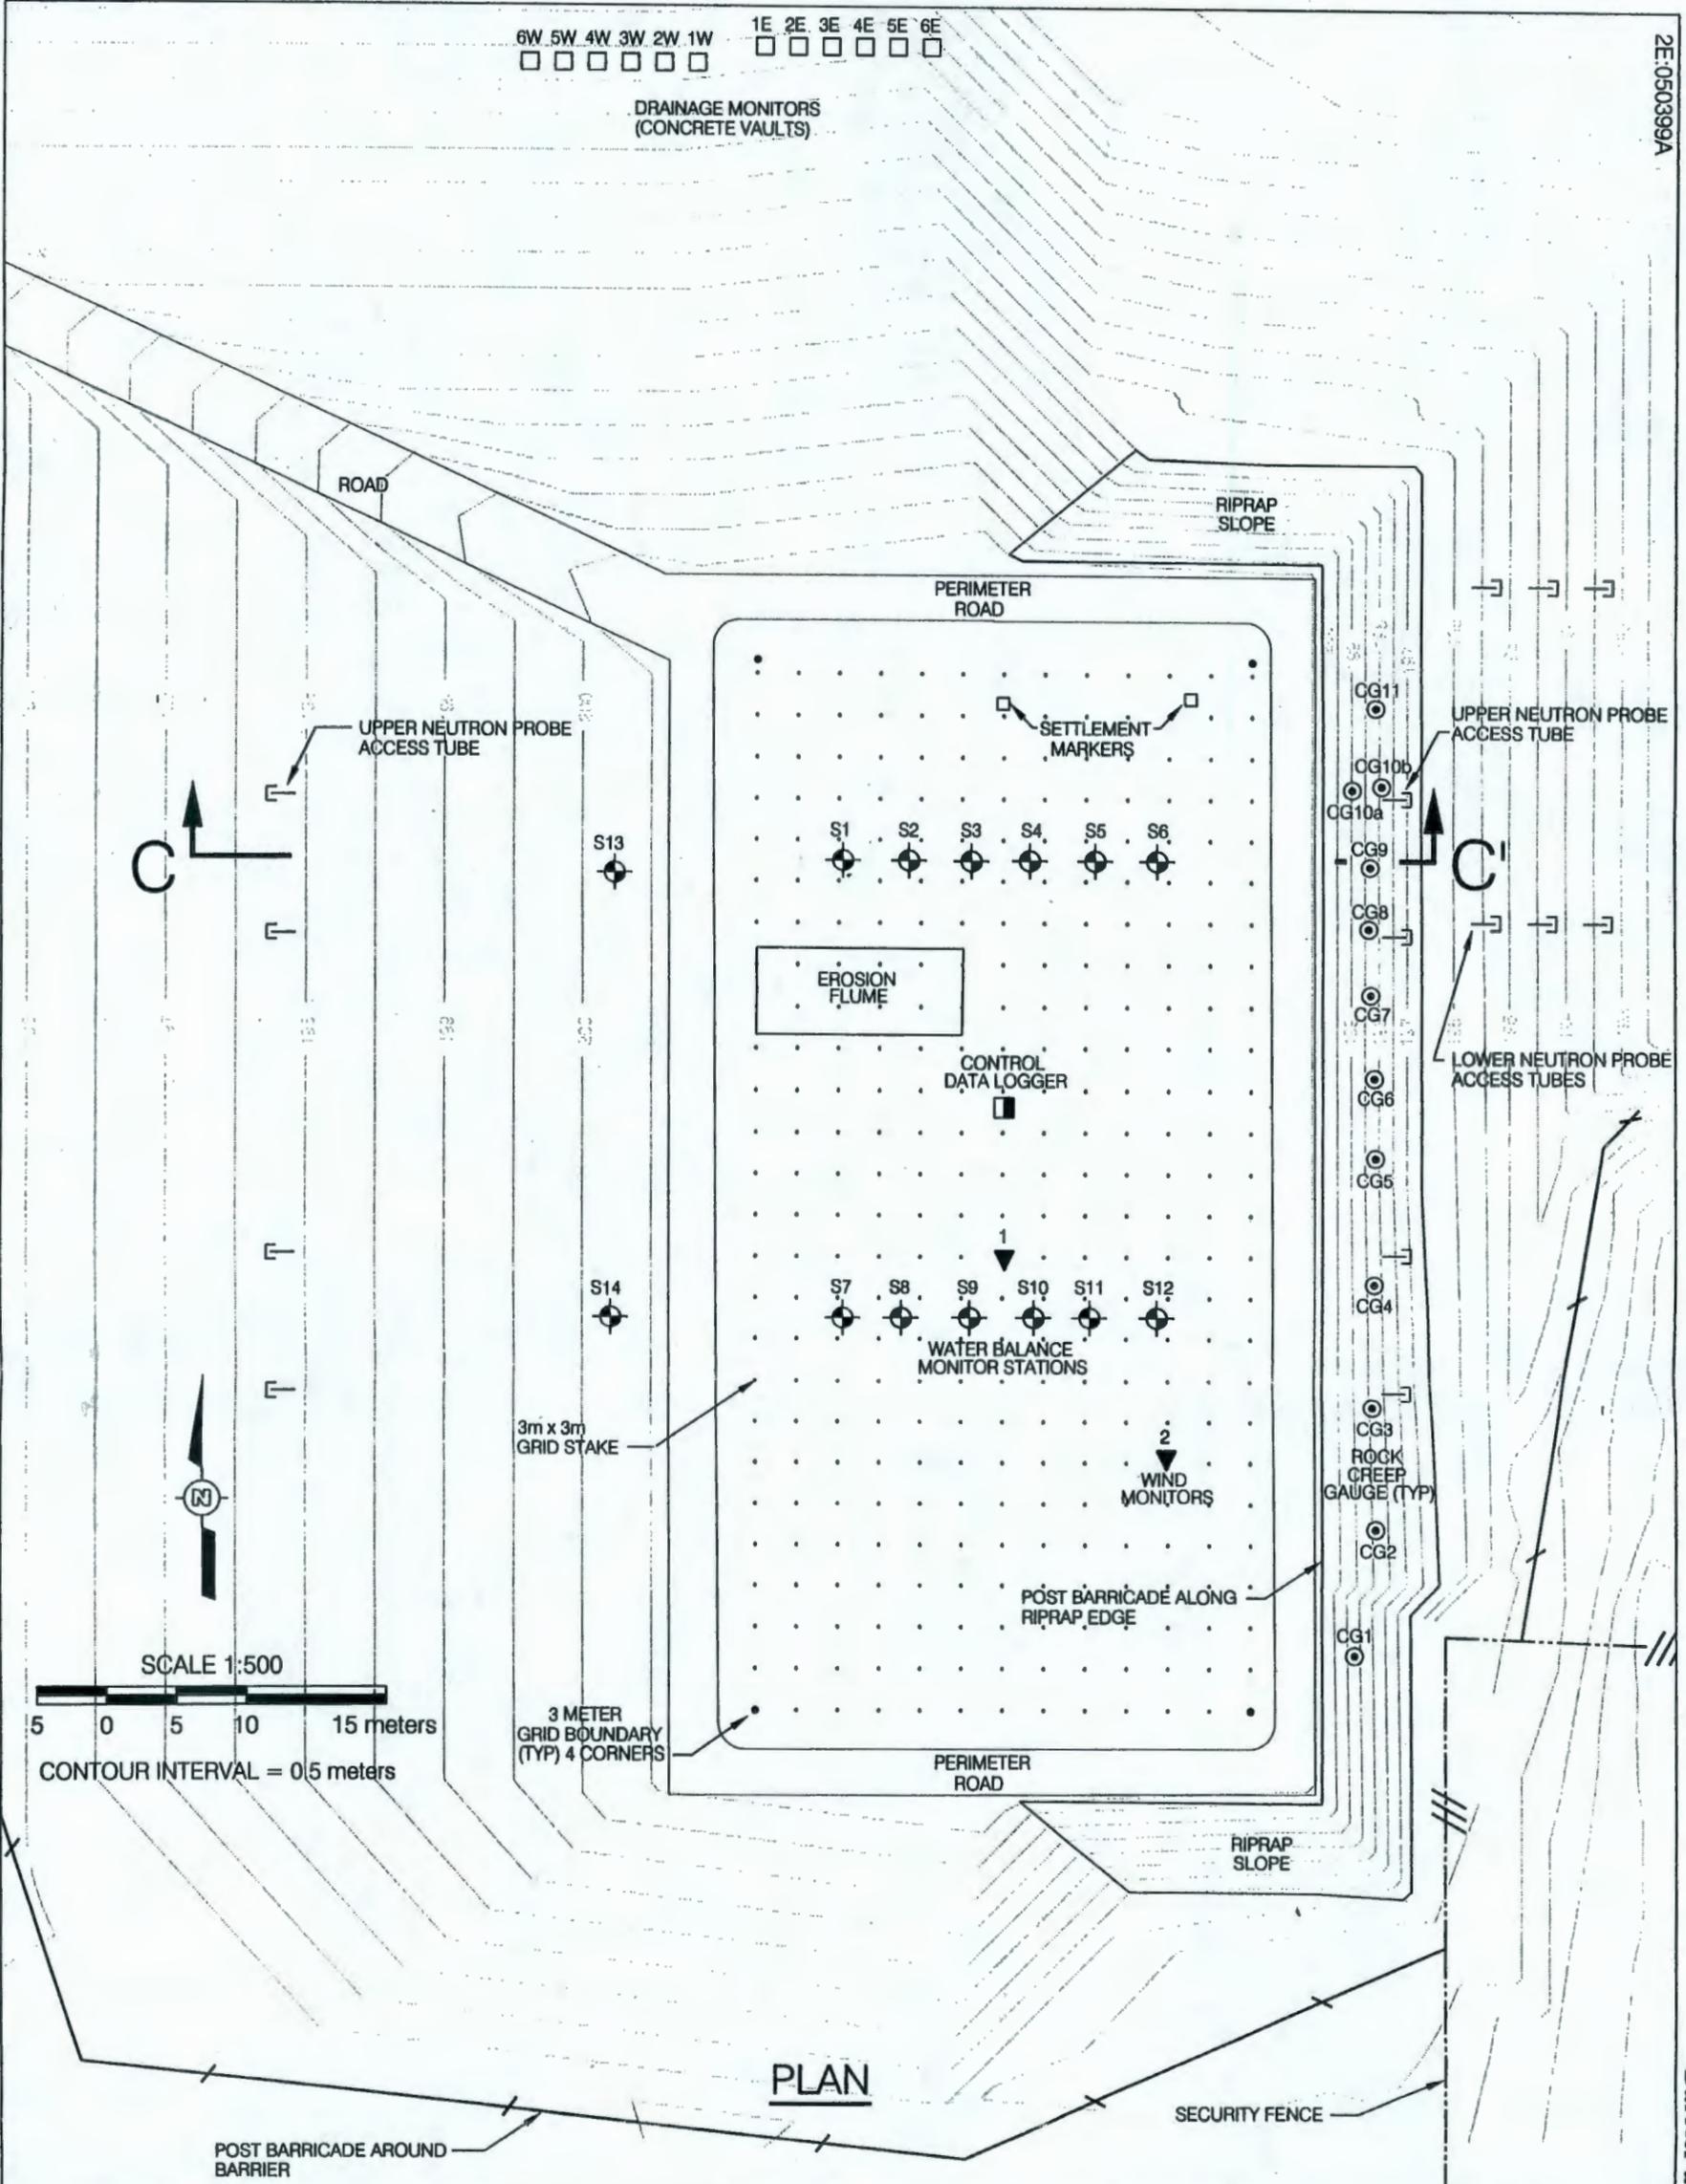
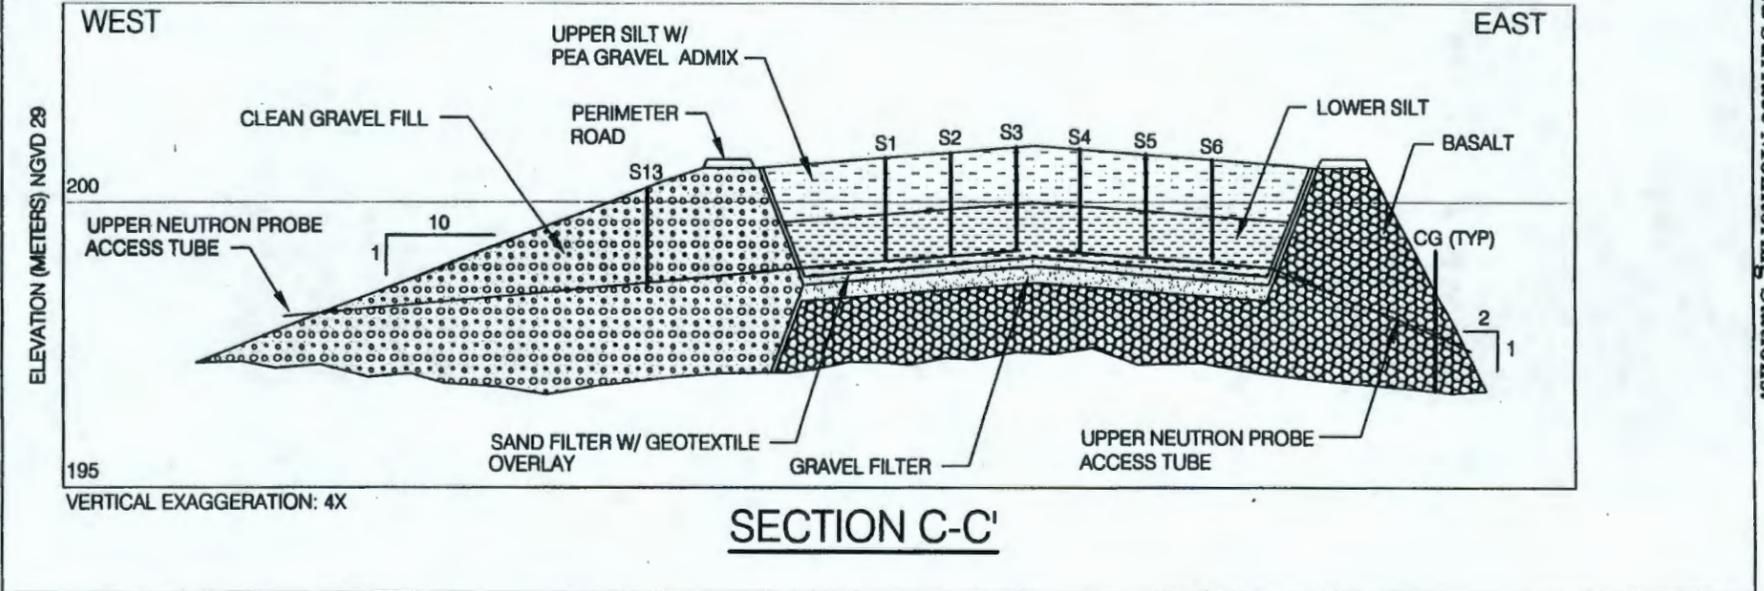
Figure A-3. Plan and East-West Cross Section of the Prototype Hanford Barrier and Surface Monitoring Stations.
