**U.S. Department of Energy  
Hanford Site**

RESPONSE TO THE WASHINGTON STATE DEPARTMENT OF ECOLOGY NON-COMPLIANCE IN 20-NWP-065 FROM DANGEROUS WASTE COMPLIANCE INSPECTION ON NOVEMBER 18, 2019, AT T-PLANT RESOURCE CONSERVATION AND RECOVERY ACT SITE ID: WA7890008967, NUCLEAR WASTE PROGRAM COMPLIANCE INDEX NUMBER: 19.688

<b>T Plant Compliance Inspection (WA7890008967)</b>	
Inspection Date: November 18, 2019	
Photographer: Phillip Buser	Support: Kathy Conaway

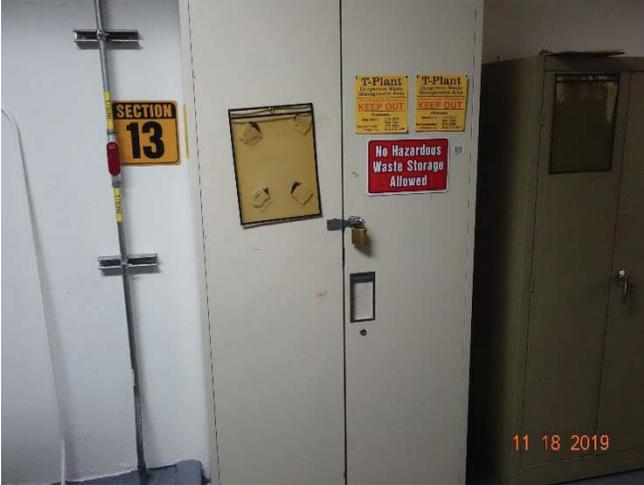
#	Title/Description	Photograph
1	<p>221-T Operations Gallery Storage</p> <p>A flammable cabinet locked with a padlock. Next to the storage cabinet there was another smaller steel cabinet that only contained an empty bucket and spill supplies.</p>

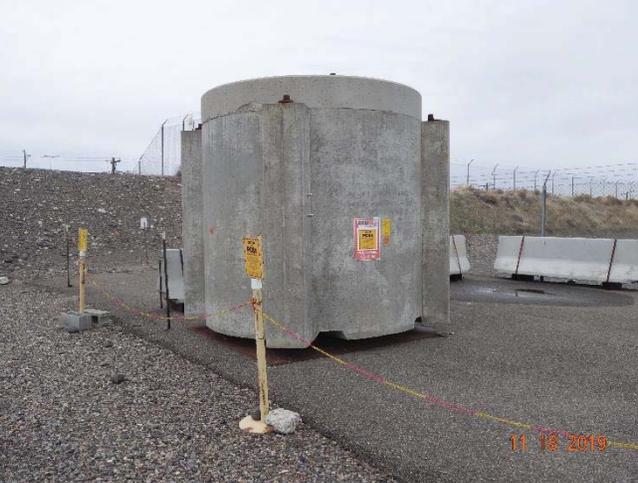
#	Title/Description	Photograph
3	<p>221-T Bone Yard Storage Area</p> <p>This storage area contains low-level waste roll-off boxes, three empty low-level waste containers which no longer meet Part A requirements, and a ten-drum cask with TRU/PCB waste inside (shown here in the photograph).</p>

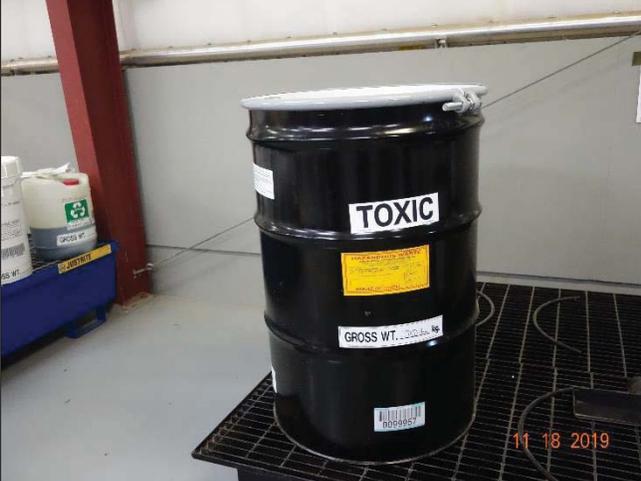
I reviewed the file for container number 0099957. I observed a large stack of historical background documents along with approximately 13 pages of correspondence. The most current waste designation sheet for this container had a D007 LDR waste code without an LDR description.

I reviewed the file for container number 0099957. I observed a large amount of historical background documents along with approximately 13 pages of correspondence. The most current waste designation sheet for this container had a D007 LDR waste code without an LDR description. Upon further review of the operating record for this container, I observed waste analysis data which supported the waste code D007 designation and records documenting this waste is debris which meets the alternative treatment standards found in 40 CFR 268.45(b). However, during my review of the operating records for container 0099957, I did not find any indication this waste had been or would be treated to meet these alternative standards. I also did not find a statement declaring that the waste is subject to land disposal restrictions and the applicable wastewater or non-wastewater category.

<p style="text-align: center;">DSC02624</p>
8	<p>214-T Building Container 0099957</p> <p>This photograph was taken to document container labeling and condition. Container 0099957 was one of three containers chosen for operating record review.</p>

The RL and CHPRC have reviewed Compliance Issue 1 and are providing the requested land disposal notification and certification form for Container 0099957 in the Attachment.

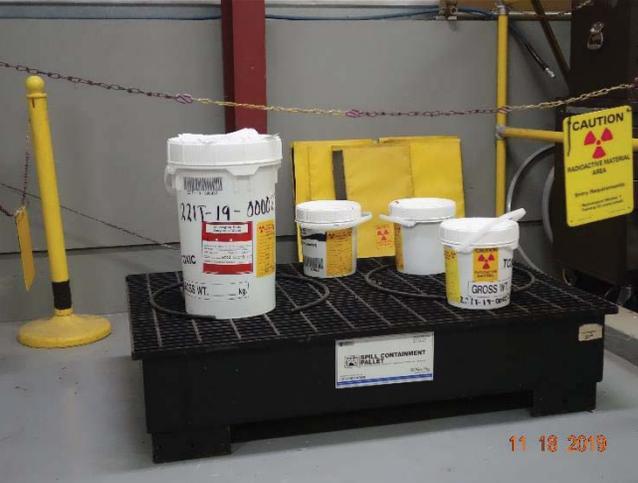
#	Title/Description	Photograph
9	<p>214-T Building</p> <p>Container 221T-19-000022, with three other containers.</p> <p>This photograph was taken to document container labeling and condition. Container 221T-19-000022 was one of three containers chosen for operating record review. This container is shown on the left.</p>

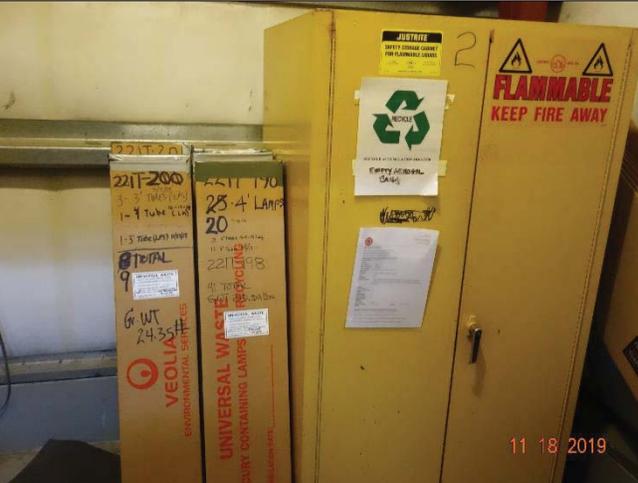
<p style="text-align: center;"><b>DSC02626</b></p>
10	<p>214-T Building Aerosol Can and Universal Waste Lamp Closet</p> <p>This photograph shows the flammable cabinet used to hold empty aerosol cans and two boxes of Universal Waste lamps. More boxes of lamps in similar condition were in this closet beyond the frame of the photograph.</p>

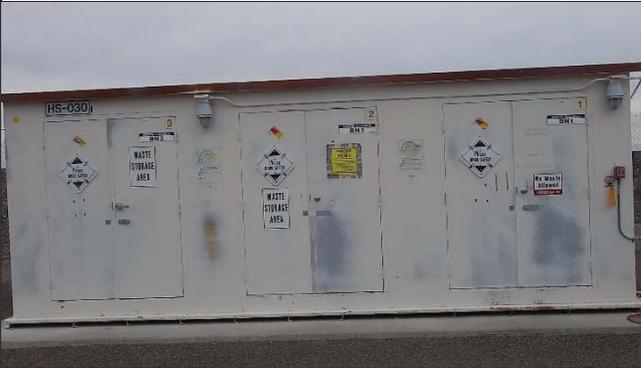
<p style="text-align: center;"><b>DSC02633</b></p>
17	<p>The HS-030 Storage Module in the 2706-T Yard</p> <p>Mixed waste is stored in this module within Cells 2 and 3. Mr. Richards showed us there was nothing stored in Cell 1 of this module because the secondary containment liner had been breached years earlier. Cell 1 also bears a sign which states, “No Waste Allowed.”</p>

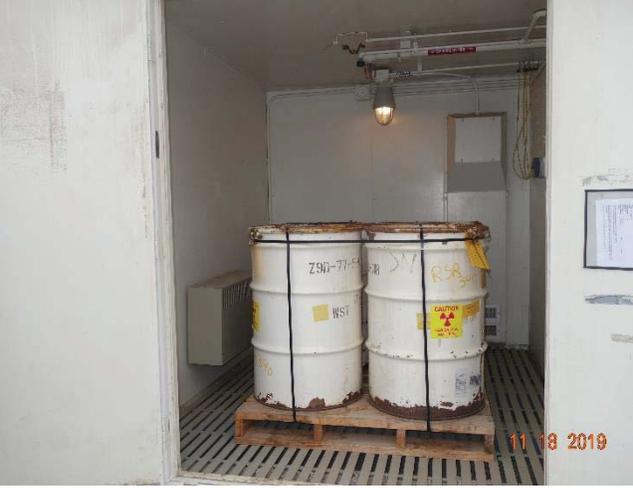
#	Title/Description	Photograph
18	<p>The HS-030 Storage Module Cell 3</p> <p>Cell 3 of the HS-030 module with four drums of transuranic mixed waste sent to the facility from Central Waste Complex for venting.</p>

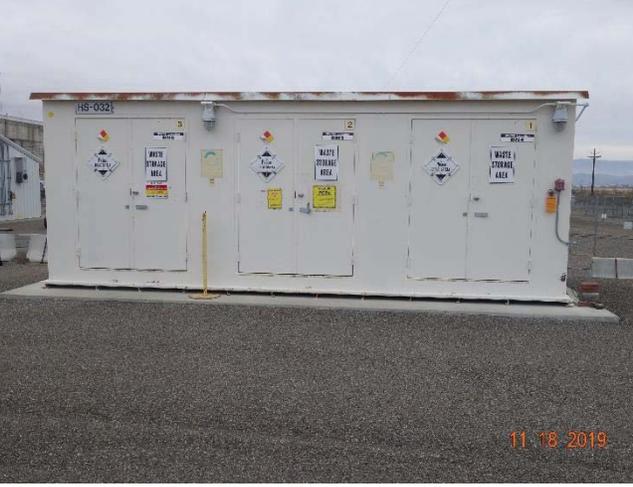
<p>DSC02635</p>
19	<p>The HS-032 Storage Module in the 2706-T Yard</p> <p>Mixed waste is stored in this module, and this is the location of the central accumulation area shown on the left in Cell 3.</p>

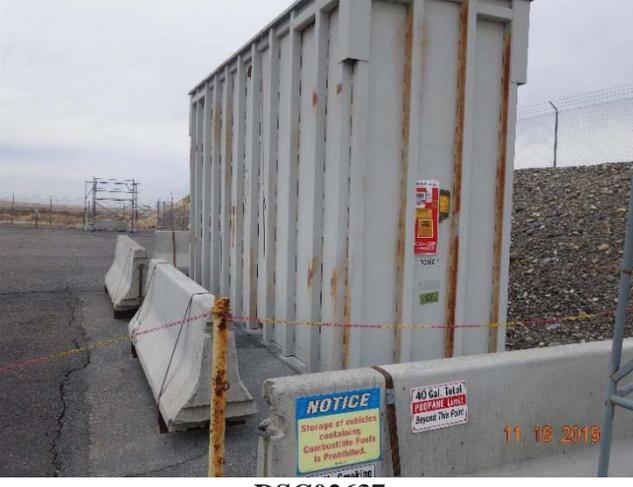
After leaving the 2706-T Yard, we walked to the 2706-T Asphalt Pad and saw the legacy container. This container is a custom-built steel box with an old glovebox inside. The container bore a PCB label and a toxic major hazard label. After this we walked back to building MO-892 for lunch.

<p>DSC02636</p>
20	<p>2706-T Asphalt Pad</p> <p>This is the only container at this location. It is a custom-built steel legacy container with an old glovebox inside.</p>
