SGW-61439
Revision 0

200-BP-5 Spill Summary

1 Summary of Events at the 200-BP-5 Cross-Site Transfer Pipeline Release

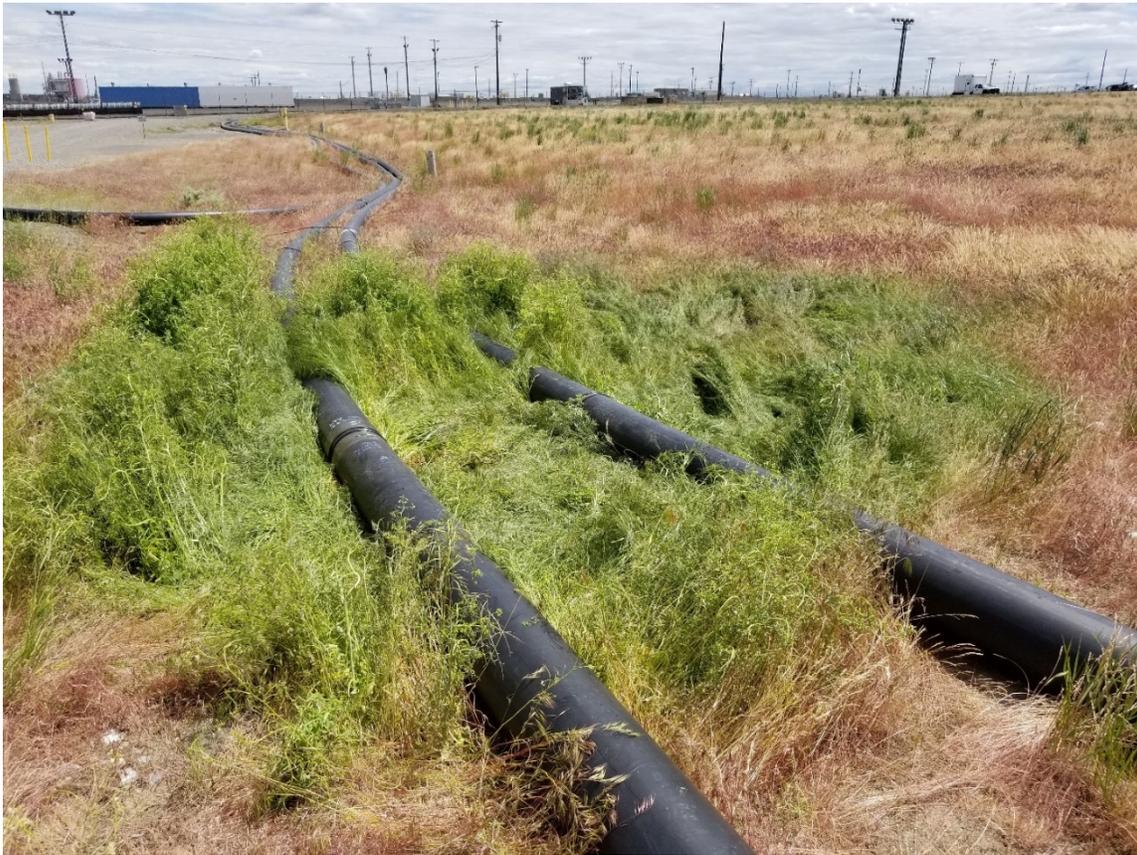
Figure 1. Initial Release Identification

On May 17, 2017, CH2M HILL Plateau Remediation Company (CHPRC) discovered a leak in a cross-site transfer pipeline (transfer pipeline) located west of the BX/BY Tank Farms and south of the 216-B-41 Trench. The leak was identified by a patch of green plants in an area that had started to brown due to lack of water, typical of late spring (Figures 1 and 2). Based on a worst-case scenario, the leak (commonly called a release) was estimated by the Soil & Groundwater Remediation Project (SGRP) Operations/Engineering and the Environmental Compliance Officer to be no more than 1 L/min for a total of 84 days. Based on information that was gathered and evaluated, it has been estimated that the release in the transfer pipeline may have been from the release discovery date back to the day that the line was fully thawed during winter. The 200 West P&T Operations records identified that the transfer pipeline was thawed and back online beginning February 22, 2017. The total volume over the course of the release has been estimated to be ~32,000 gal. CHPRC shut down the transfer pipeline when the release was detected, and began work to replace the leaking section of the transfer pipeline with a spare section of piping at the site. The transfer pipeline was placed back into service on May 19, 2017.

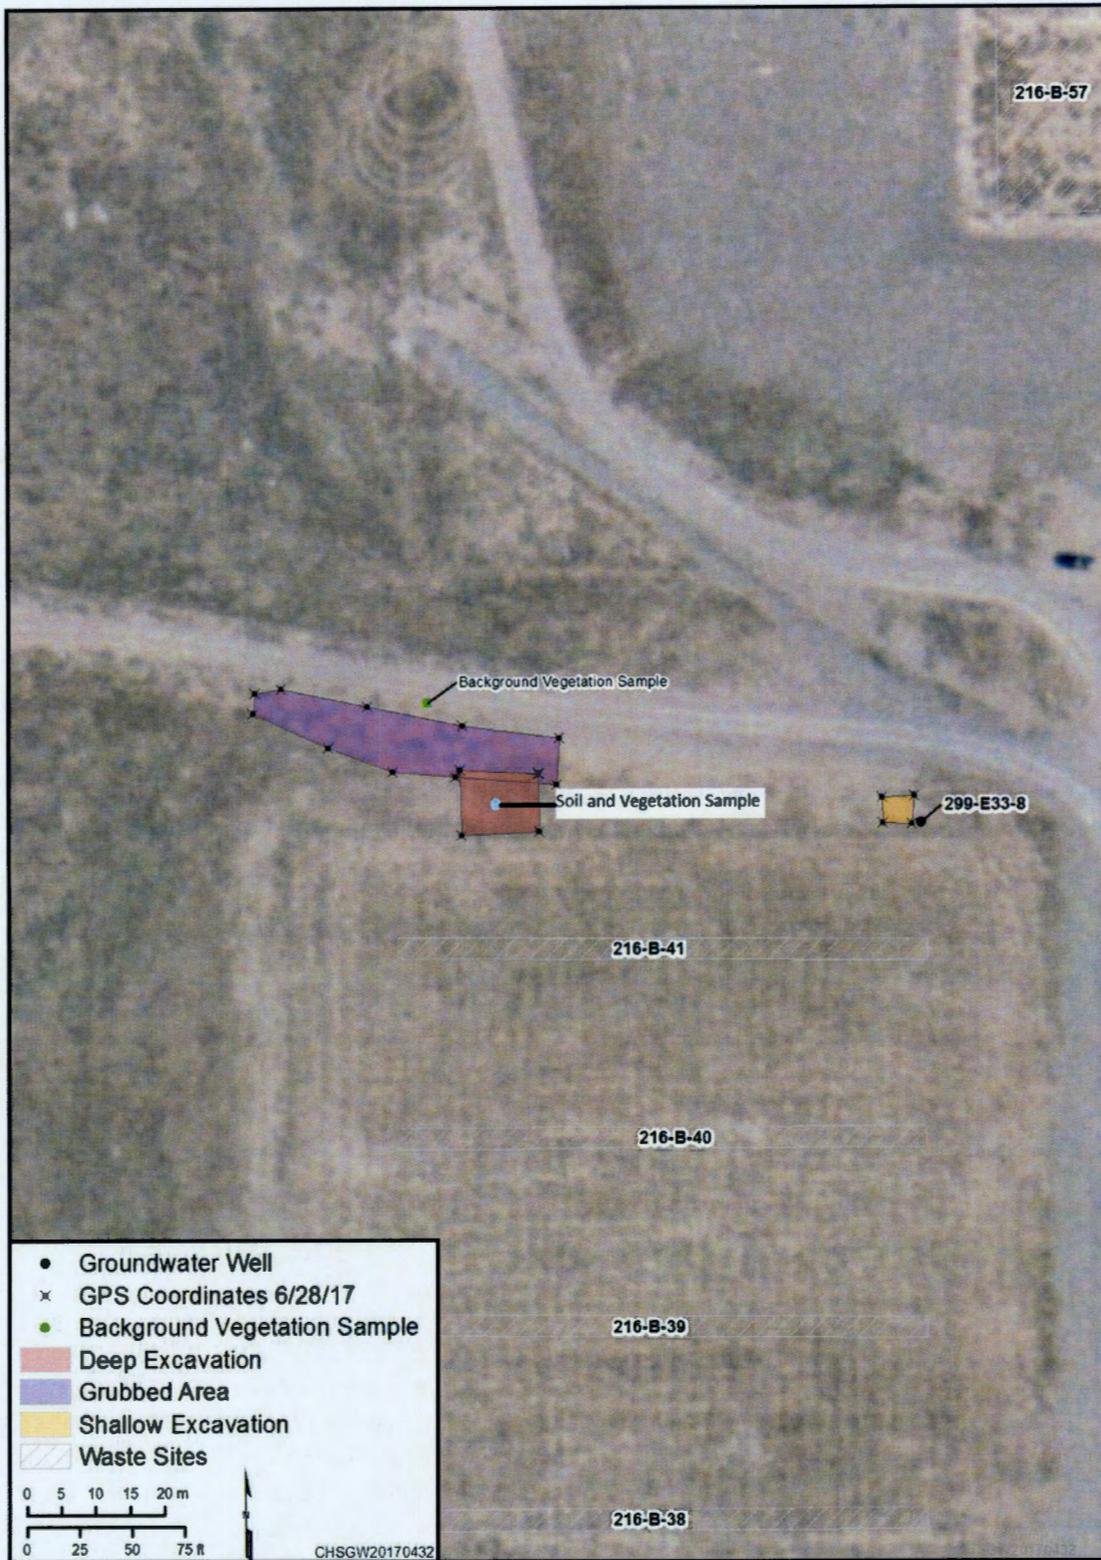
Figure 3. Release Location Map

On May 22, 2017, DOE and Ecology personnel visited the release location. Ecology requested split surface soil samples, as well as vegetation samples to be collected in the release area. CHPRC had already initiated paperwork to collect samples, and added the additional request to co-sample with Ecology. The initial round of sampling was performed on June 14, 2017 in coordination with Ecology. One soil sample was collected and two vegetation samples were collected. One vegetation sample was collected from the same area of the soil sample, which was as close as possible to the original release location. The second sample was collected as a "background" sample to compare data. This sample collected immediately south of the access road, north and west of the release location (Figure 3). Table 1 provides the sampling results. Table 2 provides a crosswalk of the sample locations, sample Hanford Environmental Information System (HEIS) numbers, and sample descriptions.

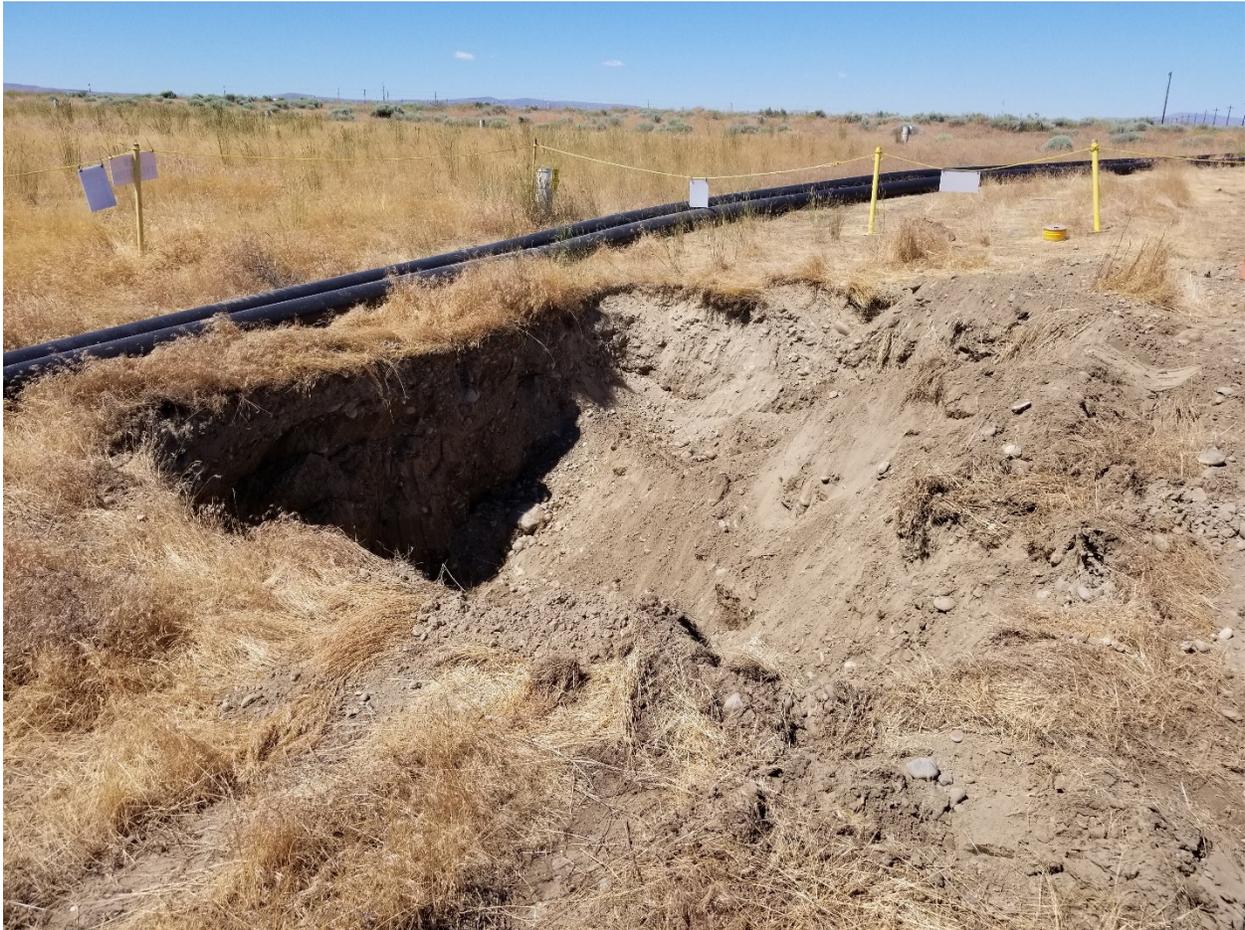
Figure 4. During Excavation

During excavation, the team was instructed to look for any areas of wetted soils, although none were identified. The excavation area was ~20 by 20 ft and 8 ft deep. Both areas have barriers in place, as well as warnings of an open excavation and a 6 ft buffer around the main excavation.

Ecology was notified that CHPRC intended to excavate the released material and collect an additional sample but were not involved in the sampling at 8 ft bgs. CHPRC had previously decided to excavate the footprint of the transfer pipeline release location, as marked by the original green vegetation. Although no longer green due to the lack of water, the area was already demarcated by the boundary and was identifiable from the taller weeds and grasses that had sprung up. Excavation began and ended on June 22, 2017. Figures 4 through 7 show the site following excavation of the spill area. One sample was collected from the base of the excavation, at ~8 ft bgs. This location was selected as close to directly vertical from the original transfer pipeline release location as possible. Only one sample location was selected due to the steep vertical walls of the excavation. The proximity of the transfer pipeline release location to the 216-B trenches and the access road prevented the excavation from having adequate sloping to safely allow workers to enter, so the sample material was collected from the excavator bucket. Tables 1 and 2 provide additional sample information.

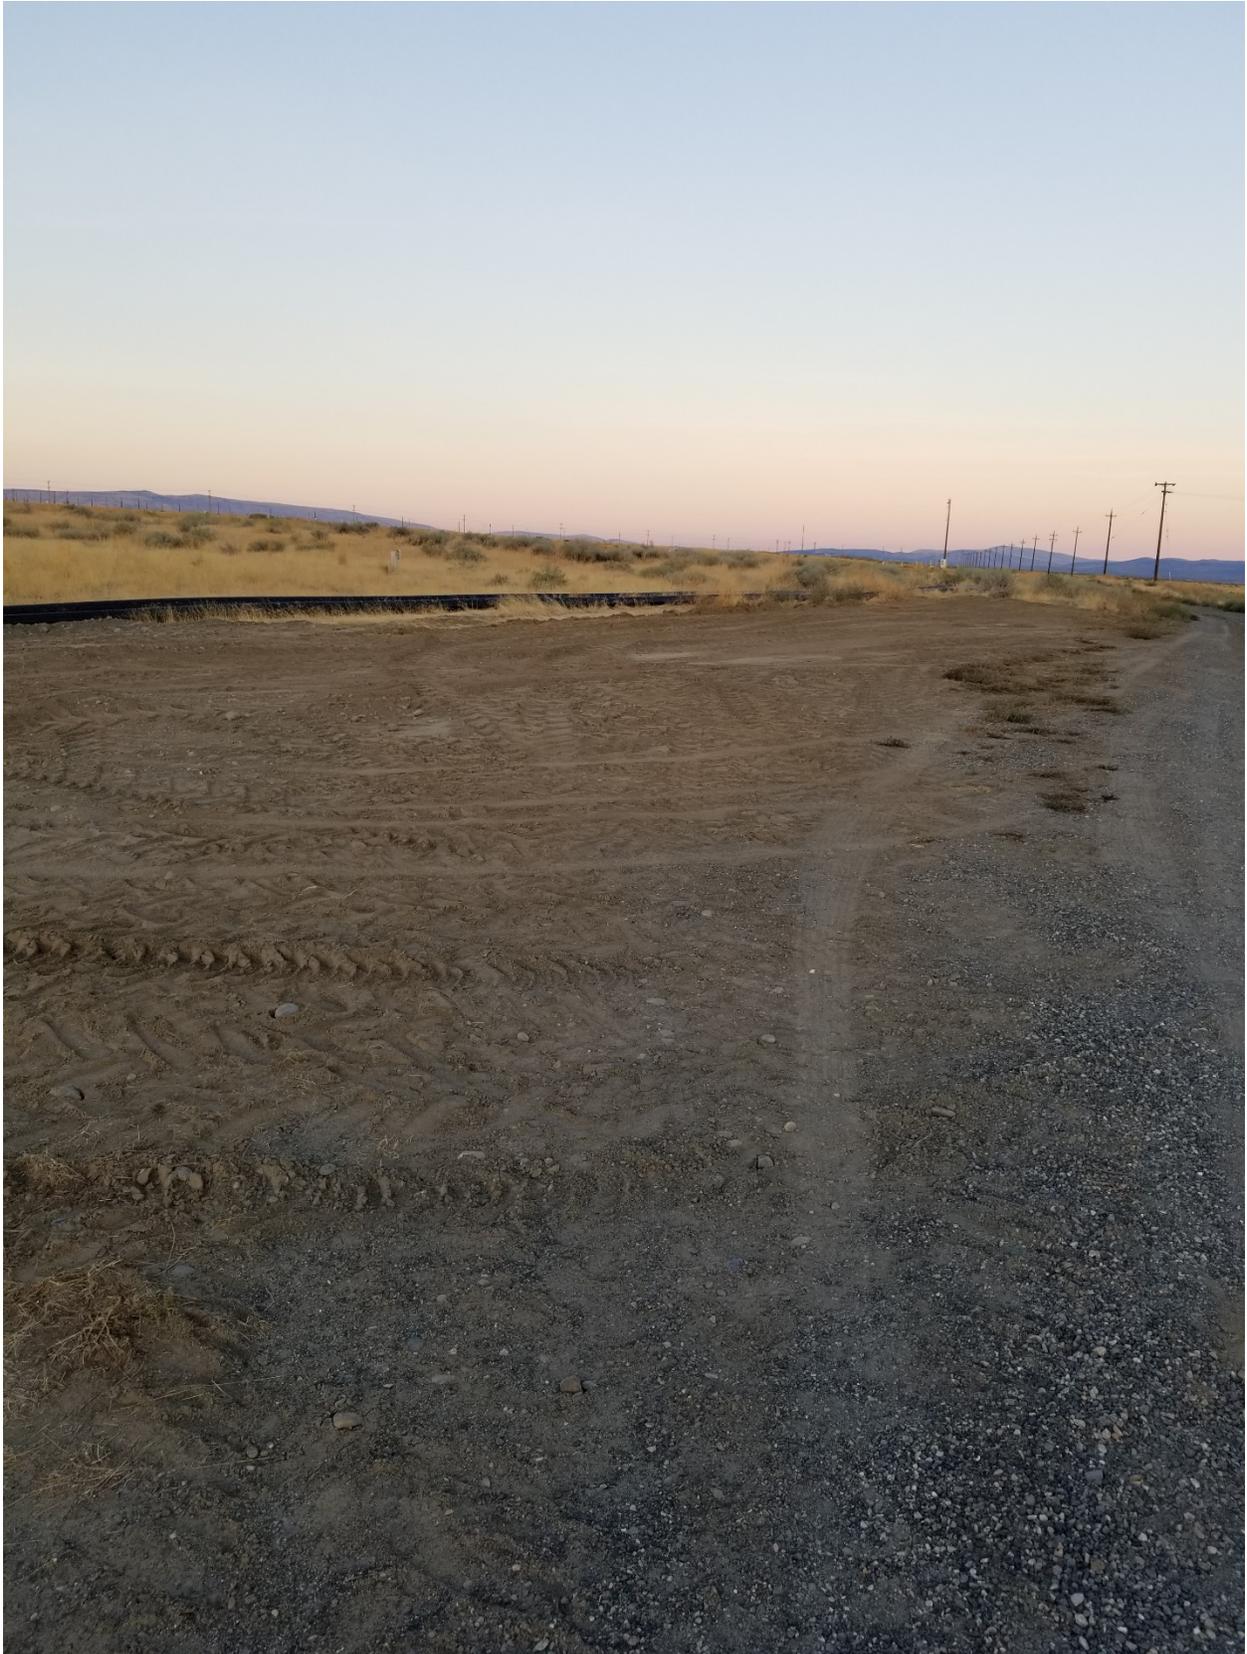
Figure 8. Excavation Following Backfill, Looking West

On September 19, 2017, the same day the final sample data were received, notification was made to DOE, Ecology, and U.S. Environmental Protection Agency (EPA) that CHPRC would be moving forward with backfilling the excavation (Appendix A). The backfill work was initiated and completed on September 21, 2017 and DOE, Ecology, and EPA were notified that backfill was complete. Figures 8 through 10 show the site following backfill and rough grading.

Future work expected at the spill location will replace the sections of high-density polyethylene pipe that as suspected to have failed, causing the material release. To ensure that the spill release is recorded properly, an entry into the closest Waste Information Data System site record, most likely the 216-B-42 Trench, will be made that describes the event and references the information presented in this summary.
