CWR-PFP-00001
Revision 0

225WC Demolition Report

As Left Characterization

Date Published
November 2016

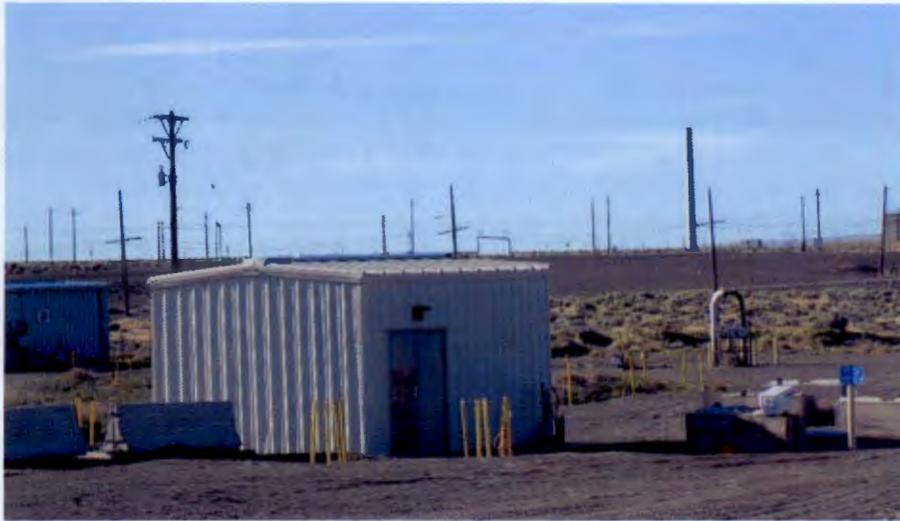
The 225WC Building (Figure 1) was a pre-engineered 280 ft² building (approximately 20 by 14 ft) with fabricated steel walls and roof built onsite in 1994. The building was located outside the PFP fenced area at longitude/latitude 119.62954/46.54899. The 225WC Building was used to support PFP wastewater discharge to TEDF by verifying that all wastewater met TEDF waste disposal criteria. During the operation of the facility, no elevated radionuclide levels were detected. All that remains of the 225WC Building is the slab, which is approximately 20 by 18 ft (Figures 2 and 3) including the front apen.

Figure 1. 225WC Building Before Demolition

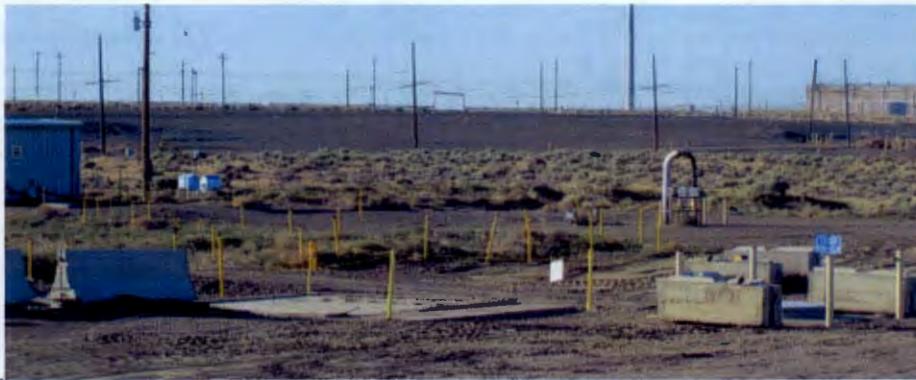
Figure 2. 225WC Building Slab Next to TEDF Manhole 4

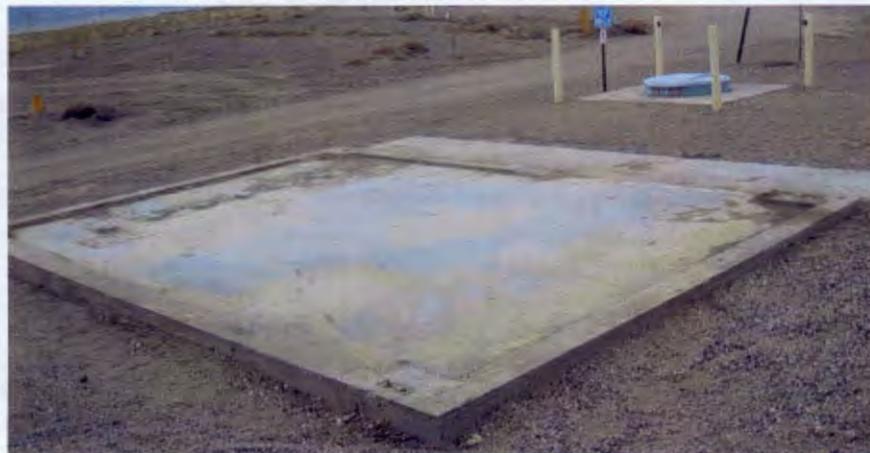
Figure 3. 225WC Building Slab As-Left Condition

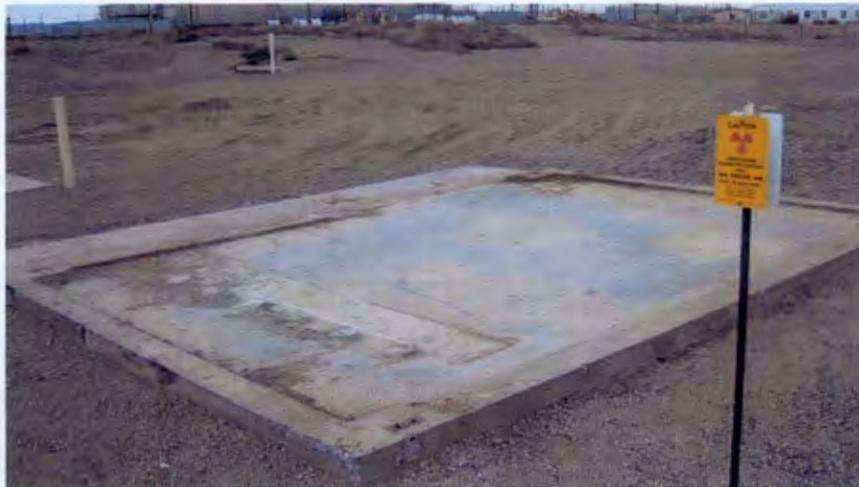
The 225WC slab was left in a clean slab-on-grade condition (Figure 4).

Figure 4. 225WC Building Slab Piping Sealed Area with Belowgrade Radiological Posting

There is no history of spills, releases, or identified radiological or chemical hazards associated with the site. The pre-demolition radiological, asbestos, and beryllium evaluations found no evidence of radiological contamination, ACM, or beryllium contamination. In accordance with the pre-demolition waste planning evaluation (CHPRC-02824), hazardous materials (e.g., refrigerant and light bulbs) were removed from the area prior to demolition. Data from the Hanford Environmental Information System database for TEDF water samples taken in the 225WC Building were reviewed, and all results were within radiological drinking water limits. The TEDF pipeline is labeled as potentially radioactively contaminated due to historical contamination in upstream piping.

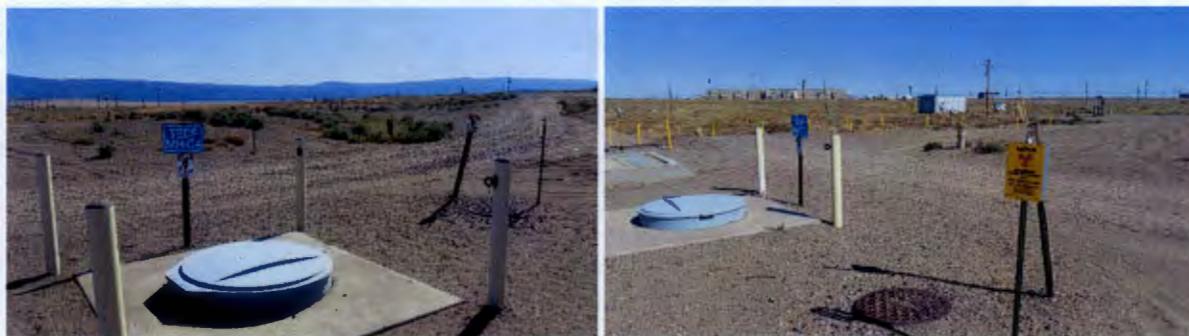
At the time of this report, steam condensate and some surface drains continue to discharge to TEDF. The TEDF manholes (MH-3 and MH-4) adjacent to the slab (Figure 5) remain accessible and managed under the PFP confined space program to support maintenance and sampling of the active TEDF system. The area around the 225WC is considered an underground material radioactive area, due to adjacent waste sites and the TEDF line beneath the slab. The manholes remain active and are properly posted in accordance with the site confined space requirements, as shown in Figure 5. Final disposition of the manholes is deferred to overall endpoint administrative checklist item 5, which addresses remaining confined spaces.

Figure 5. TEDF Manholes 3 and 4
