WHC-SD-EN-TI-181
Revision 0

100-D Area Technical Baseline Report

Prepared for the U.S. Department of Energy
Office of Environmental Restoration and
Waste Management

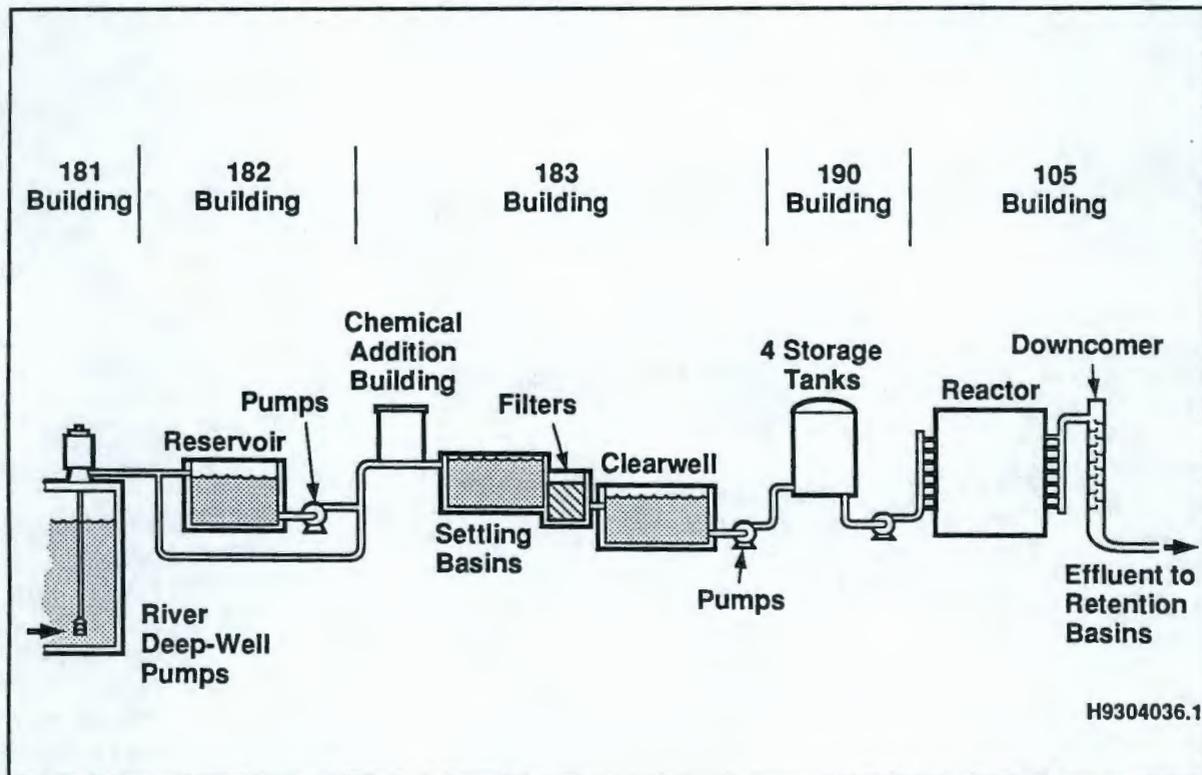
Figure 2-4. Typical Water Treatment System.

A continuous supply of high-quality cooling water was essential to reactor operations. It prevented reactor core damage from heat generated by the fission reactions. Many of the 100-D Area facilities were part of this cooling water system. At a daily use rate of 148-204 million gallons, this system generated the largest liquid waste volume in the 100-D area (Figure 2-4).

Water obtained from the Columbia River was extensively treated before passing through the reactors. Settling, chemical treatment, filtering, pH management, and refrigeration were utilized to purify and prepare the water. It then circulated in a single pass through the reactor process tubes, cooling tubes imbedded in the thermal shield, and reactor horizontal control rods. The cooling water exiting the reactors contained radioactive species from the fission process reactors, activated products from impurities in the water, and chemical contaminants added to treat the raw water before use. After exiting the reactors, the cooling water passed through retention basins and was discharged through outfall structures to the center of the river via large steel pipes embedded in the river bottom.

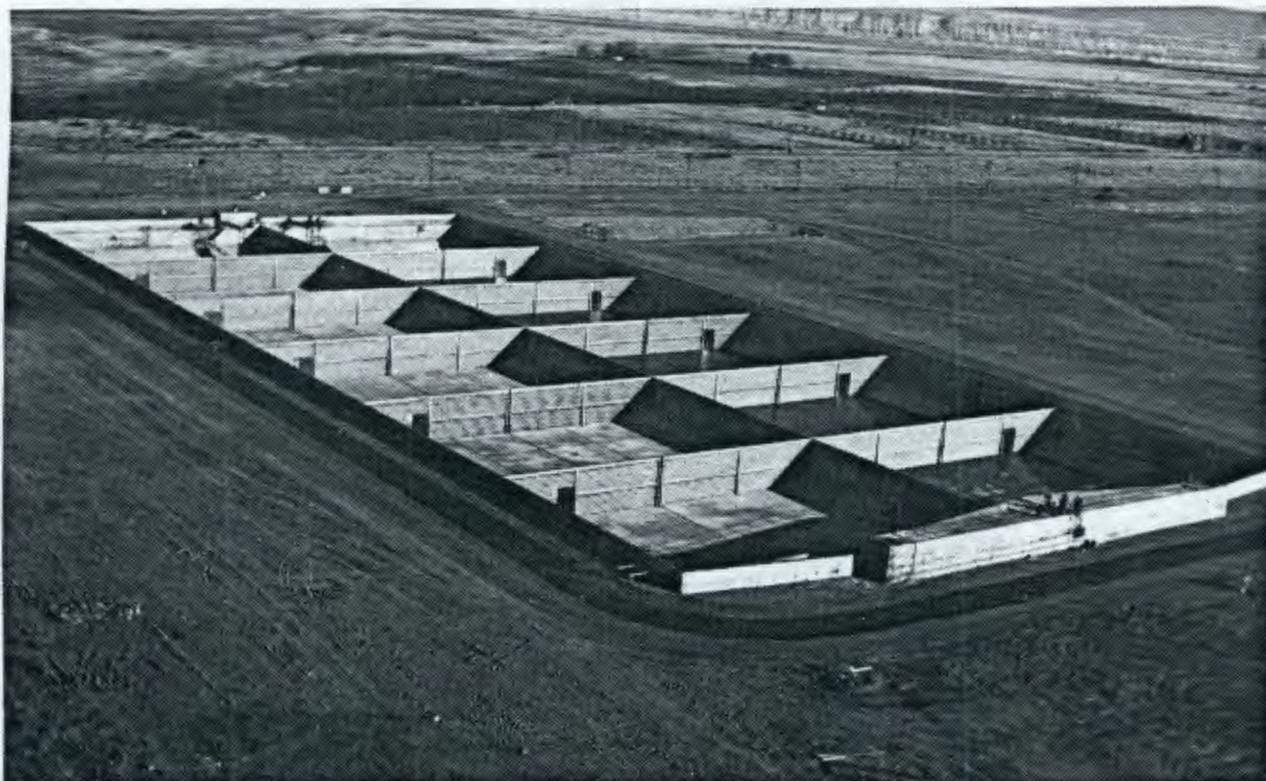
Figure 2-6. 107-DR Retention Basin, 1948.

- Open emergency dump trenches were used beginning in 1950. The highly contaminated water was segregated and drained to the 116-DR-1 basin trench via a 24-in.-diameter steel pipe that connected the basin outlet with the west end of the trench (PNL 1991). The retention basins were, by construction, divided into two compartments. When a fuel cladding failure occurred, the highly contaminated water was diverted into one of the two compartments. It was then drained to the emergency dump trench. This practice continued on a regular basis until 1954 when increased flows and structural stresses on the basins due to the temperature differences between the full and empty sides necessitated that both sides of the basin be used at the same time. The change to parallel operation in virtually marked the end of "cribbing" rupture effluent (Dorian and Richards 1978) (Figure 2-6).

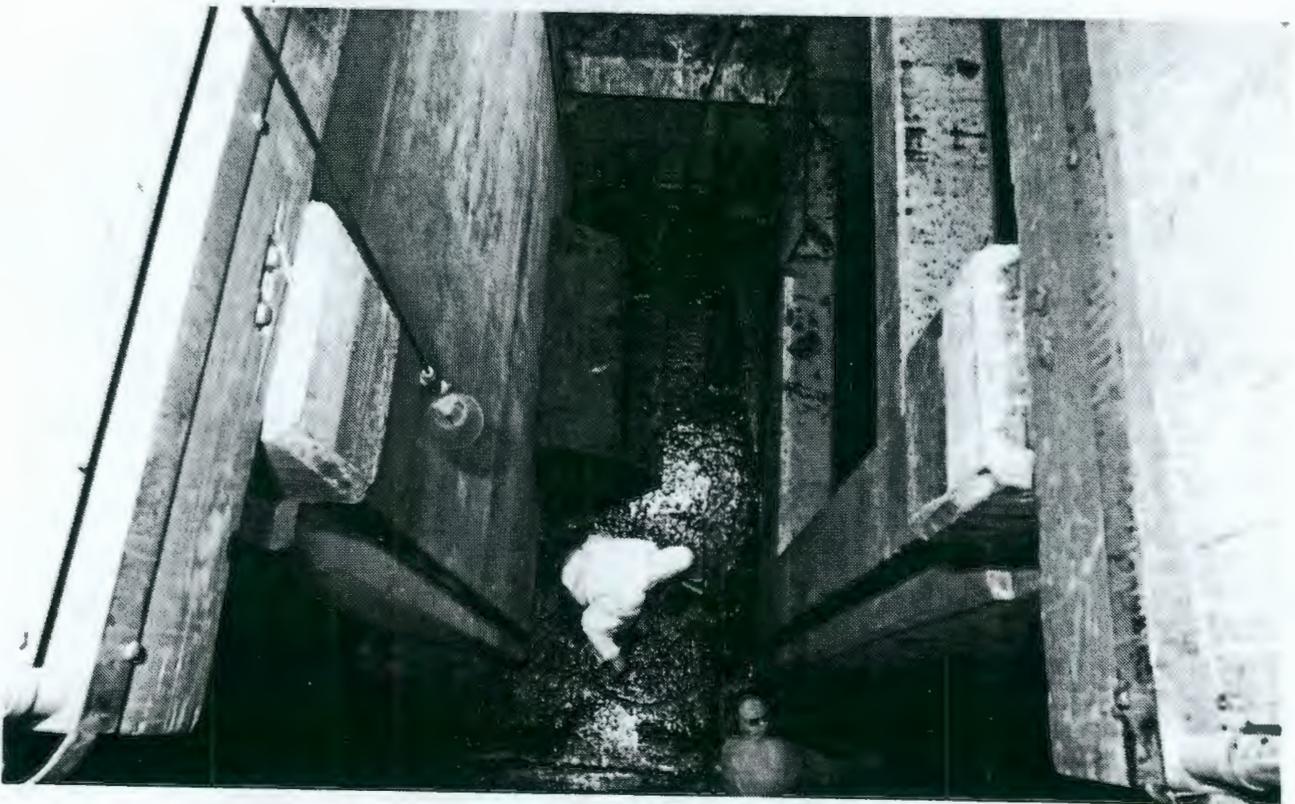
Figure 2-8. 105-D Fuel Storage Basin During Cleanout.

An asphalt emulsion (ATCO Asphalt 1840, tradename expired) was applied to the floors and walls of the basins to fix loose contamination. The remaining basin hardware, perfs, buckets, and sludge were packaged and disposed of as low-level radioactive waste in the 200 Area burial grounds (Miller and Steffes 1986) (Figure 2-8).

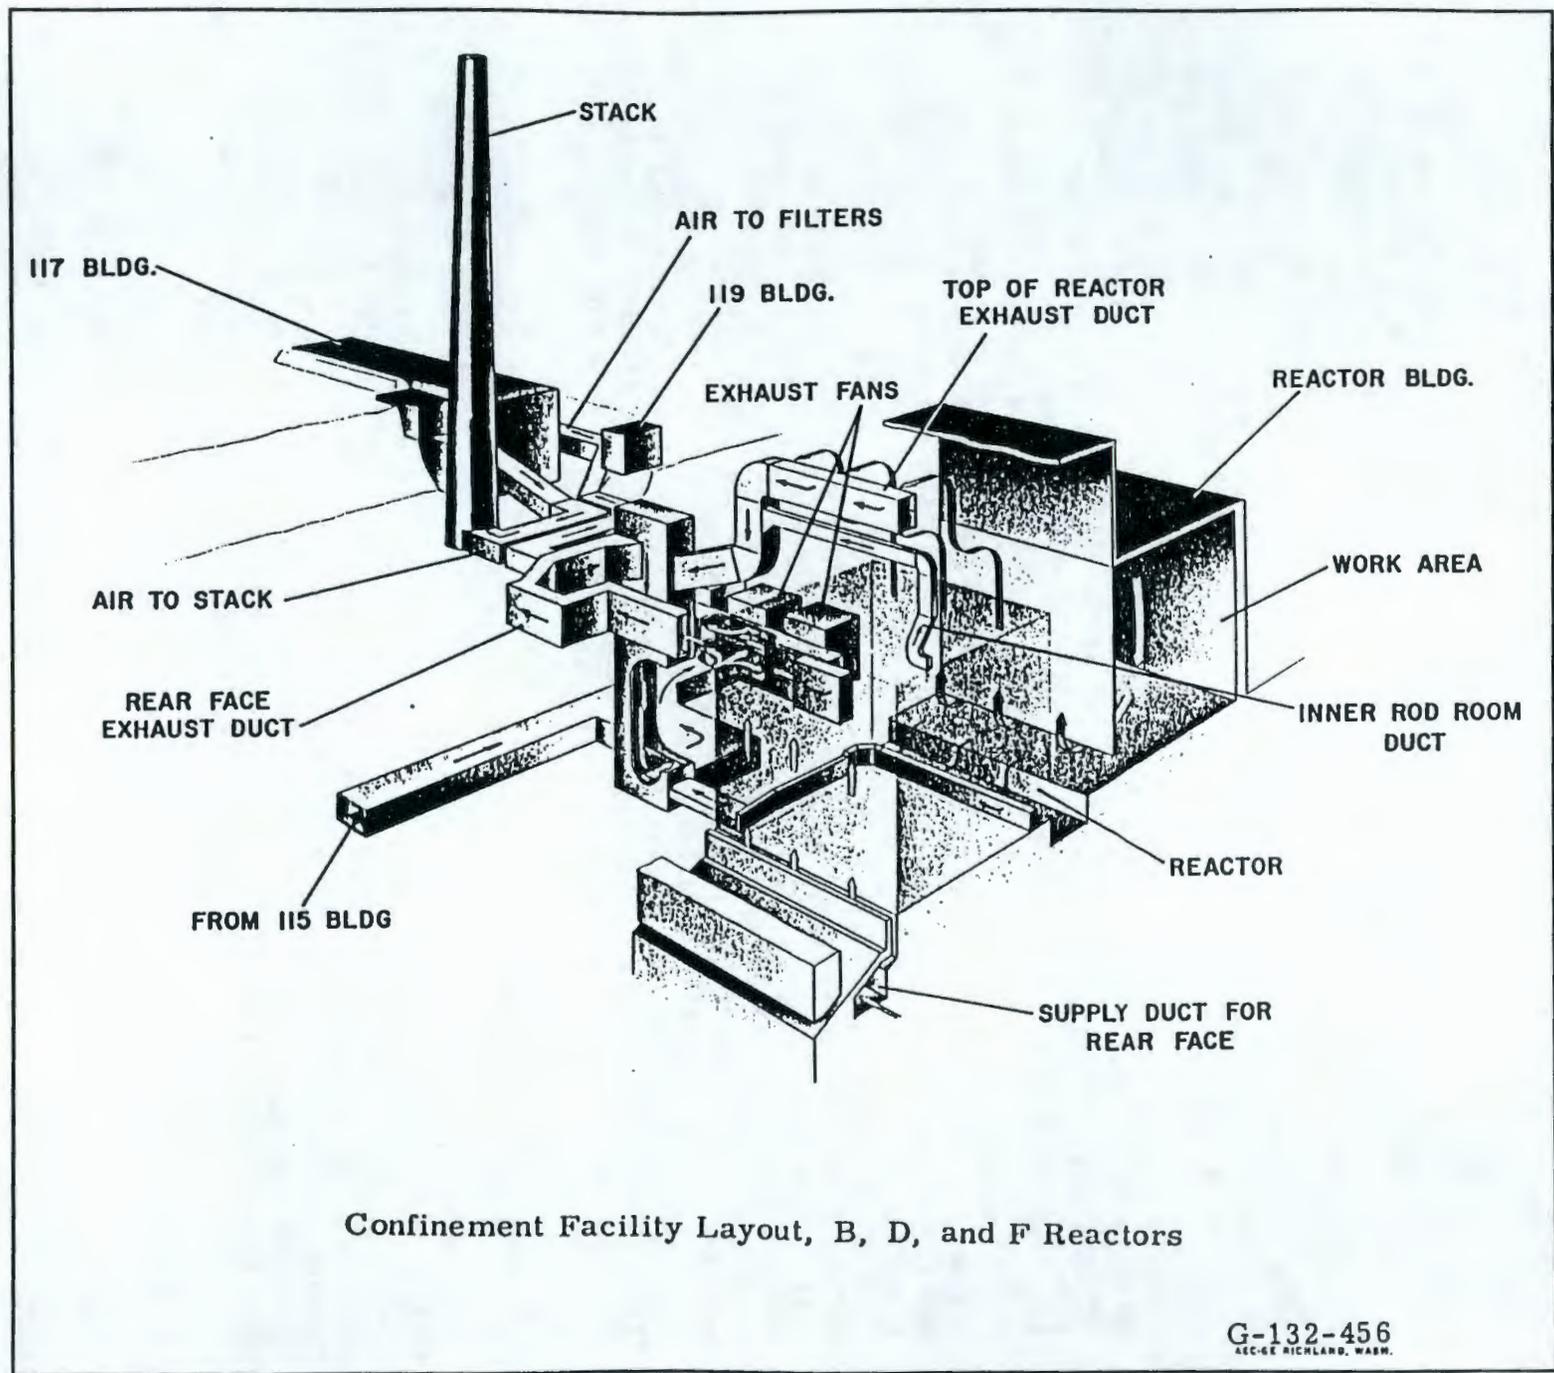
Figure 2-9. Typical Confinement Facility Layout.

Confinement Facility Layout, B, D, and F Reactors

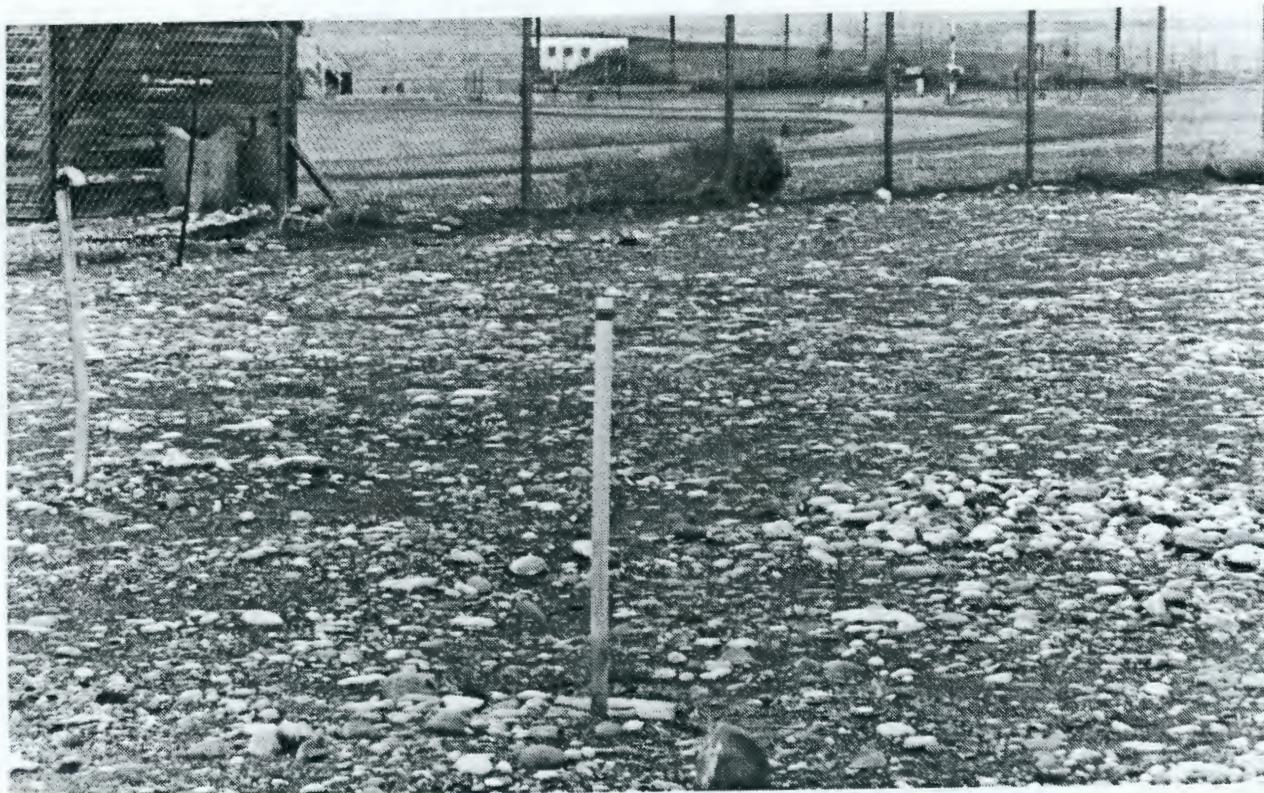
Figure 4-2. 116-D-1A, 1993.

The 116-D-1A appears today as a cobble-covered field. Additional soil has been added as shielding to a portion of the trench, and the surface is built up about 1 to 2 ft above the surrounding surface area. There is a 1 1/4-in. stainless steel pipe which extends about 36 in. above grade at the location of this waste site. It appears to be a vent pipe. The trench is treated annually with defoliant and no vegetation grows on the surface. The waste site is unfenced and is included in a larger area that is marked by permanent concrete monuments and Underground Radioactive Material warning signs. No markers uniquely identify the trench as the 116-D-1A site (Figure 4-2).

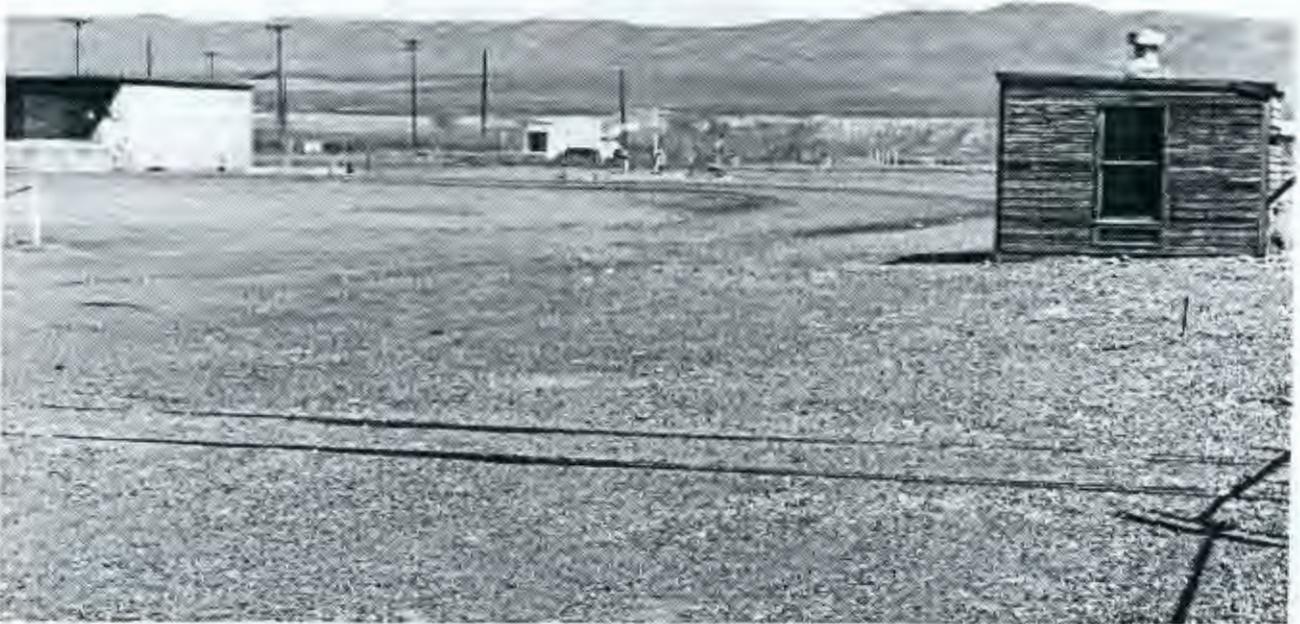
Figure 4-4. Possible Location of the 116-D-2 Pluto Crib, 1993.

Confusion exists about the location of these two pluto crib sites; there are three separate locations identified for them. The first is located just north of the rail tracks leading into the 105-D fuels transfer area and just south of the 1821-D Emergency Gasoline Generator Building that corresponds to the Hanford coordinates given above. This site currently has a steel rod marking its approximate location. It is shown in Figure 4-4. The second location is southeast of the 105-D Building and was identified during a walkover in February 1992 (WHC 1992). The site is marked by a recently placed concrete marker with a brass identification medallion embedded in the surface (Figure 4-5). The third location is located about 70 ft south and 30 ft west of the second site. This location was identified by ground probing radar (GPR) survey. A test hole drilled at the site appeared to confirm the location as the pluto crib (WHC 1992). This site is also marked by a recently placed concrete marker with a brass identification medallion embedded in the surface and is identified as 116-D-2A (Figure 4-6). This final site may be the location of a solid waste burial ground unrelated to the pluto cribs and is discussed in Section 4.33.

The 116-D-2 cribs have been fully backfilled with 10 feet of soil and appear today as unmarked gravel covered fields. All of the crib sites are within the exclusion area security fence but have no fencing unique to the cribs.

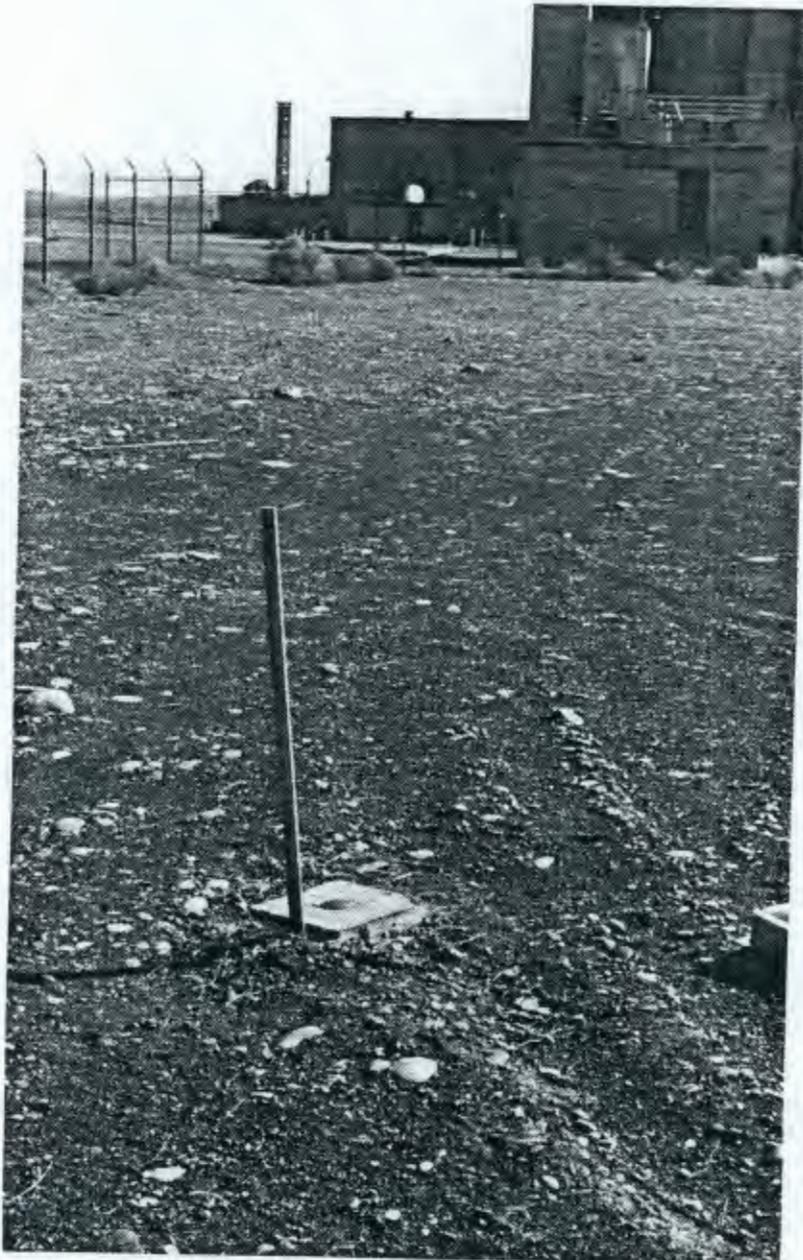
Figure 4-7. 108-D French Drain #1.

The site appears today as a vegetation-free cobble-covered field within the 100-D Area fence just northwest of the exclusion area fence. A recently placed concrete marker with a brass identification medallion embedded in the surface identifies this waste site (Figure 4-7). The 116-D-3 is a registered underground injection well (DOE 1988) and has an HRS score of 8.64 (Stenner et al 1988).

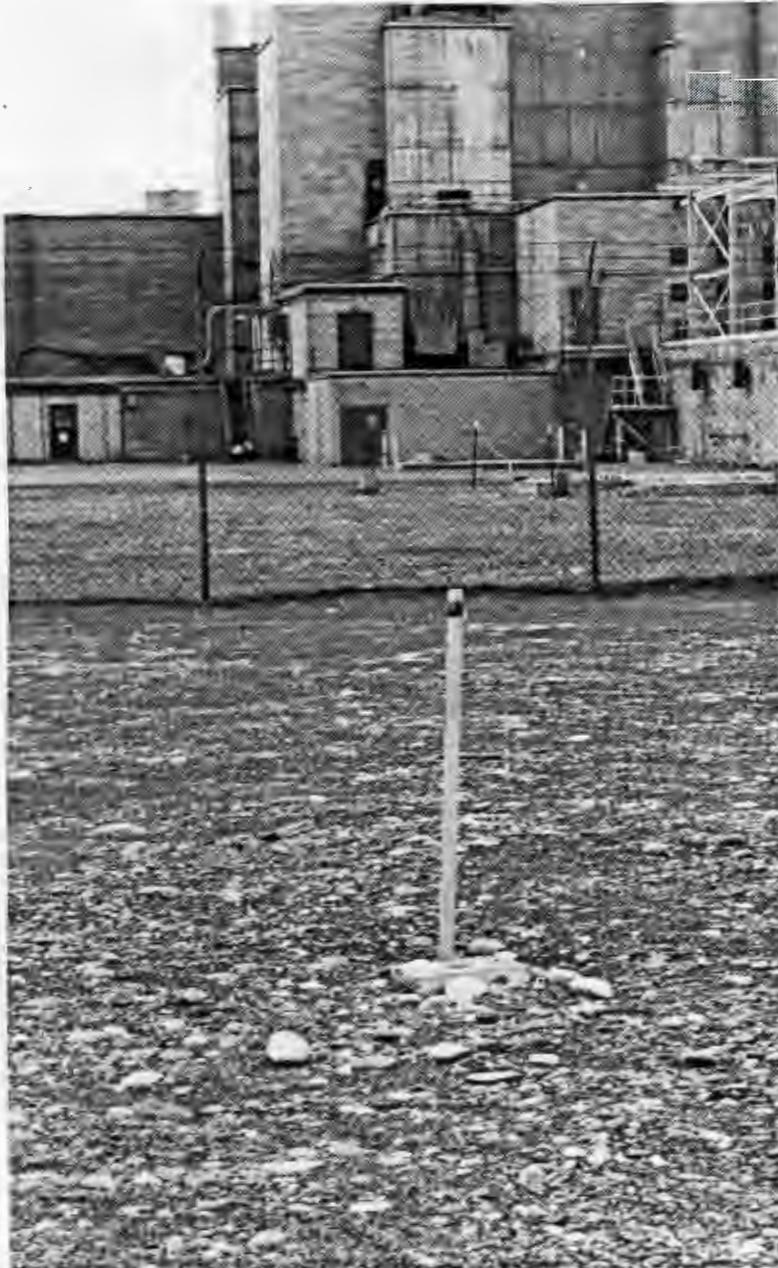
Figure 4-8. 108-D French Drain #2.

The site appears today as a vegetation-free, cobble-covered field. It is marked by a recently placed concrete marker with a brass identification medallion embedded in the surface, located about 75 ft east of the 100-D Area fence. It is within a larger radiologically controlled area bounded by permanent concrete markers posted with Underground Radioactive Material warning signs (Figure 4-8).

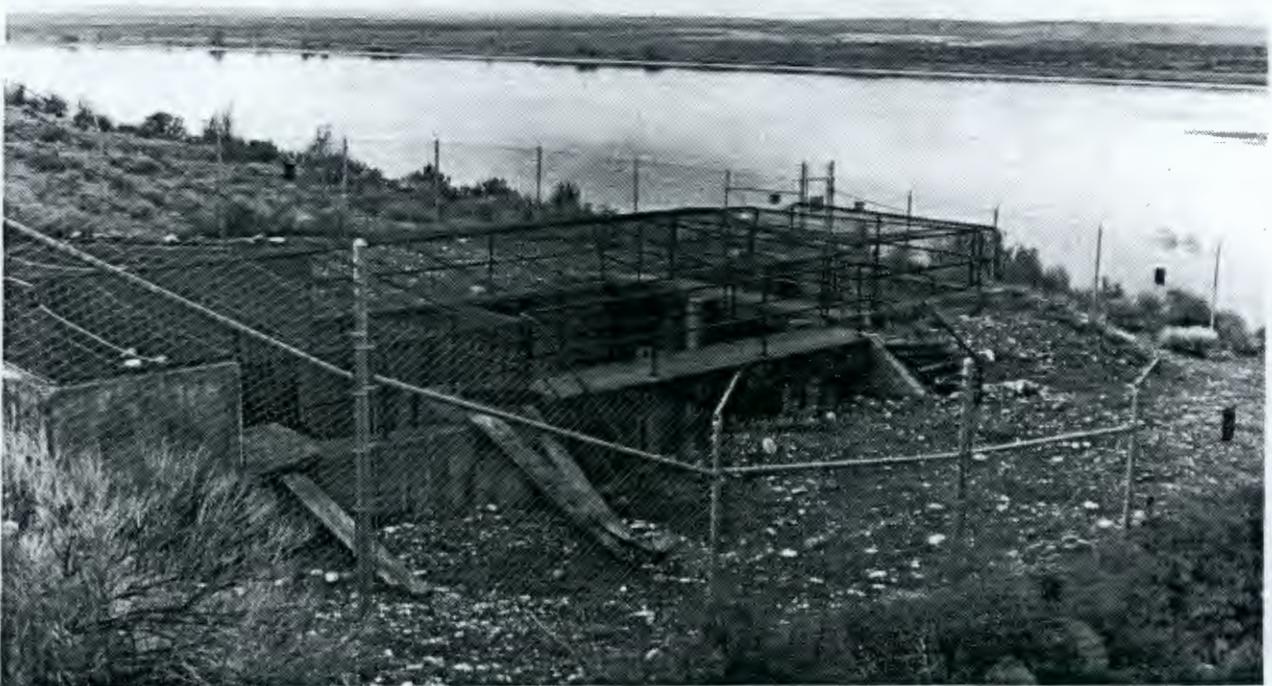
Figure 4-10. 116-D-5, 1904-D Outfall Structure, 1992.

The outfall structure appears today as an open, reinforced concrete structure that is enclosed by an aviary exclusion mesh cover and an 8-ft chain link fence. The 116-D-5 overflow spillway has been covered with soil from its origin to the shoreline (WHC 1991). During low river conditions, about 20 to 30 ft of the spillway is exposed (Figures 4-9, 4-10, and 4-11).

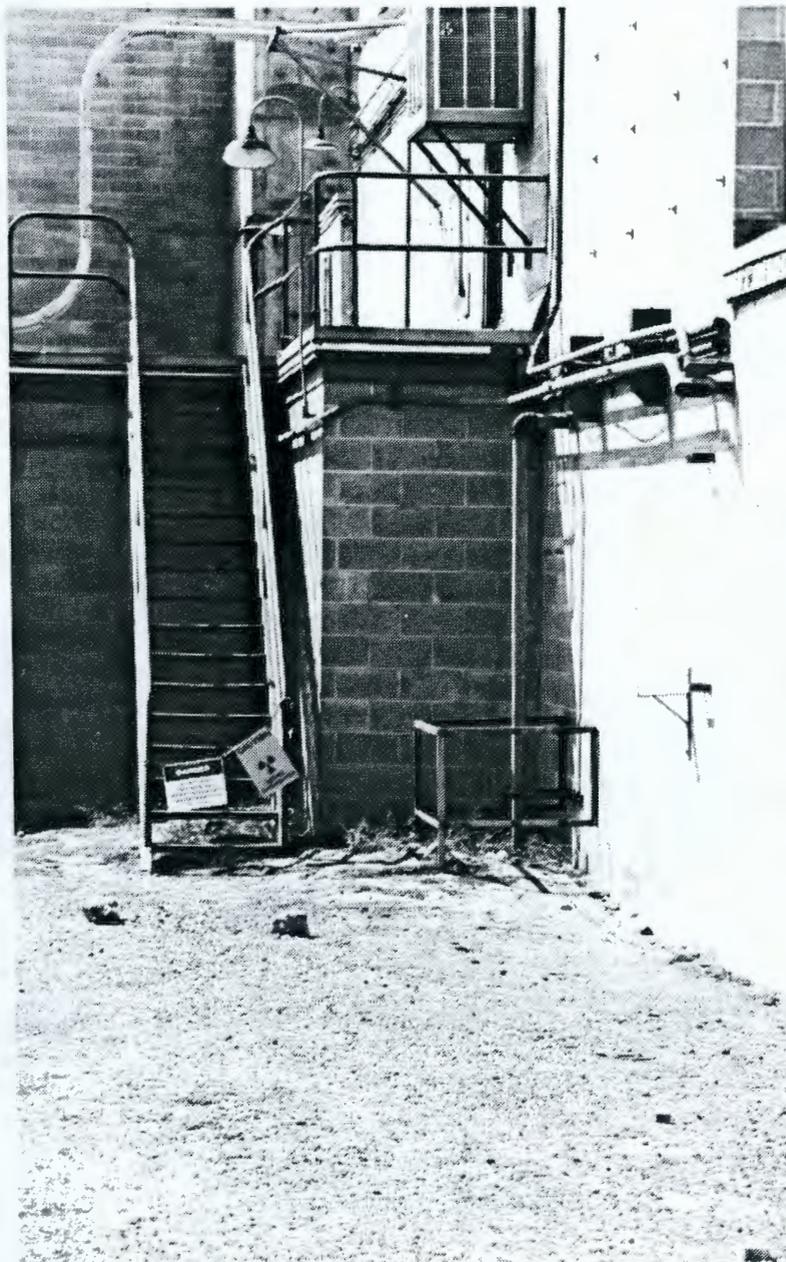
Figure 4-12. 105-D Cushion Corridor French Drain.

Today, 116-D-6 is almost completely covered by wind blown sand. It is surrounded by a light duty steel barricade structure bolted to an outside wall of the 105-D Facility. The elaborate physical barrier is probably due to the fact that this waste site is at the base of an outside access staircase on the northeast side of the 105-D building (Figure 4-12).

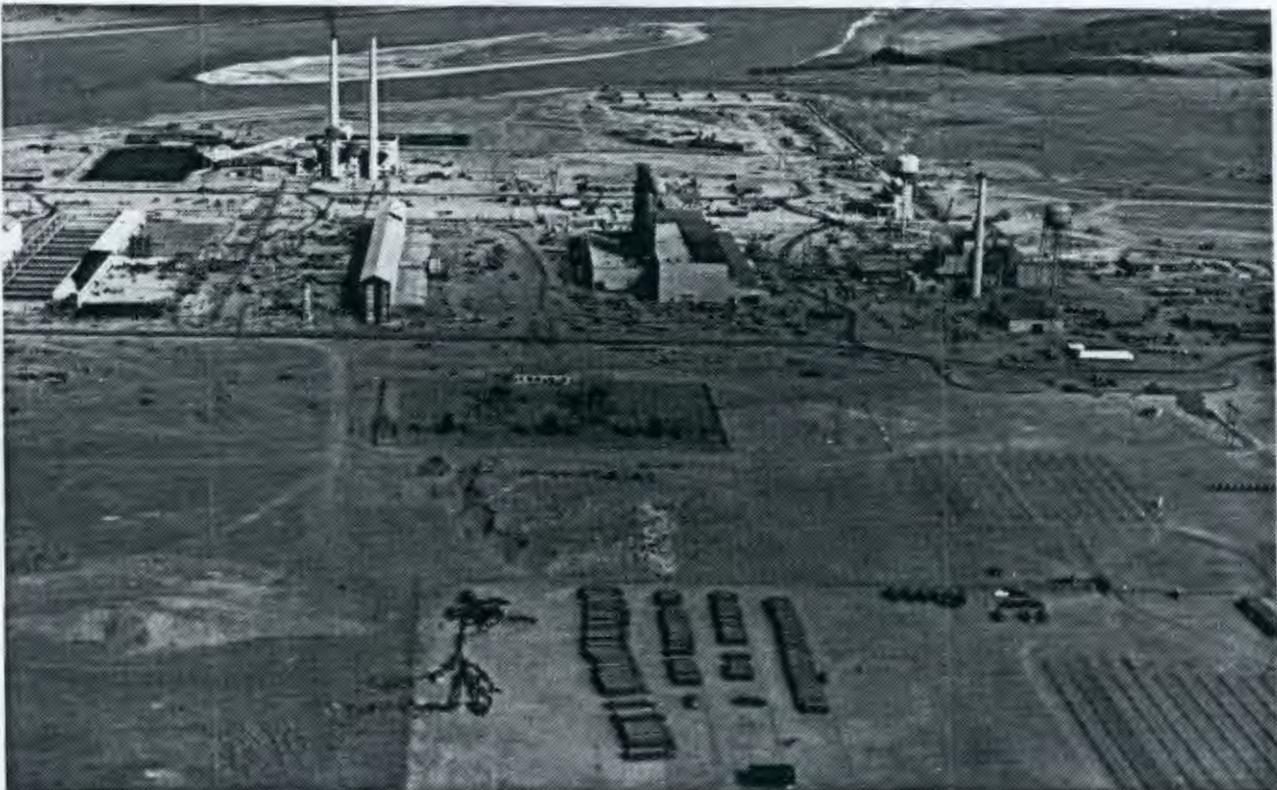
Figure 4-13. 100-D Area, 1944, Retention Basins.

The 467- by 230- by 24-ft-deep basin was an open concrete structure with a vertical concrete divider constructed lengthwise down the middle of the basin. The floor was constructed of concrete slabs, their joints originally closed with neoprene water seals. The walls sloped from the floor to a point 10 ft above floor level with the remaining wall (about 10 ft) being vertical. The sloping wall sections were 4 in. thick, and the vertical walls were made of reinforced concrete with a minimum thickness of 1 ft at the top and 5.75 ft at the bottom. Each side of the basin was divided into five sections by baffle walls constructed of concrete and wood. The purpose of these baffle walls was to slow and control channeling of the effluent and to maximize cooling and decay of short lived radioactive isotopes prior to release to the Columbia River (Figure 4-13).

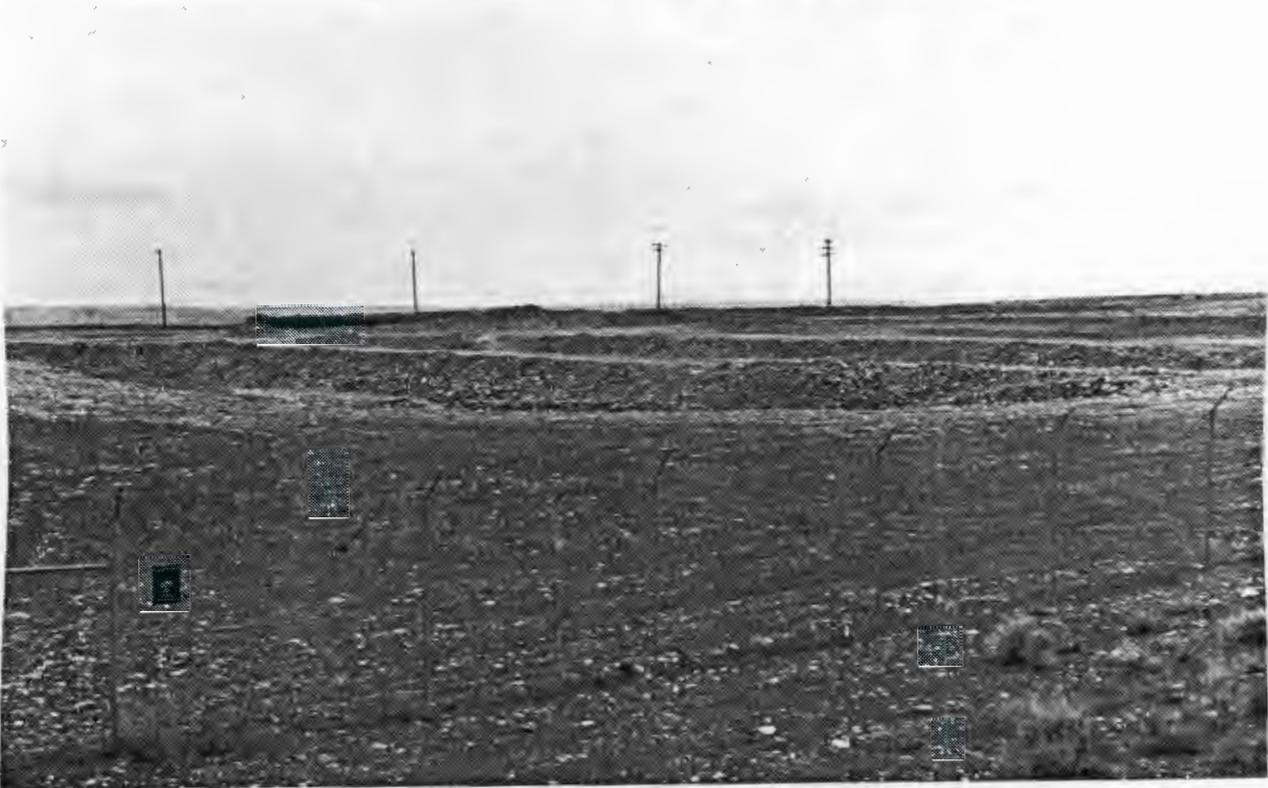
Figure 4-14. 116-D-7, 107-D Retention Basin, 1993.

The site appears today as a large, vegetation-free, cobble-covered excavation with a central berm that runs the entire length. A portion of the steel effluent line remains exposed above ground; the exposed end has been backfilled with soil to limit access to the pipe interior. The entire area is surrounded by an 8-ft fence (which also encloses the 116-DR-9 retention basin) and is posted with Surface Contamination warning signs (Figure 4-14). The ground surface over the buried effluent line is surrounded by a steel post and light duty chain barrier that is posted as a Surface Contaminated Radiological Area. This area is about 100 ft wide and 500 to 600 ft long. It stretches from the fence surrounding the basin to the railroad tracks south of the basin and is covered by natural vegetation.

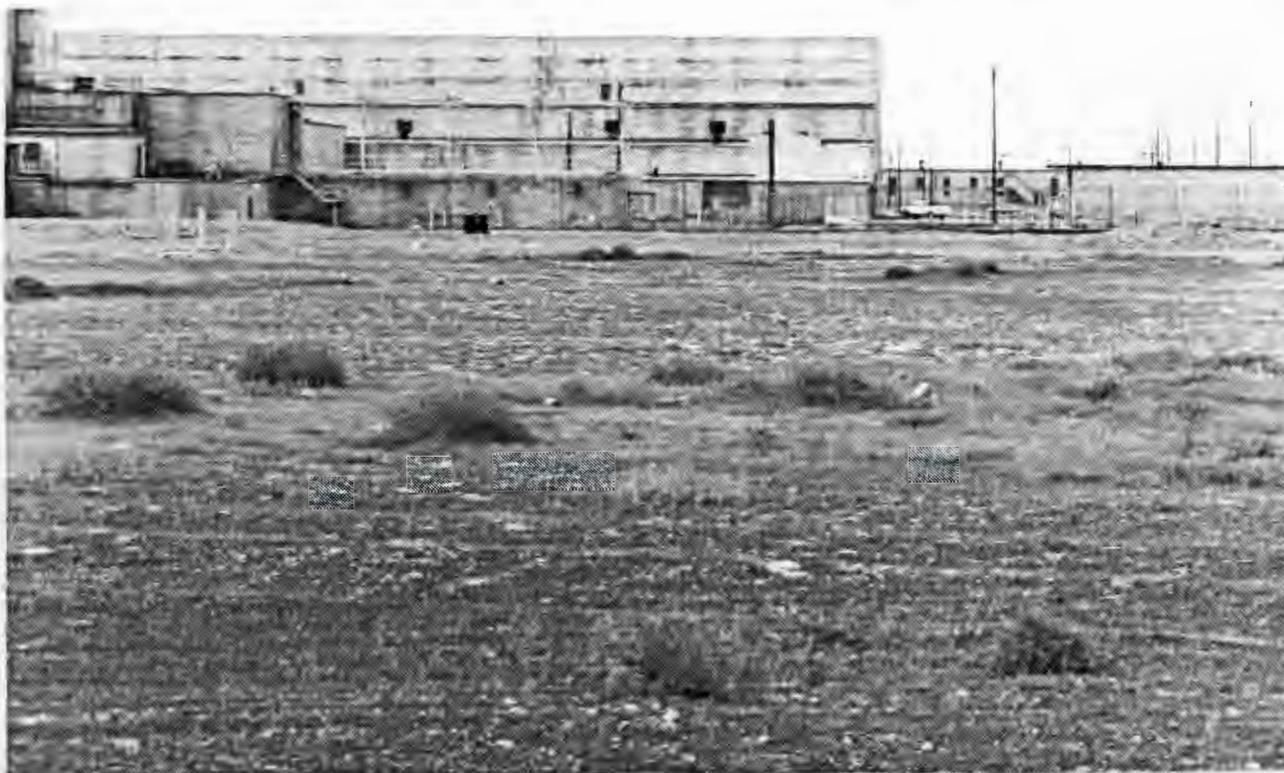
Figure 4-16. 100-D Fuel Storage Basin Cleanout Ponds.

There is no apparent visible evidence of the percolation pits at the site; it appears today as a cobble-covered field located outside the permanent concrete markers. Local natural vegetation (grasses, etc.) is beginning to reestablish itself in the area (Figure 4-16).

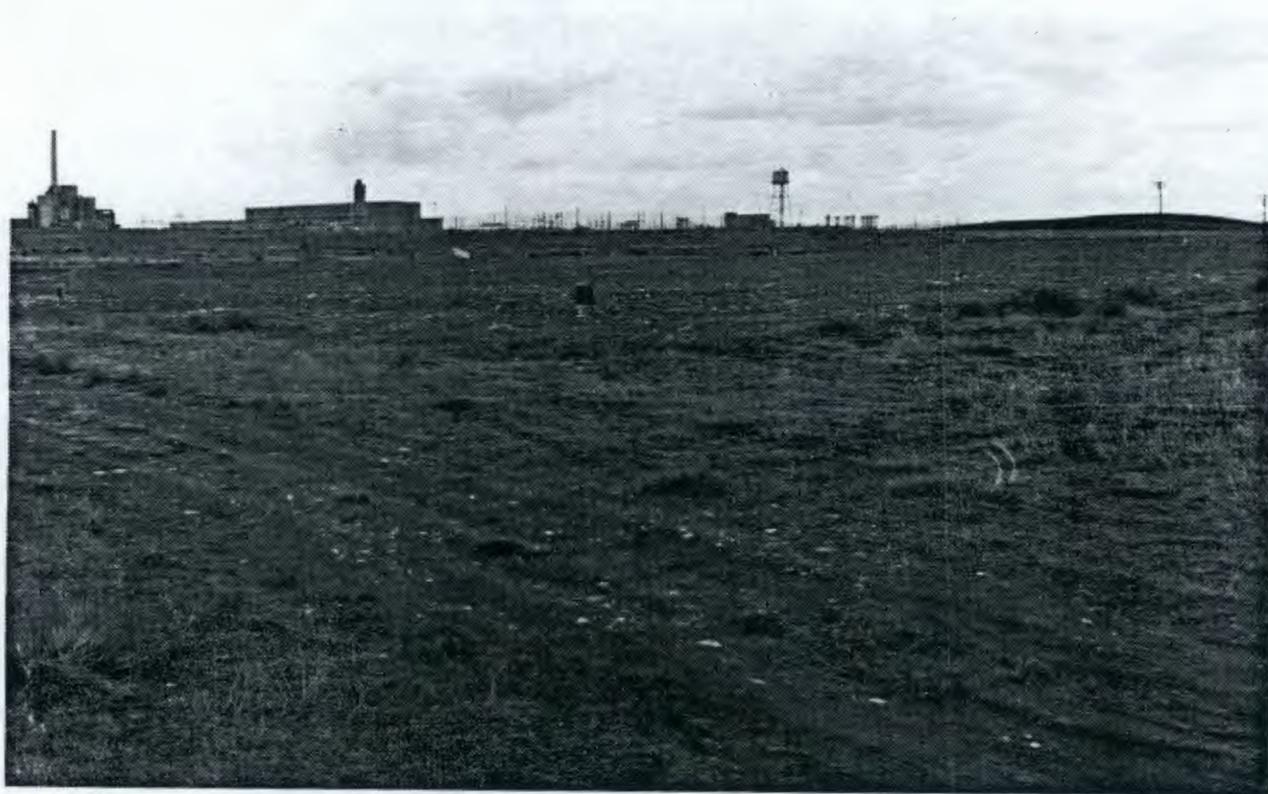
Figure 4-17. 116-DR-1 and 116-DR-2, 107-DR Liquid Disposal Trenches.

The 116-DR-1 appears today as a vegetation-free, cobble-covered field surrounded by permanent concrete markers and posted with Underground Radioactive Material warning signs. A terraced dirt mound located on the southeast end of the site was constructed prior to 1987 as part of a feasibility study for the revegetation of burial grounds. It was terraced to determine the minimum soil depth required to sustain plant growth. Currently the 116-DR-1 and mound are treated with defoliant annually (Figure 4-17).

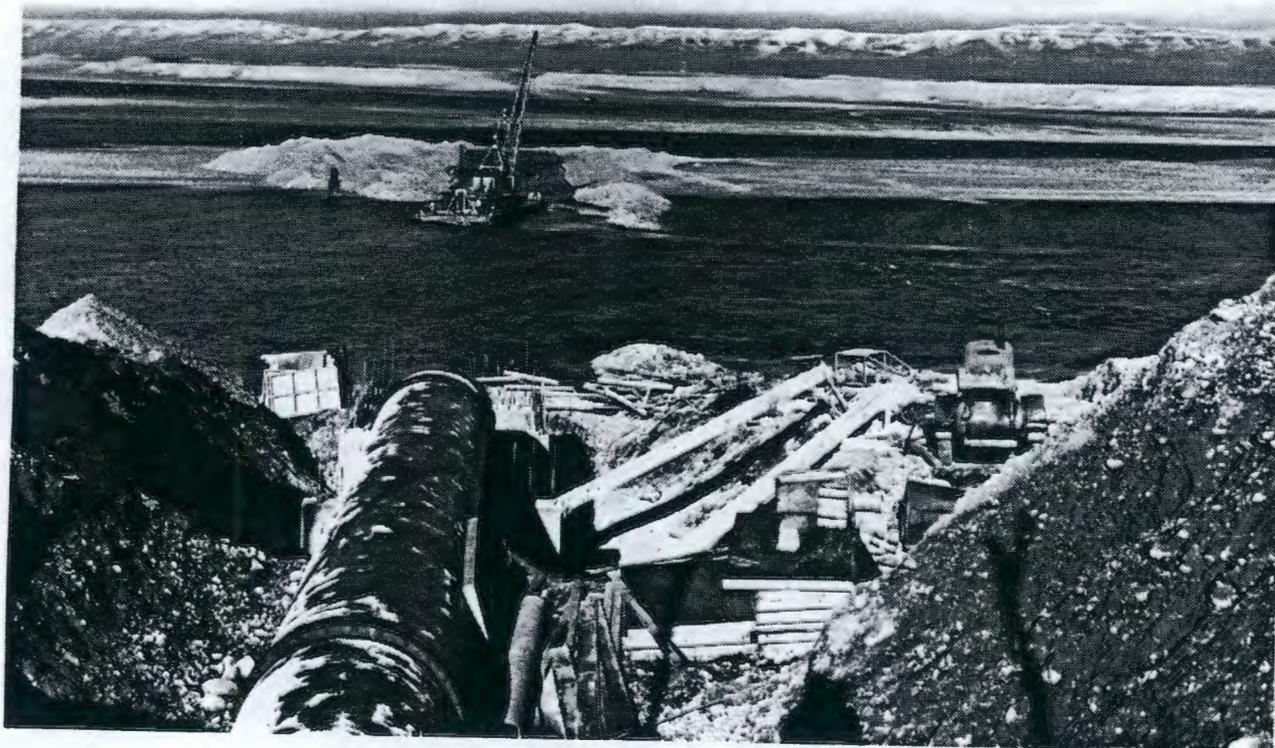
Figure 4-18. 116-DR-5, 1904-DR Outfall, 1956.

The outfall structure was an open, reinforced, compartmentalized concrete water box (weir) that directed the effluent into a single 66-in. steel pipeline that extended to the river center bottom. This outfall pipeline passes through the approximate center of the small island north of the 100-D Area and ends approximately 1,850 ft from shore. A reinforced concrete overflow spillway to the Columbia River shoreline was provided as part of the outfall structure in case the line became plugged (DOE 1992b) (Figure 4-18).

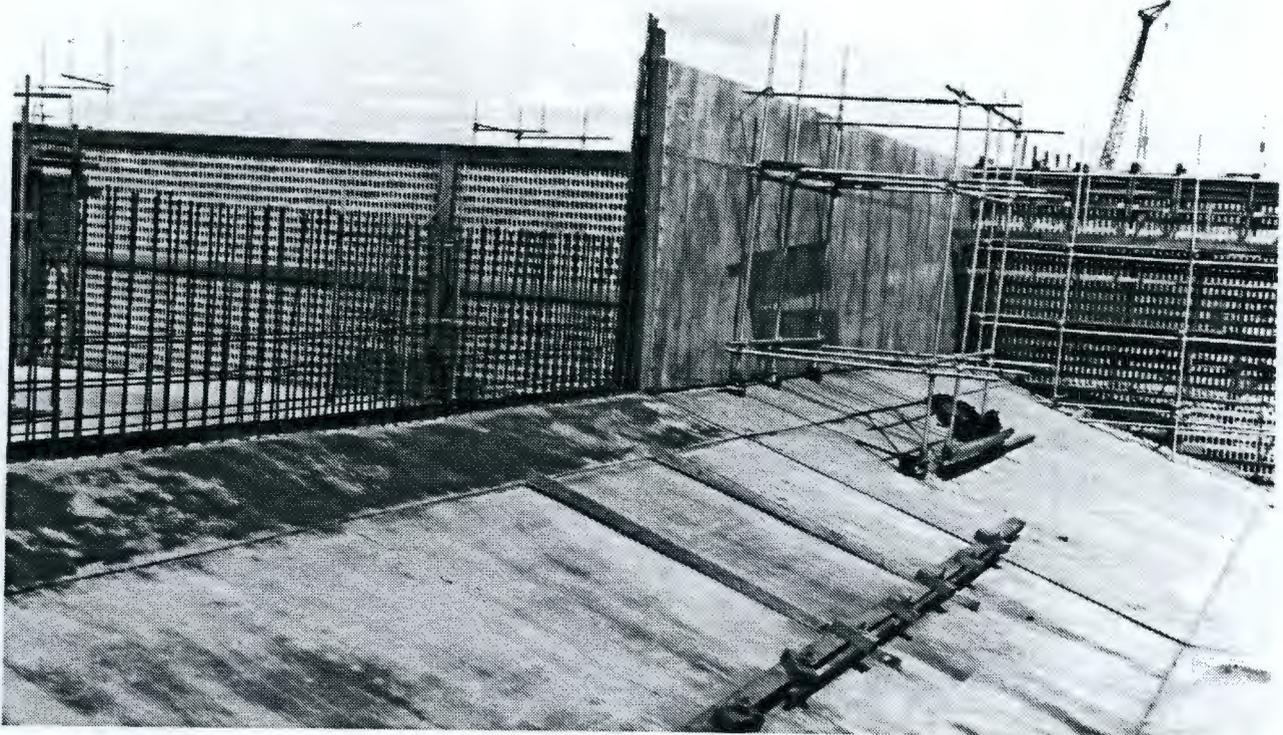
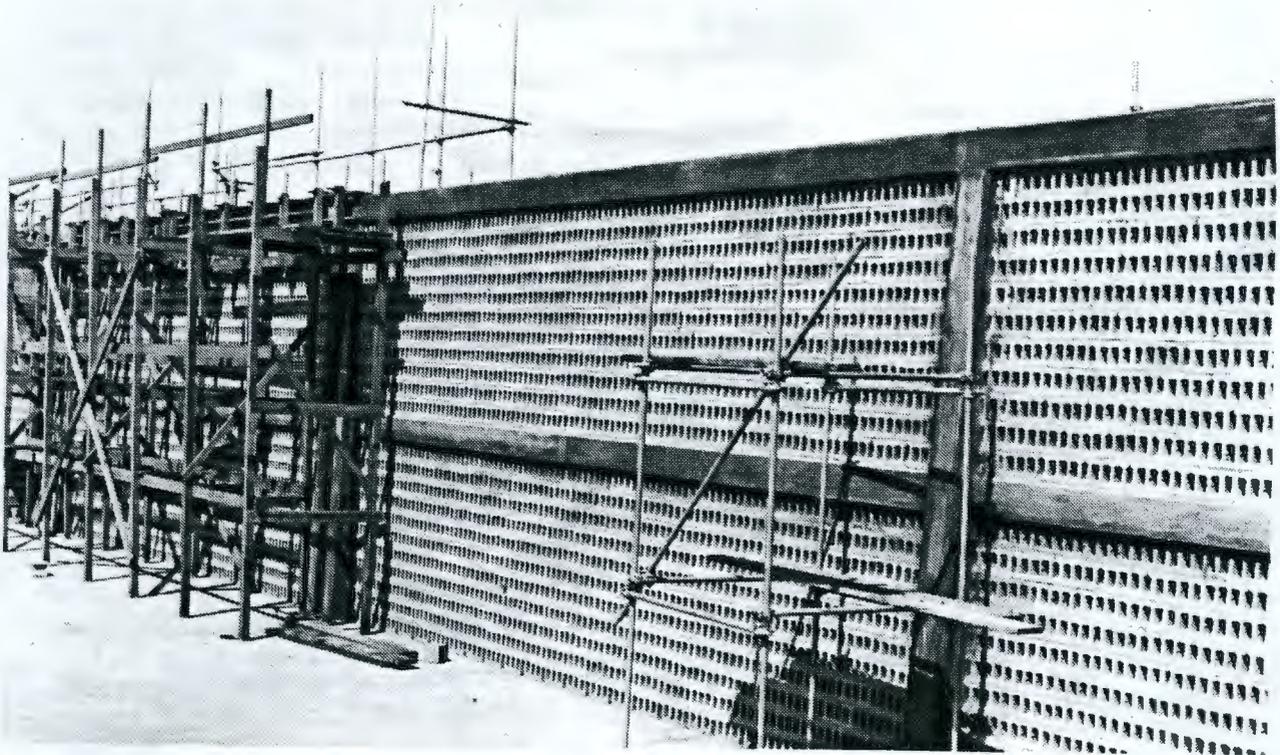
Figure 4-21. 107-DR Retention Basin Construction.

The walls sloped from the floor to a point 10 ft above the floor level with the remaining wall (about 10 ft) being vertical. The sloping wall sections were 4 in. thick, and the vertical walls were reinforced concrete with a minimum thickness of 1 ft at the top and 5.75 ft at the bottom. Each side of the basin was divided into six sections, separated by baffle walls constructed of concrete and concrete blocks set on their sides. The purpose of these baffles was to slow and control channeling of the reactor cooling effluent water to maximize cooling and decay of short lived radioisotopes prior to release to the Columbia River (Figures 4-21 and 4-22).

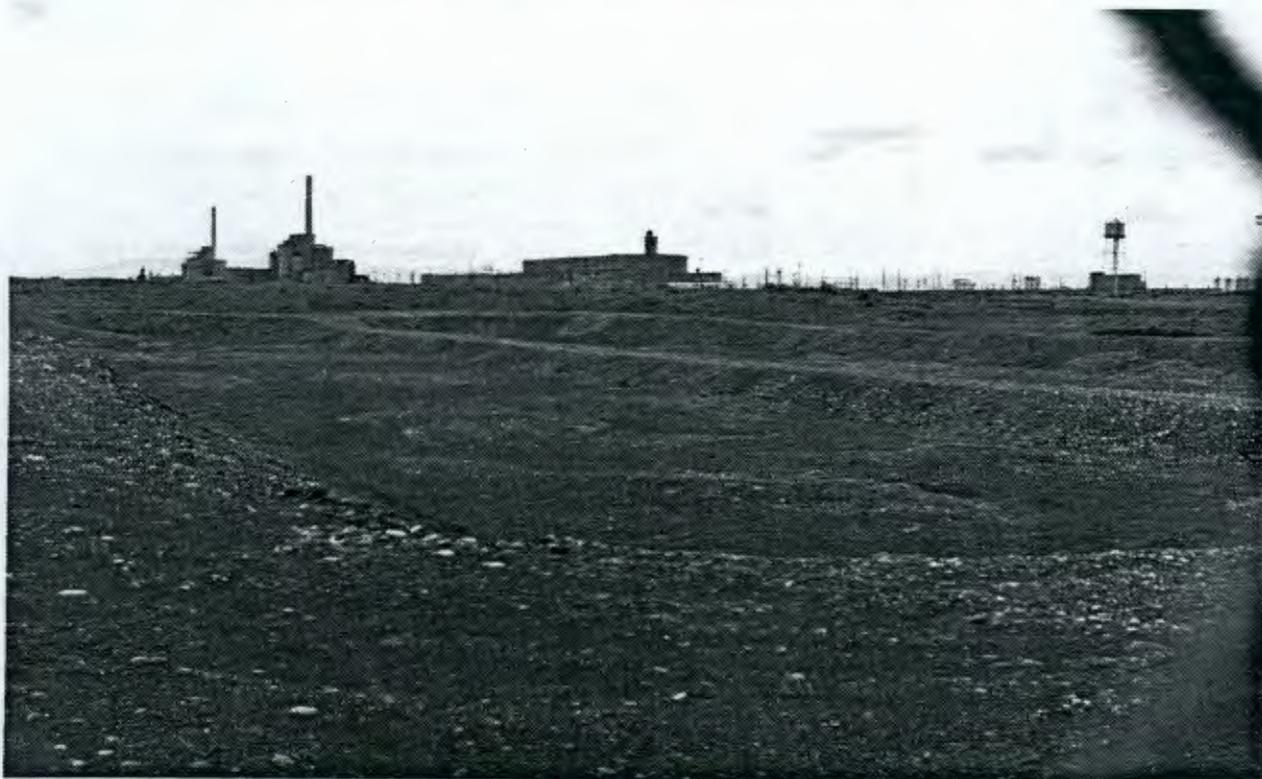
Figure 4-23. 116-DR-9, 107-DR Retention Basin, 1993.

The area appears today as a large, vegetation-free, cobble-covered excavation with a central berm running the entire length. It is surrounded by an 8-ft chain-link fence that encloses the 116-D-7 retention basin and is posted with Surface Contamination warning signs (Figure 4-23). A large area on the west side, outside the chain-link fence, is surrounded by a steel post and light chain barricade that is posted with Surface Contamination warning signs. This area begins at the south end and extends west of the basin to the steel post and light chain barricade surrounding the 107-D basin effluent line area. The ground surface is covered by natural vegetation of the area.

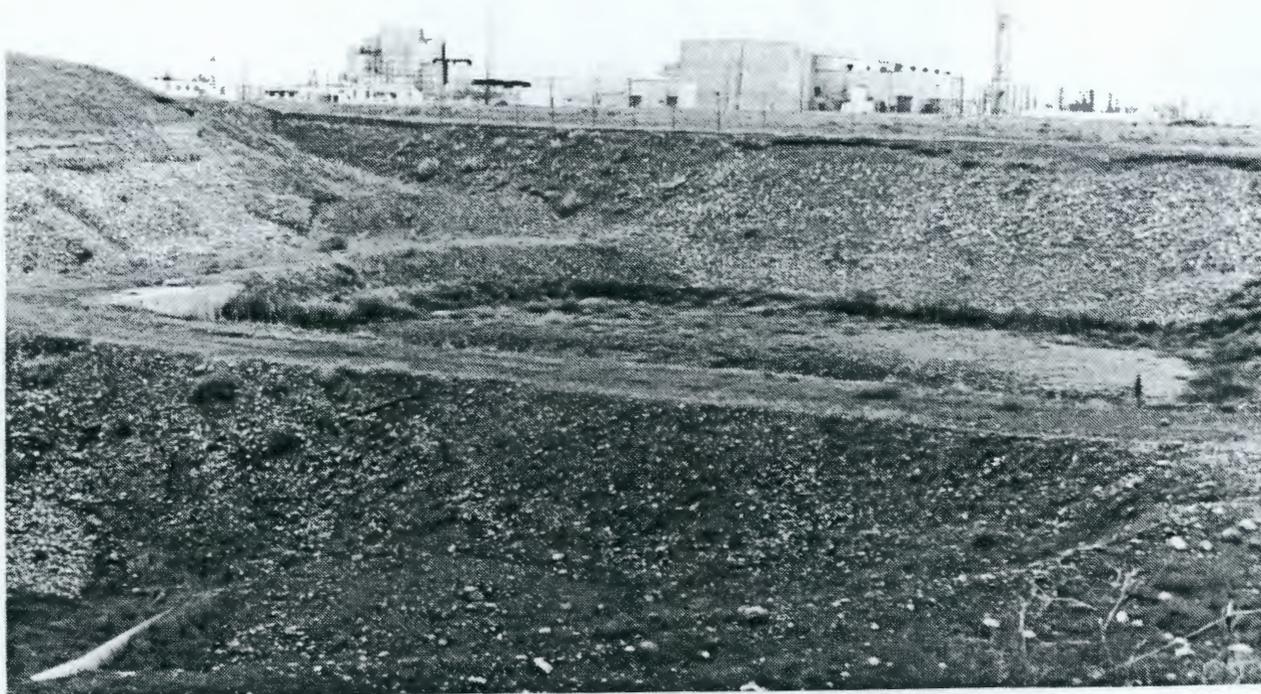
Figure 4-25. 120-D-1, 100-D Area Ponds, 1993.

The ponds have been modified. The corrugated steel pipe connecting the two ponds has been removed and is currently laying on the bottom of the percolation side of the ponds. Two steel overflow pipes have been added: the first, a 6-in. pipe, is at the approximate center and top of the dividing dike; the second, located closer to the east side of the ponds and also extending through the dike, is an 8-in. schedule 40 steel pipe that is 2 to 3 ft below the dike top. There appears to be a valve in this pipe at the center of the dike. There is also 24-in. overflow riser located about 10 feet from the dike and 10 ft from the pond inlet structure (concrete box). The riser has a closable steel cover that is partially open. The inlet structure is a 2-m (6 ft 9 in.) wide by 2-m (6 ft 9 in.) high box (DOE 1992b) that was a part of the 100-D Area process sewer system (Figure 4-25).
