WHC-SD-EN-TI-181
Revision 0

100-D Area Technical Baseline Report

Prepared for the U.S. Department of Energy
Office of Environmental Restoration and
Waste Management

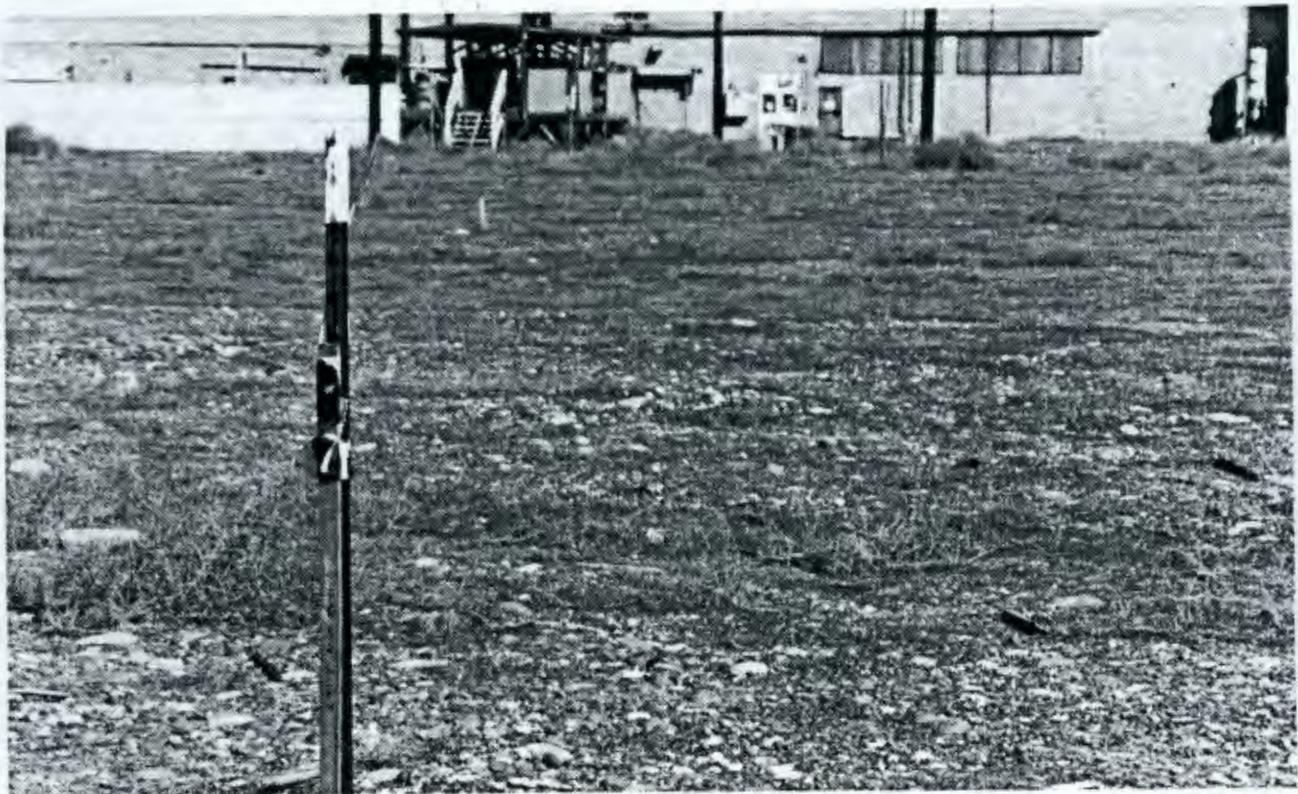
Figure 4-26. 186-D Waste Acid Basin.

The site currently appears as a cobble- and vegetation-covered field. A wood and steel post marker identifies the site (Figure 4-26). It could not be confirmed by documentation or drawings that the two brick manholes near the site were in any way associated with waste acid reservoir. There is a large square concrete structure with a metal cover nearby that is part of the 100-D Area process sewer system.

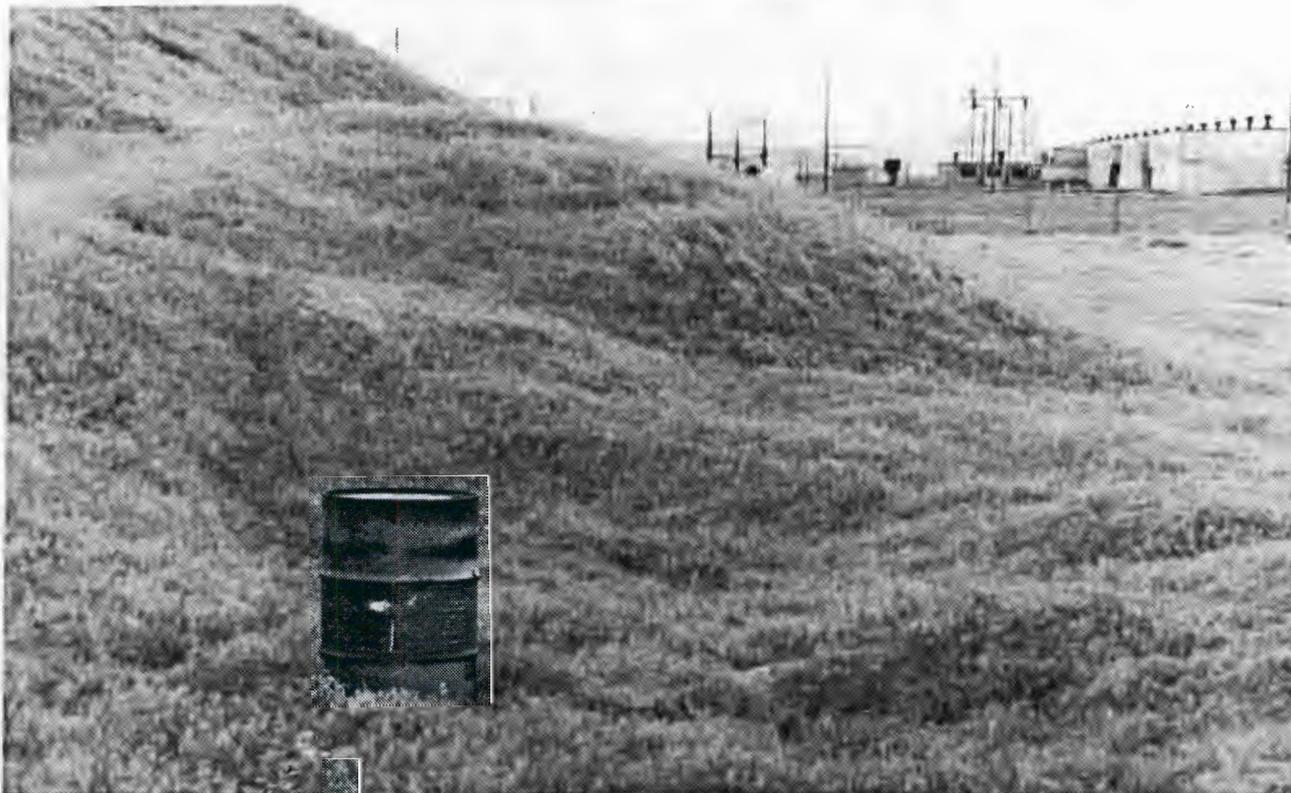
Figure 4-27. 100-D Area Ash Disposal Basin Orphan 55-gal Drum.

The ash basin is no longer apparent and the entire area is covered by a large ash deposit about 6 to 9 m high. At the northwest end of the site there is an empty 55-gal drum standing near the pile. Weathering and rust have obliterated any identification of the drum's former contents, which it appears to have leaked. Very near the drum are sections of large steel grating. The ash piles are currently covered by grasses and other natural vegetation (Figure 4-27).

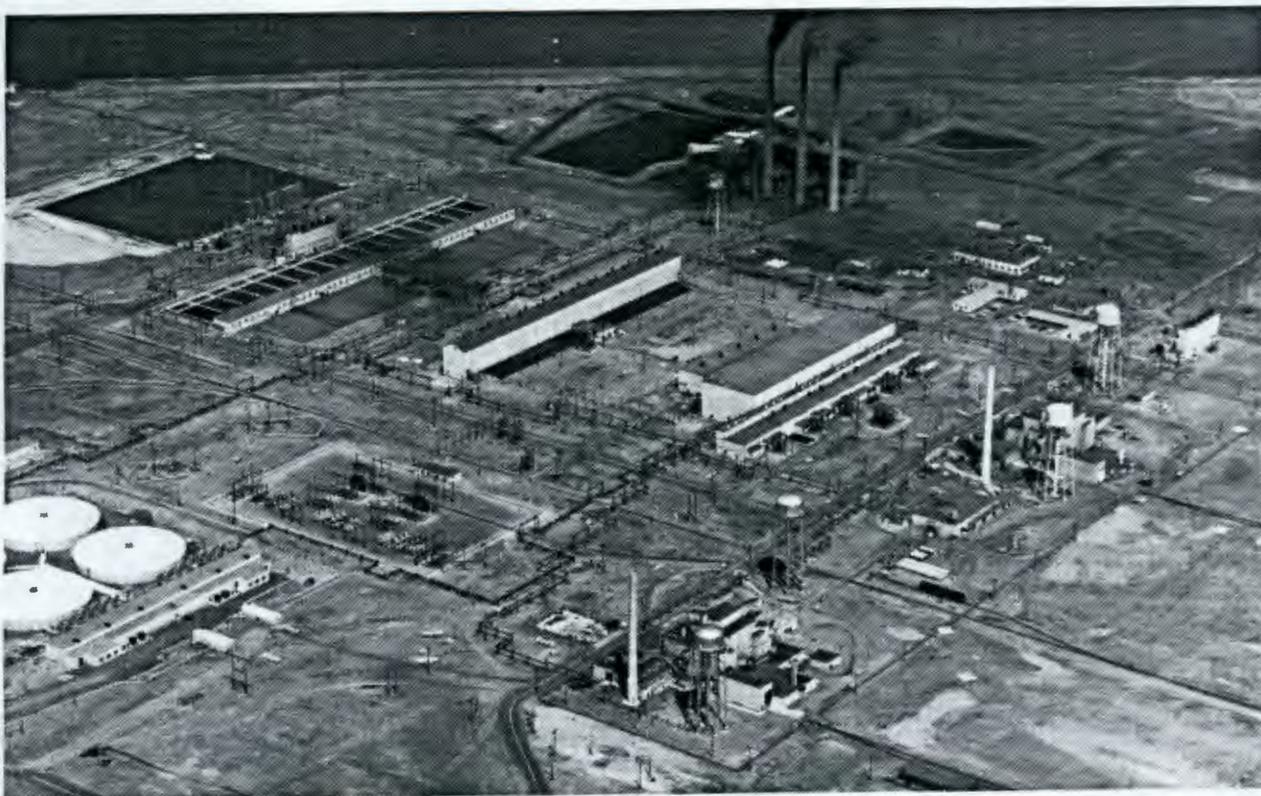
Figure 4-28. 100-D Area, Coal Pit.

Originally the coal pit was used to store coal for the powerhouse (Figure 4-28). Later it was used to receive solid wastes from demolition activities and demolished facilities such as the 184-D (including stacks), 108-D, released portions of the 115-D/DR, 186-D, and miscellaneous auxiliary building materials (roofing and transite siding).

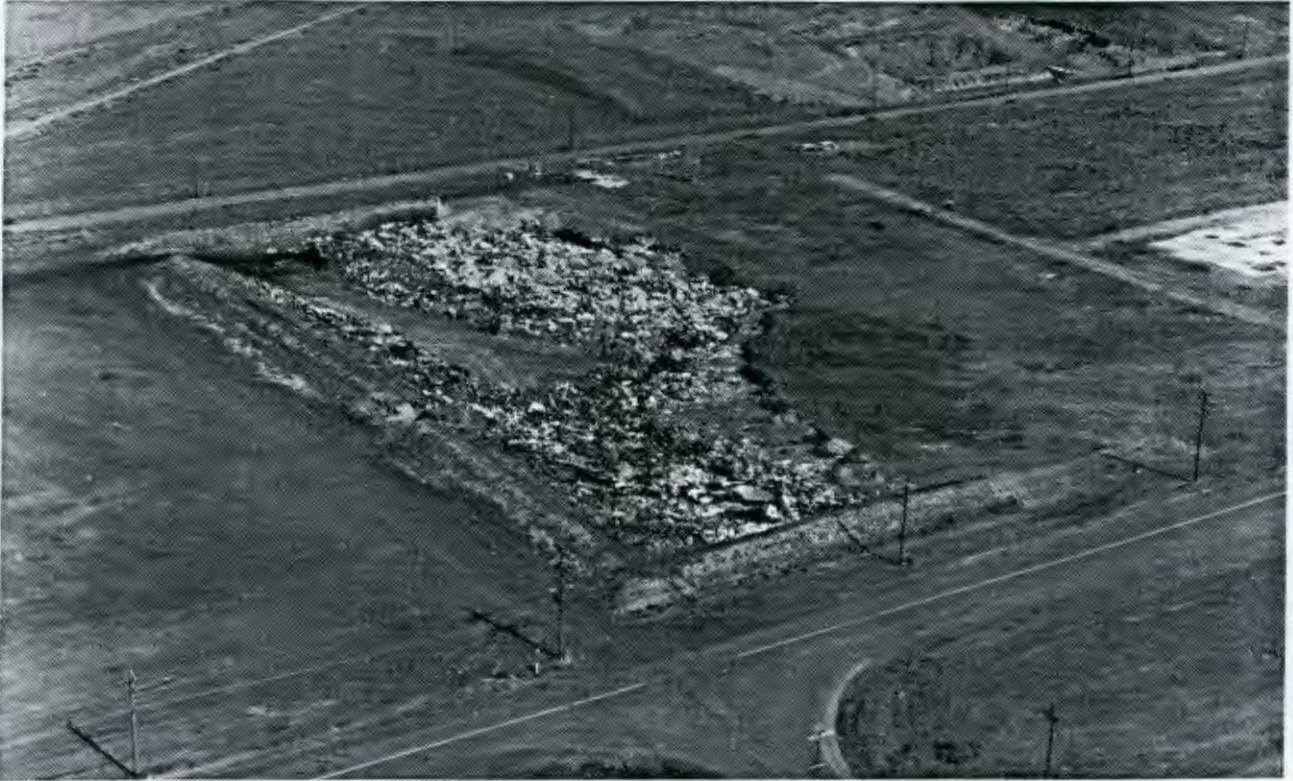
Figure 4-29. 184-D Coal Pit, 1969.

The 126-D-2 site appears today as a vacant field covered with an ash-like material and natural vegetation (grasses and annual weeds) (Figures 4-29 and 4-30).

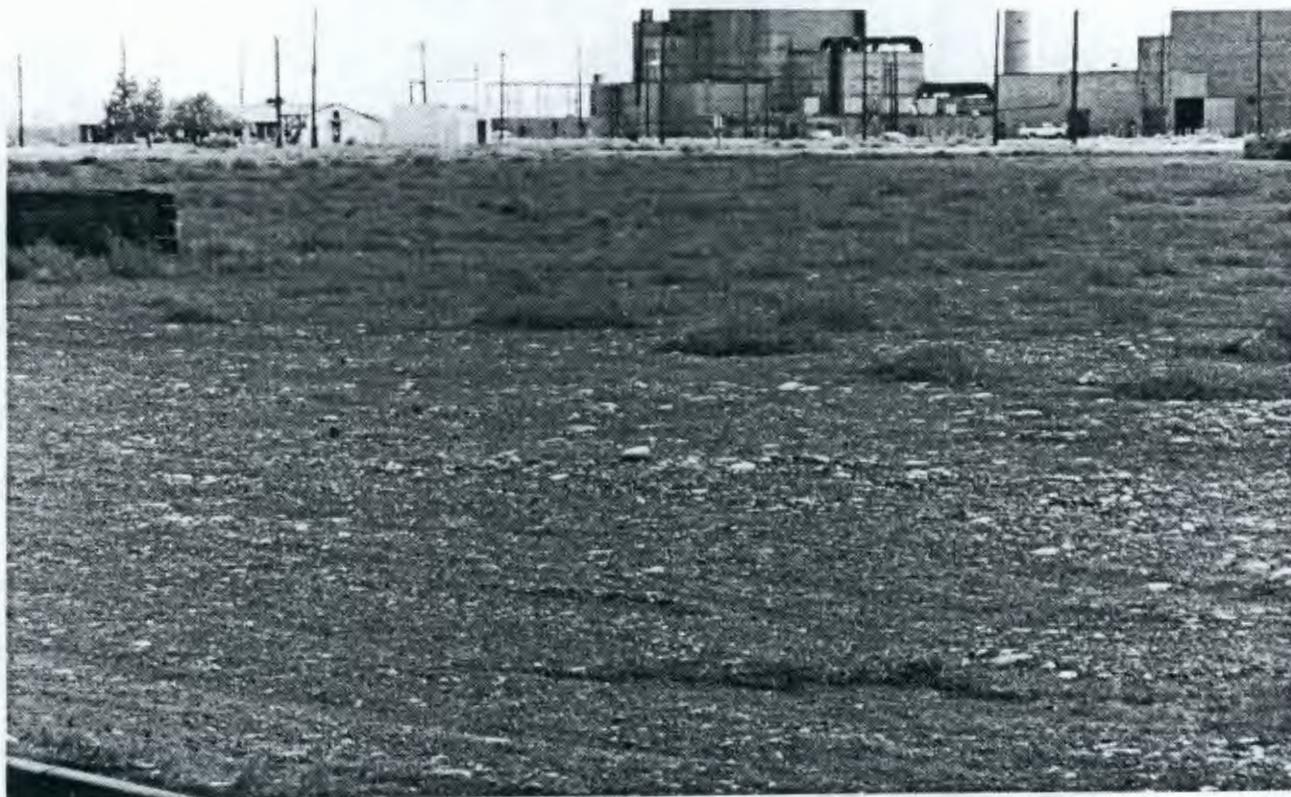
Figure 4-31. Salt and Brine Pit.

The current appearance is that of a cobble-covered field. There is evidence of heavy equipment activity at the site. Nearby to the east there is a soil subsidence that contains concrete and steel grating debris (Figures 4-31, and 4-32).

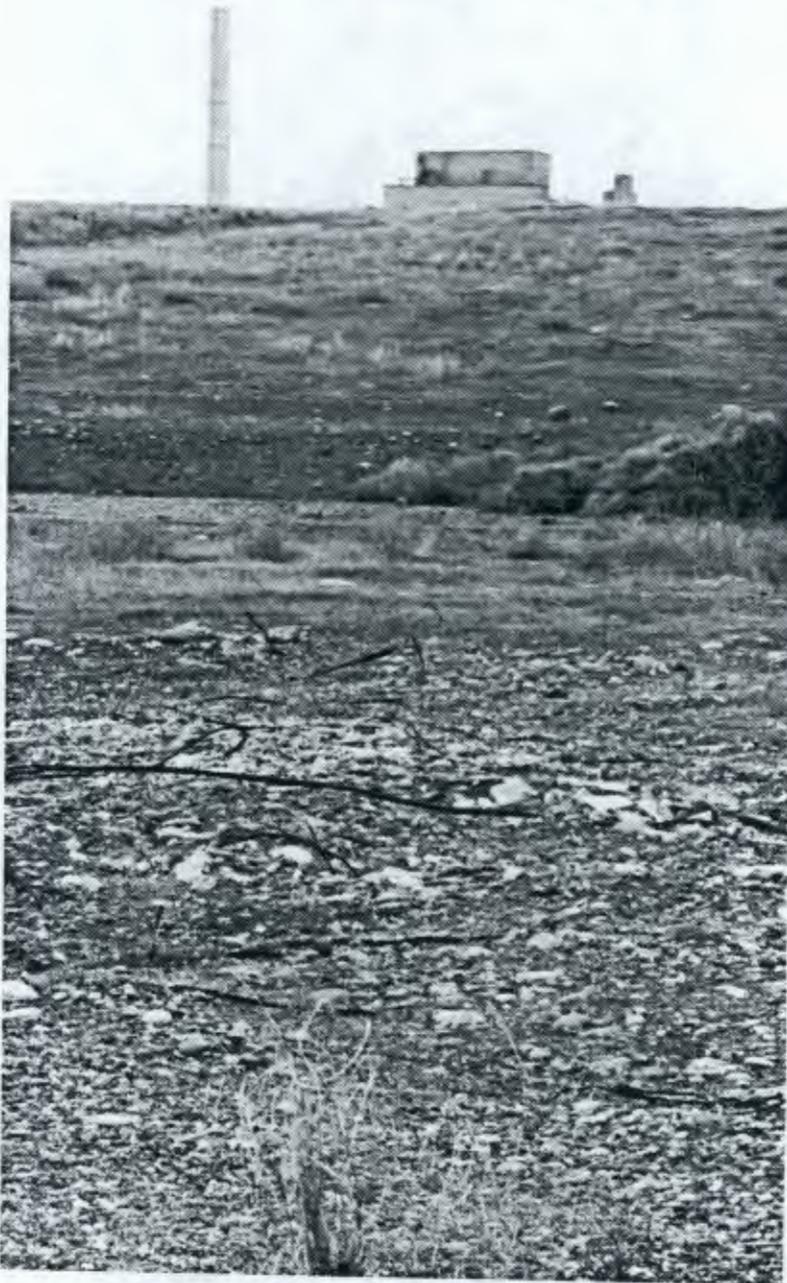
Figure 4-33. 128-D-2, Burn Pit, 1993.

Concrete and metallic debris exposed on the surface just north of the area indicate possible buried solid wastes. The site appears to have been built up with backfill material, although it is difficult to tell where the burn area ends and the burial area begins. The site is currently being used as a disposal area for tumble weeds (Figure 4-33).

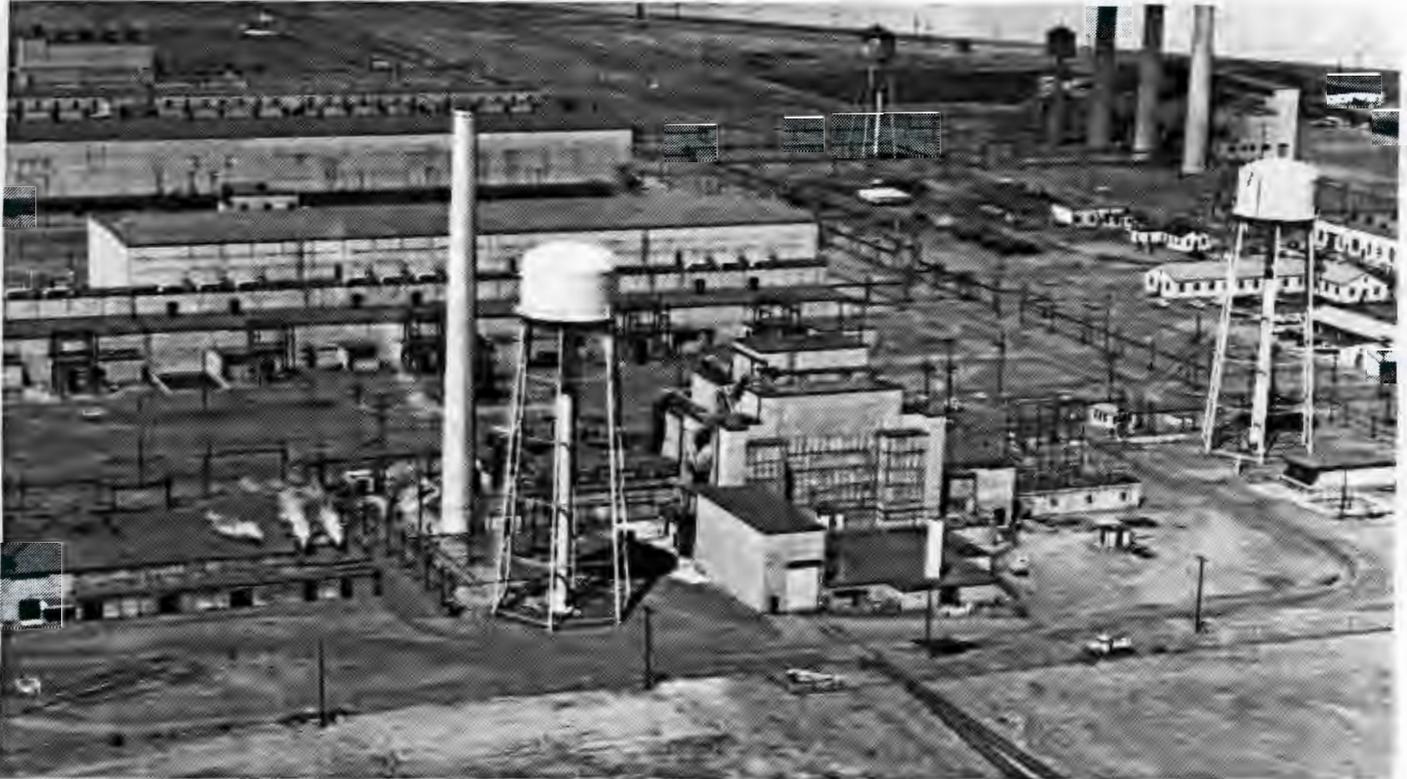
Figure 4-35. Septic Tank Surrounded by White Fence, 1953.

| SEPTIC TANK DESIGNATION | HANFORD LOCATION | COMMENTS |
|---|---|--|
| 1607-D4 | N91850 W52650 | Supported 115-D/DR (Figure 4-35). The septic tank can be seen to the left surrounded by a white wood fence |

At the completion of the "D" and "DR" tie-in of the effluent lines phase of the job in 1950, contaminated soil and pipe were buried at a site just north of the 105-D and east of the 103-D Buildings. The material was covered by at least 2 ft of soil and a removable concrete top. A wooden fence posted with radiation zone signs marked the area (Heid 1956). This site can be clearly seen in Figure 4-35, a photograph taken in June 1953.

There was a small trench located about 100 ft east and about 40 ft north of the south end of the 115-D/DR (132-D-1) Facility which was used for the disposal of contaminated silica gel removed from the 115-D/DR drying towers (Tatum 1967) (Figure 4-35: the area surrounded by the dark wood fence).

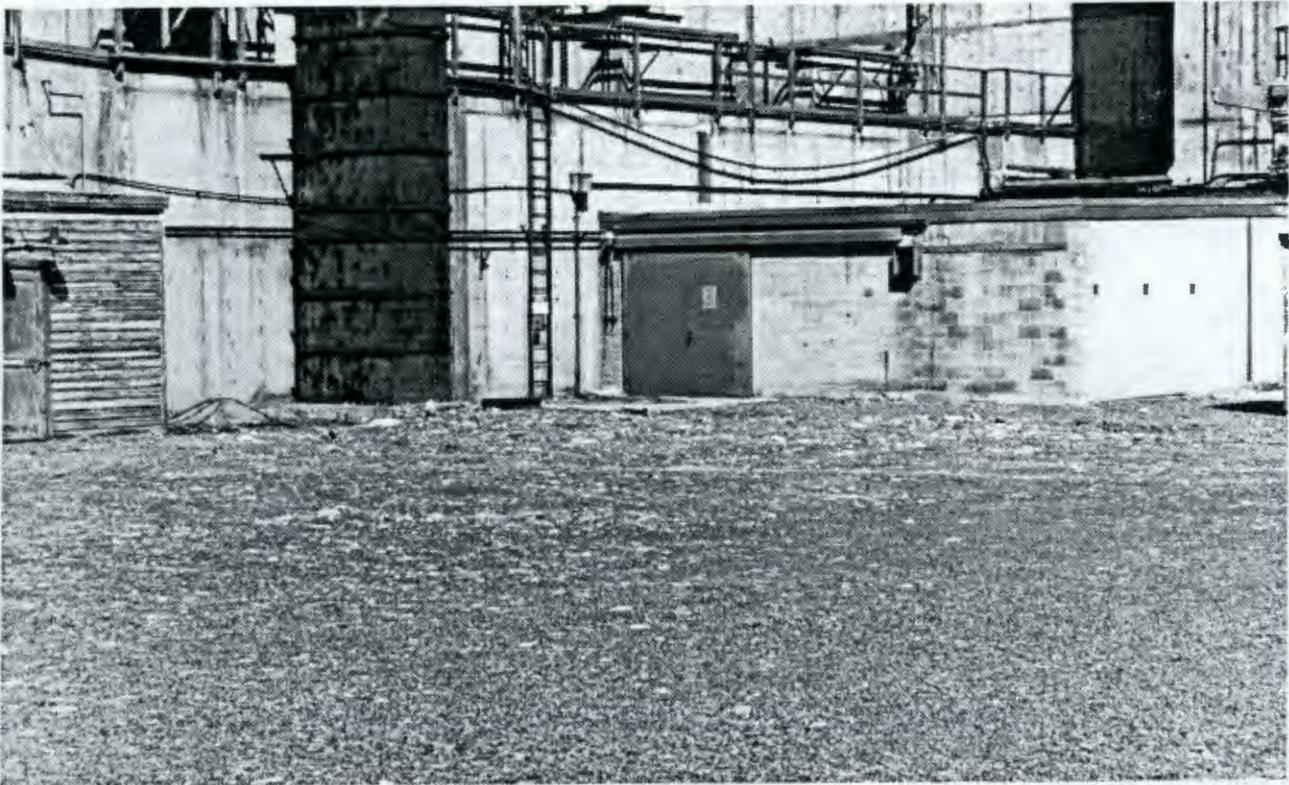
Figure 4-38. 1608-D Facility.

The site appears today as a gravel parking lot (Figure 4-38) and has not been assigned an HRS Migration score.

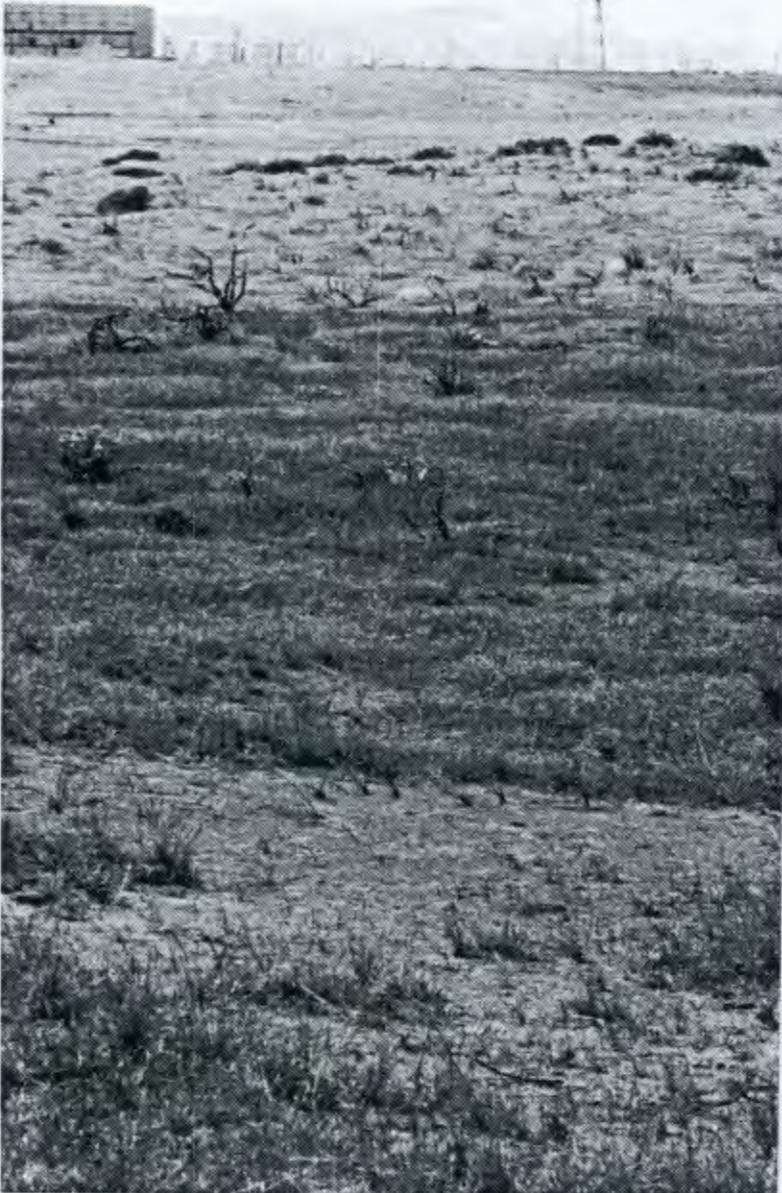
Figure 4-39. 628-3 Suspect Site.

This waste site could not be definitely located during site surveys conducted for this report. The site depicted in Figure 4-39 is the suspected site location. Several small pre-Hanford dump sites were located in the area of this burn pit (Figures 4-39 and 4-40). No asbestos, friable or non-friable, could be found.

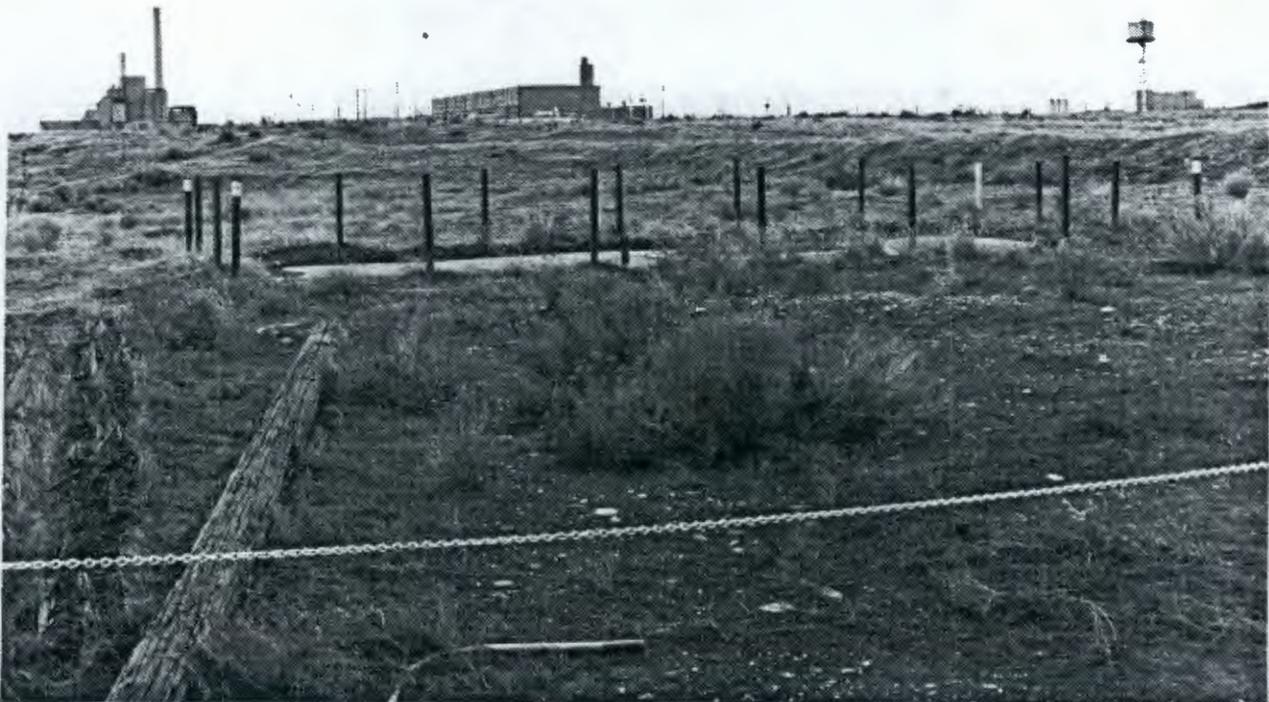
Figure 4-41. 1607-D2, Septic Tank, 1993.

| SEPTIC TANK DESIGNATION | HANFORD LOCATION | COMMENTS |
|---|---|--|
| 1607-D2* | N94300 W52695 | Supported 189-D, 185-D, 182-D, 183-D, 1700-D Administration and Service Buildings and 105-D. There are several clay brick manholes associated with this septic system located throughout the 100-D Reactor facilities area (Figures 4-41 and 4-42) |

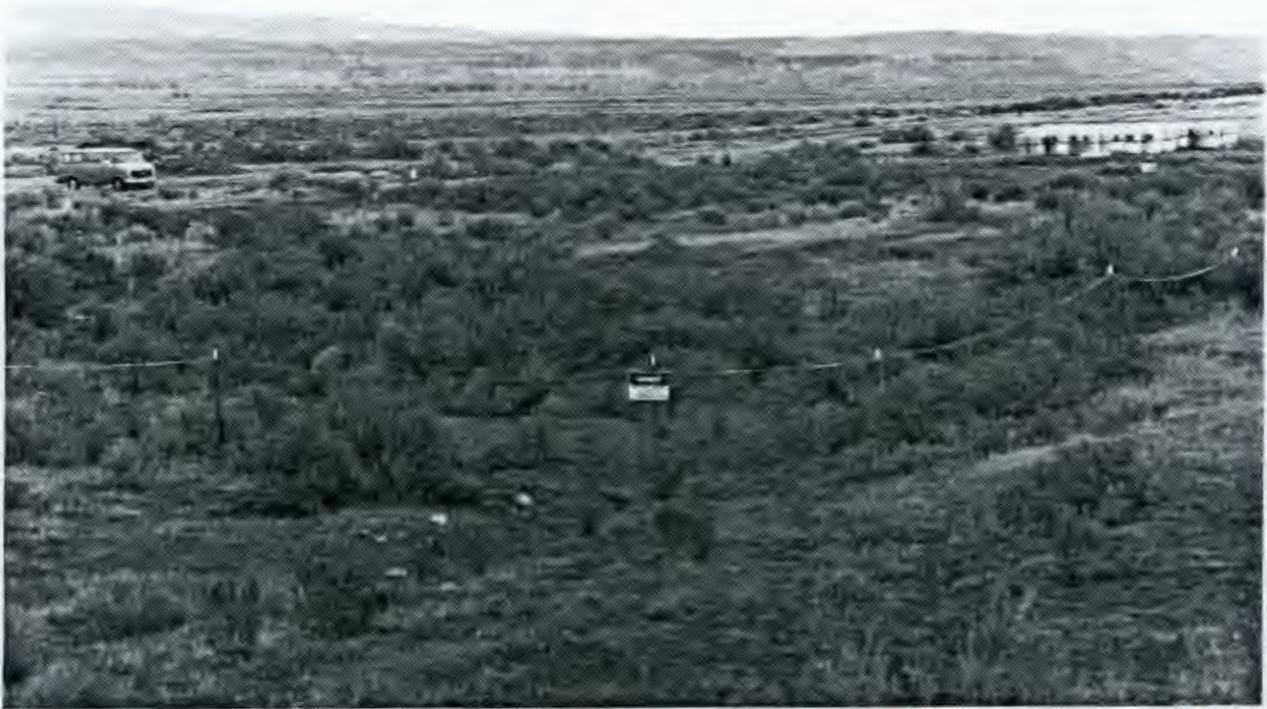
Figure 4-42. 1607-D2 Septic Drain Field, 1993.

* During a field visit on March 7, 1989, a small quantity of flow was observed along the pipeline at the 1607-D2 tank (DOE 1992b). The drain field for this septic system was moved to a large area north of the 107-DR retention basin in 1950. This drain field is north of the perimeter road and between the road and the river bank. It is a large area that is surrounded by a light chain and steel fence post barricade and is posted with "Danger No Unauthorized Personnel Allowed" signs.

Along the north boundary and about 8 ft in from the light chain barricade is a row of vertical 4-in. concrete vent pipes that are about 6 ft apart and extend about 2 ft above grade. Approximately 36 of the pipes are standing and one has been knocked over. They all have loosely-fitting steel caps, and two bear blue labels (in very poor condition) that identify the area as a drain field.

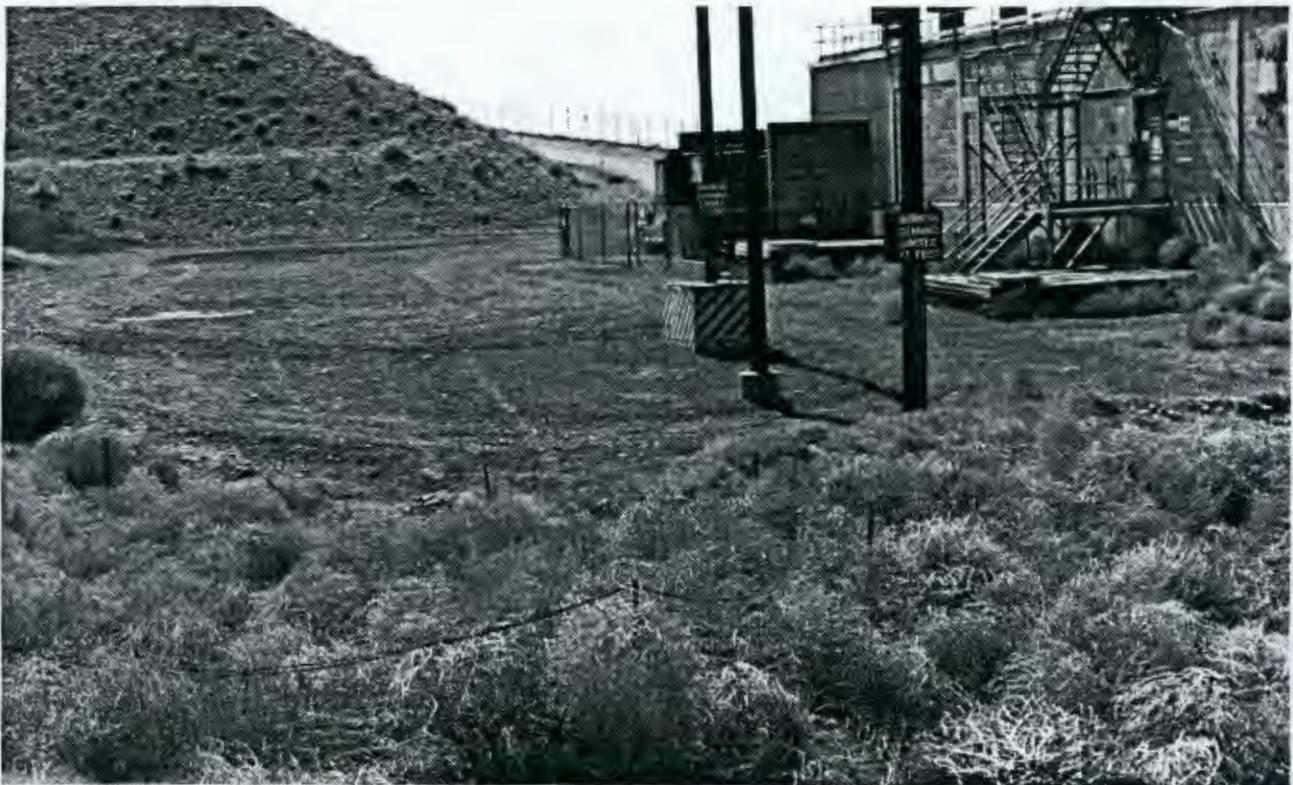
Figure 4-43. Septic System at 181-D.

| SEPTIC TANK DESIGNATION | HANFORD LOCATION | COMMENTS |
|---|---|--|
| 1607-D5 | N92900 W55790 | Supported 181-D (Figure 4-43) |

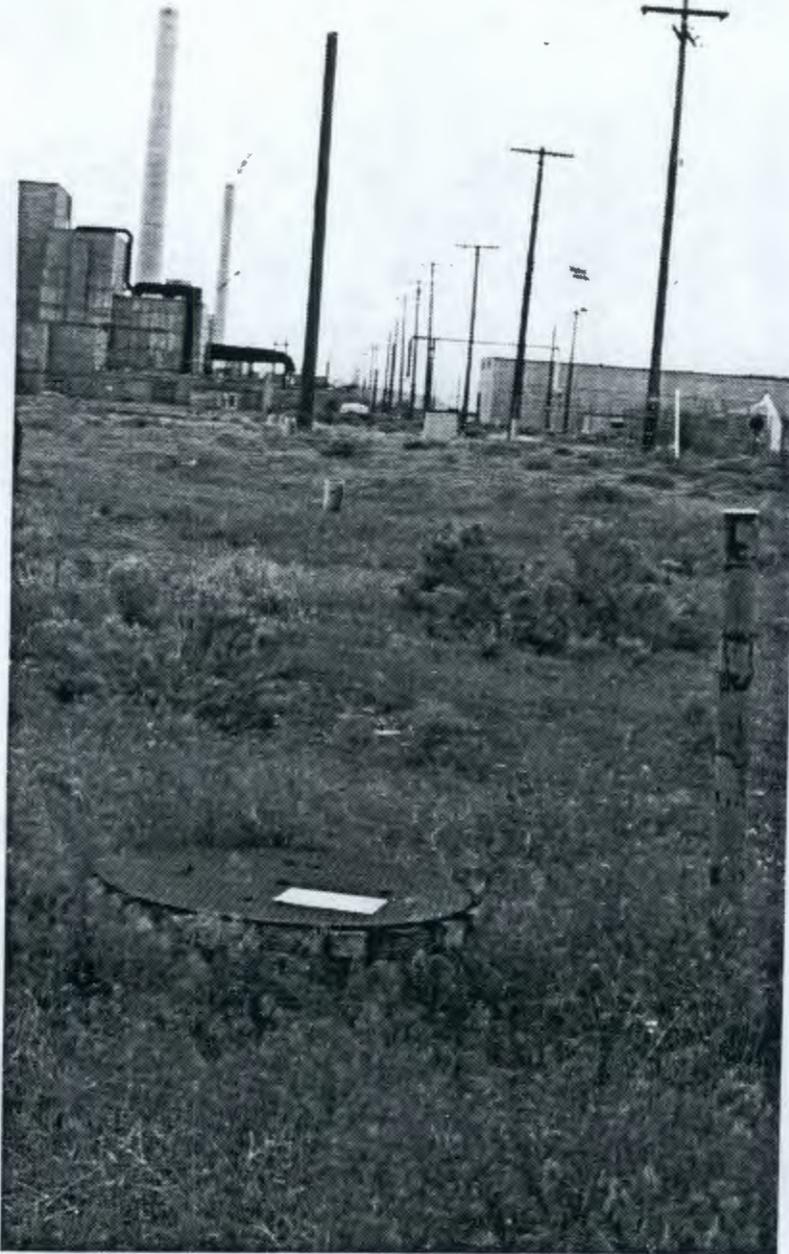
Figure 4-44. Suspect Septic System Manhole.

| SEPTIC TANK DESIGNATION | HANFORD LOCATION | COMMENTS |
|---|---|--|
| SUSPECT | N93050 W52850 | Existence is questionable; according to drawings it is a drop manhole structure to the 1607-D2 system. No other information is available (Figure 4-44) |

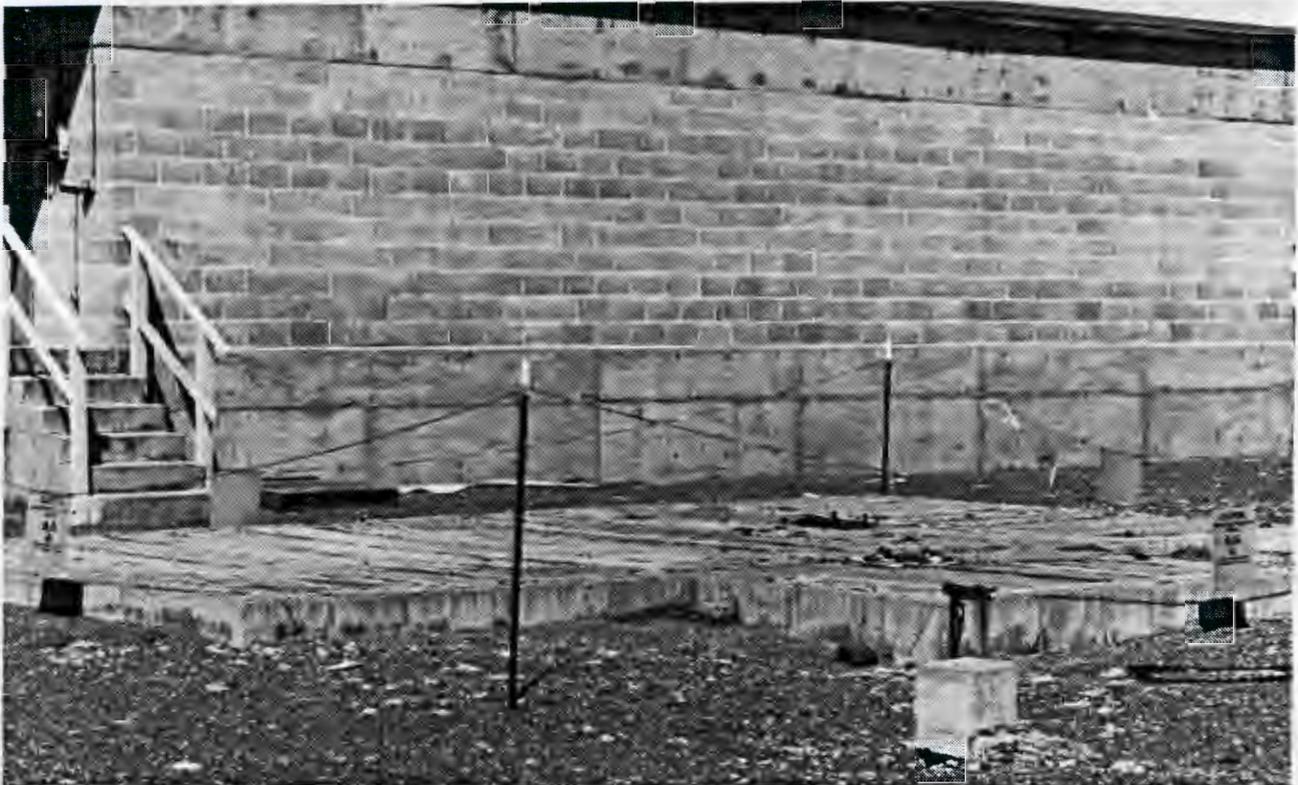
Figure 4-45. Suspect Solid Waste Burial Site, 1993.

The wooden fence no longer exists. Today the site is surrounded by a steel post and light-duty chain fence and is posted with Underground Radioactive Material warning signs (Figure 4-45).

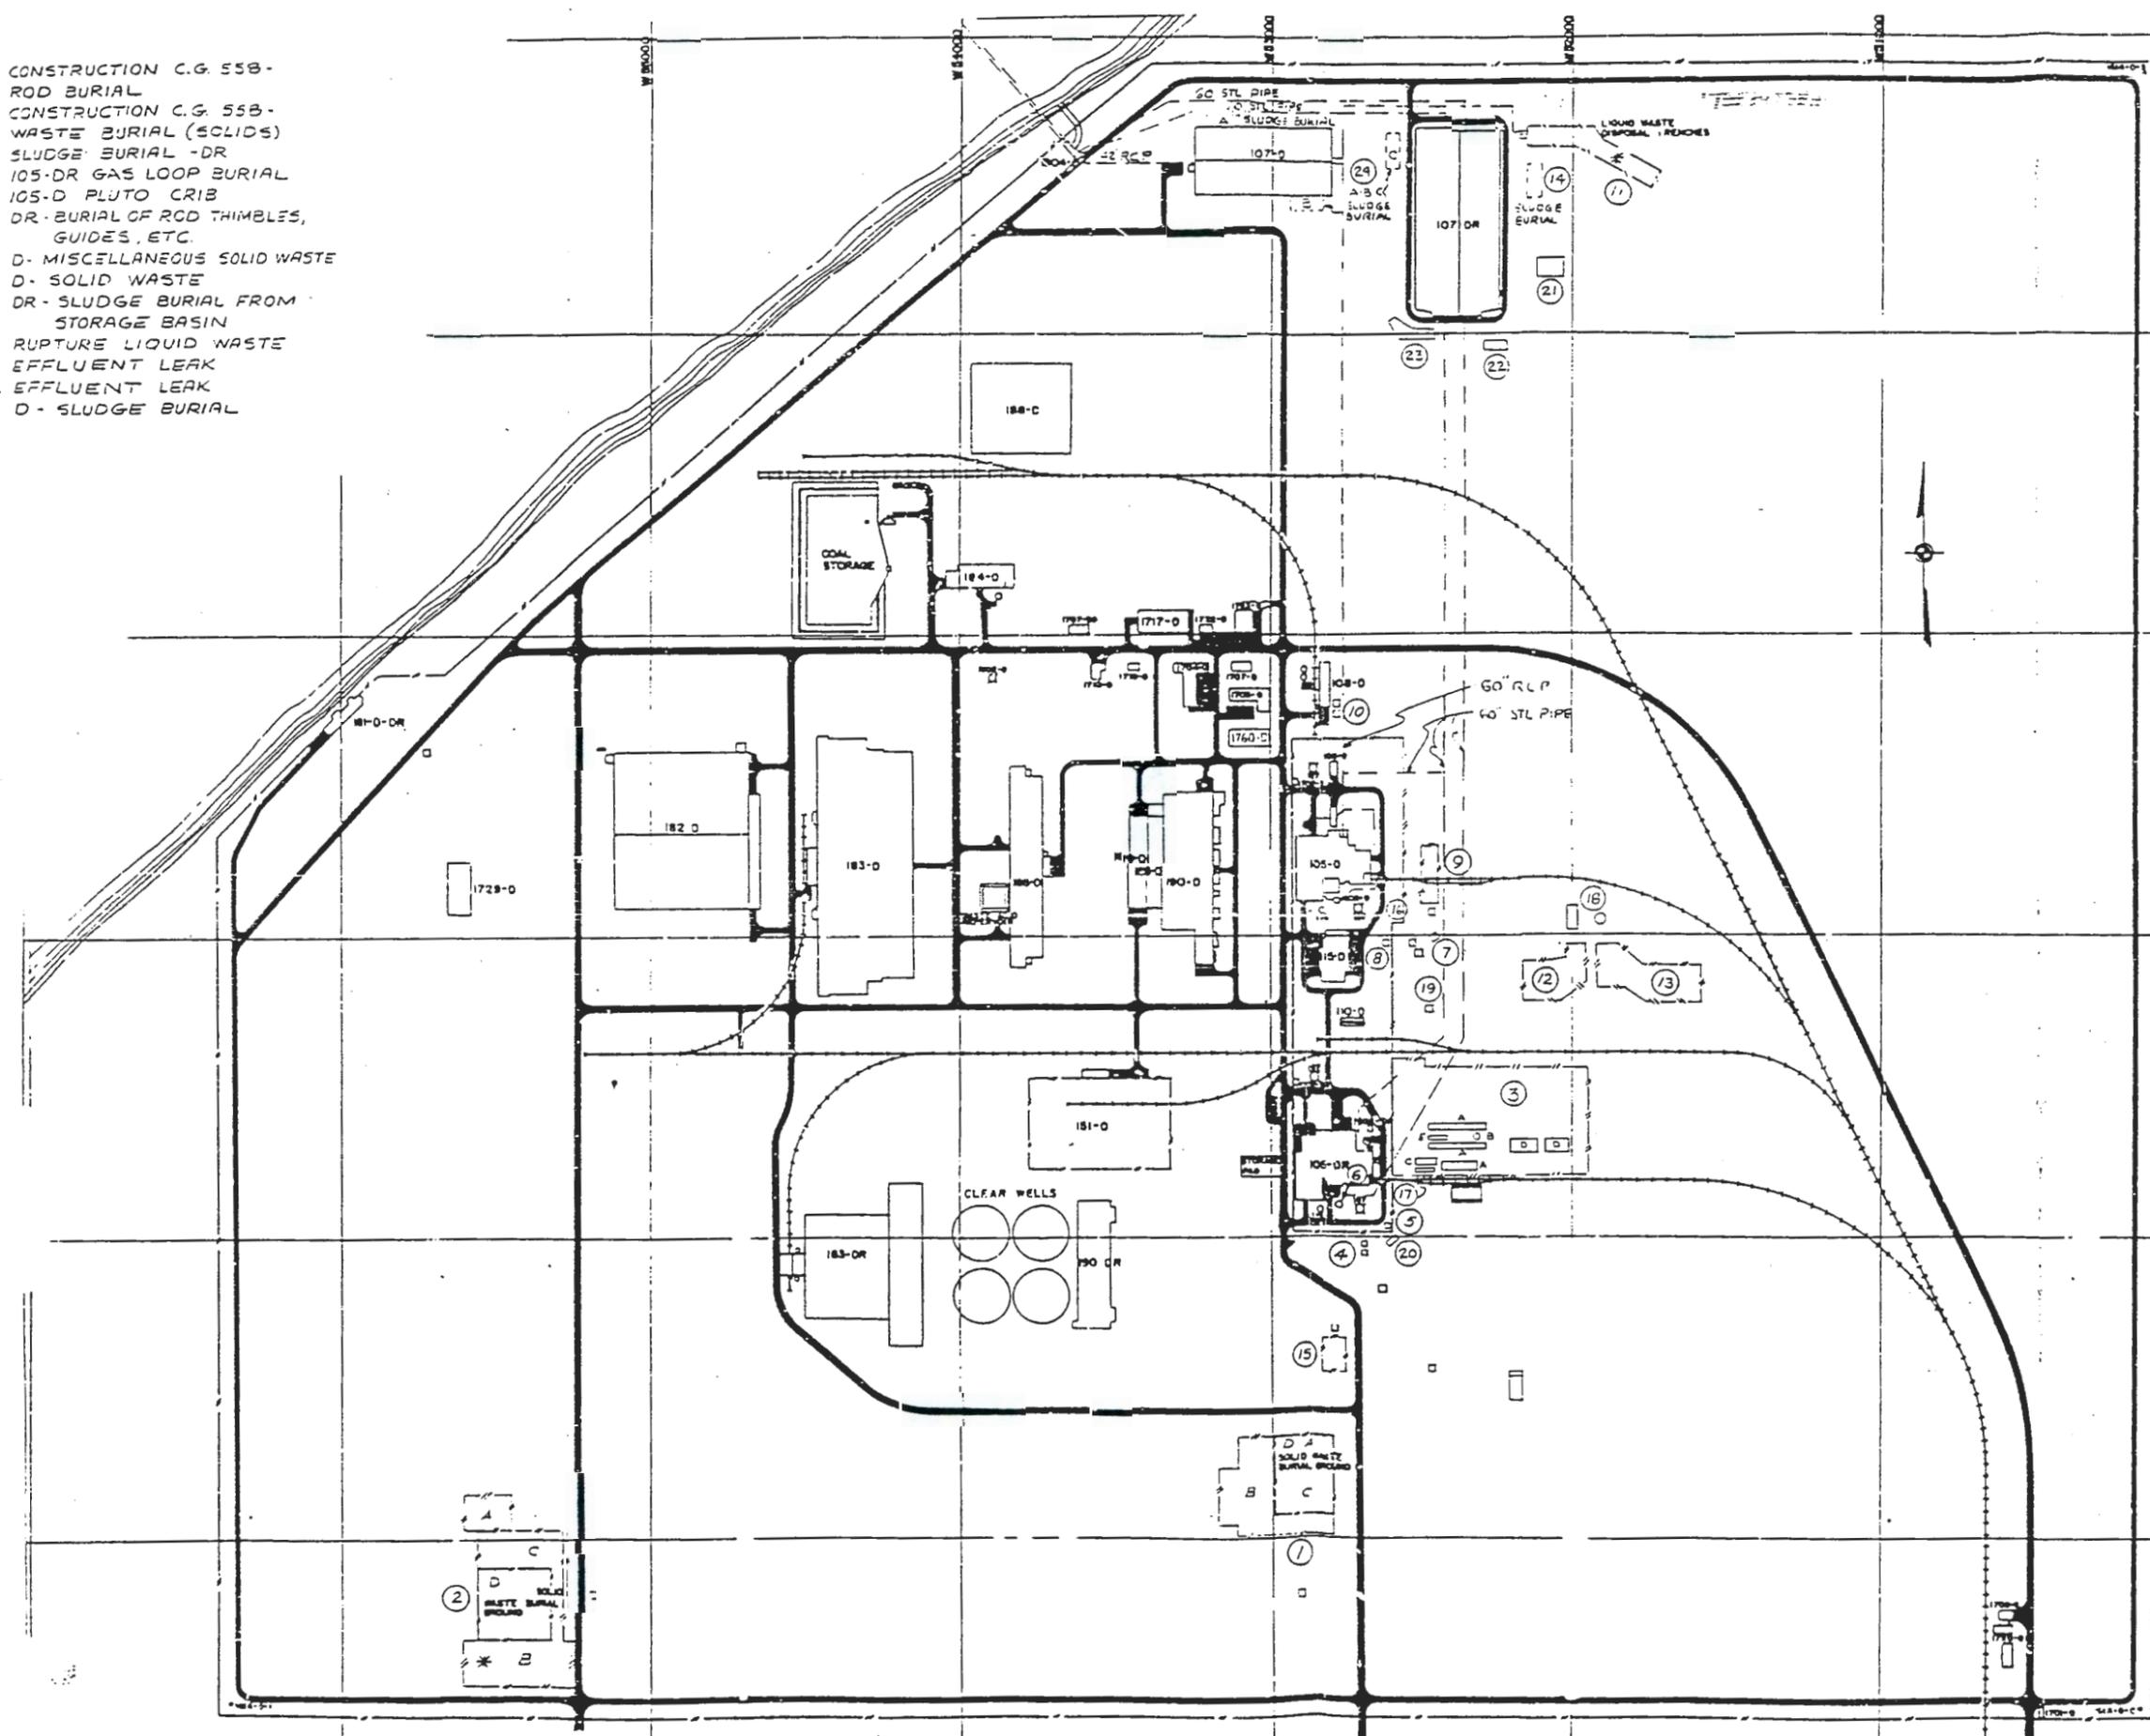
Figure 4-47. Hanford Drawing H-1-4046.

- * DENOTES OPEN PITS
- 1. SOLID WASTE BURIAL GROUND
 - A POISON STORAGE
 - B V.S.R. THIMBLE PIT
 - C GENERAL BURIAL
 - D ROD BURIAL
- 2. SOLID WASTE BURIAL GROUND
 - A DUMMY (SILO) BURIAL
 - B YOKES & BUCKETS
 - C GENERAL BURIAL
 - D 2 ROD TIP & THIMBLE
- 3. SOLID WASTE BURIAL GROUND
 - A DUMMY (SILO) BURIAL
 - B BURNING PIT
 - C WASH PAD LIQUID WASTE
 - D GENERAL WASTE
 - E ROD BURIAL
- 4. DR - V.S.R. THIMBLES
- 5. DR - PLUTO CRIB
- 6. DR - INK FACILITY TANK
- 7. D - V.S.R. THIMBLES
- 8. D - PLUTO CRIB
- 9. D - STORAGE BASIN CRIB (WASH PAD LIQUID WASTE)
- 10. 108 CRIB
- 11. 107 LIQUID WASTE DISPOSAL TRENCH

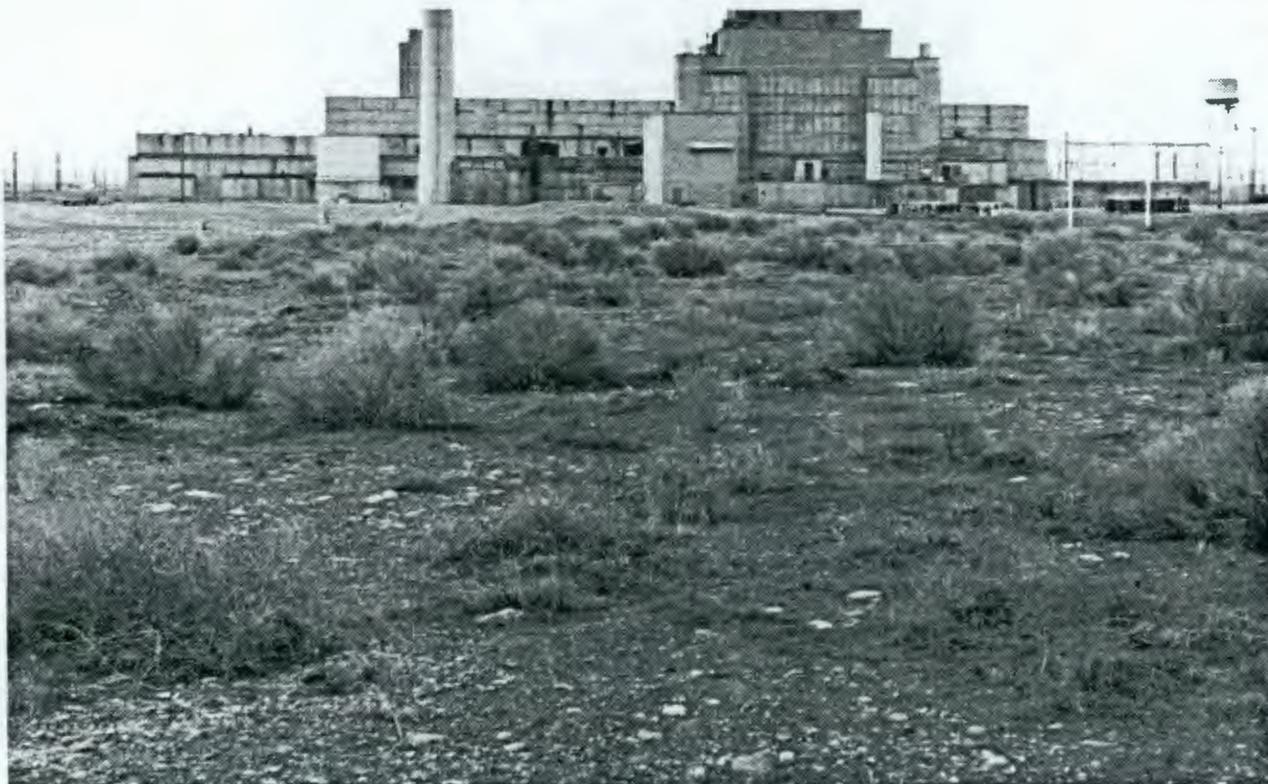
Figure 4-49. Undocumented Solid Waste Site Outside Burial Ground Markers.

These burial grounds appear today as vegetation-free, cobble-covered fields, with the exception of Minor Construction burial ground number 5. This site lies partially outside the area currently bounded by permanent concrete markers and has natural vegetation growing on the surface (Figure 4-49). There are also concrete slabs located within this area that were reportedly foundations for temporary construction buildings during construction of D-Reactor facilities.

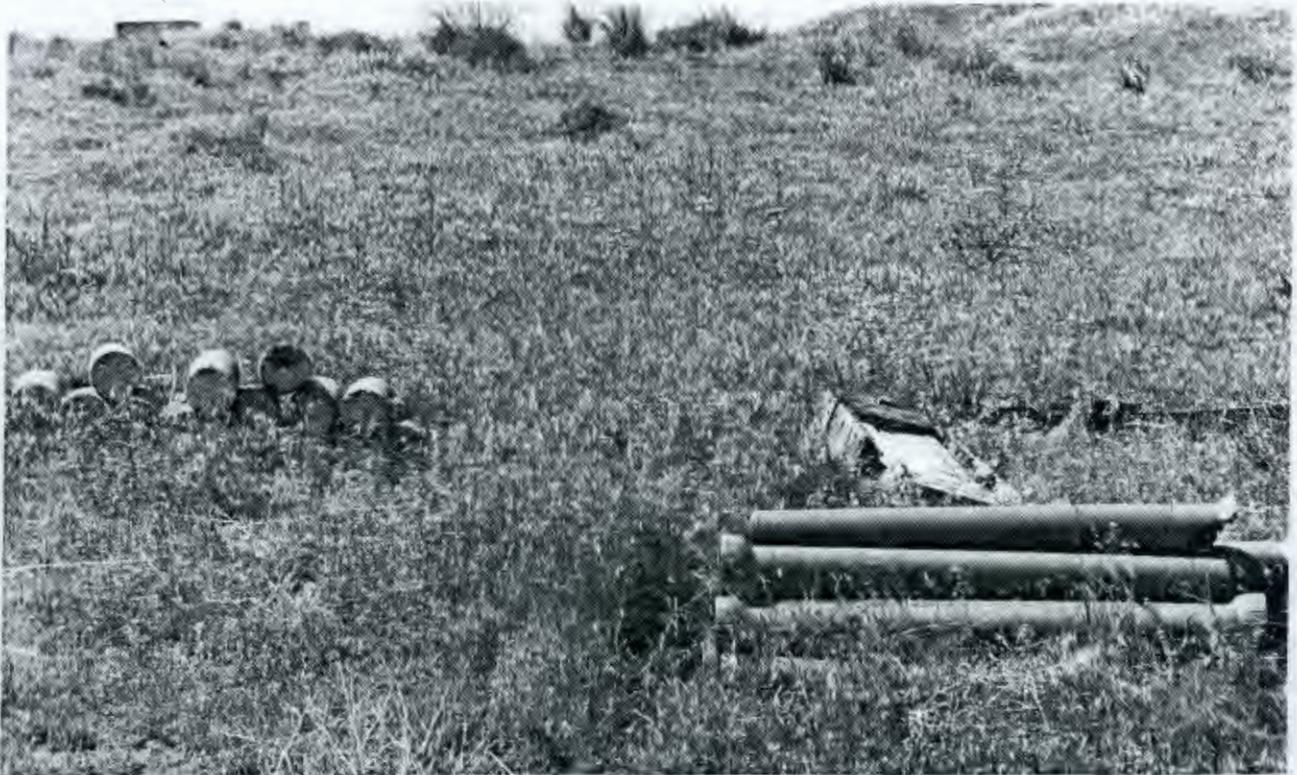
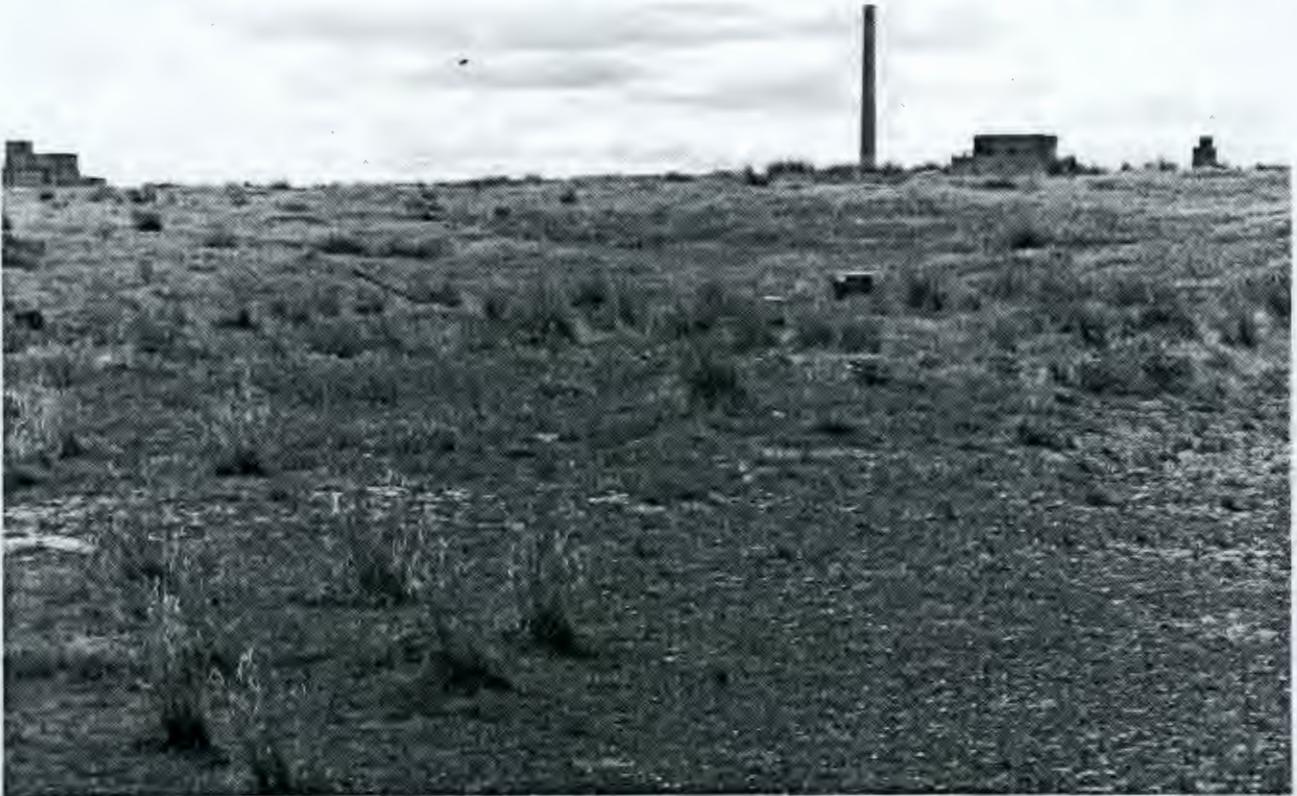
About 100 yds east of the 128-D-2 burn pit is a solid waste dump site that contains bundled 4-in. vitreous clay pipe, concrete cores, metal paint cans, and wood debris (Figures 4-50 and 4-51).
