WHC-SD-EN-TI-181
Revision 0

100-D Area Technical Baseline Report

Prepared for the U.S. Department of Energy
Office of Environmental Restoration and
Waste Management

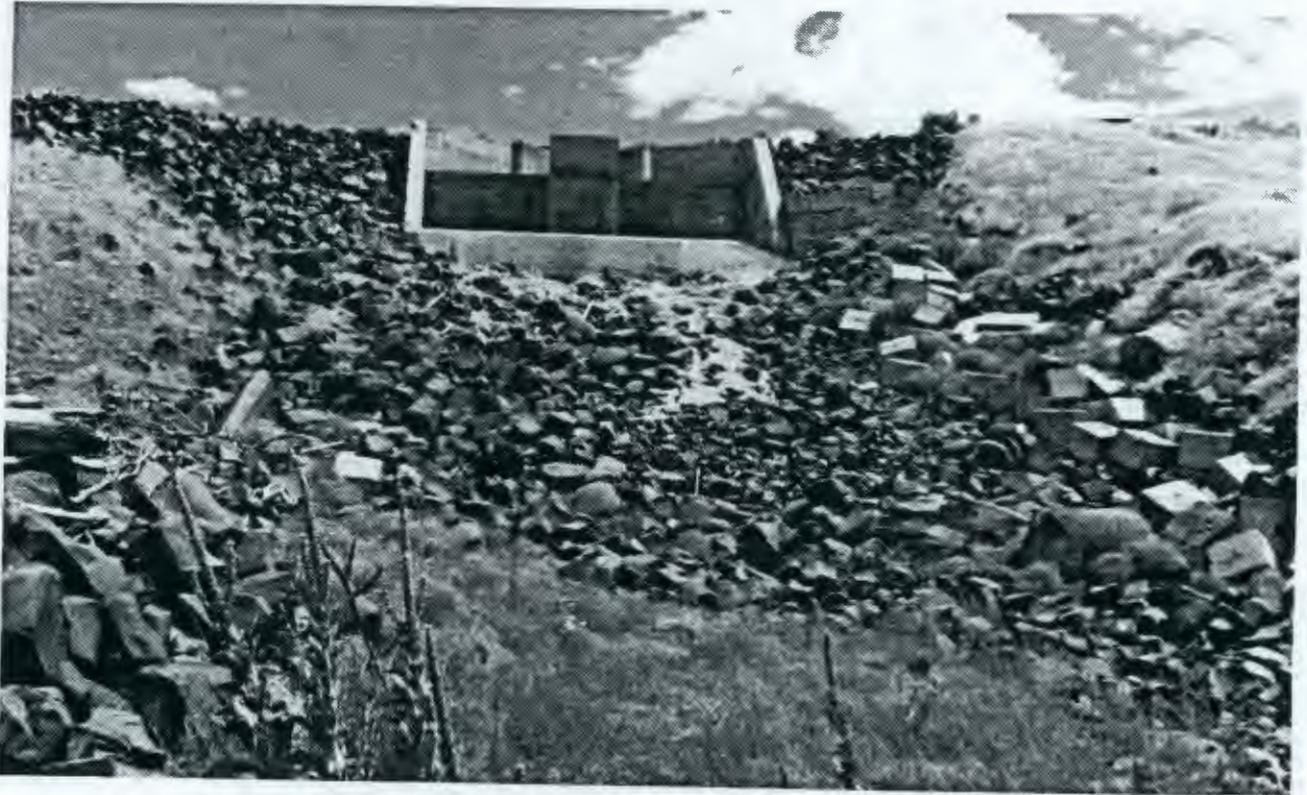
Figure 4-52. 1907-DR Outfall Before Demolition.

The 100-DR process sewer outfall (1907-DR outfall) was located at Hanford coordinates N92217.36 W56522.40, which is south of the 181-D Building on the river bank. This outfall was used to discharge waste water from the 183-DR and 190-DR water treatment facilities and from rain runoff drains including the 100-D Area cask pad and 100-DR facilities. There is slight potential for contamination due to the drain located on the 100-D Area cask pad, which was known to be contaminated on the surface. In 1987, this outfall was demolished (using a demolition ball), backfilled, and blended to match the surrounding river bank (Wahlen 1991) (Figures 4-52 and 4-53).

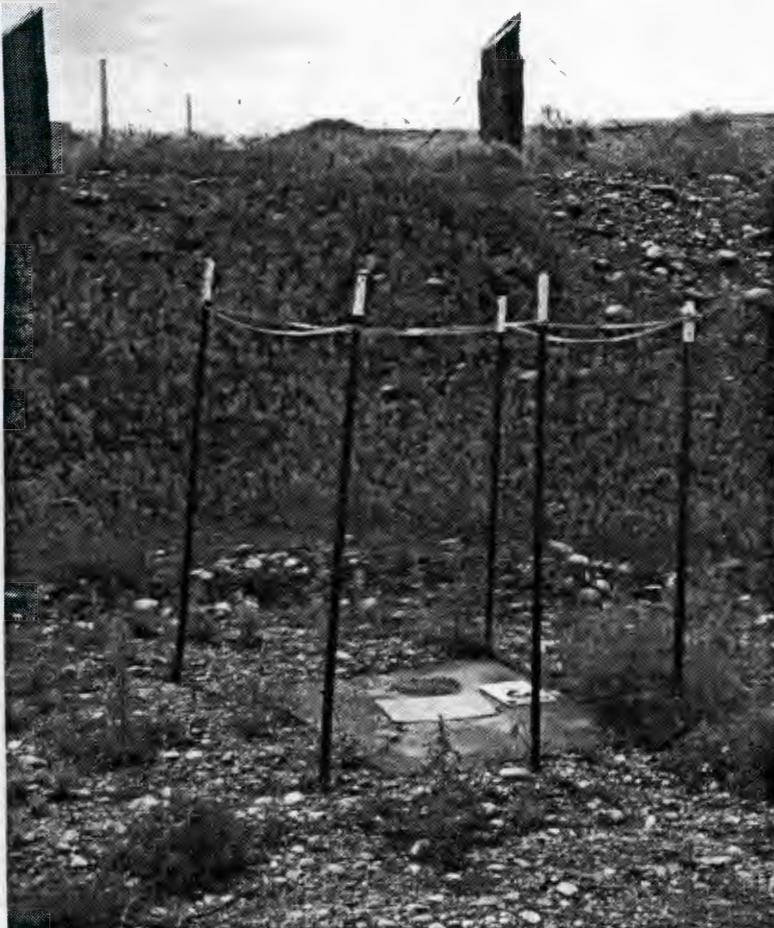
Figure 4-54. Suspect Liquid Waste Site,
Storm Drain Near 1904 Outfalls.

Located just north of the patrol road between the 1904-D and 1904-DR outfall structures is a small concrete storm drain box that is covered with a steel plate. It is posted with a Surface Contamination radiological warning sign. The site is surrounded by steel post and light-duty chain barrier. Drawings indicate that this storm drain was installed to provide drainage from the south side of the patrol road. It probably became contaminated by effluent water leakage from the nearby retention basins. It is unknown if the drain pipe from this box to the river remains in place. Reportedly, it has been removed (Figure 4-54).

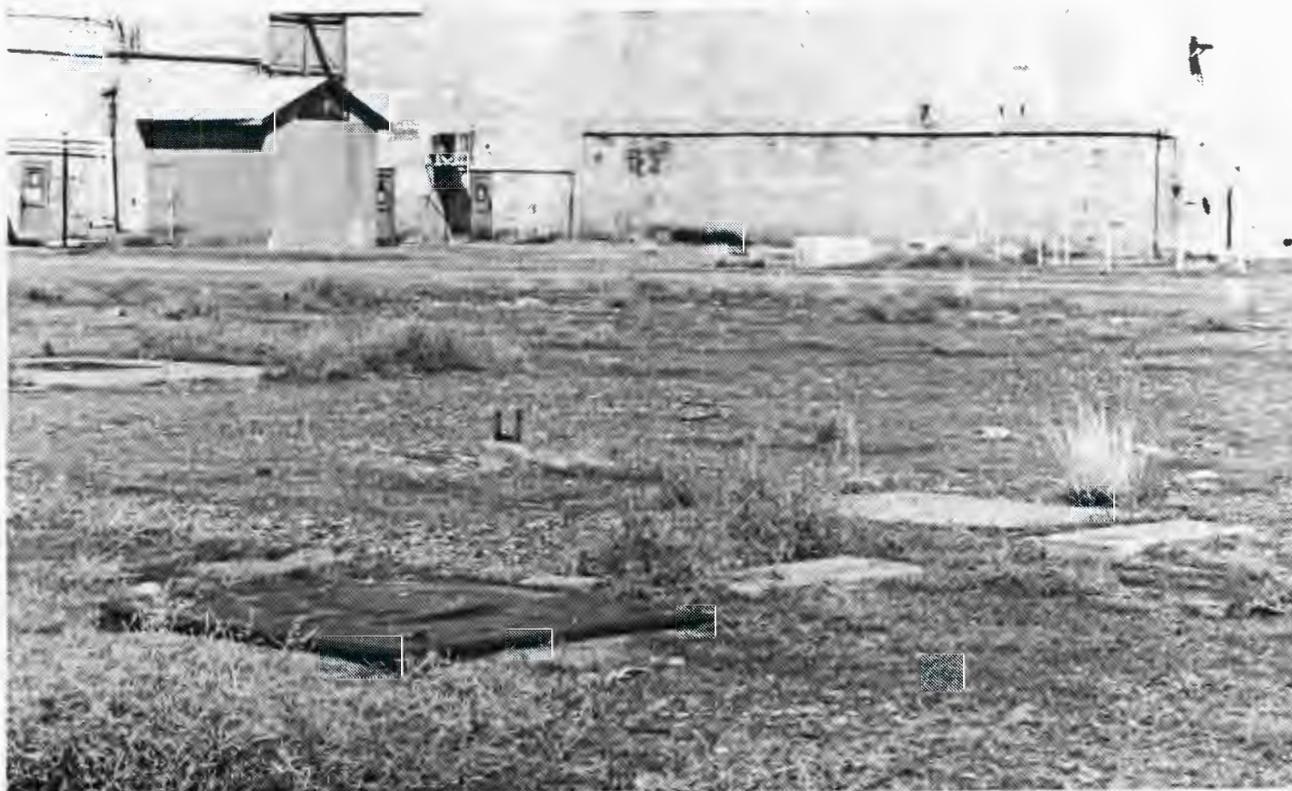
Figure 4-55. Lead Sheet Cover on Concrete Pad South of the 186-D Building Site.

Located 25 ft south and 245 ft west of the 100-DR annex of the 190-D Building is a small concrete pad that is covered by lead sheeting. The purpose of this structure could not be determined by documentation (Figure 4-55).

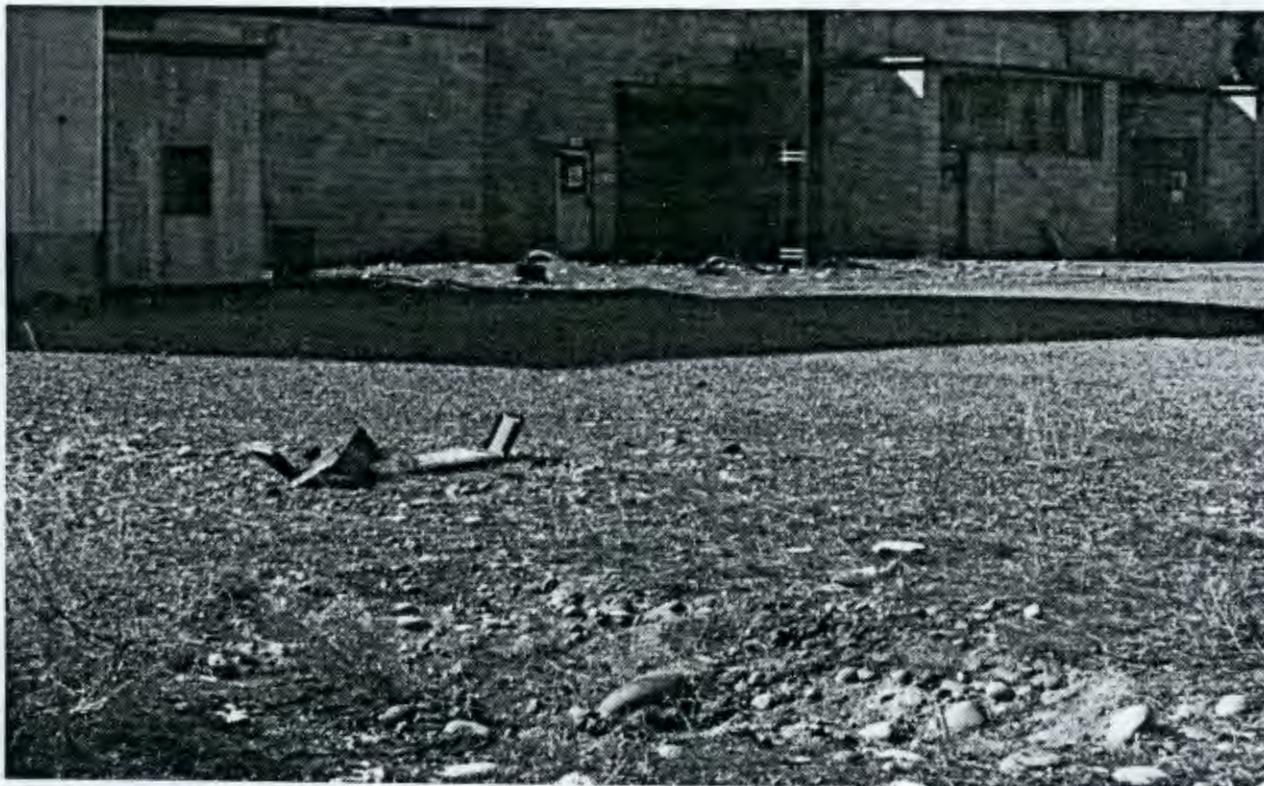
Figure 4-56. Oil-contaminated Soil East of 190-D.

Located 60 ft east of the 190-D Building Trampoline Test Facility and about 15 ft south of the paved road leading to the test facility is a soil depression that is surrounded by oil-contaminated soil. The origin of the oil could not be determined and the total volume appeared to be small (Figure 4-56).

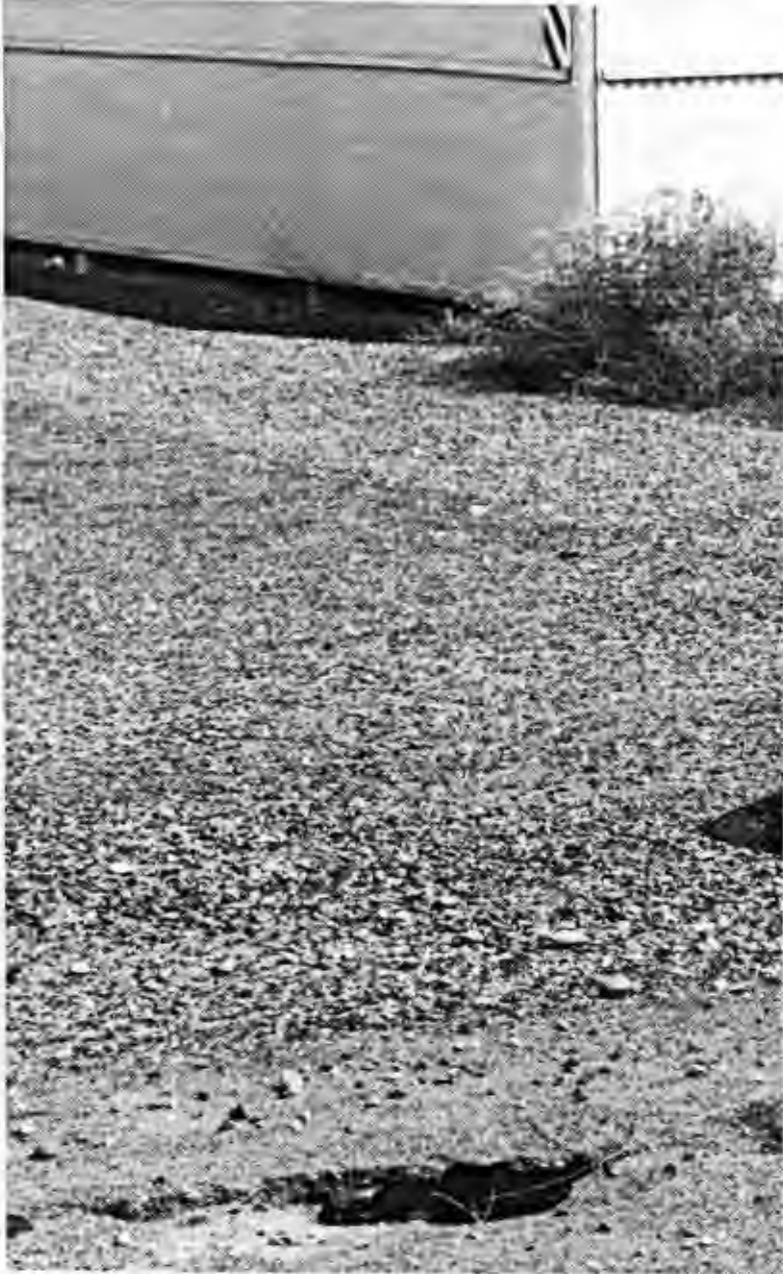
Figure 4-57. Subsidence Near the 189-D Storage Pad.

| FACILITY | HANFORD LOCATION | COMMENTS |
|---|---|--|
| 189-D | N92230 W53380 | Was attached to and considered a part of 185/189-D. A storage pad west of the facility is considered a part of the facility. The storage pad is surrounded by a 6-ft metal fence and includes a gas cylinder storage dock. This area is currently being used to store Environmental Restoration Program Investigation Derived Wastes. Nearby to the northeast is a subsidence area that can be seen in Figures 4-57 and 4-58 |

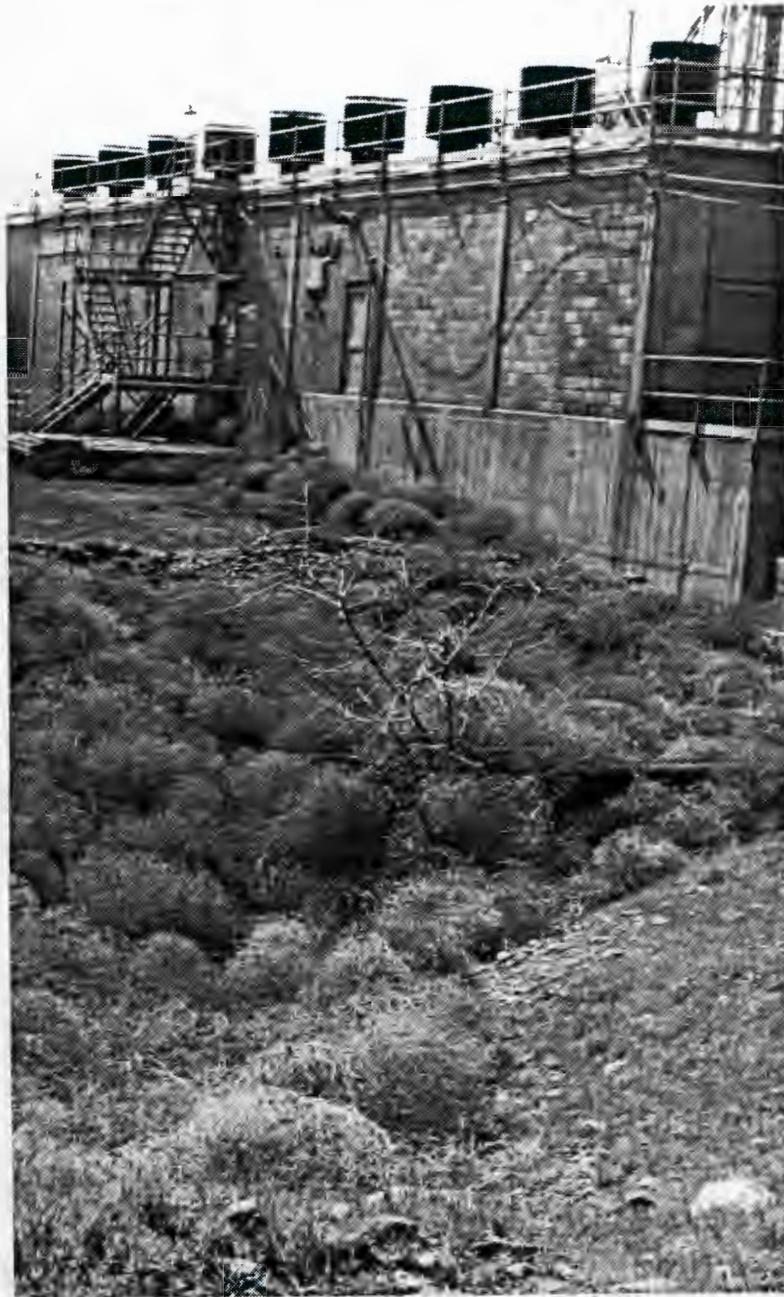
Figure 4-59. Filter Backwash Trench.

Contamination could potentially exist in the pit used to back flush the filter screens. This is unlikely, however, because the contaminants found earlier were a result of effluents discharged from reactors located upstream of this facility. The discharge pit was not in place prior to 1975, nearly ten years after all but N-Reactor had been shut down (Figure 4-59).

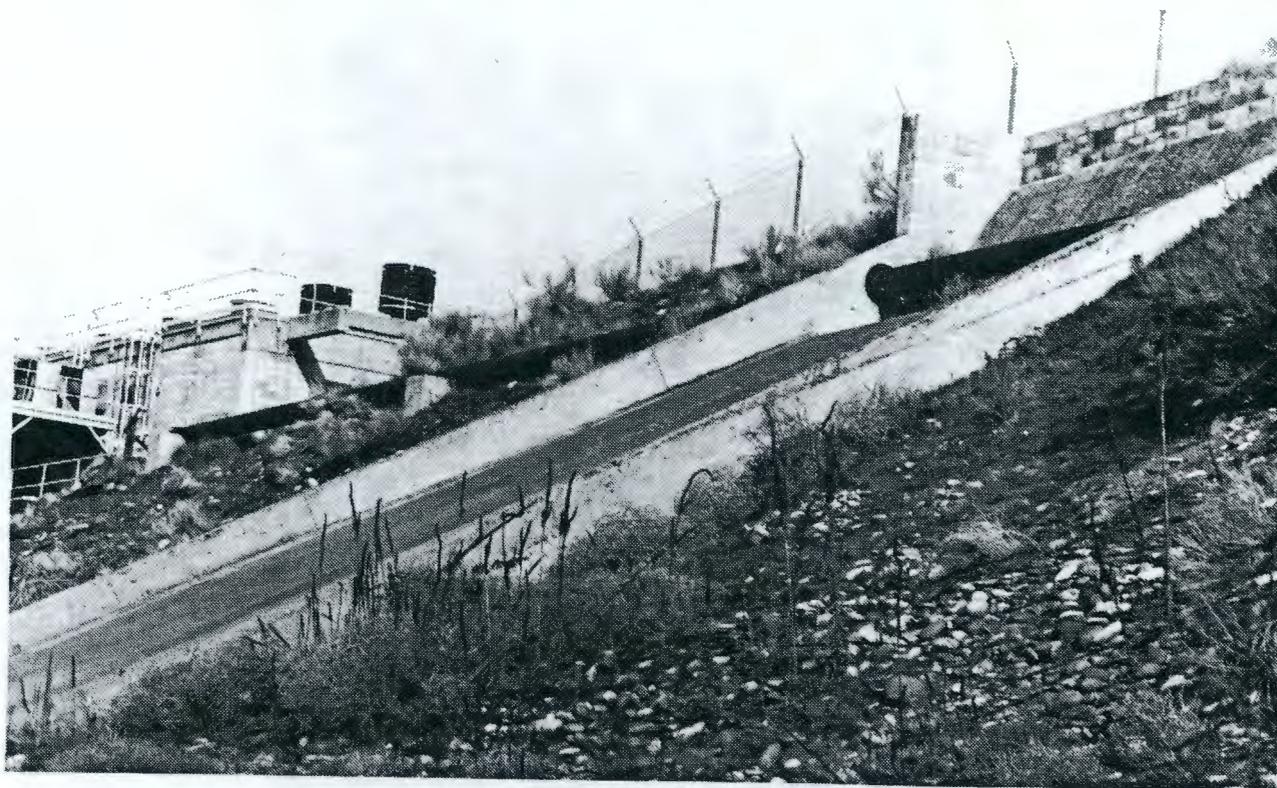
Figure 4-60. Flume Upstream of the 181-D Pumphouse.

A second 14-in. discharge pipe terminates about 200 ft upstream of the facility at a concrete flume that is about 20 ft wide and extends to the river bank. The discharge pipe's end is capped and the pipe wall has had small holes drilled over the top surface along the entire length of the flume. It appears that it is connected to the barometric condensers. According to site personnel, it is a condenser discharge pipe (Hanford Drawing W-73564) (Figures 4-60 and 4-61).

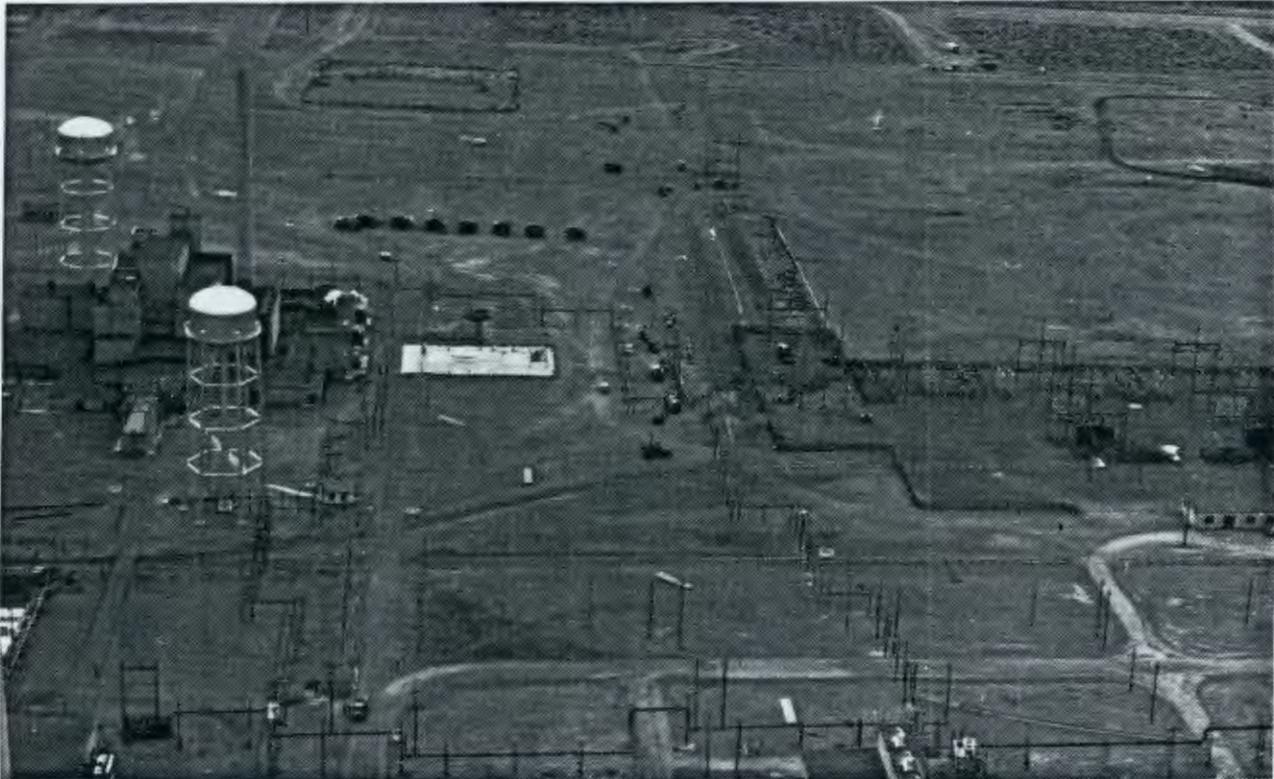
Figure 5-1. Cask Pad, Suspect French Drain Addition, 1949.

The 116-D-8, located at Hanford coordinates N91200 W53000 (WHC 1991), is an inactive solid waste site that operated from 1946 to 1975. It is a concrete pad with two drains that was used to store shipping and handling casks when they were not in use. One of the drains facilitated rain runoff and the disposal of minor decontamination solutions and drained into the 105-DR process sewer (WHC 1991). The second drain was for decontamination use and discharged to a french drain. The location of the french drain is currently unknown, although a photograph taken in December 1949 shows the construction of a trench and pit that could be the drain (Figure 5-1). It was also thought that the french drain was located beneath the loading dock floor on the west side of the pad.

All casks were removed, and the surface contamination, consisting of trace amounts of radionuclides and decontamination chemicals, was fixed to the concrete with an asphalt emulsion coating. Four depressions on the pad have been filled with gravel. Two of these depressions, located at the approximate center of the pad, are small rectangular pits lying parallel to each other, about 2 ft wide and 6 to 8 ft long. These two pits have been described as decontamination basins. It is believed that these two pits drained to the previously mentioned french drain.

A larger pit on the west side of the cask pad was a loading dock that also drained to the french drain. The final gravel-filled location has an irregular shape and is located just south of the two small decontamination pits. Site employees report that the concrete in this area was removed due to excessive contamination, and gravel was added to bring the resulting hole up to grade.

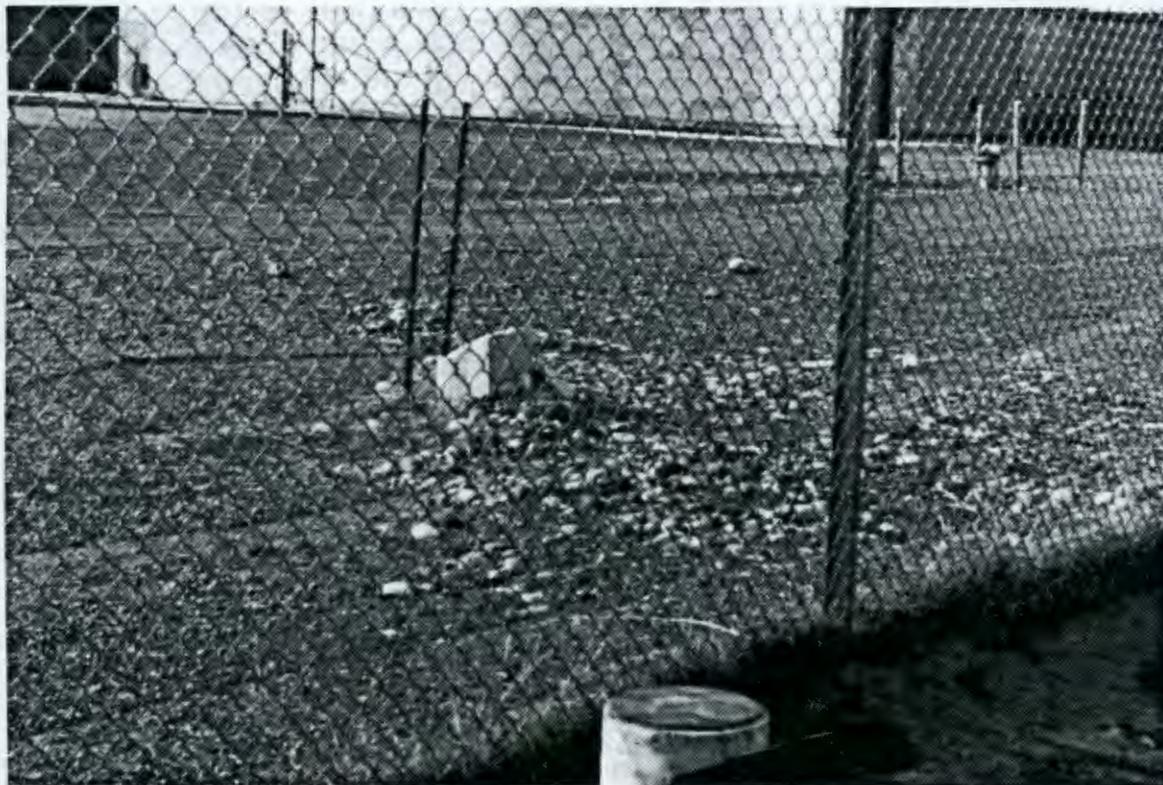
Figure 5-4. 105-DR Pluto Crib.

The appearance today is that of a vegetation-free, cobble-covered field. There is a square concrete marker identifying the pluto crib site. It is physically located just inside the exclusion area fence in the southeast corner near the 100-DR Reactor (Figure 5-4).

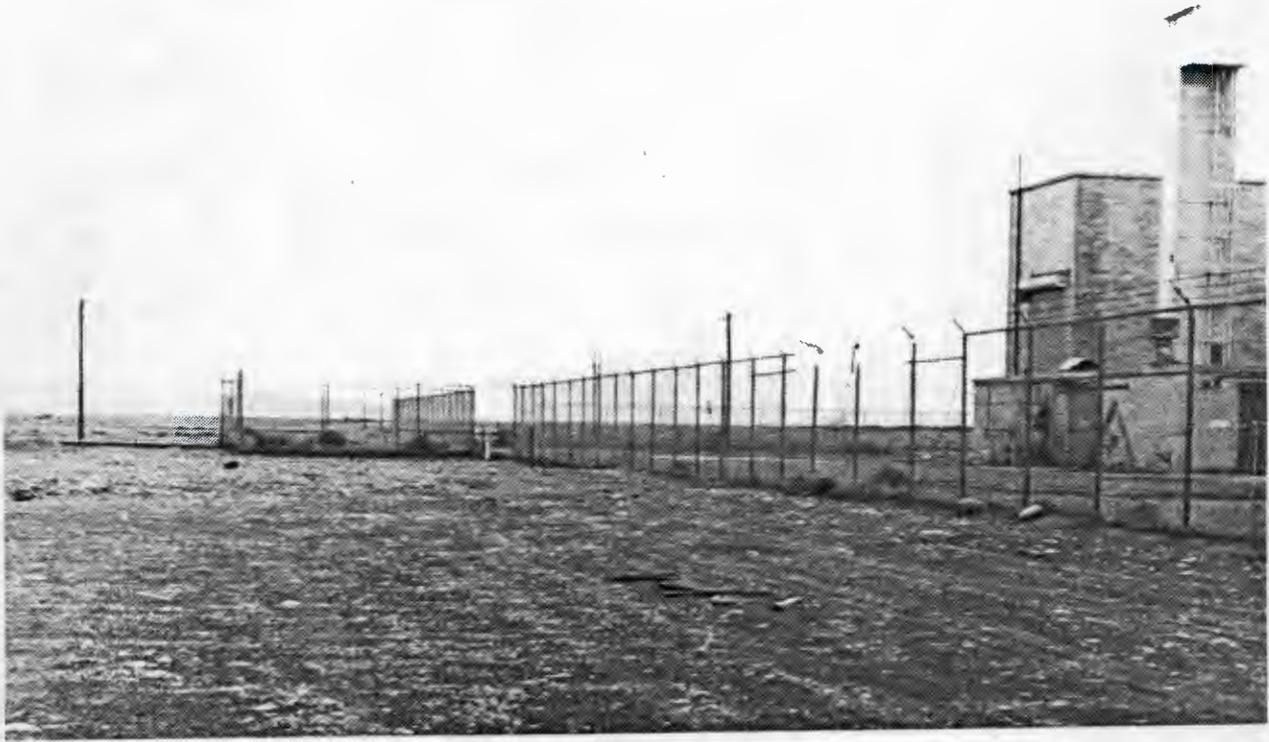
Figure 5-5. 1608-DR Effluent Trench.

The site appears today as a vegetation-free, cobble-covered field. There are no other markings or identifying features. It is included in a much larger area that is surrounded by permanent concrete markers and posted with Underground Radioactive Material warning signs. Just to the north of the trench location, the exclusion area fence has been modified (Figure 5-5).

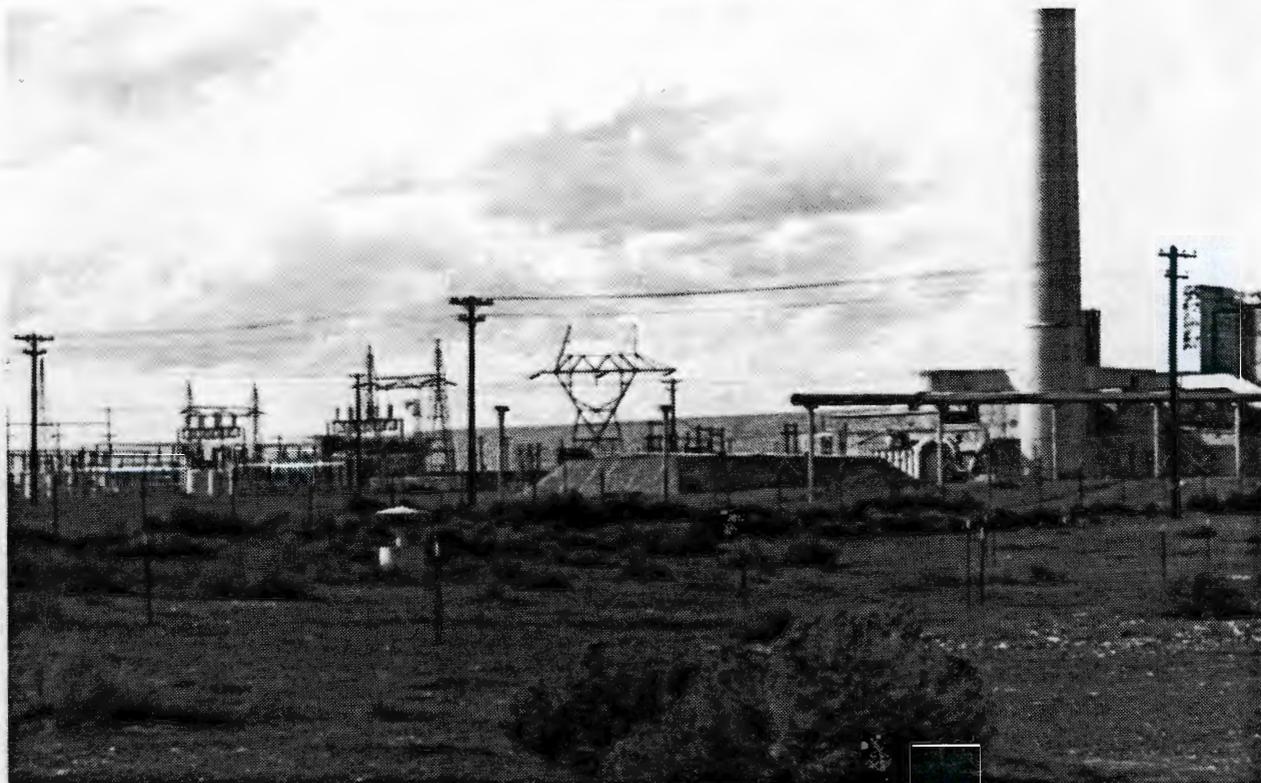
Figure 5-7. 117-DR Crib (116-DR-8).

The site appears today as an open field, covered with grasses and other natural vegetation, surrounded by red steel posts. There are no other postings at the site (Figure 5-7).

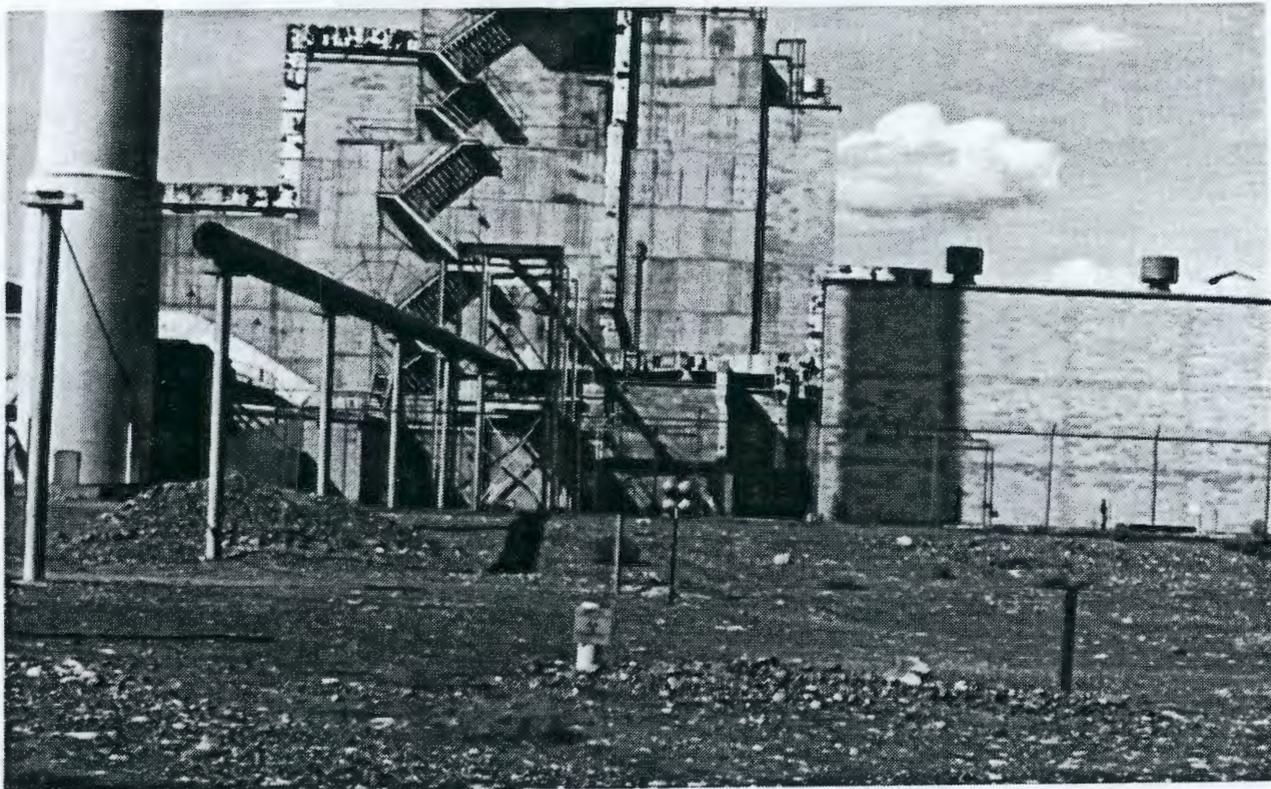
Figure 5-8. VSR Thimble Burial Ground South of 105-DR.

The site appears today as a vegetation-free, cobble-covered area with uneven terrain. A concrete box with a steel lid, part of the septic drain system for the 105-DR facilities, is located within the area. Support structures for the level one experimental discharge pipe also remain in place at each end of the site. The level one experimental discharge pipe, north of the access road near the site, remains intact to the 105-DR Reactor Building (Figure 5-8).

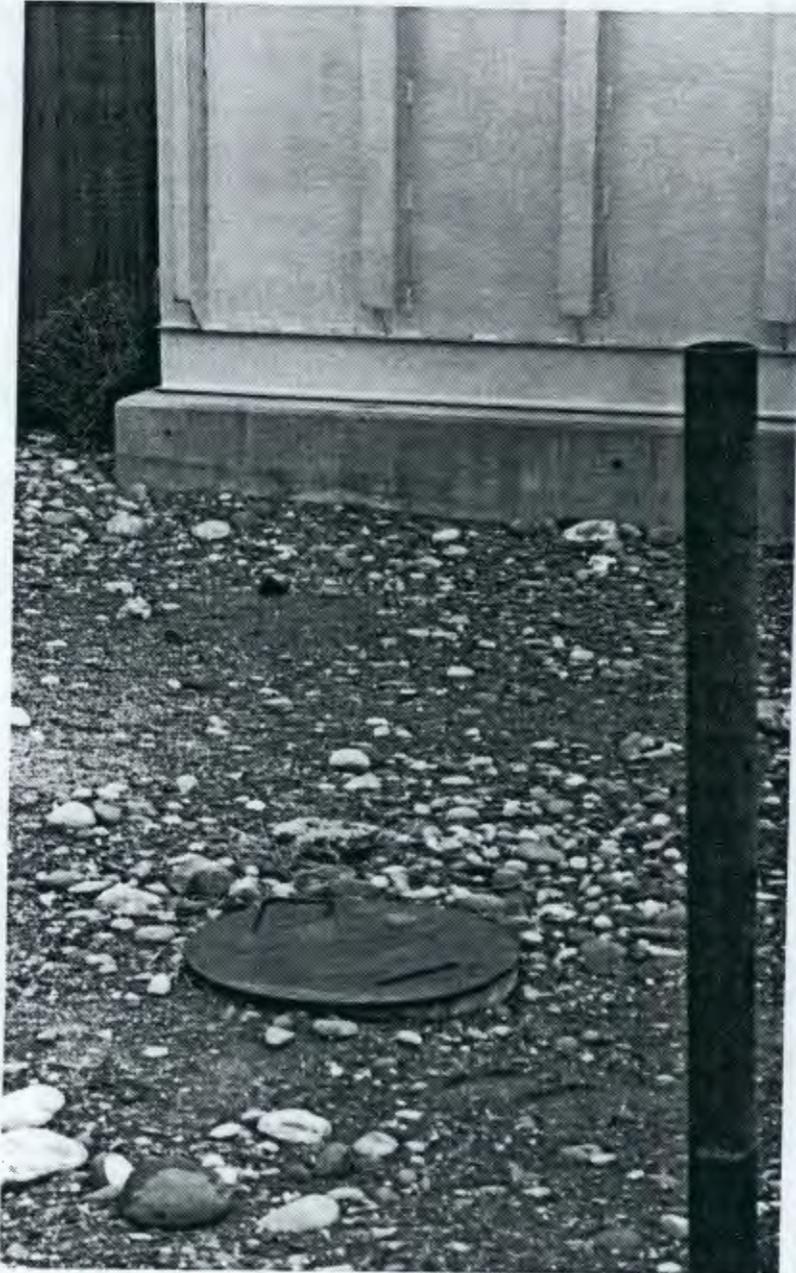
Figure 5-11. French Drain Near the Sodium Fire Facility Water Filter.

A field survey of the facilities on March 17, 1992 revealed a small french drain, made of 12-in. concrete pipe, located just west of the water scrubber building. This drain, which is covered by a steel lid, has a 2-in. inlet pipe that enters the drain on the east side about 2 ft below grade. The drain is protected from traffic by three yellow steel posts. The purpose of the drain is unknown (Figure 5-11).

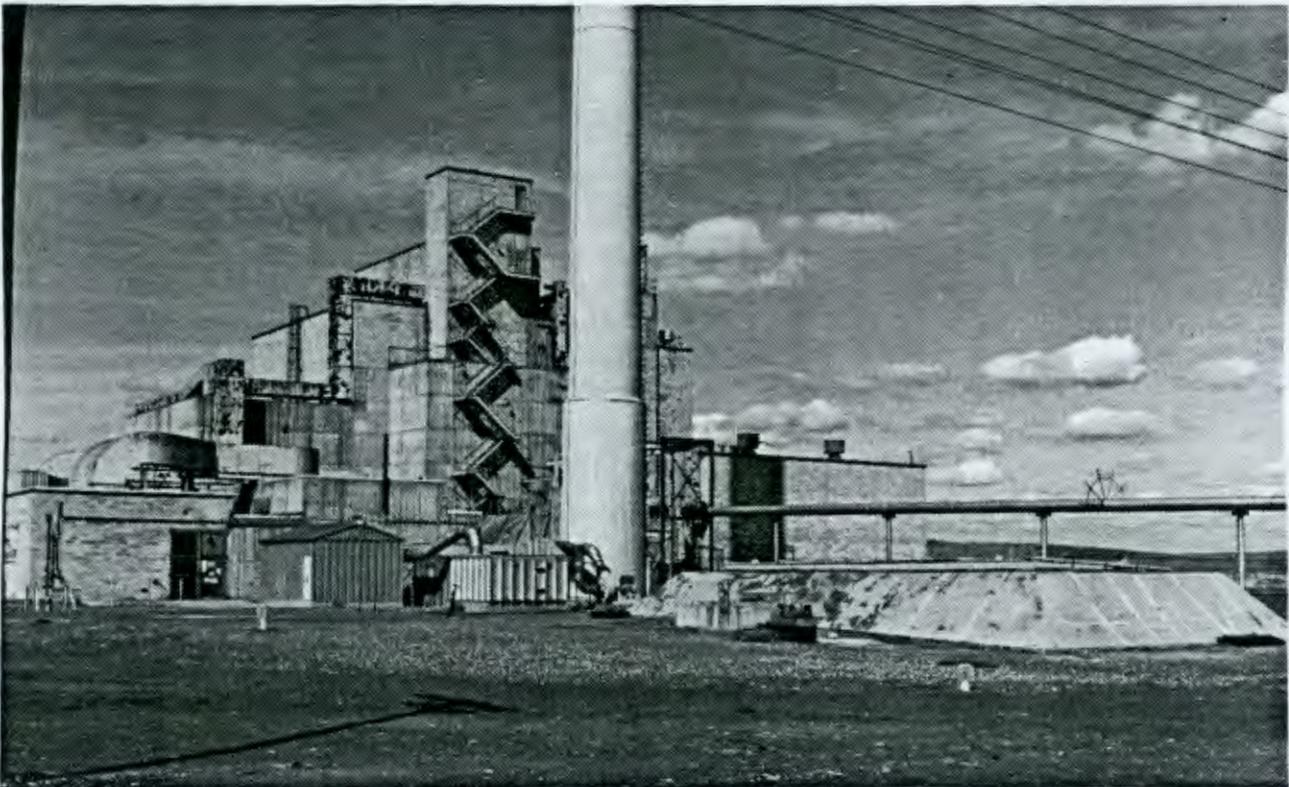
Figure 5-12. Sodium Fire Facilities.

The facility as it appears today can be see in Figure 5-12. This waste site has not been assigned an HRS Migration score.

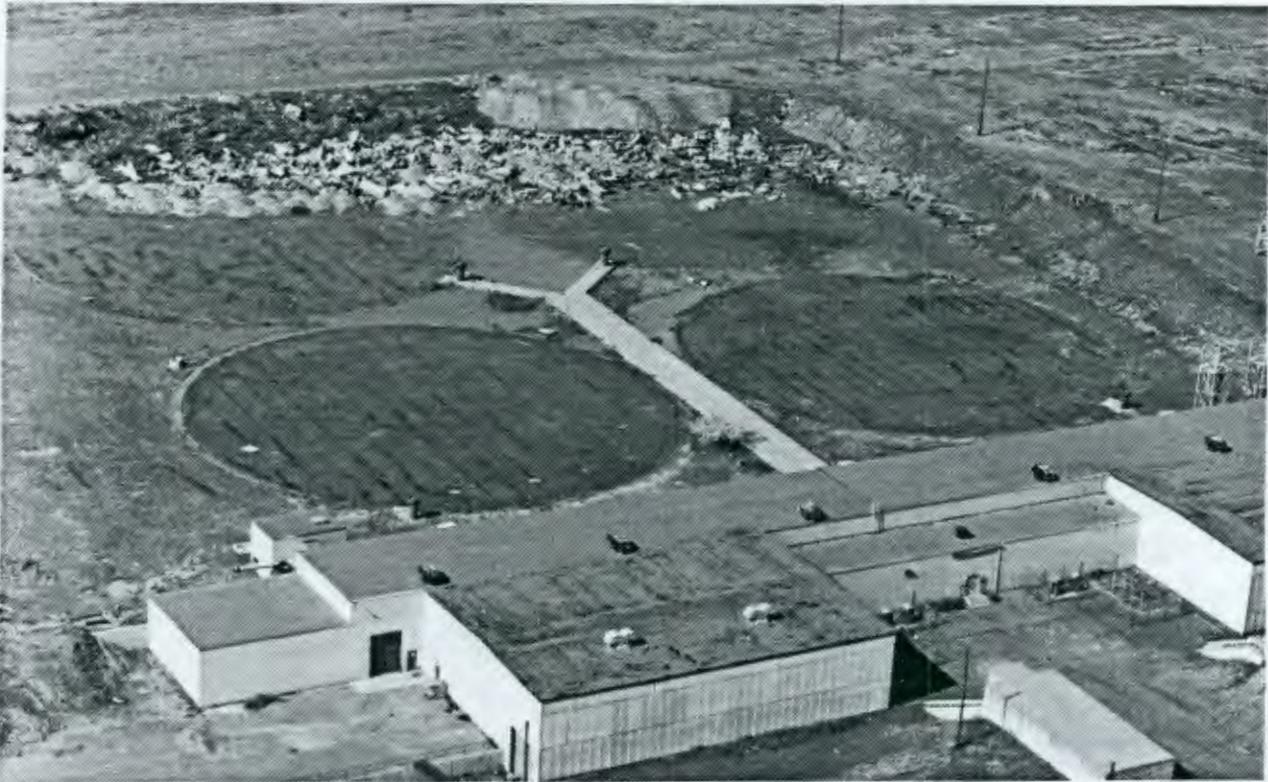
Figure 5-13. 190-DR Tankwell Pit Burial Ground.

It is an excavated area between the 183-DR and 190-DR that once contained four 3,750,000-gal steel water storage tanks. The tanks were removed by a salvage contractor. Approximately 25% of the bottom surface area (the north-west sector of the pit) contains a layer of waste about 5 to 10 ft deep that is covered with pit run backfill. Demolition and inert waste from demolished facilities, including rubble from portions of the 115-D/DR and some rubble from 183-DR, were placed in this area. In 1989, small amounts of friable asbestos were found scattered throughout the southern sector and now it is posted as an asbestos area. The asbestos is believed to be pipe lagging remnants that resulted from salvage operations during the 1970's (Figures 5-13 and 5-14).

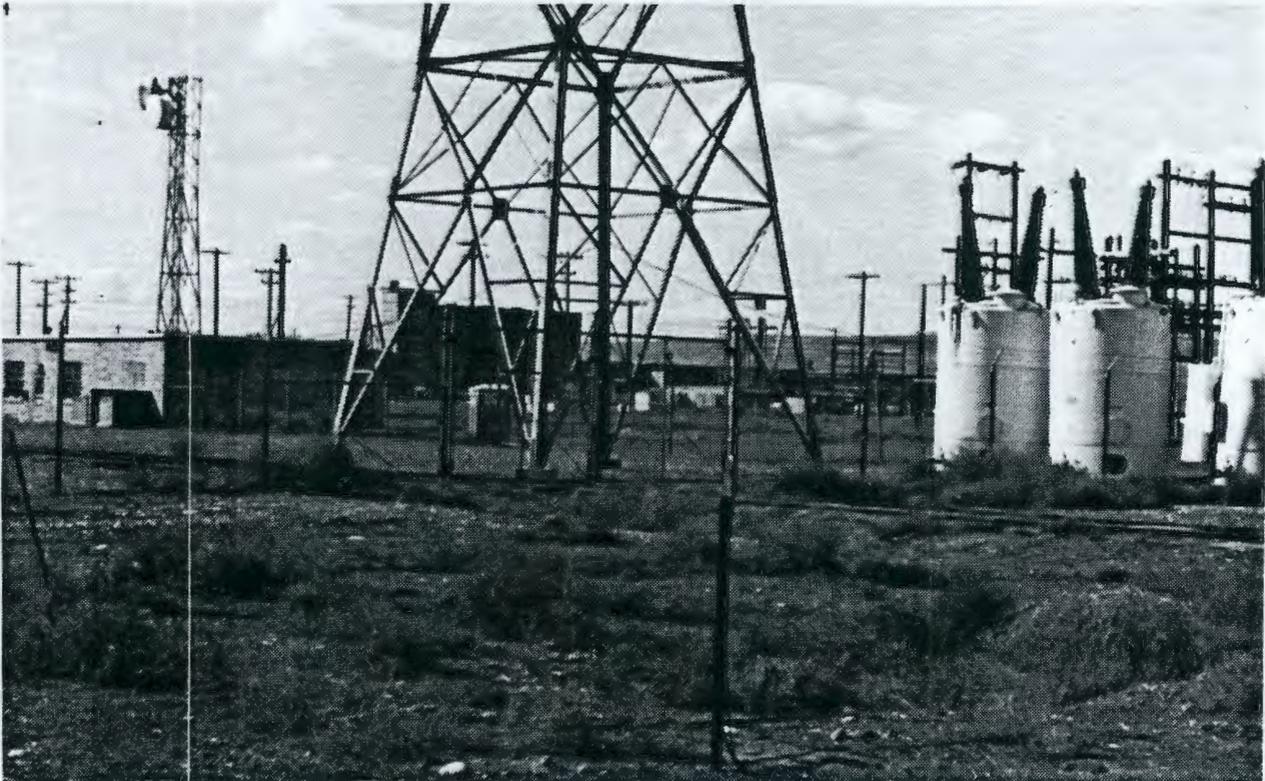
Figure 5-16. 151-D Septic Tank and Drain Field.

| SEPTIC TANK DESIGNATION | HANFORD LOCATION | COMMENTS |
|---|---|--|
| 1607-D3 DRAIN FIELD | N91395 W53250 N91340 W53250 | Supported 151-D. The septic tank and drain field are located east of the substation enclosure, part of a steel post and light chain barricade surround a portion of the septic tank (Figure 5-16). |

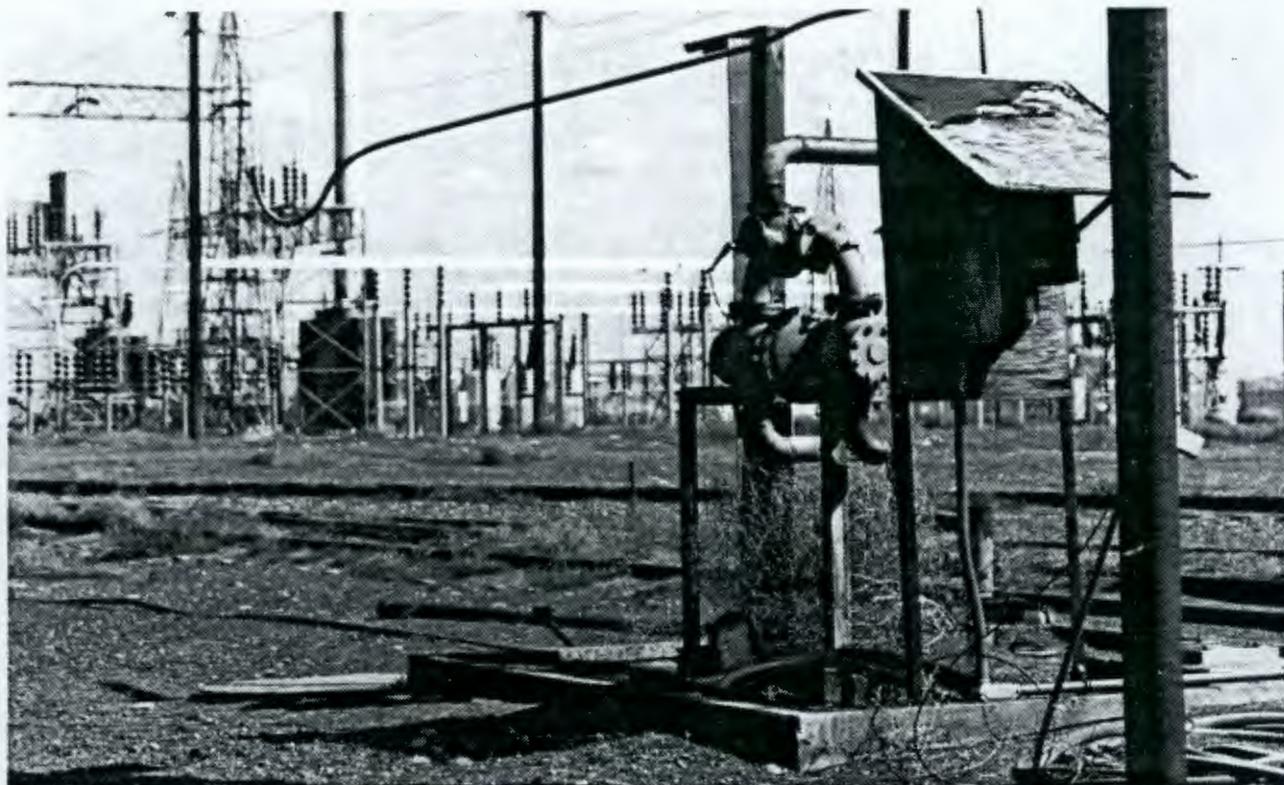
Figure 5-17. Sodium Dichromate Pumping Station.

A 3-ft-diameter french drain located at the site supported the flushing and draining of hoses and lines that connected to the tank cars. This is a significant waste site because undiluted volumes of sodium dichromate and acid solutions were dumped directly to the soil column at this location (Figure 5-17).

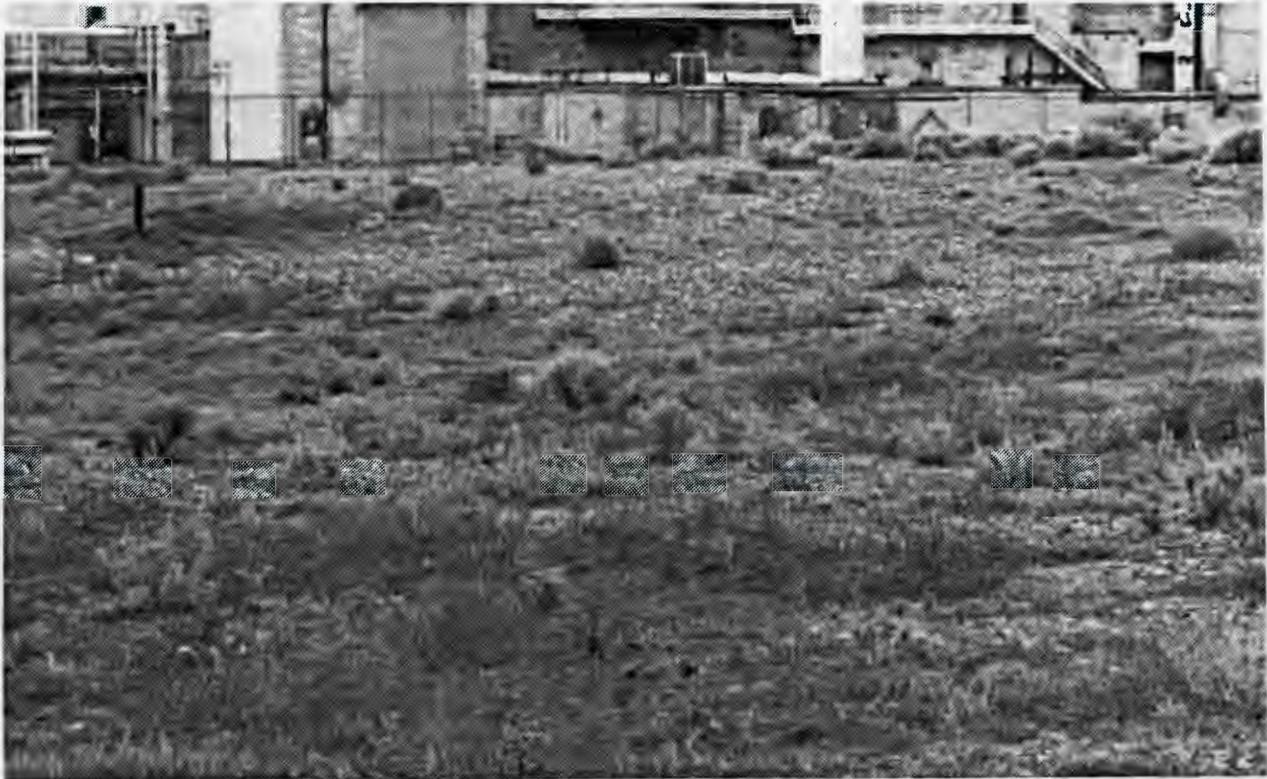
Figure 6-1. 105-DR Fuel Storage Basin Cleanout Pond.

The site was backfilled and graded to match the natural terrain. It appears today as a shallow (less than 2 ft deep) excavation in which vegetation is slowly reestablishing ground cover (Figure 6-1).

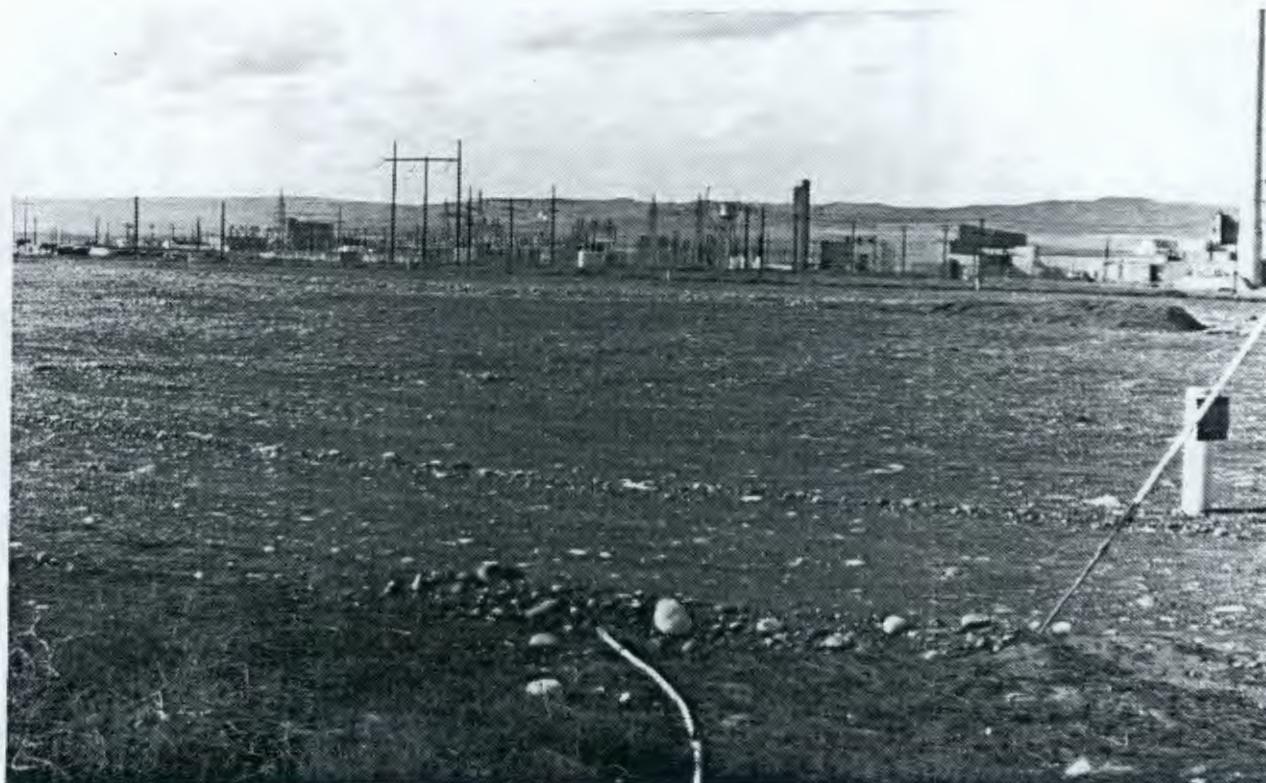
Figure 6-2. 100-D Area Burial Ground Number One.

The area appears today as a vegetation-free, cobble-covered field. It is bordered by permanent concrete markers and is posted with Underground Radioactive Material warning signs. The western section of the site is elevated about 2 ft above the rest of the area. A terraced dirt mound, located in the southeast corner of the site, was constructed prior to 1987 as part of a feasibility study for the revegetation of burial grounds. It was terraced to determine the minimum soil depth required to sustain plant growth. Currently the 118-D-1 and mound are treated annually with defoliants (Figure 6-2).

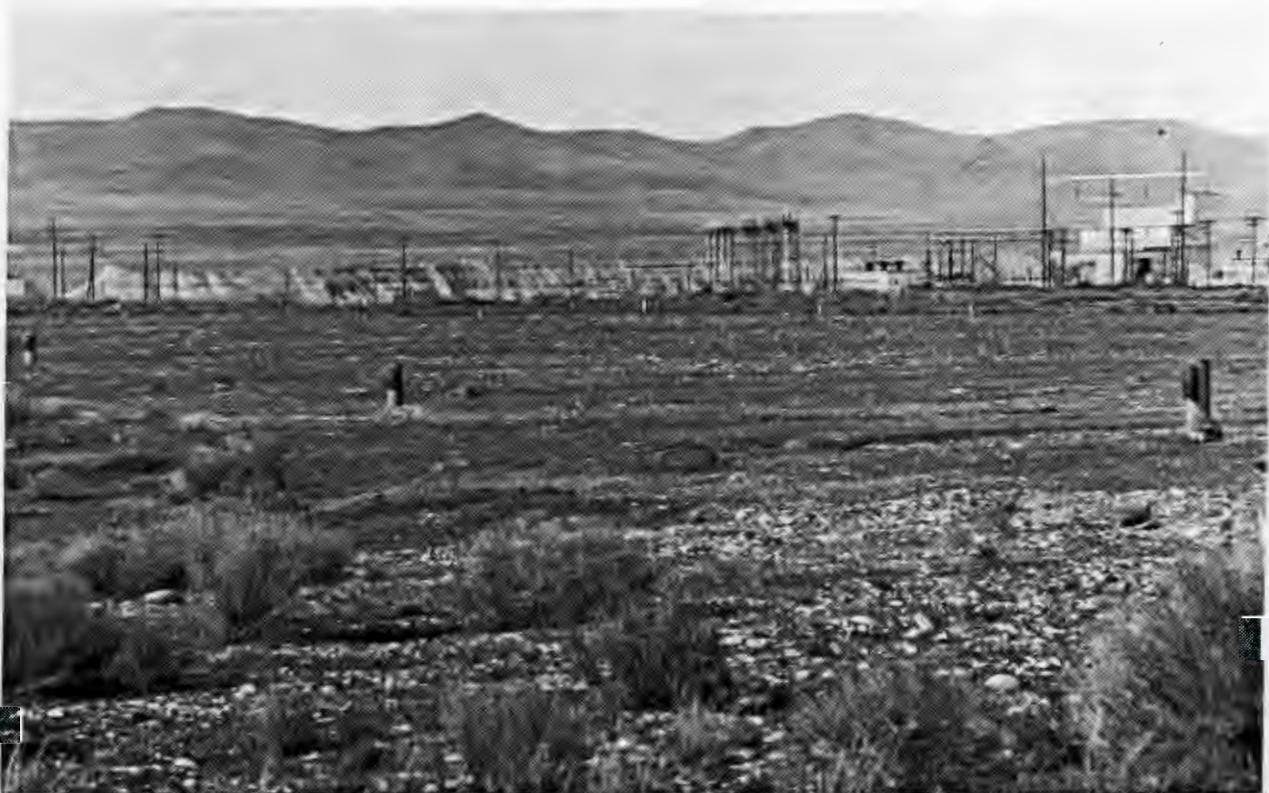
Figure 6-3. 100-D Area Burial Ground Number Two.

The site appears today as a large, vegetation-free, cobble-covered field surrounded by permanent concrete markers that are posted with Underground Radioactive Material warning signs. Much of the burial ground surface is about 1 ft above the grade of the surrounding area (Figure 6-3).
