WHC-SD-EN-TI-181
Revision 0

100-D Area Technical Baseline Report

Prepared for the U.S. Department of Energy
Office of Environmental Restoration and
Waste Management

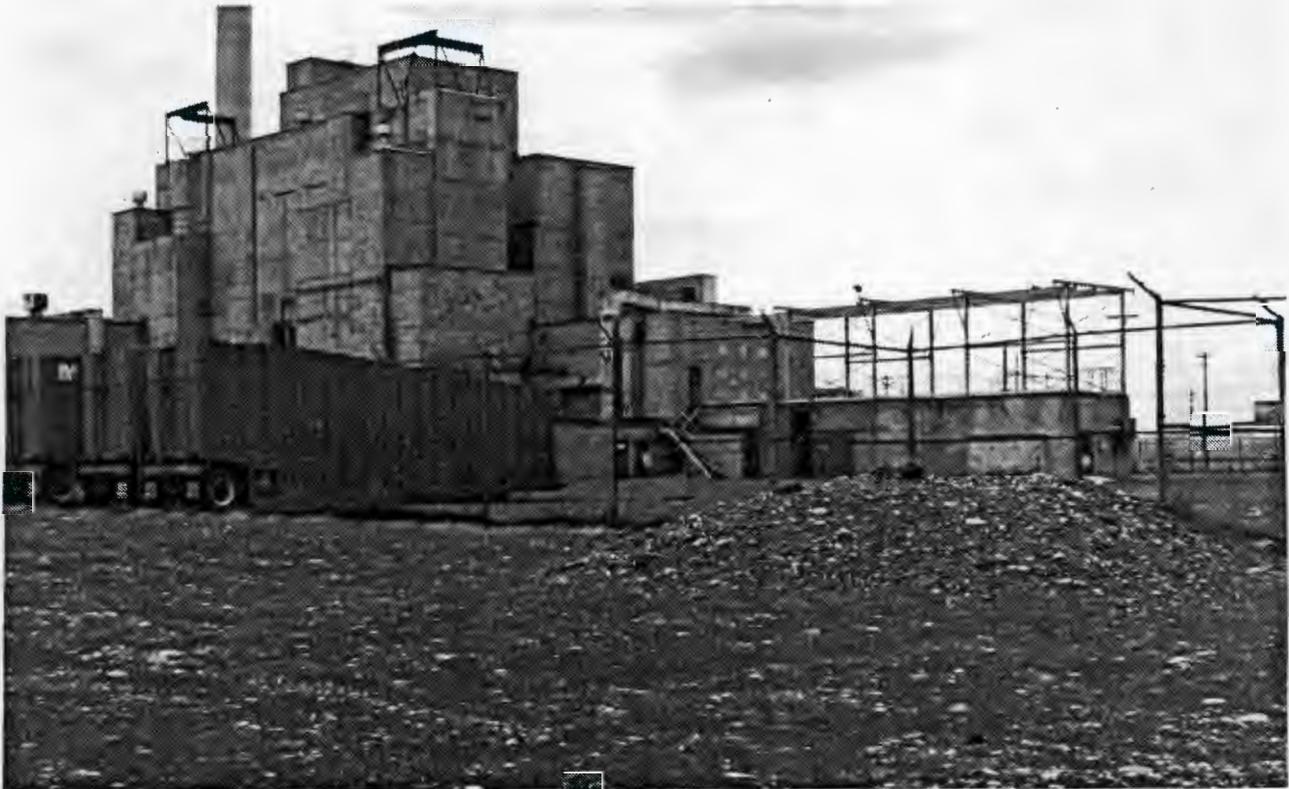
Figure 6-4. Suspect Liquid Waste Site.

- Minor Construction burial ground number 2 was a trench dug in 1953 to receive contaminated thimbles, rod guides, and miscellaneous waste removed from the 105-DR Reactor during an extended Ball 3X outage. The contaminated wastes were then covered with 6 ft of dirt and the location was marked with cement monuments (Heid 1956). The concrete monuments are no longer in place.
- A small trench was dug in March 1954 to receive effluent water from the number one DR west effluent expansion box during repairs. It was described as being a "grave" (a trench that was dug to receive a specific waste and covered over soon after the waste was received) (Clukey 1956). It is assumed that the trench was dug very near the expansion box and should be located in the northwest corner of the burial ground (Figure 6-4).

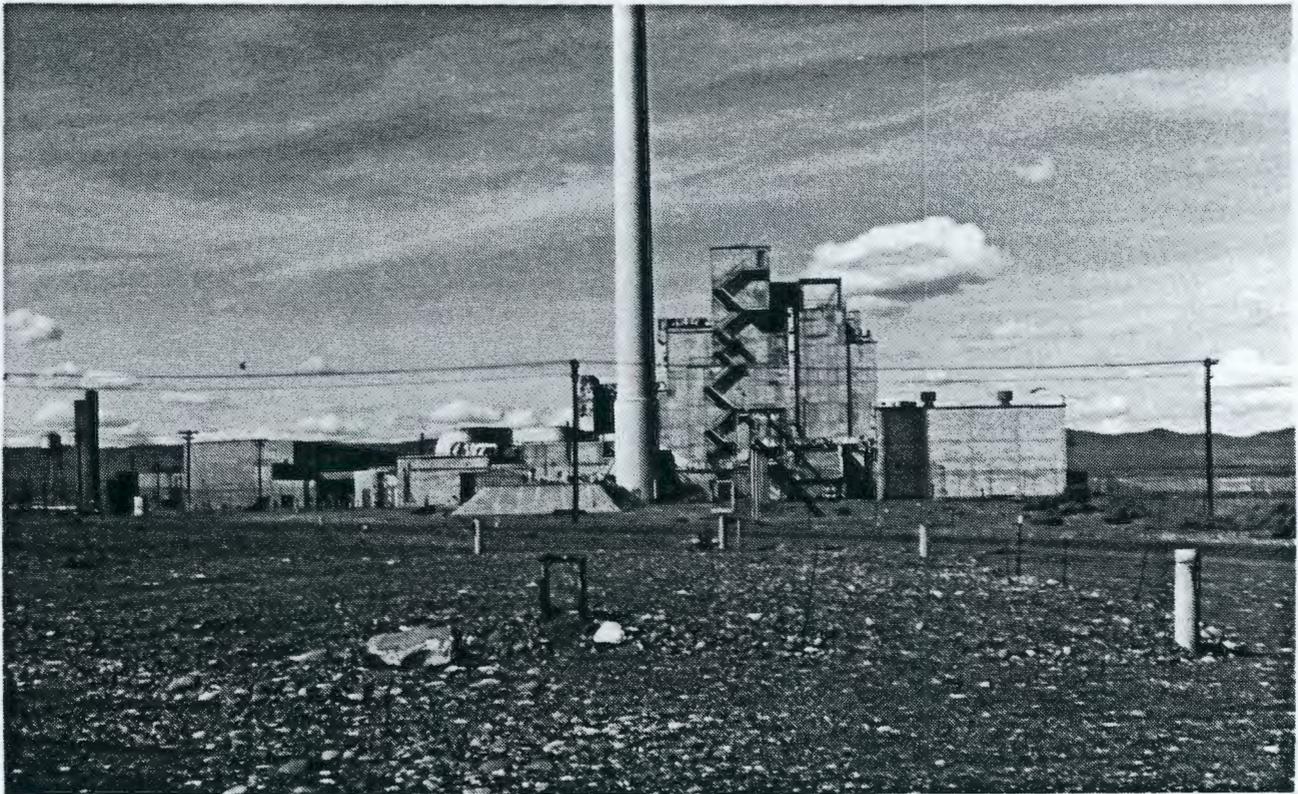
Figure 6-7. 100-DR Gas Loop Burial Ground.

The site appears as a vegetation-free, cobble-covered field. Support structures for the test assembly removal pipe are in place at the north and south ends of the site (Figure 6-7).

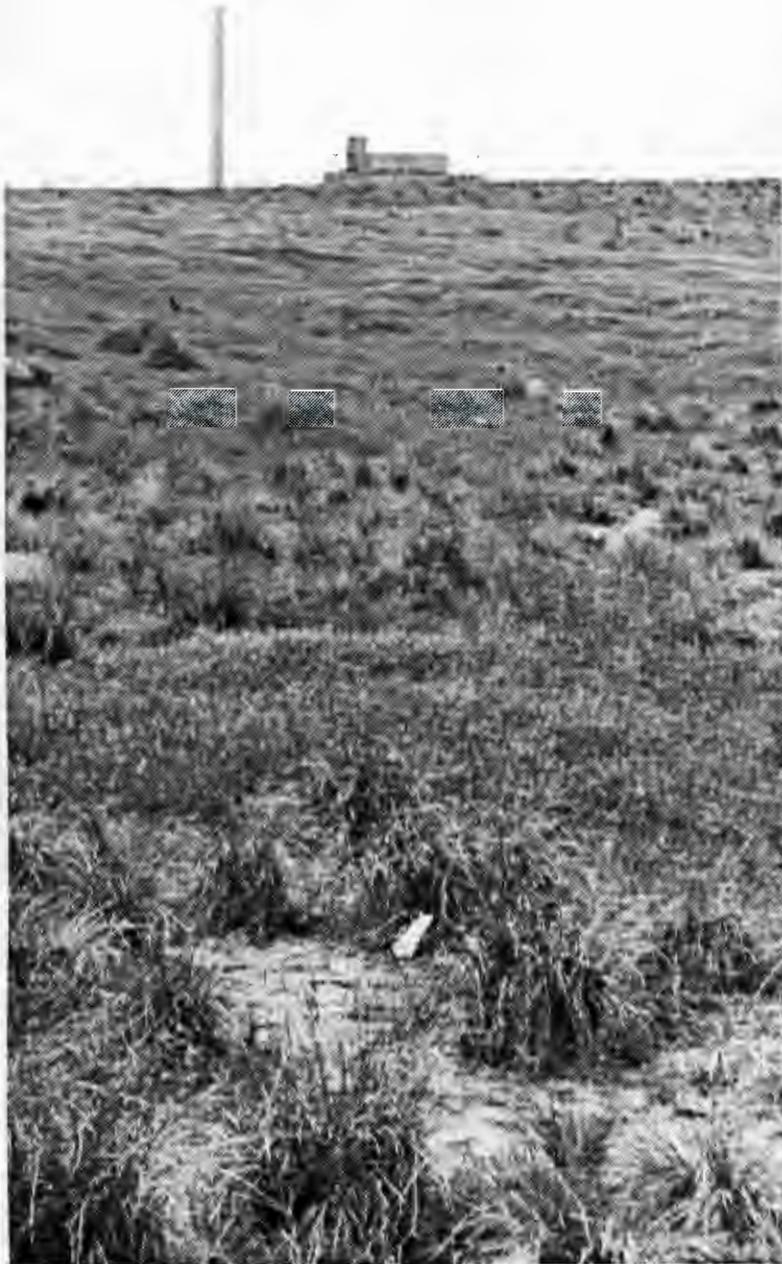
Figure 6-8. Suspect Location of the
128-D-1 Burn Pit.

During site inspections conducted for this report, the exact location of this burn pit could not be found, although there was some evidence of a burn pit at the site location (wood ash material and pieces of transite siding) (Figure 6-8).

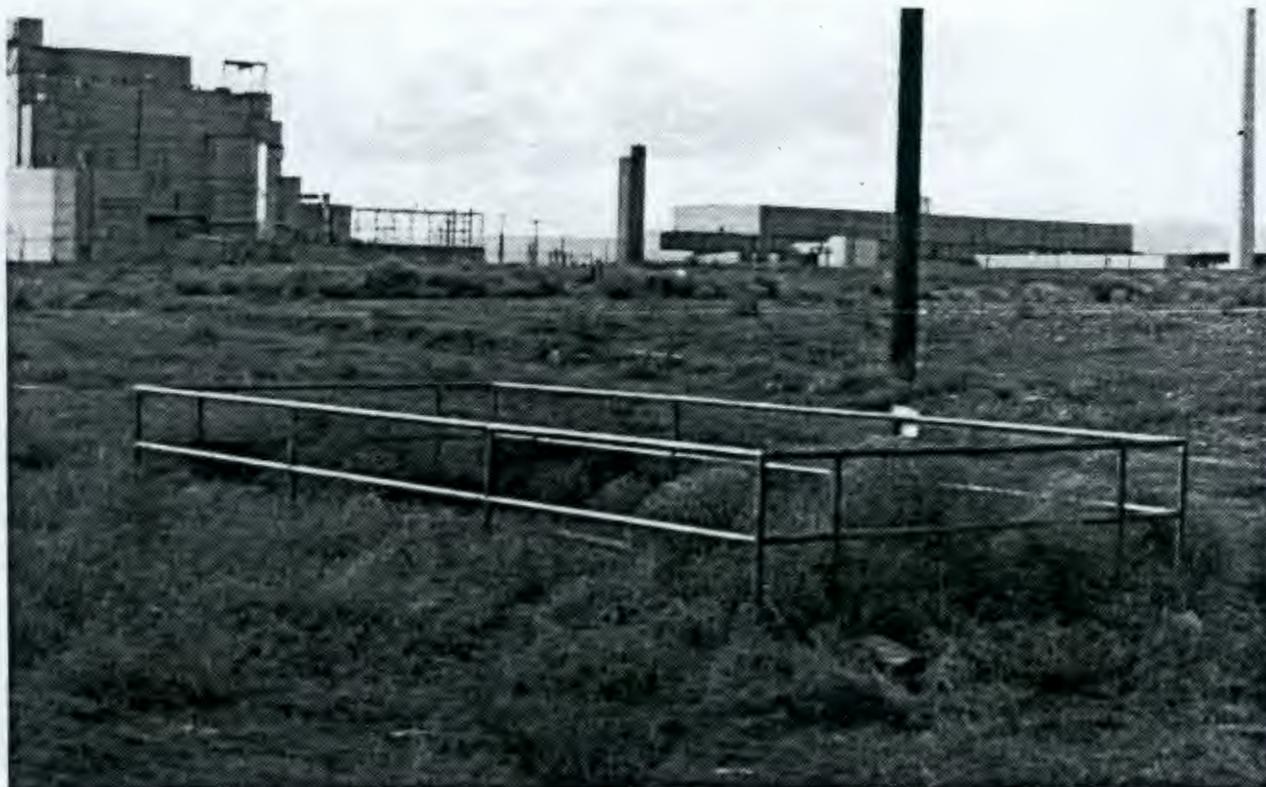
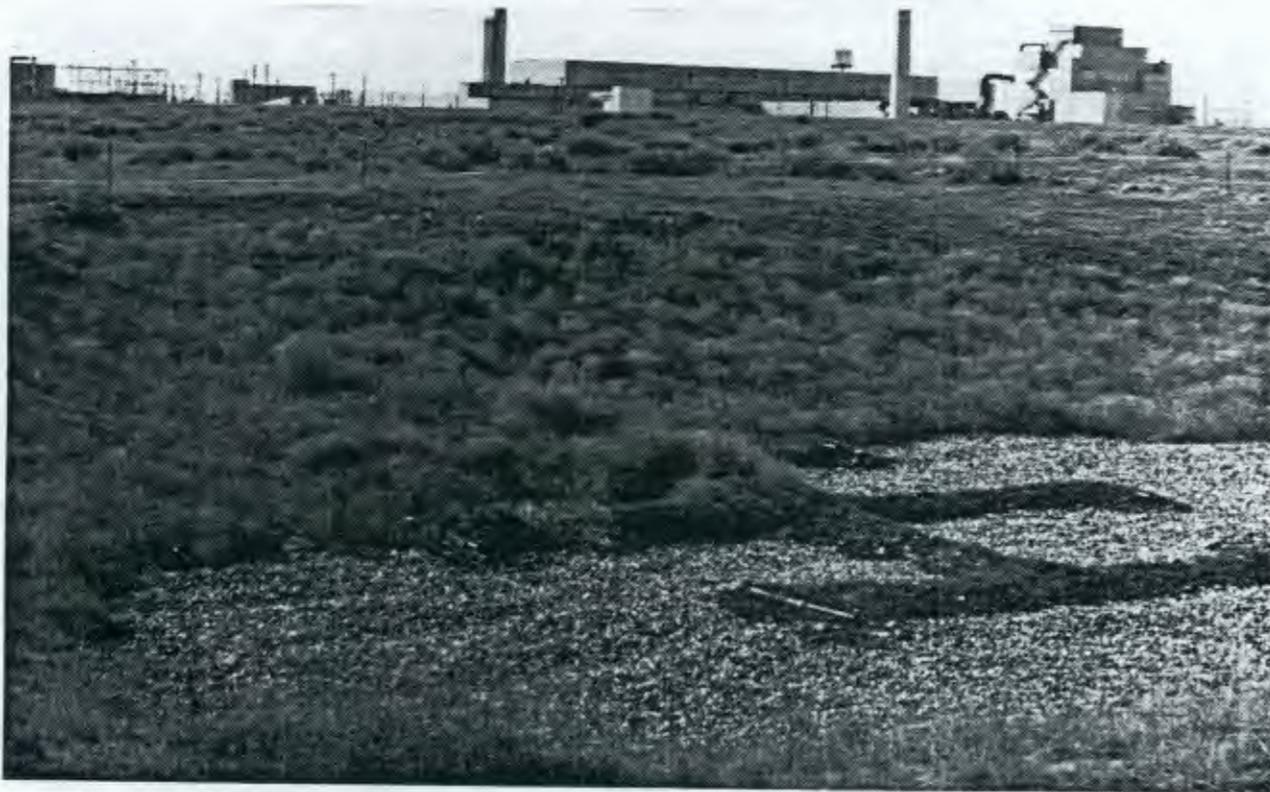
| SEPTIC TANK DESIGNATION | HANFORD LOCATION | COMMENTS |
|---|---|--|
| UNNUMBERED | N90900 W51900 | Supported temporary construction facilities and overflow from the high tanks located at 100-DR and the 100-DR Reactor. The system consisted of an IMHOFF tank and drain field. The tank is a concrete structure with a steel lid surrounded by a steel pipe barricade fence. There are two access cover plates and three vents on the top cover plate. There is standing liquid in the tank bottom. The drain field is about 100 yards north-east of the tank and is a large pit surrounded by a steel post and light chain barricade that is unmarked (a sign found on the ground near the fence identifies the area as a septic drain field). A large concrete weir box is located on the west side that has a deteriorated wooden lid. The pit bottom is a cobble surface. A dispersion manifold lays on the surface that has been capped. There are several small access covers to the lines leading to this septic system: three are located south and east of the 100-DR Reactor Facility outside the exclusion area fence and two more are located within the 100-DR-2 Operable Unit to the south west and south of the 100-DR Reactor Facility. These access covers are surface level concrete boxes with a steel lid rectangular or square in shape (Figures 6-10 and 6-11) |

Figure 6-10. Undocumented Septic Tank (IMHOFF Tank).

Figure 6-11. Undocumented Septic Drain Field.

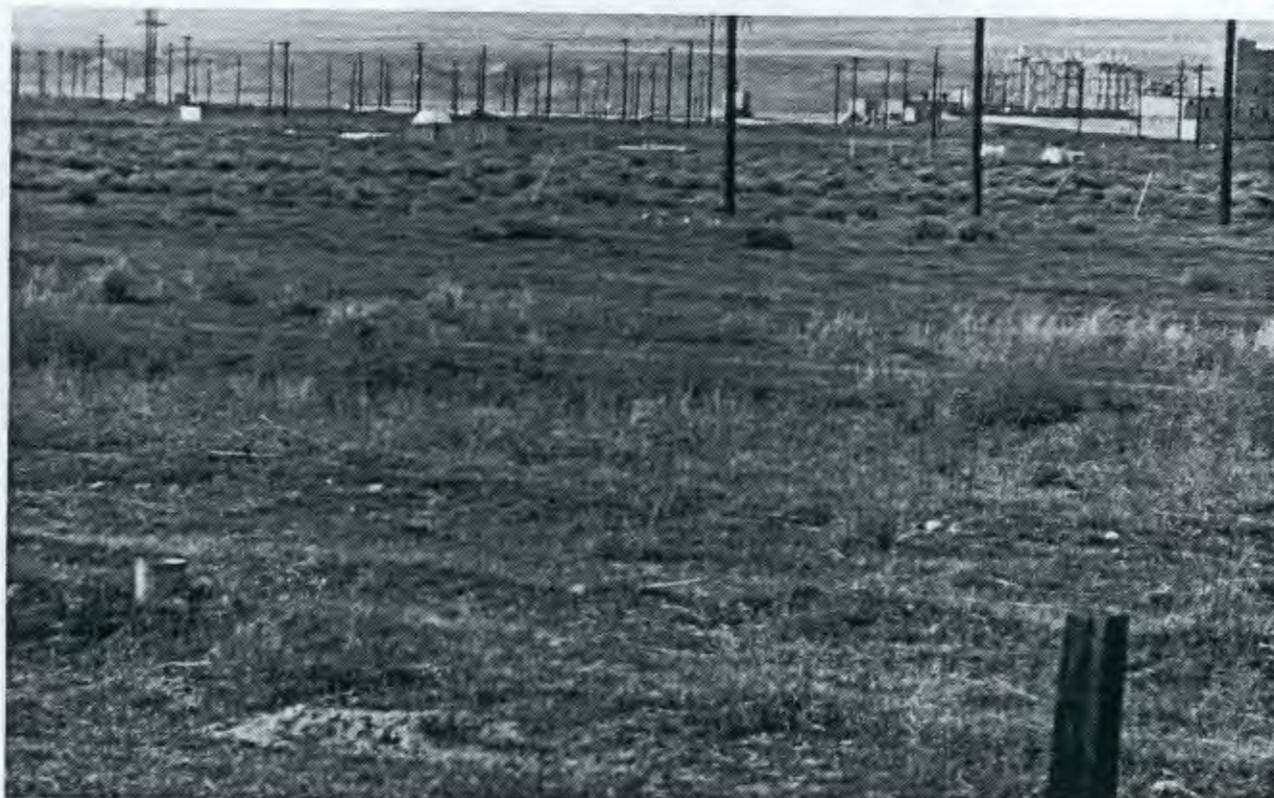
Figure 6-12. Undocumented Septic Tank and Drain Field.

| SEPTIC TANK DESIGNATION | HANFORD LOCATION | COMMENTS |
|---|---|--|
| UNNUMBERED | N89380 W52870 | Supported Construction Badgehouse before relocation (H-1-8090). It is located about 40 yds. south of the roadway and 25 ft northeast of a small soil pile. There is a 4-in. concrete vent pipe and a nearby depression that most likely is the septic tank, although the tank is not evident on the surface. (Figure 6-12) |

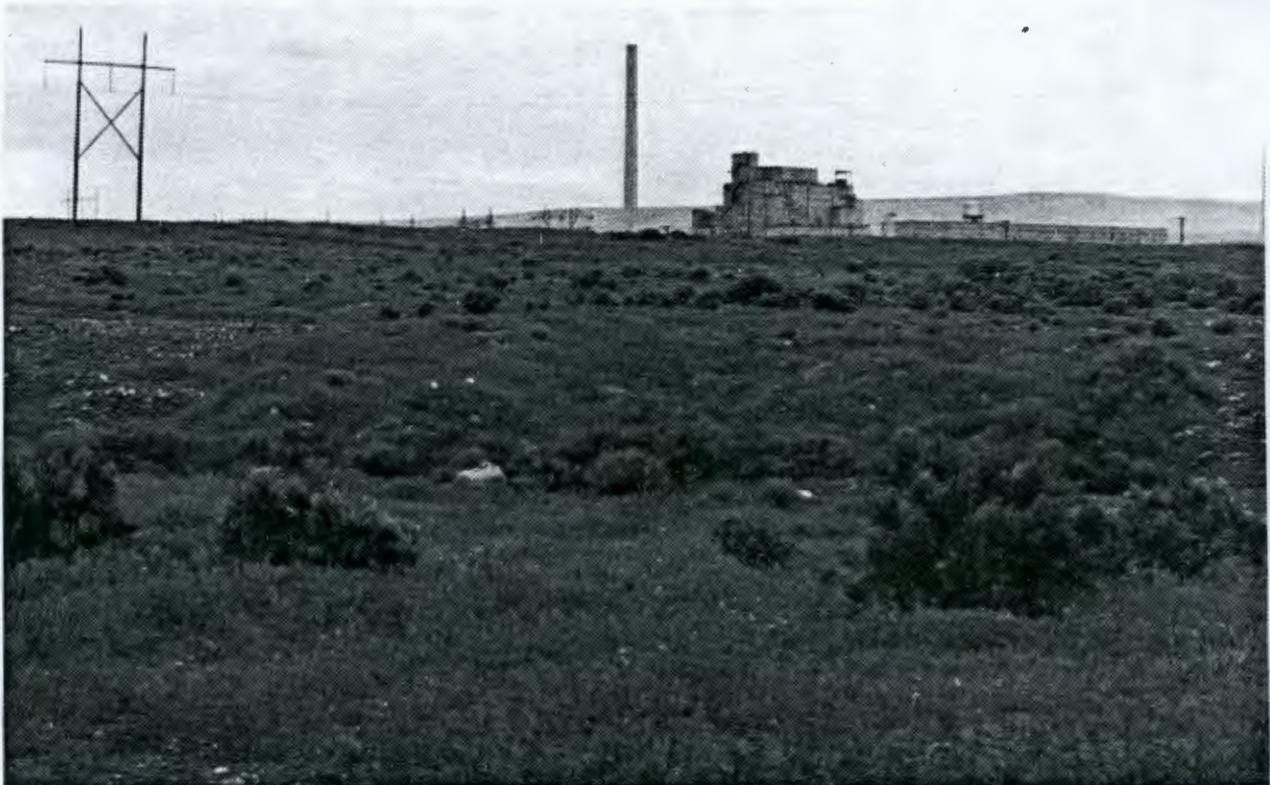
Figure 6-13. Old Barrow Pit Burial Ground.

A large barrow pit that was used as a solid waste burial pit was located to the southeast of the 100-DR Reactor facilities and west of the old Patrol Headquarters, at approximate Hanford coordinates N89800 W51000. This site contains backfill and construction debris consisting of concrete rubble, metallic materials, and asphalt material. Site employees report that it was used to dispose of empty cans collected from Army sites located to the northeast of the 100-D Area. These Army wastes would have included 5-gal oil cans, cleaning solvent cans, and other miscellaneous solid wastes. A dirt road leading to the site near the railroad tracks has exposed broken floor tile pieces (potential asbestos hazard) at the surface. It is assumed that much of the concrete wastes located here came from demolition of the security and fire station facilities located not far to the east of this waste site (Figure 6-13). The original barrow pit can be seen in the left lower corner of Figure 2-1.

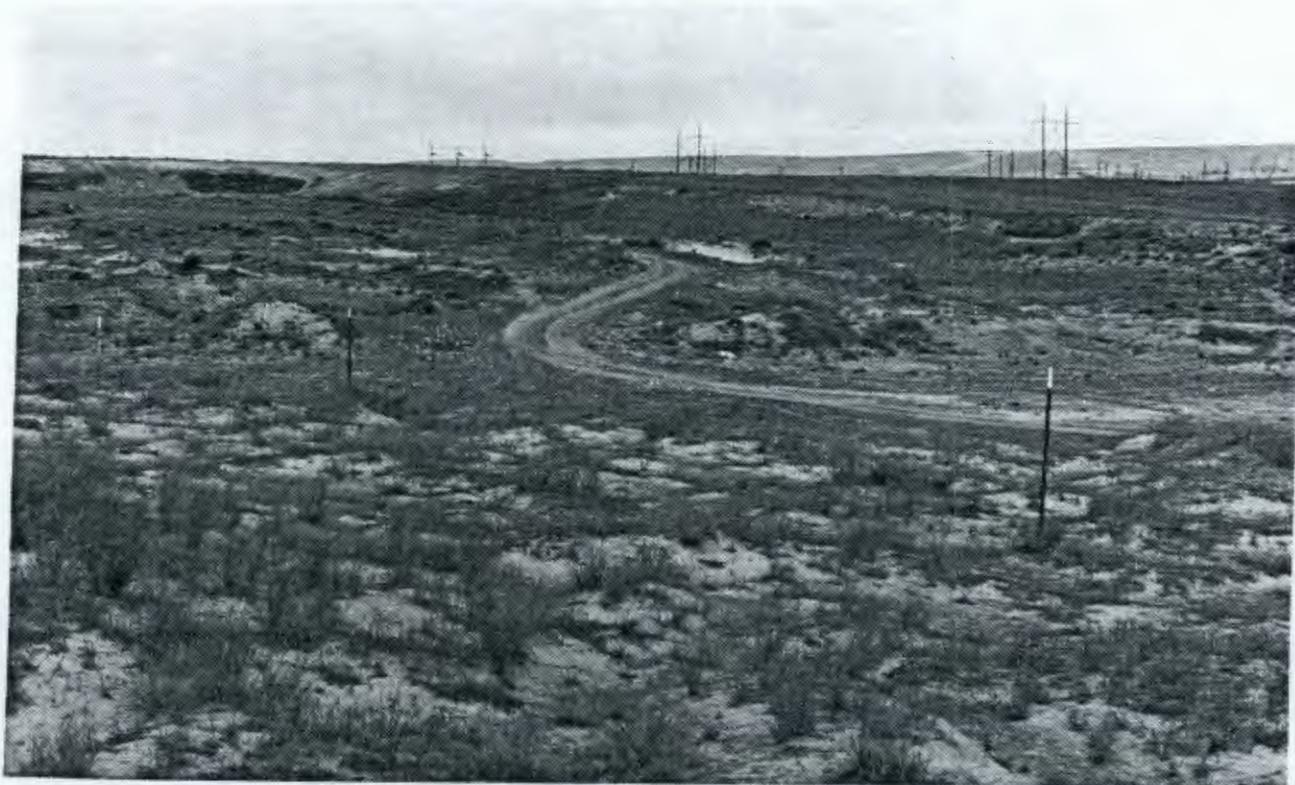
Figure 6-14. Present Barrow Pit and Burial Ground.

Another barrow pit was excavated to the south and west of the previous site and was also reported to have been used to dispose of solid wastes. This pit is located between the perimeter road and the main access road. There appears to have been dumping of construction debris, concrete and asphalt debris are evident on the surface within the pit. It is reported that construction and demolition wastes were disposed of at the west end of the site where there is evidence of heavy equipment activity. The pit site is posted with a "No Dumping" sign at its the south side entrance (Figure 6-14).

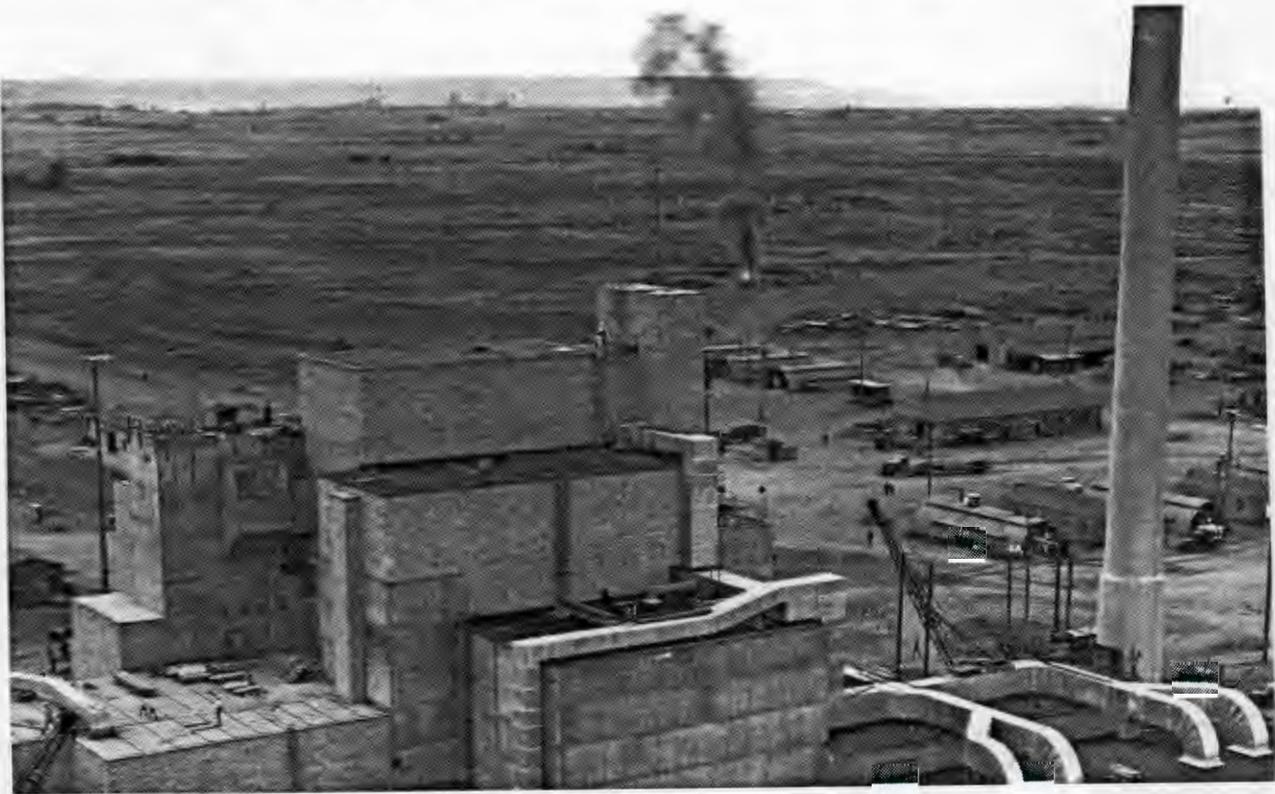
Figure 6-15. Undocumented Burn Pit, 1948.

A construction burn pit is evident in aerial photographs taken during the construction of the 100-DR Reactor. No evidence of this burn pit remains today and the exact location is uncertain. Photographs taken in August, October, and November 1948 indicate that a large volume of combustible waste was disposed of at this site during the construction of the 100-DR Reactor (Figure 6-15). The entire burn pit has been leveled and graded; natural grasses and vegetation cover the entire area.

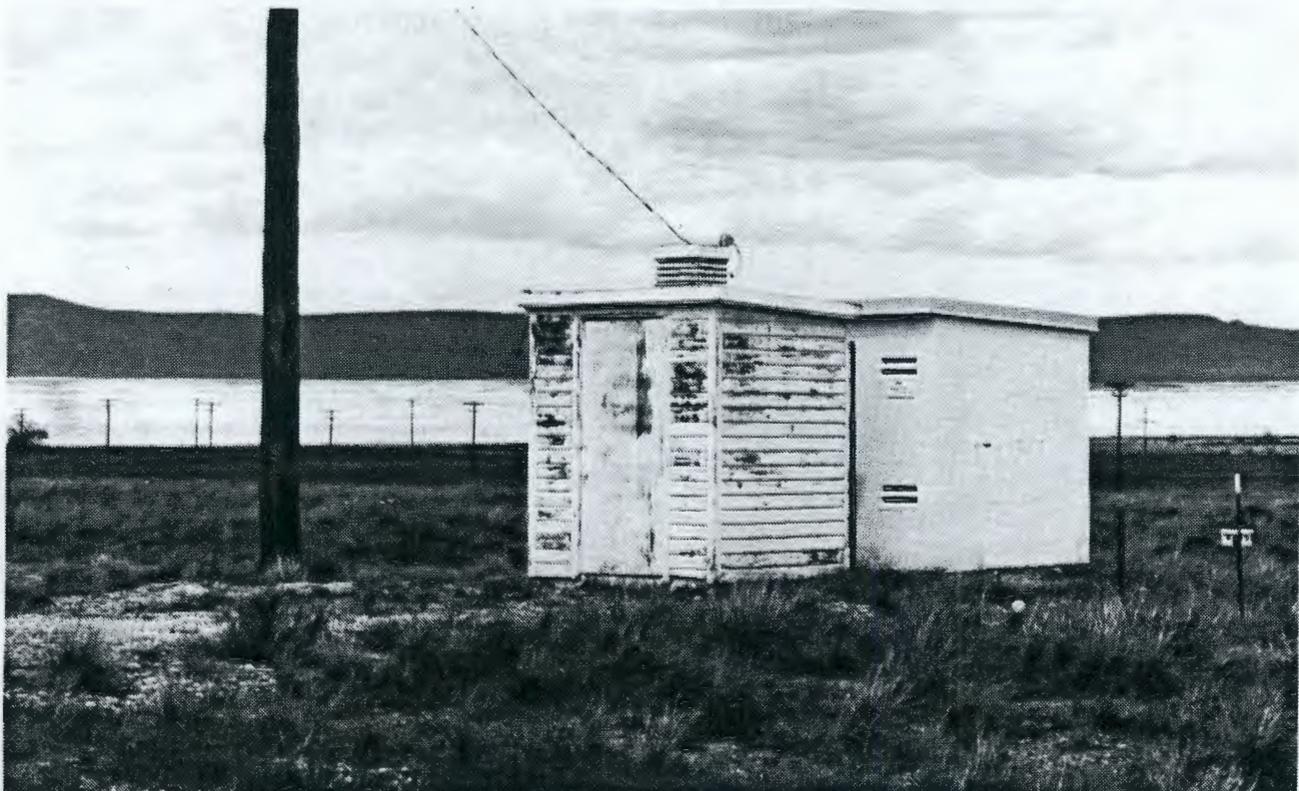
Figure 6-16. 100-D Area Air Monitor Station (Historic Landmark).

| FACILITY | HANFORD LOCATION | COMMENTS |
|---|---|--|
| 1614-D | N90310 W50440 | Monitor Station. Figure 6-16 is the one existing Monitor Station in the 100-D Area and is 1614-D-3. |

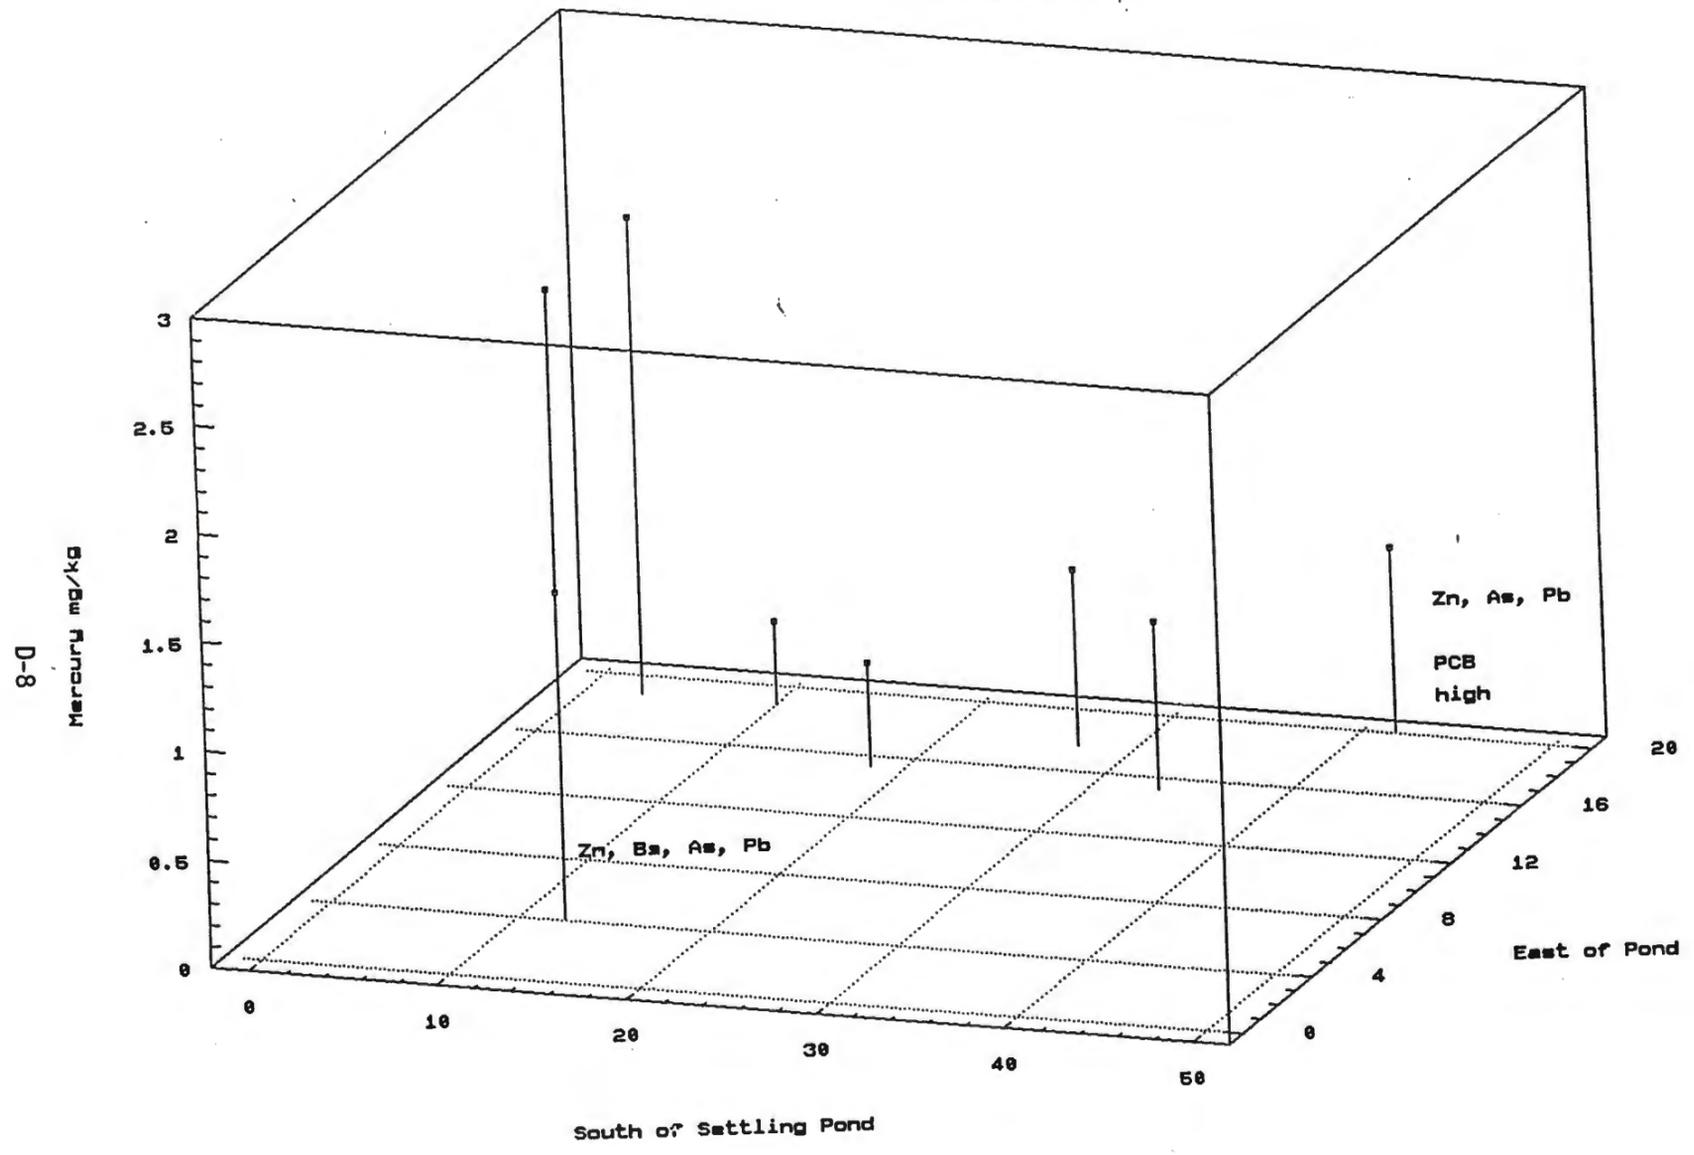
Plot of Mercury Above Background in
100-D Settling Pond

Background Mercury < 0.1 mg/kg
