2734ZB Facility Status Change Form

FACILITY STATUS CHANGE FORM

2734ZB Gas Bottle Storage

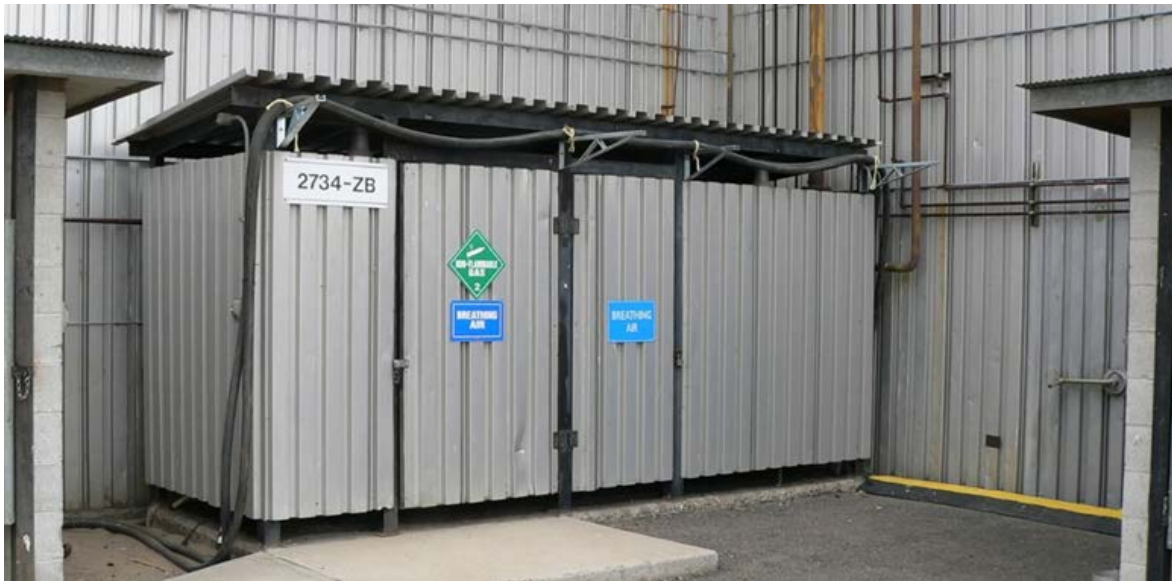
Figure 2. 2734ZB Pre-Demolition

The 2734ZB Gas Bottle Storage was approximately 15 ft long by 5 ft wide. It was a lean-to structure with metal sides and roof on a concrete slab located on the southeast side of PFP between 2734ZA and 2734ZC. A metal door on the front provided access to compartments for gas storage areas. The building was constructed in 1971 and is located on the southeast side of PFP (Figure 2 in this Facility Status Change Form provides additional details).

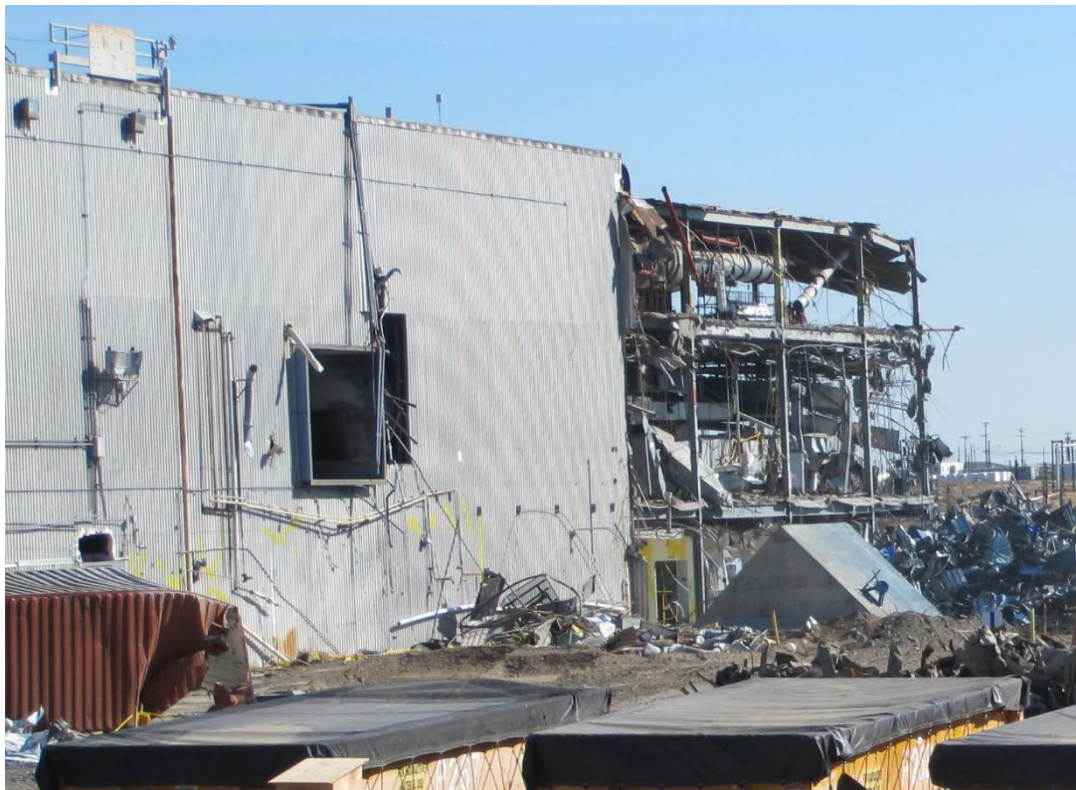
Figure 3. 2734ZB Post Demolition

Description of Current/As-Left Conditions:
Demolition was completed on September 21, 2017. The 2734ZB slab was left in place and will be addressed with the 234-5Z slab. A walkdown of the area where the structure previously stood was conducted to confirm that demolition was completed, waste was removed, and the area had been appropriately posted in accordance with radiological and occupational safety requirements.

No anomalies were discovered during demolition. Soils around the slab displayed no visual evidence of staining or discoloration.
