BHI-00146
Rev. 00

100-IU-6 Operable Unit Technical Baseline Report

Author
D. H. DeFord

Date Published
January 1995

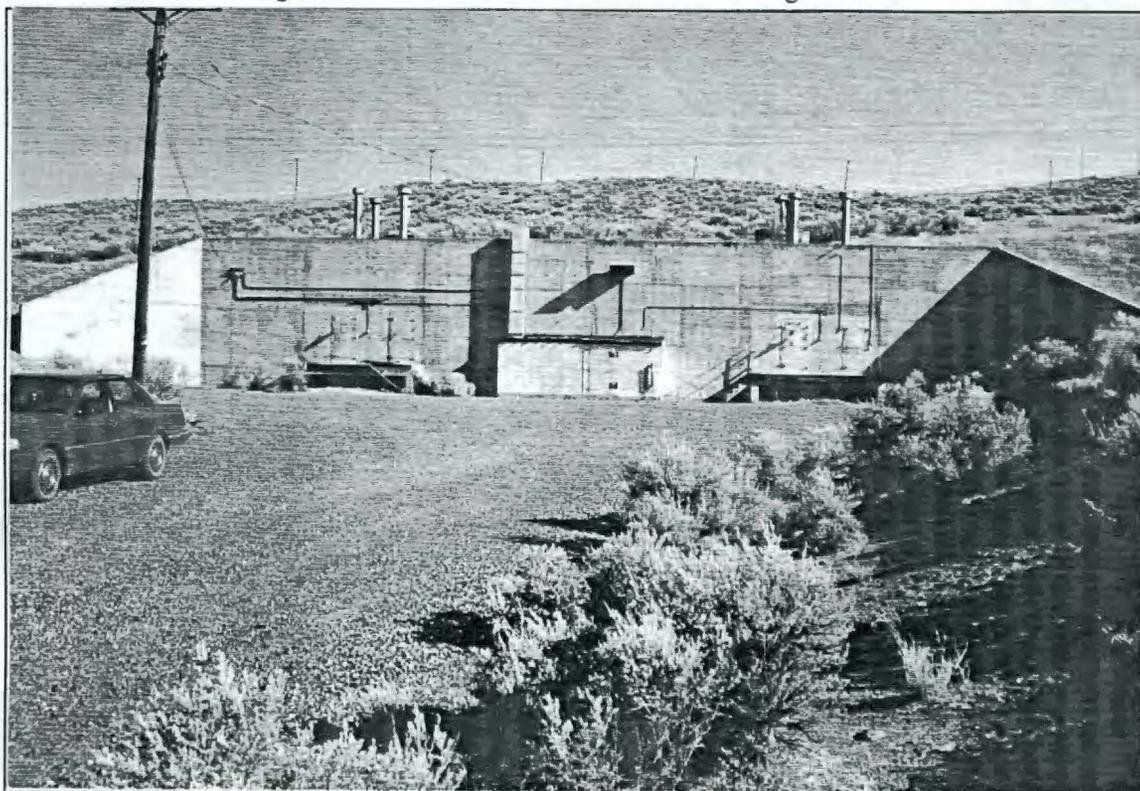
Figure 3. 213-J and 213-K Plutonium Storage Vaults.

The 213-J and 213-K Plutonium Storage Vaults are identical underground storage vaults located side by side on the south slope of Gable Mountain, about 3 mi northeast of the 200 East Area and 4 mi west of the Hanford townsite at approximate Hanford coordinates N55000 W35000 (Figure 3).

Each vault is 12 ft wide, extends 40 ft horizontally into the mountain, and has an 8-ft ceiling. Each has a concrete loading dock and a steel outer door opening from the dock to a small inner vestibule. A steel Mosler vault door separates the small chamber from a larger store room beyond. A ventilation and air conditioning building is located between the loading docks on the front face of the vault. Four ventilation ducts are visible on the surface above each vault. A second steel door opens from each loading dock to a 5-ft 6-in. x 9-ft instrument room that housed instrumentation related to the original plutonium storage mission.

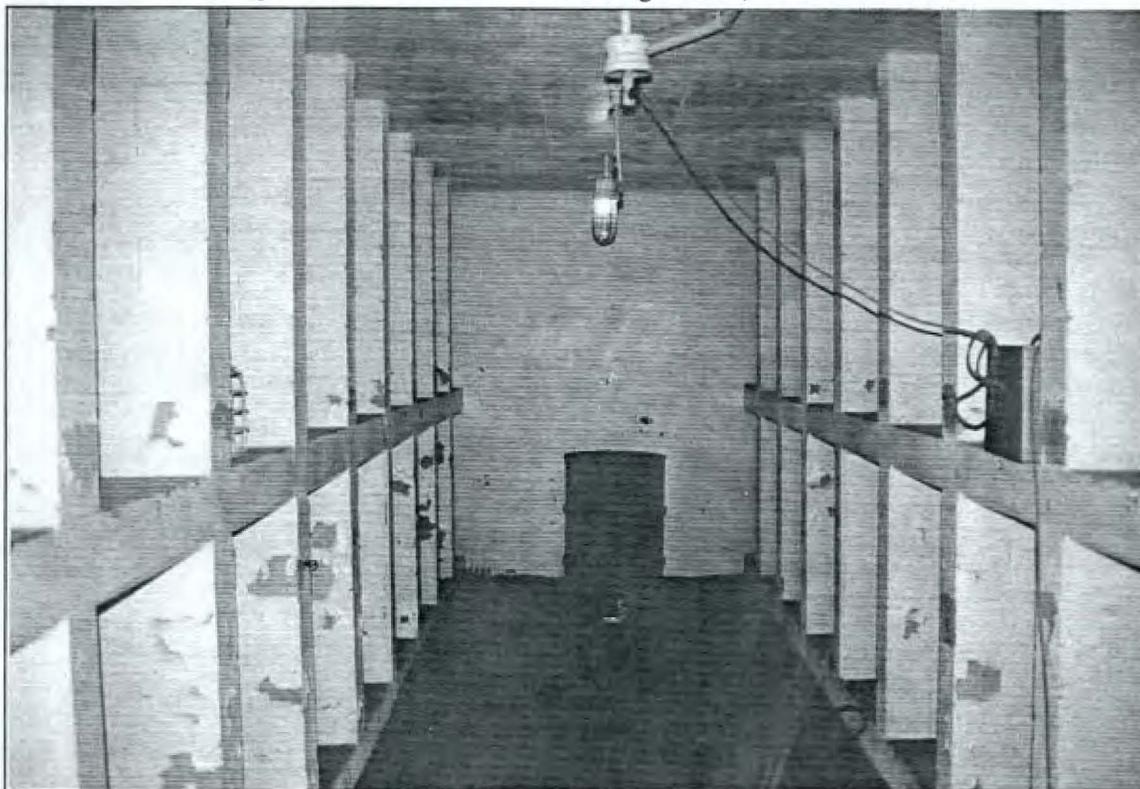
Figure 4. Interior of 213-K Storage Vault, Vault Section.

An examination by this author revealed that each vault section has three chambers, entered though one of two outside doors. The large chambers, made up of vestibule and magazine and separated by a vault door, are to the west and are as described above. The smaller chambers, or instrument rooms, are located to the east and are entered through the doors to the right of the vault door. These are about 8 x 4.5 x 8 ft high (inside dimension) with a concrete shelf on the rear wall (Figure 4).

The vaults have been used for various purposes during their history. Constructed for storage of Hanford plutonium, they were used only briefly, if at all, for that purpose. They have since been used for storage of explosives and for hardware contaminated with radioactive sodium. Dose rates up to 5 mR/hr were measured in 213-K during the sodium storage period. At present, 213-K is empty and being used for seismic testing, while 213-J is used by Pacific Northwest Laboratory (PNL) to store soil samples from various Hanford locations. Sodium metal storage signs and a sodium metal Material Safety Data Sheet were located in a litter pile inside 213-K. The remnants of a radioactive symbol (trifol) are visible on one storage vault wall.

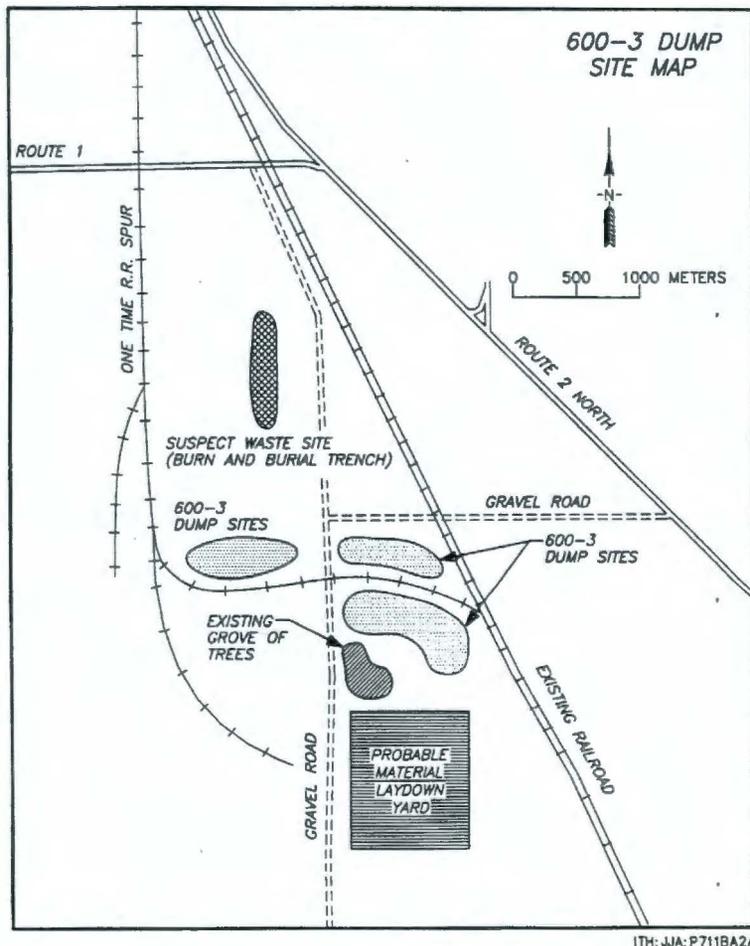
Figure 5. 600-3 Dump Site Map.

Located west of Route 2 North, south of Route 1, and west of the existing railroad line at approximate Hanford coordinates N68000 W33000 (center), the site covers approximately 34 acres and includes multiple dump sites that received various classes of refuse (see Figure 2 for location and Figure 5 for detail).

A site inspection disclosed metal scrap including machine lathe turnings and filings, most of it stainless steel or aluminum; paint contaminants, paint cans, cans and bottles; electrical insulators; small arms ammunition casings; electrical batteries; transite; and other debris. Multiple areas, including a 30-ft radius near the northeast corner of the site, appear to be contaminated with materials that have stained the soil brown and precluded vegetation growth. This 30-ft radius is covered with machining scrap. Bulldozer marks and the manner in which scrap debris protrudes from the surface suggest that the multiple dump sites have been partially covered with soil and that additional scrap exists below grade.

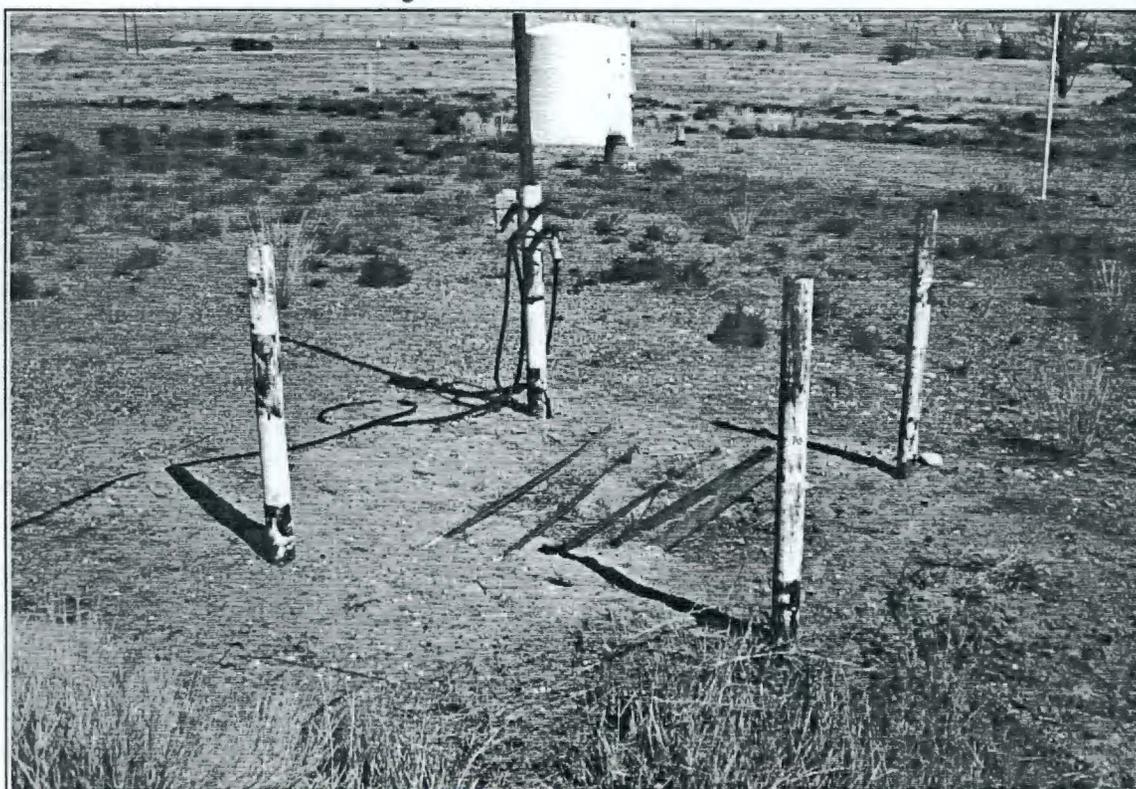
Figure 7. 600-27 Test Well Site.

Several test wells currently exist at this site, including 54-18A (A8855), 6-54-18B (A8856), 6-54-18C (A8857), 6-54-18D (A8858), and others. Two unnumbered and abandoned wells are also located at this site, and it is from one of these that the organic-contaminated groundwater was detected. Both abandoned wells are protected by steel posts (Figure 7).

Small amounts of asbestos transite and other debris are also visible in the general area of the well site.

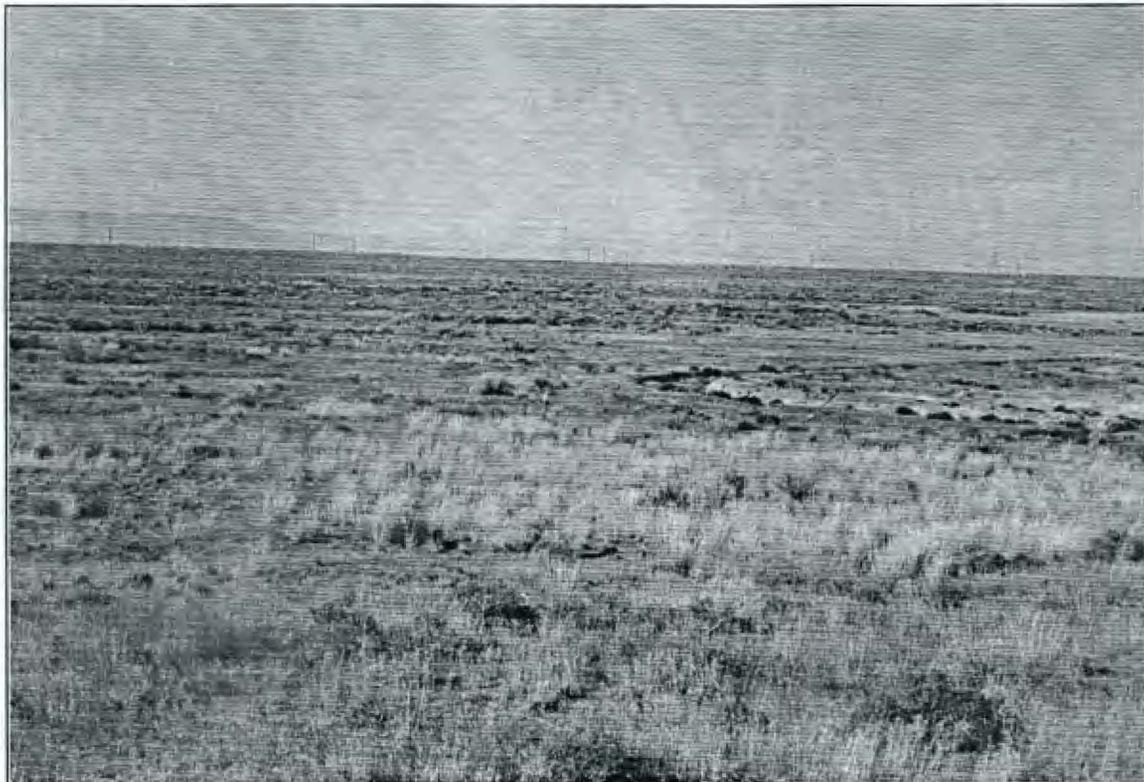
Figure 8. Hanford Townsite Landfill - Horseshoe Bend of Canal.

Miscellaneous metal and glass waste of a type common to community land fills may be found scattered about and protruding from the surface. The surface has been bulldozed. Past employees verify this location, as does Denton and Buslach (1987).

Additional debris may be found immediately south and southeast of the accepted location of the landfill along the outer radius of the horseshoe bend of the canal. This area also appears to have been bulldozed to cover debris, and it is likely that preproject Hanford residents dumped domestic waste along both banks of the canal in the area of the horseshoe bend.

This waste site should therefore be considered to extend to both sides of the canal in the areas described. Figure 8 shows the horseshoe bend of the canal and the landfill to the left and right of the canal.

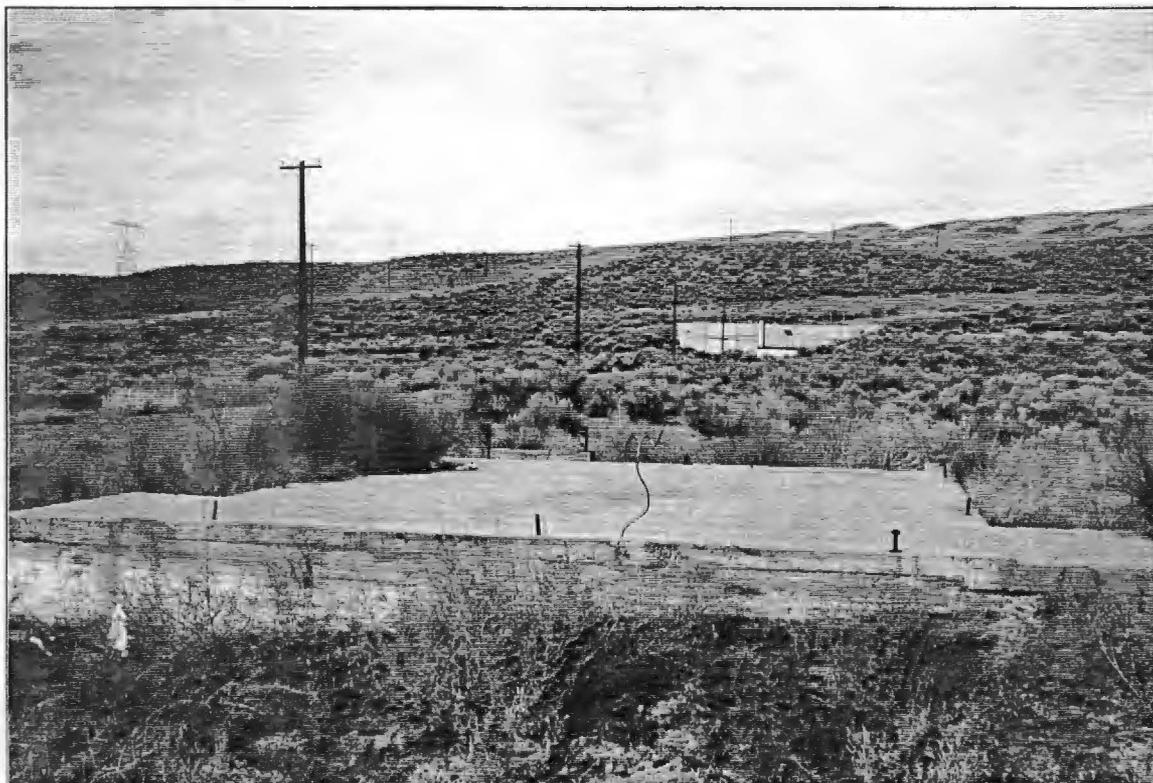
Figure 9. 213-J and 213-K Guard Tower Base and Toilet Pit.

A second guard tower site is located at the northern limits of the security enclosure around the 213-J and 213-K Vault area, but no sewage pit is apparent at this site.

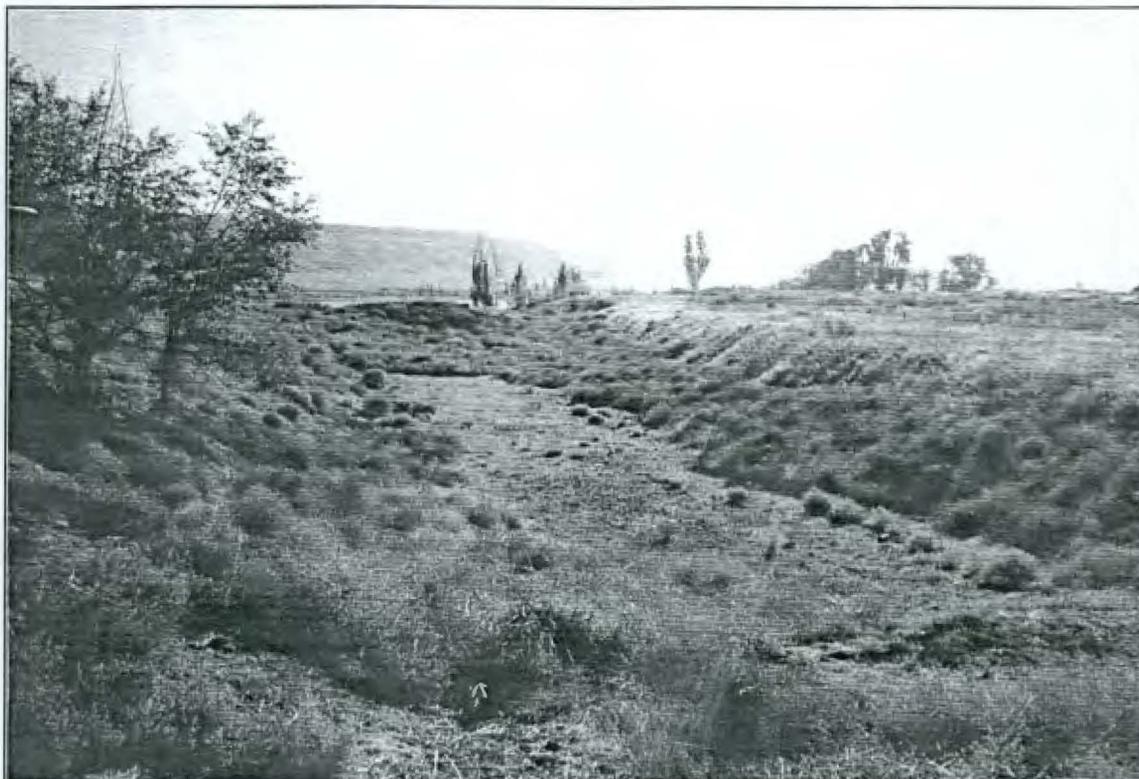
Figure 10. Suspect Waste Site -- Sewage Treatment Plant Trench.

The sewage treatment plants operated from 1943 to 1945 to support the construction camp. These consisted of "baffled chlorine mixing chamber, chlorinator house, and a settling basin 80 x 230 x 4 ft deep and were located on the river side of A Avenue between 4th and 6th Streets and at 10th Street (DuPont 1945) (see Figures 6 and 10).

The treatment plants appear today as rectangular excavations of somewhat larger dimensions than described above (i.e., 15 ft deep). The basins are unlined with soil bottoms and are grass covered. None are protected by barriers or warning signs and present a minor hazard to foot traffic and a more serious hazard to off-road vehicle traffic.

Concrete foundation remnants of the chlorinator buildings are evident at the north end of each treatment plant. Concrete and vitrified clay pipe and pipe rubble are evident in each area.

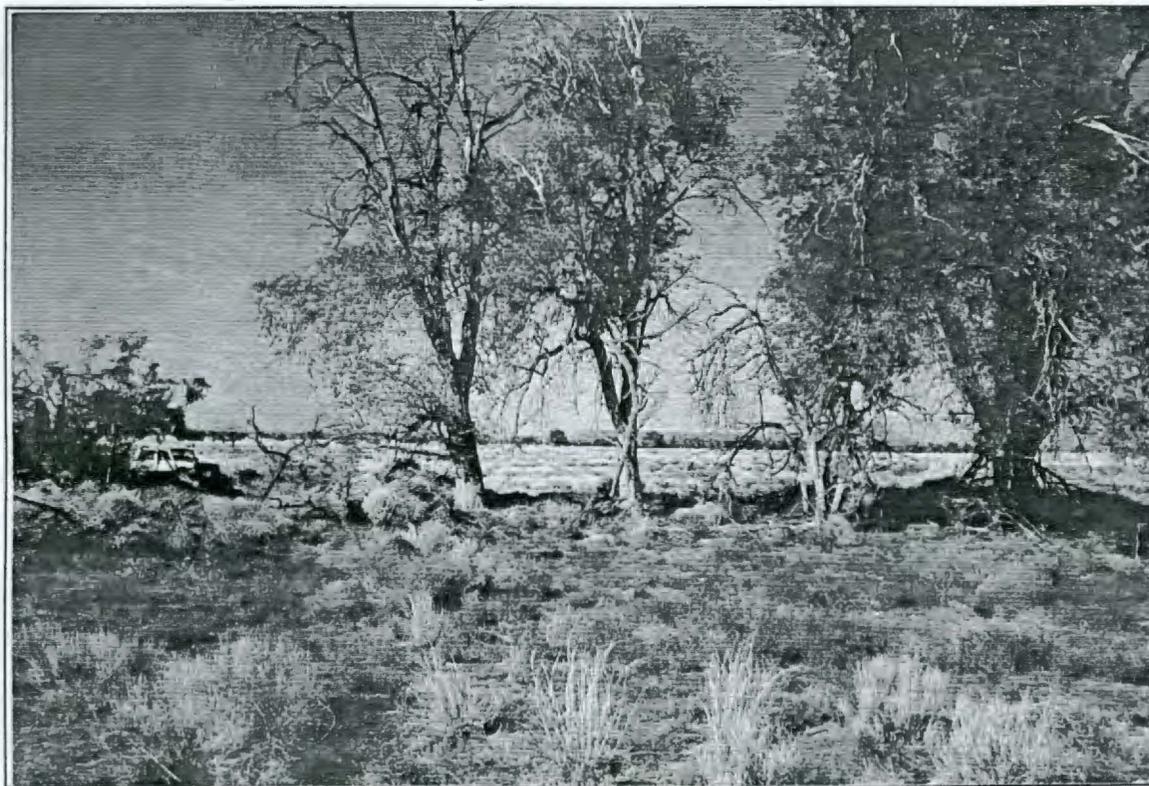
Figure 11. Site of Suspect Waste Site -- Fumigation Chamber.

The site appears today as a grass covered field adjacent to a small grouping of trees. No remnant of the fumigation chamber is evident (Figure 11).

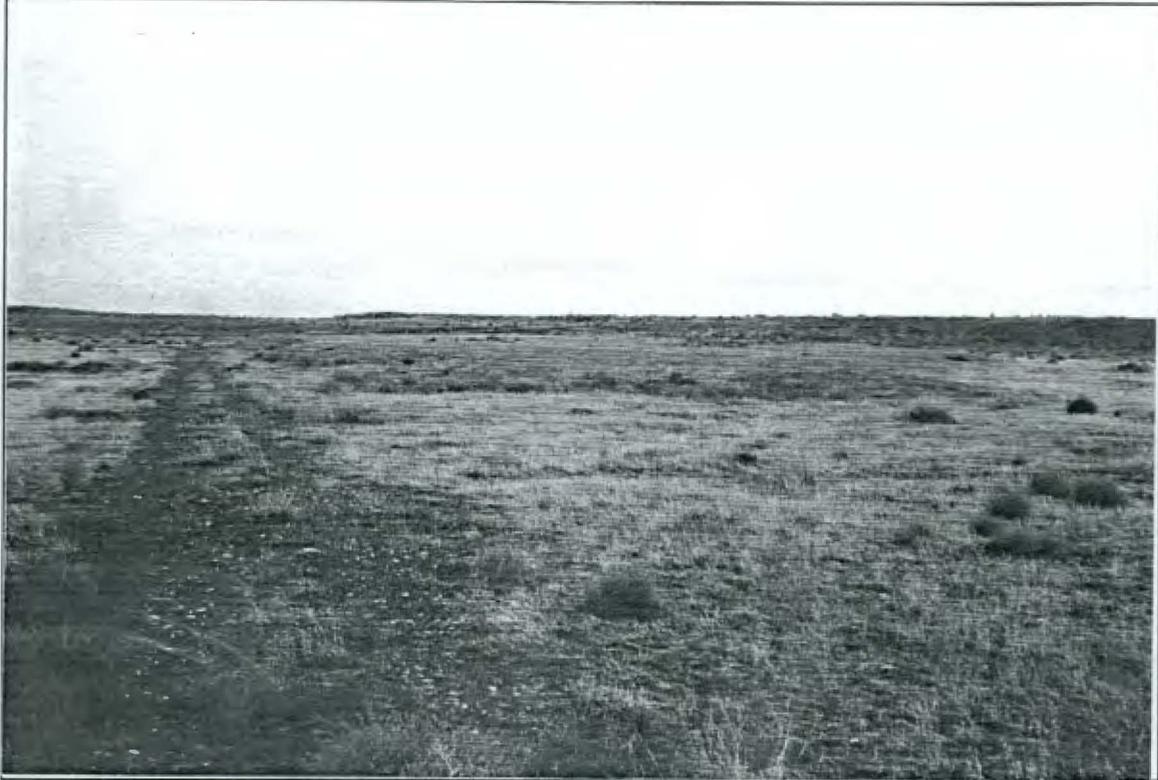
Figure 12. Suspect Waste Site -- Power House Ash Pile.

A large ash pile exists at a site 1/2 mi south of the southern limits of the Hanford Construction Camp (see Figure 6). The pile is pear-shaped and oriented north to south with the wider portion to the south. It is about 250 x 60 x 10 ft deep. The ash appears characteristic of power house ash and probably came from coal fired power houses used at the Hanford Construction Camp (1943 to 1945). The dirt road leading to the site has been overlaid with ash (Figure 12).

A small ash pile may be found a few yards northwest of the large pile. No records could be located to characterize the site or verify its source.
