TRANSMITTAL OF APPROVED WASTE SITE RECLASSIFICATION FORM AND SUPPORTING DOCUMENTATION FOR THE 600-378, 506 TELEPHONE EXCHANGE EMERGENCY GENERATOR BUILDING UNDERGROUND FUEL STORAGE TANK WASTE SITE, REVISION 0

WASTE SITE RECLASSIFICATION FORM

**REMAINING SITES VERIFICATION PACKAGE FOR THE
600-378, 506 TELEPHONE EXCHANGE EMERGENCY
GENERATOR BUILDING UNDERGROUND
FUEL STORAGE TANK WASTE SITE**

Attachment to Waste Site Reclassification Form 2014-051

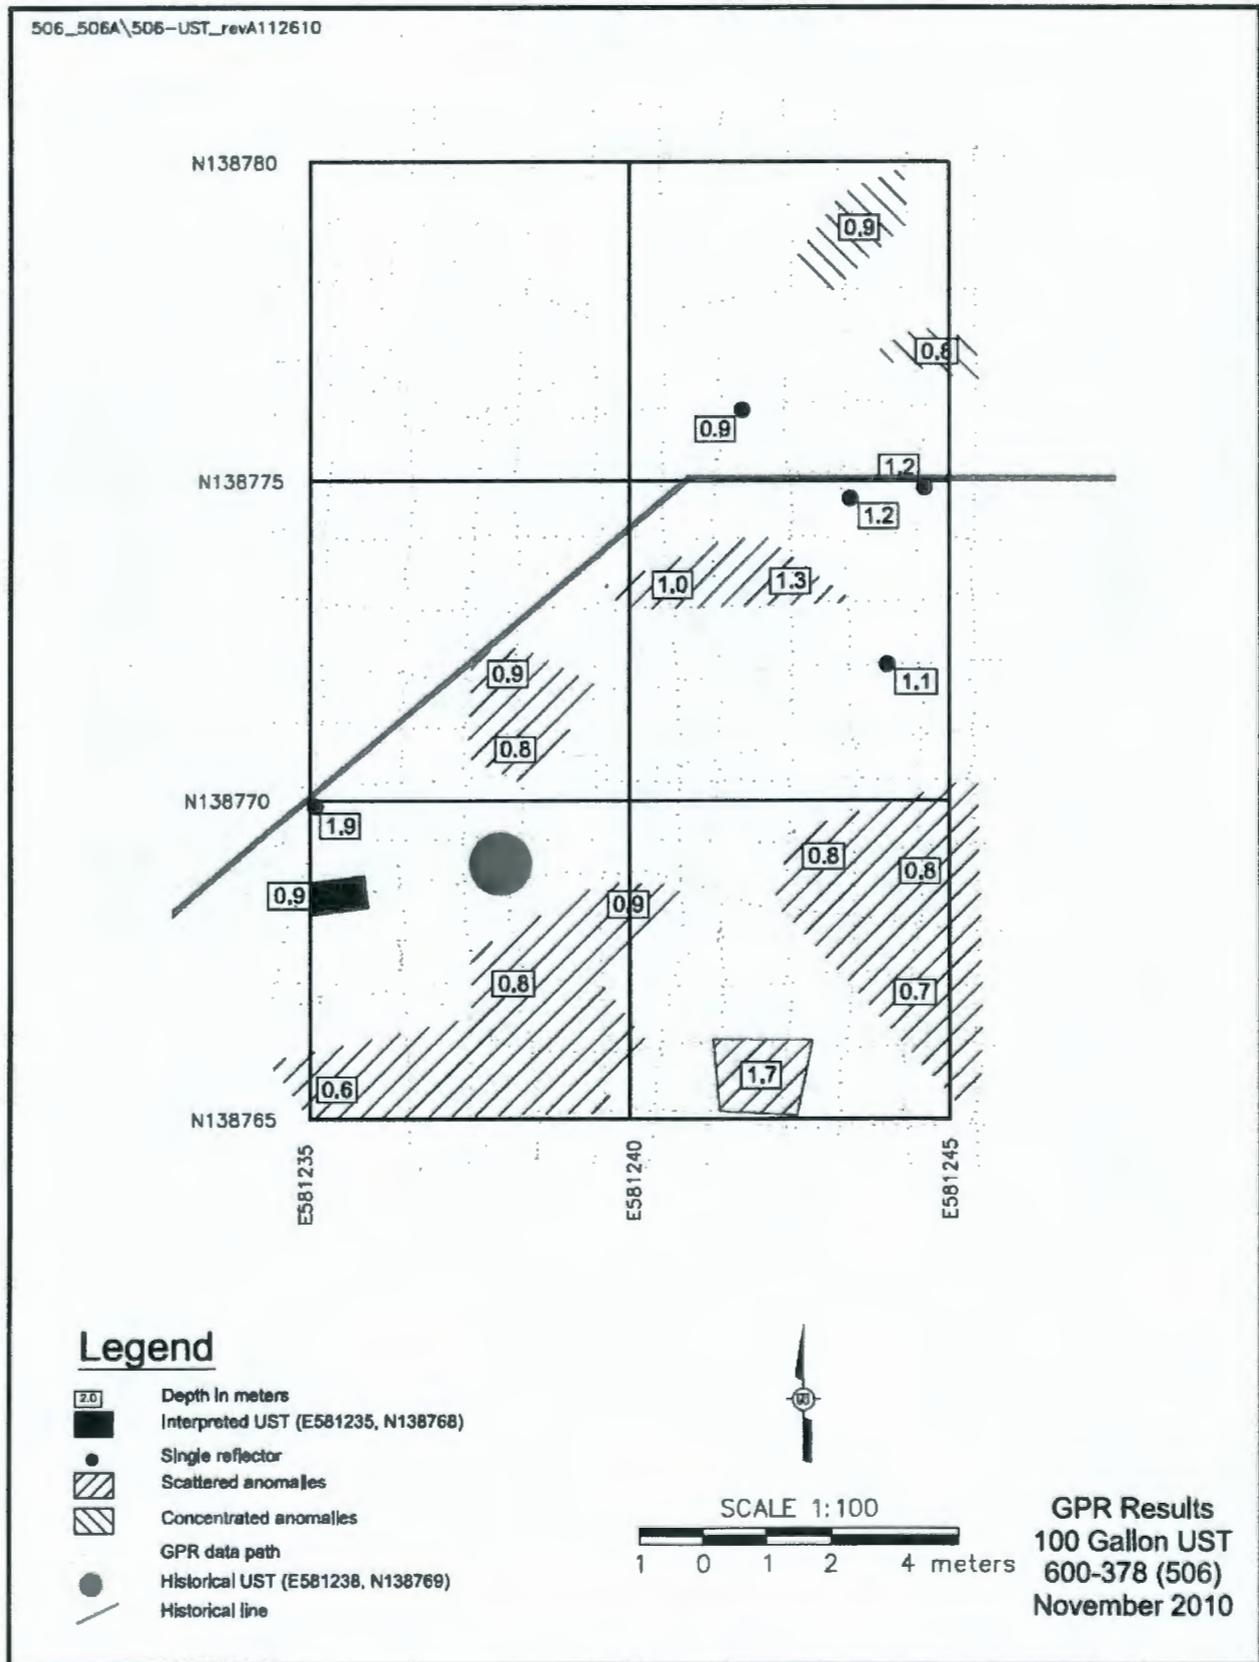
Figure 2. Geophysical Interpretation Map for the 600-378 Waste Site.

A geophysical survey was performed in November 2010 for the historical area of the potential UST (WCH 2011b). An anomaly representative of a UST was found approximately 2 m (6.6 ft) west of the suggested historical location. Much of the area was surveyed with ground-penetrating radar and EM-31 and EM-61 electromagnetic induction that detected areas of scattered debris, often metallic in nature, which is representative of a facility that has been demolished in place.

Figure 2 shows a geophysical interpretation map with the suggested historical location and the location determined by the geophysical investigation to be where the UST was likely to be found (at WSP coordinates N 138768.8, E 581237.9). The top of the UST was anticipated to be approximately 0.9 m (3 ft) below ground surface (bgs).

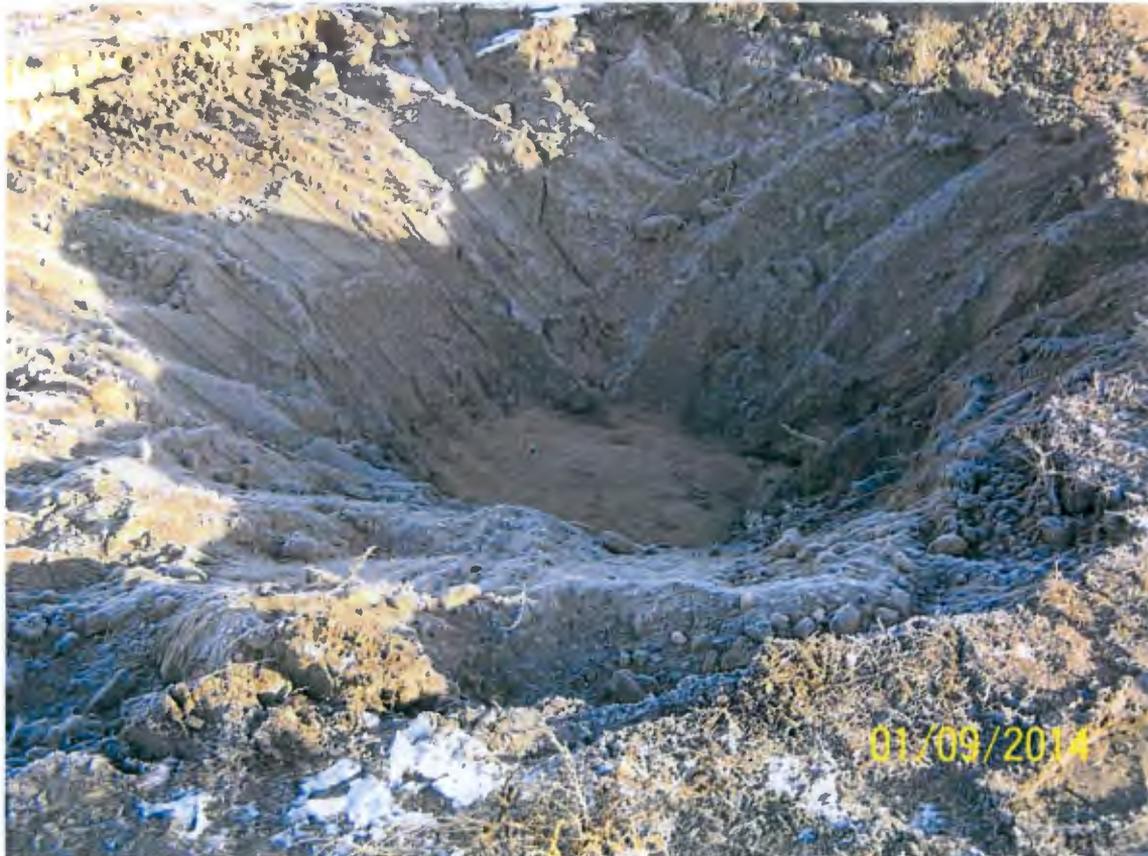
Figure 3. Photograph of the 600-378 Waste Site Excavation Looking Northeast (January 9, 2014).

As the excavation continued, some burned debris including burned wood debris was found at 0.9 m (3 ft) bgs on the northwest side of the excavation. This burned material was only partially removed because it is not associated with the 600-378 waste site fuel tank. Approximately 7.5 bank cubic meters (BCM) (9.8 bank cubic yards [BCY]) of soil and debris was removed and direct loaded for disposal at the Environmental Restoration Disposal Facility (ERDF). No overburden soil was stockpiled to be used as backfill. A post-remediation photograph is shown in Figure 3.

Remediation of the 600-378 waste site began on December 18, 2013. A 379 L (100 gal) underground fuel tank was discovered 0.46 m (1.5 ft) bgs. The tank was found to be completely empty of contents and positioned sideways as shown on drawing H-5-548 (Appendix B). Remediation of the 600-378 waste site continued on January 8, 2014, to remove and dispose the underground fuel tank and underlying soil. While removing the fuel tank, it was noted that the valve attached to the tank was broken off. After removing the tank from the excavation and loading it for disposal, dark black staining was observed below the tank. However, after excavating through the stained soils it was noted that the black staining under the fuel tank was the result of the dust-suppression water applied to the inside of the tank.

The two pipeline segments that connected to the fuel tank (Appendix B) were found and removed for disposal. A 0.6-m (2-ft)-long, 2-in.-diameter galvanized steel (Schedule 40) pipeline was observed buried beside the fuel tank. As shown in Appendix B, Figure B-2, this pipe was a fill pipe that connected to the top of the fuel tank. A copper 3/8-in.- diameter pipeline that trended east and connected to the generator structure was also found within the excavation. Concrete debris was uncovered on the east side of the excavation, consistent with the location of the 508 Emergency Generator Building.

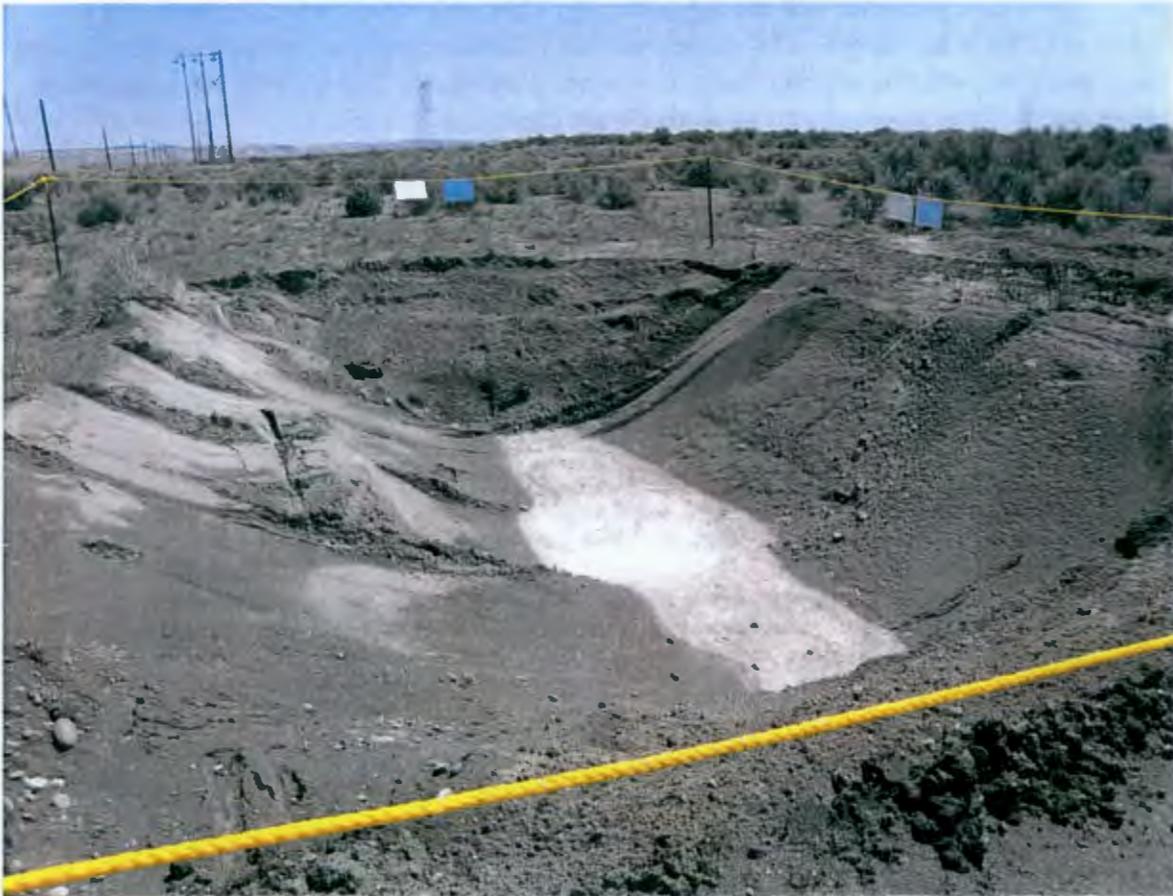
Figure 4. Photograph of the 600-378 Waste Site Excavation, Following Additional Remediation – Looking East (May 15, 2014).

Verification sampling performed on February 25, 2014, indicated that benzo(a)pyrene was above the direct exposure cleanup criteria at sample location FS-3. Additional remediation was performed on April 30, 2014, to remove contaminated material from the excavation. The entire 600-378 excavation was re-excavated (Figure 4). Approximately 36 BCM (47 BCY) of soil was removed and direct loaded for disposal at ERDF. The final excavation depth is approximately 2.2 m (7.2 ft) bgs.

Remediation of the 600-378 waste site resulted in a total excavation of approximately 43.5 BCM (56.8 BCY) of contaminated soil and debris that was direct loaded for disposal at ERDF. No stained soils were visible within the excavation during and after remediation.

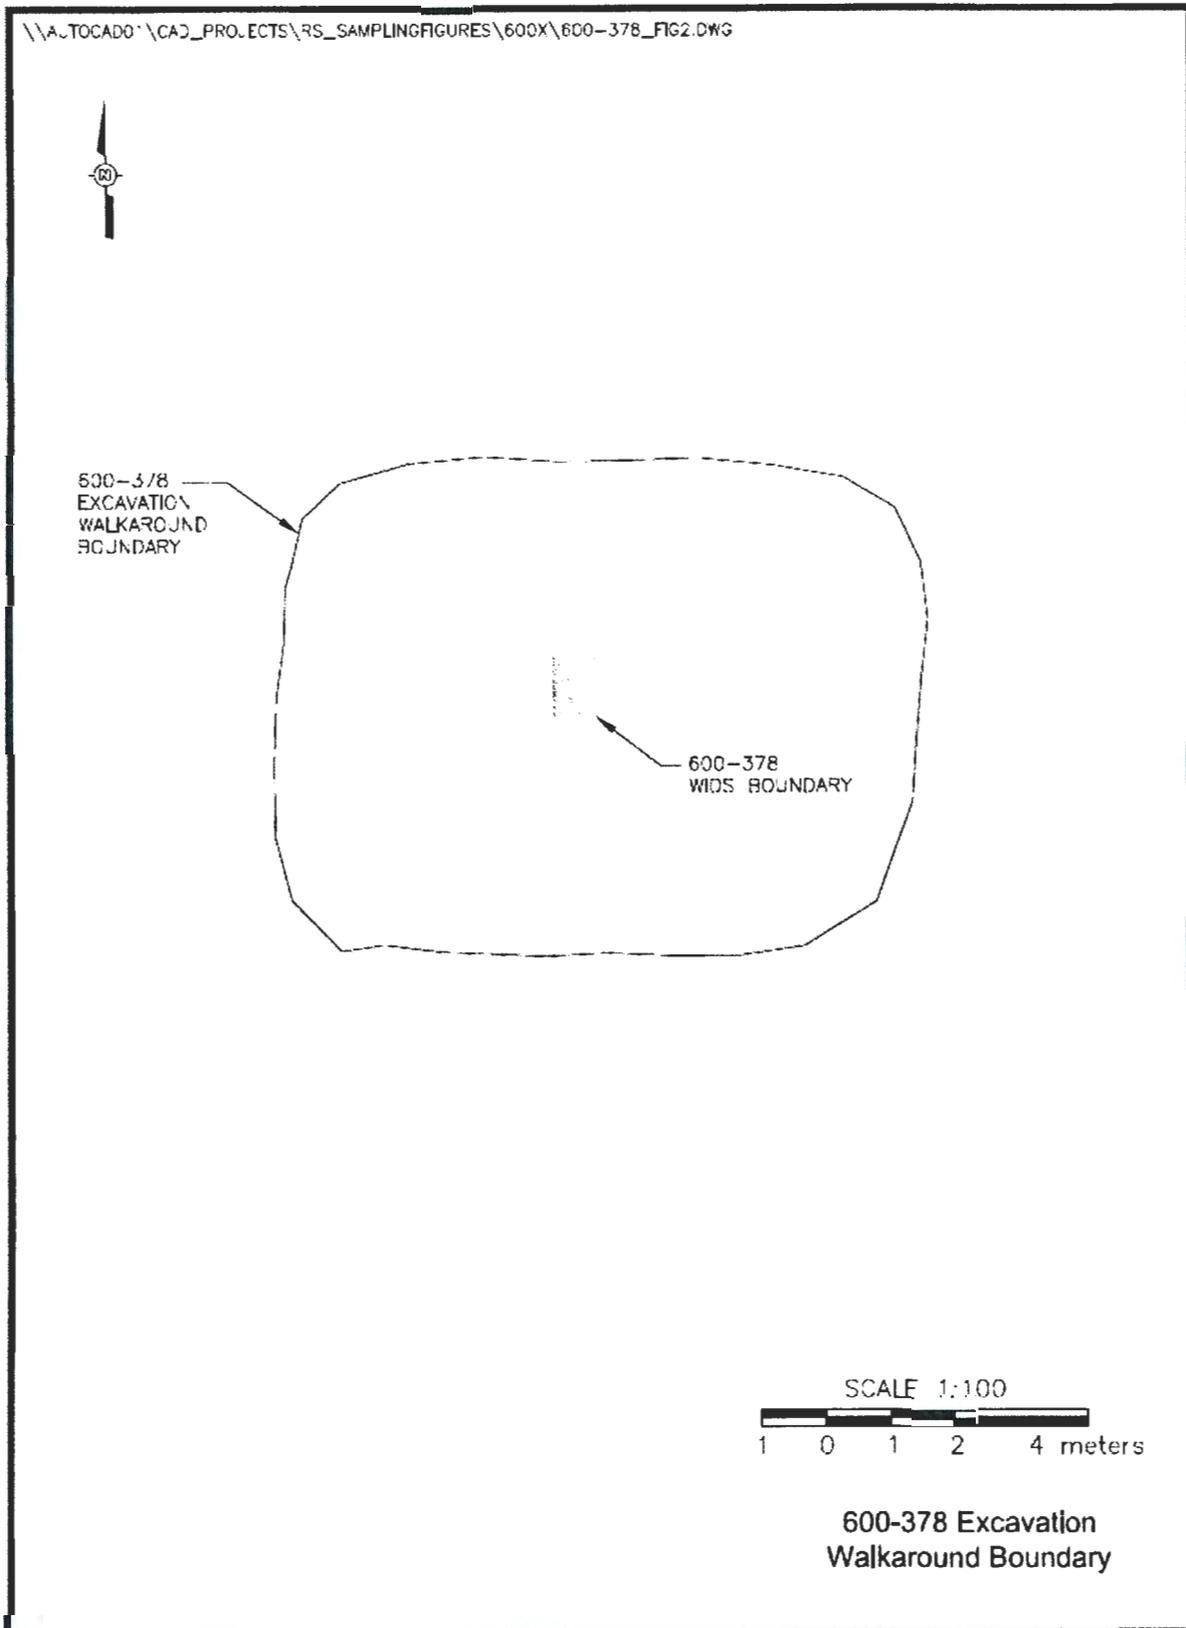
Figure 5. The 600-378 Waste Site Post-Excavation Boundary, Following Additional Remediation.

Following remediation, a boundary walkaround survey of the 600-378 waste site excavation was performed and is shown in Figure 5. Due to the small size of the excavation (approximately 4 m by 6 m [13 ft by 20 ft]) a focused sampling plan was developed. The FS-1 sample location was the approximate area where the fuel tank was found. Sample location FS-2 was the approximate location of the 3/8-in.- diameter copper fuel pipeline that connected the fuel tank to the generator. The FS-3 sample is the location of the northern section of the excavation, where some burned material was observed. According to the available historical drawings and photographs of the 600-378 waste site, it is likely that the tank was filled at the north side of the tank through a fill pipe that connected to the top of the tank. Therefore, FS-3 also accounted for this location. Verification sampling performed on February 25, 2014, indicated that benzo(a)pyrene was above the direct exposure cleanup criteria at sample location FS-3. Additional remediation was performed at this location, as discussed in the Remedial Action Summary section of this remaining sites verification package. Sample location FS-4 was focused to sample the southwest section of the excavation.

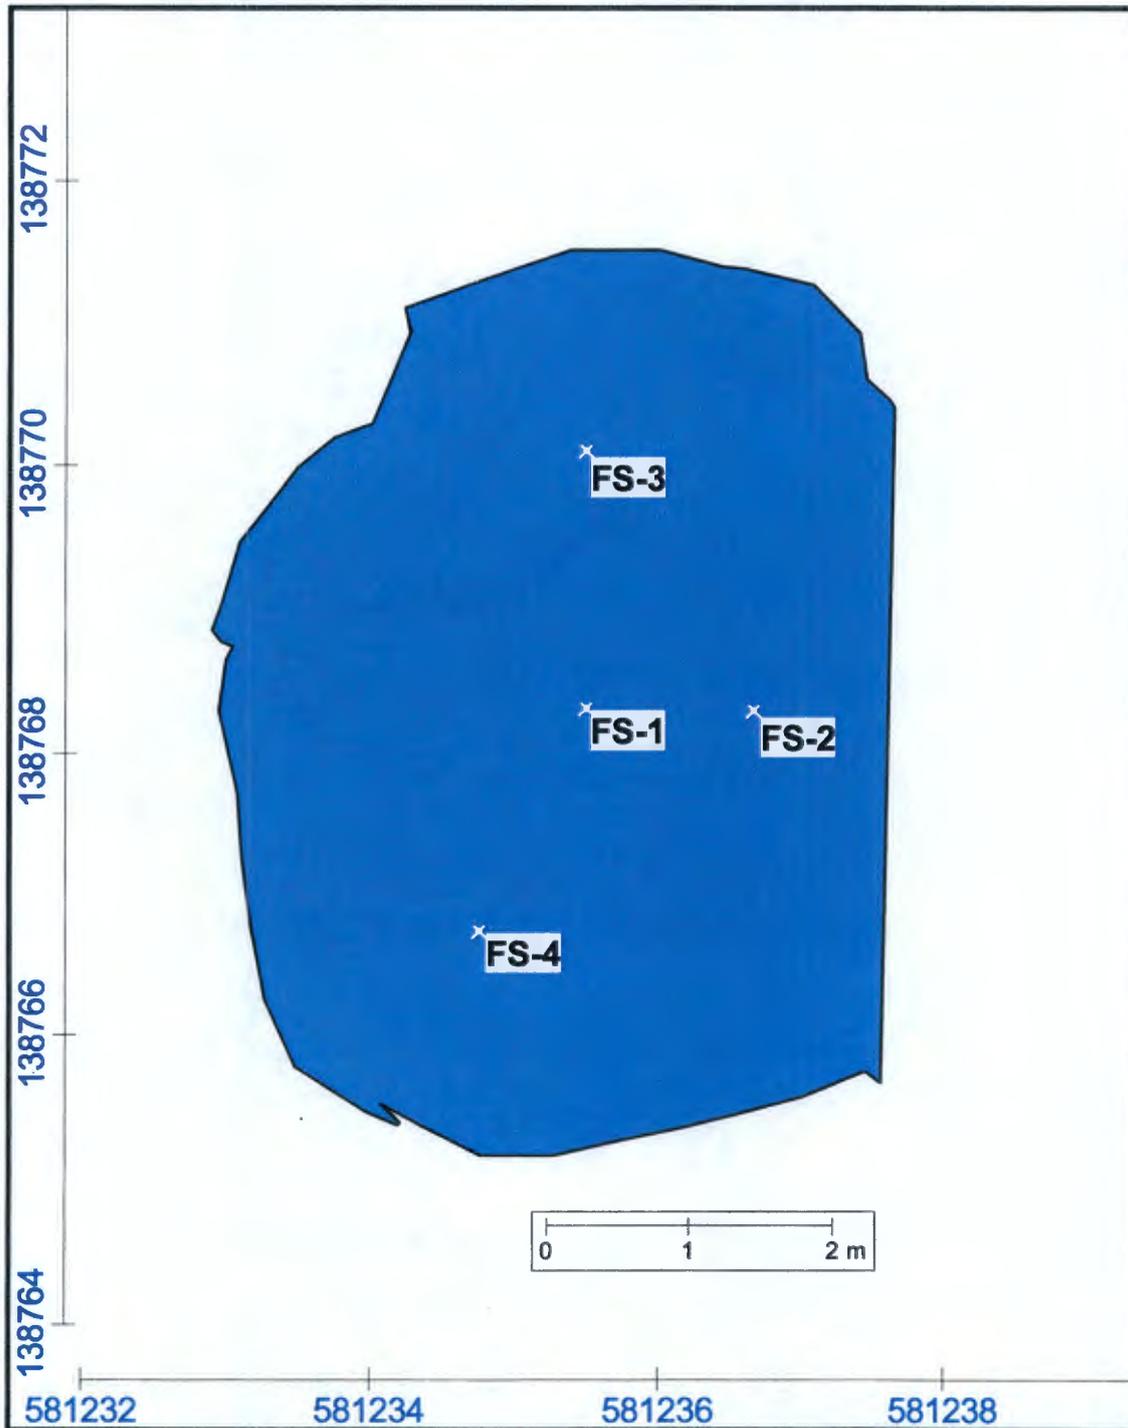
Figure 6. 600-378 Waste Site Verification Sample Locations.

The 600-378 waste site verification sampling locations map is shown in Figure 6. Additional information related to verification sampling can be found in the field sampling logbooks (WCH 2014a, 2014b). A summary of the verification samples collected and laboratory analyses performed is provided in Table 2.
