CWR-PFP-00002
Revision 0

2904ZA AND 2904ZB Demolition Report

As Left Characterization

Document Type: RPT Program/Project: PFP Closure

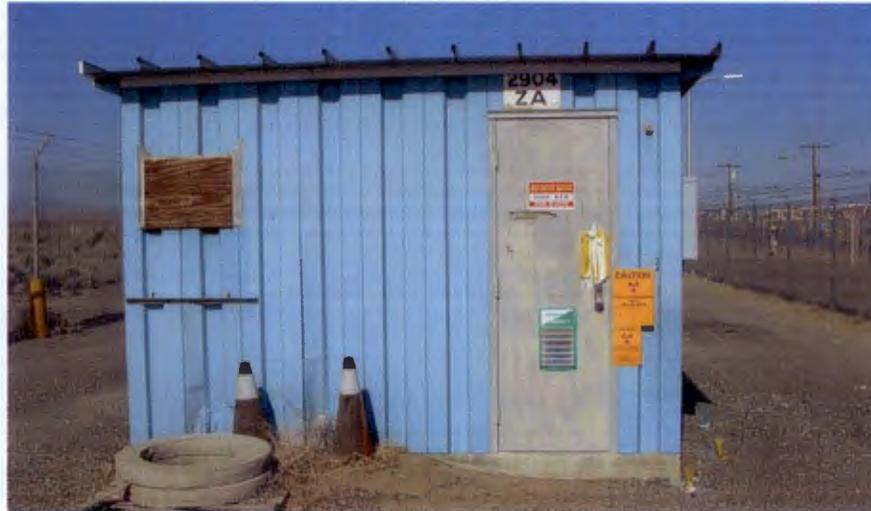
Figure 1. 2904ZA Building Before Demolition

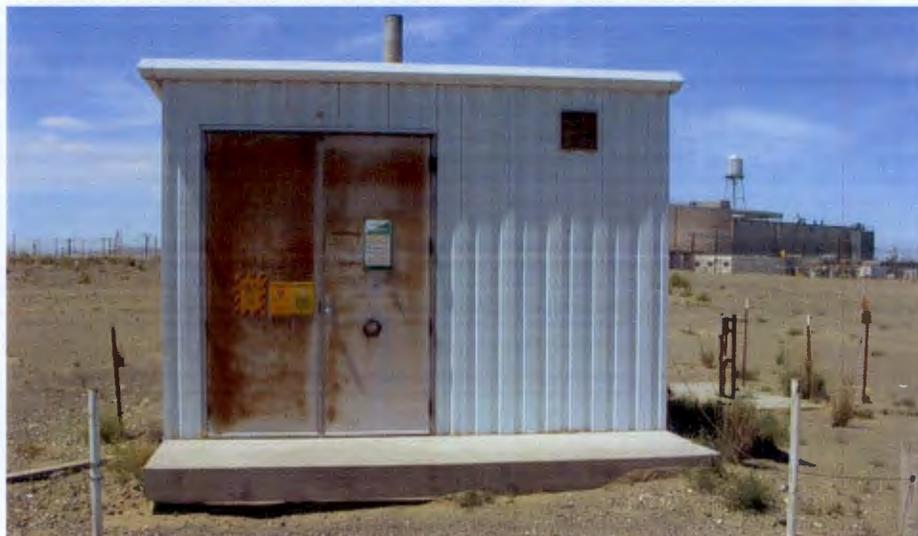
Figure 2. 2904ZB Building Before Demolition

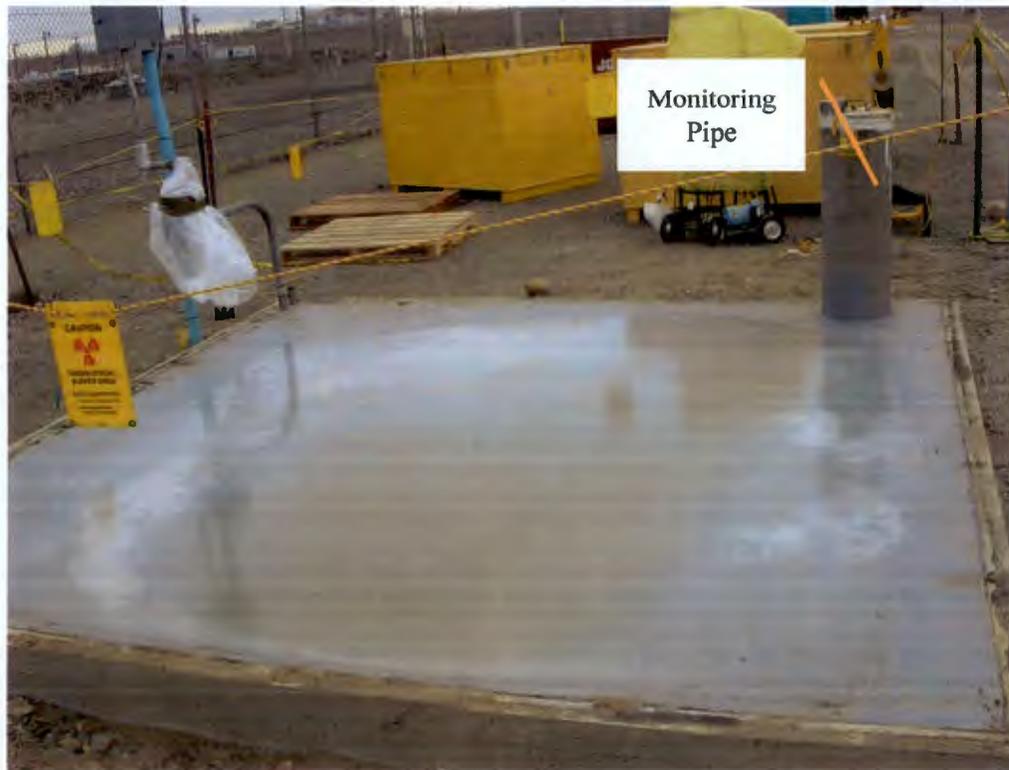
Figure 3. 2904ZA Building Monitoring Pipe

Radiological characterization of the two buildings was based on both process knowledge and predemolition radiological surveys. While the surveys reflect no detectable removable contamination at the time of demolition, the narrative in the 2904ZA work package (2Z-04-05401) reflected that removable contamination was encountered in the southeast corner of the building, in the area around the 12 in. monitoring pipe and on the floor that was fixed with paint prior to dismantling the building. After demolition, the 12 in. monitoring pipe in 2904ZA (Figure 3) was brought down to slab level.

The package narrative noted that no contamination was detected during size reduction of the monitoring pipe. Subsequently, both slabs were covered with a new concrete slab. Copies of the predemolition radiological surveys are included in CWR-PFP-00002-ADD1.

- **Below-grade:** No direct survey of the below-grade portion of the monitoring pipe was conducted. While the work package indicates that no contamination was detected while size reducing the monitoring pipe, the slab contamination indicated that sampling activity in the past had resulted in contamination in the building. This is corroborated by the event described in BHI-00174, involving an estimated 30 to 60 g of alpha activity accidentally released on March 25, 1976 from the Z Plant complex into the 216-Z-19 Ditch. The release described would have been detected and sampled in the 2904ZA Building. Two additional events in BHI-00174 described that levels of the microcuries per liter order of magnitude were detected in 1984 and 1985 and discharged to the 216-Z-20 drain field.

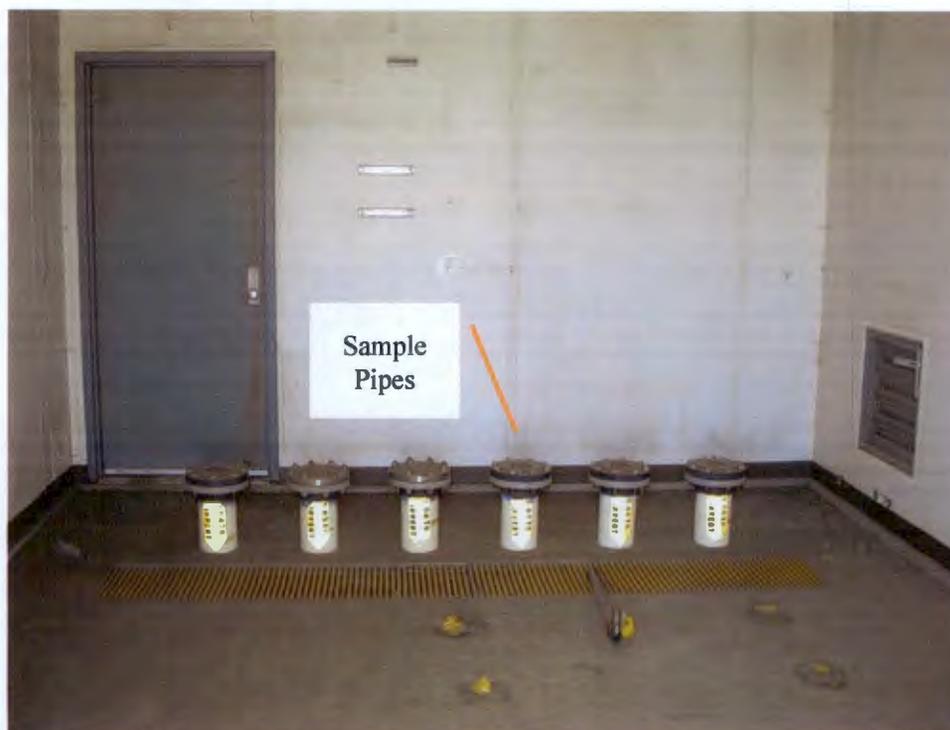
Figure 4. 2904ZB Building Sample Pipes

- **Slab:** As discussed in Section 2.1, no fixed or removable contamination was detected on the 2904ZB slab. The 2904ZB slab interior photograph (Figure 3) shows no evidence of paint on the floor.
- **Below-grade:** No direct survey of the below-grade portion of the pipes was conducted. Based on the liquid process waste history during the period the building operated, low levels of activity may be expected in the below-grade portion of the piping.

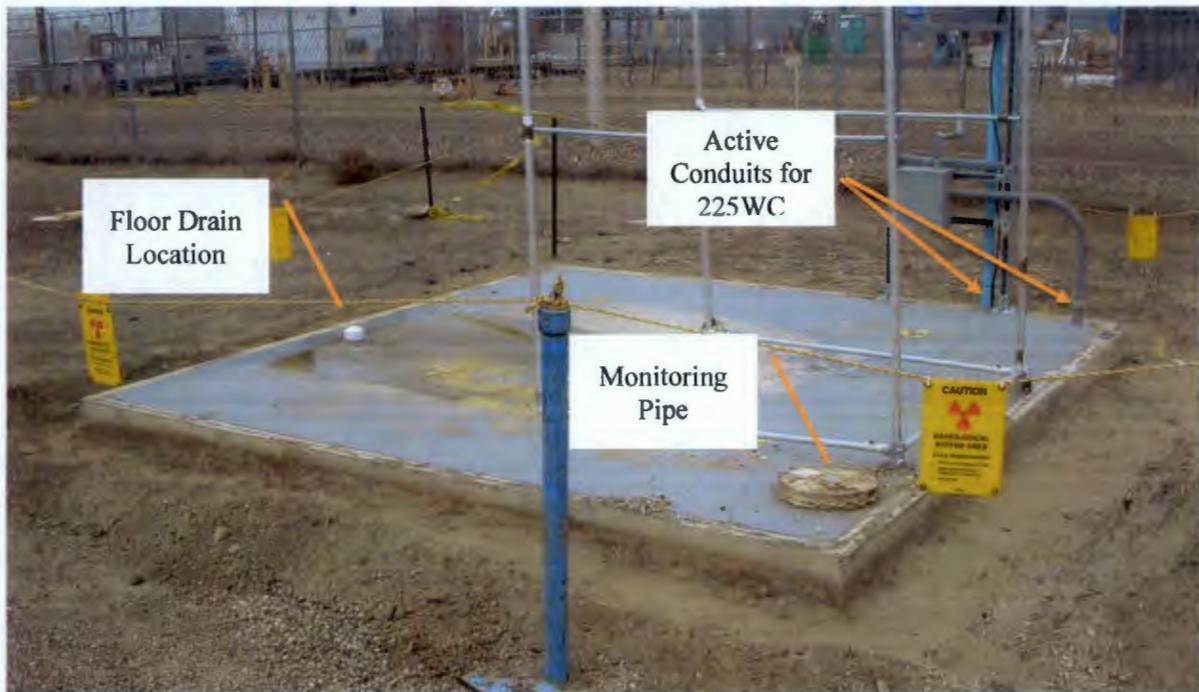
Figure 5. 2904ZA Slab Prior to Slab-on-Slab Installation

- **Slab:** As discussed in Section 2.1, removable contamination was noted on the 2904ZA slab prior to demolition that had been painted over. Figure 5 is a photograph of the 2904ZA slab after demolition that shows evidence of yellow paint, implying more extensive contamination on the building slab. It was common practice to use a coat of yellow paint as a warning indicator to fix contamination then cover it with a layer of grey. Based on the paint color palette developed as part of the PFP characterization effort, yellow and grey paint on the surface of the slab can be expected to contain heavy metals of cadmium, chromium, lead, and mercury as well as elevated levels of polychlorinated biphenyls.

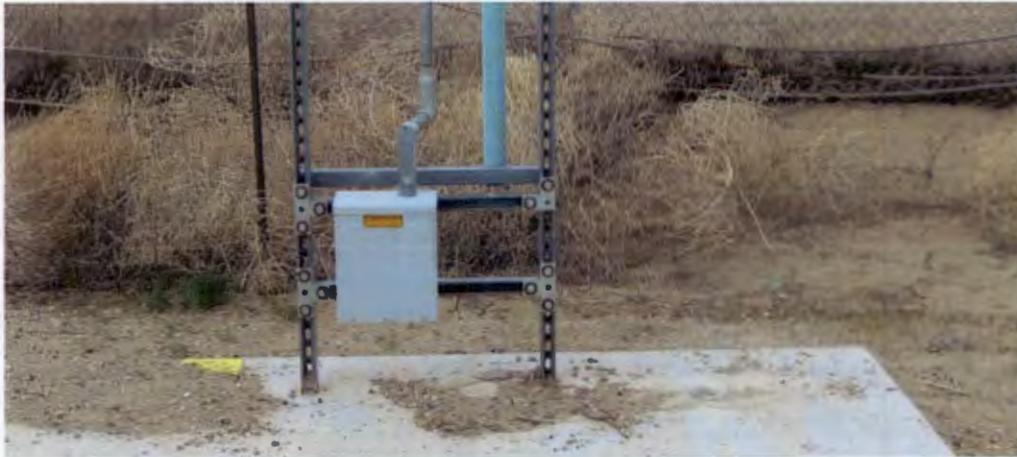
Demolition of 225WC completed the electrical isolation and sealing of the remaining circuits at the 2904ZA slab under work package 2Z-16-0091, *Isolate and Demolish Building 225WC* (Figure 6).

Figure 6. 2904ZA Slab May 2016 Conduits Cut and Sealed

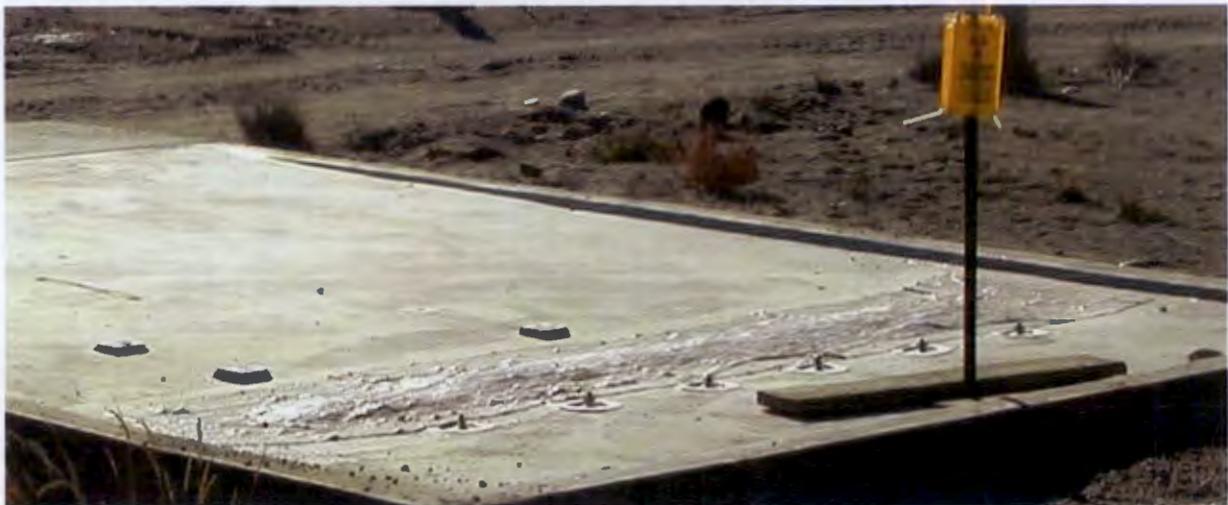
Mechanical isolation of the two structures was performed under the respective work packages. In the case of 2904ZA, the floor drain was noted in the work package as being previously sealed with grout. The 12 in. monitoring pipe (Figure 3) was cut down to slab level and capped after demolition (Figure 5). In the 2904ZB Building, the remaining sample port risers were cutoff near floor level expandable plugs installed in sample pipes and floor drain, and the drain trench was filled (Figure 7).

Figure 7. 2904ZB Slab Prior to Slab-on-Slab Installation

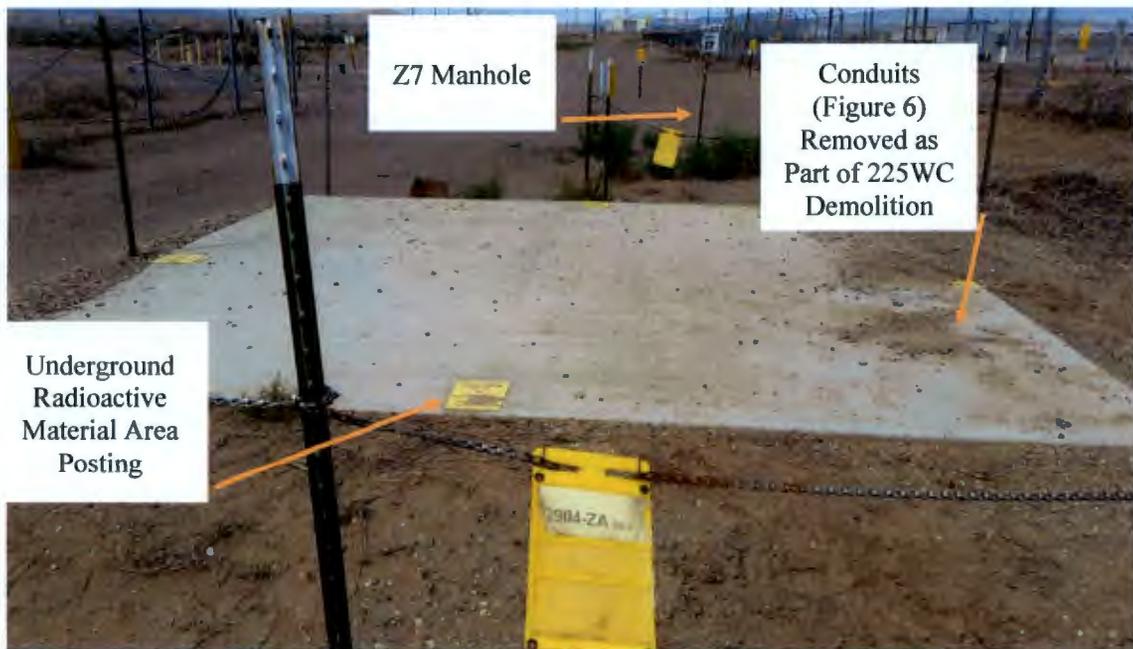
Figure 8. 2904ZA Slab after Slab-on-Slab Installation and Conduit Removed

The 2904ZA and 2904ZB slabs (Figures 8 and 9) were left in a clean slab-on-slab at grade condition. Both 2904ZA and 2904ZB were capped with a new concrete cap slab-on-slab. Any minor in slab contamination was sealed with no contamination on the surface. Manholes adjacent to the slabs were left accessible and managed under the PFP confined space program until turnover to S&M. The Z7 manhole (PFP confined space #81) west of the 2904ZA slab (Figure 8) remains active and supports the TEDF storm drains located on the south side of PFP. The Z9 manhole (PFP confined space #84 and S&M confined space # 0382), north of the 2904ZB slab (Figure 9), is inactive and remains open to support future remedial investigation of the 216-Z-20 Crib. The area around both buildings is considered an underground radioactive area due to adjacent waste sites.

After removal of the building and plugging all drain holes, a concrete control cap was installed on both slabs per drawing H-2-831931, *Civil Contamination Control Cap Details*. The control cap extended out (approximately 12 in.) from the original slab, effectively sealing the conduits to the building, with the exception of the active conduits on the 2904ZA slab, which were subsequently cut and sealed in 2016. The as-left condition is shown in Figures 8 and 9.

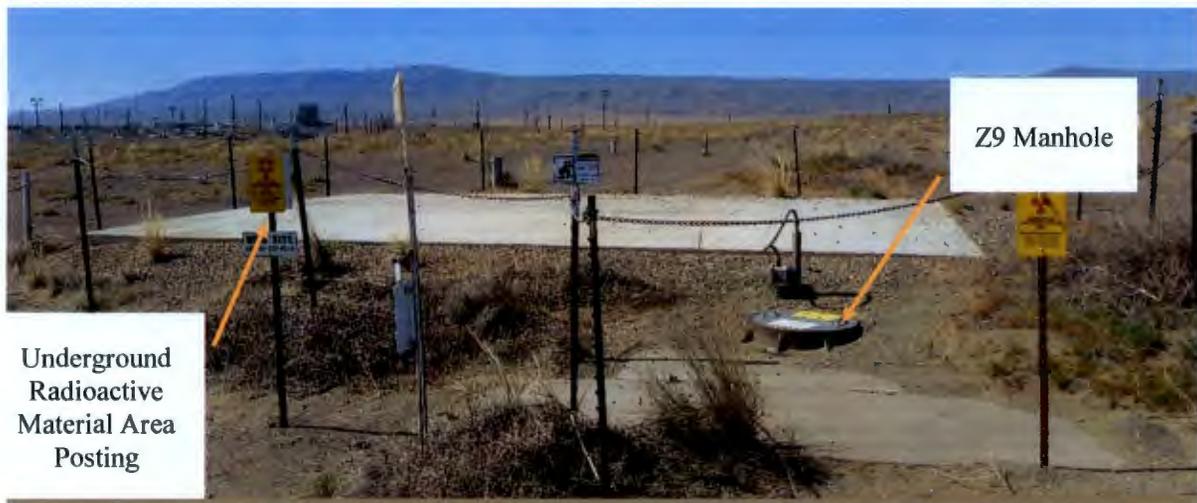
Figure 9. 2904ZB Slab after Slab-on-Slab Installation

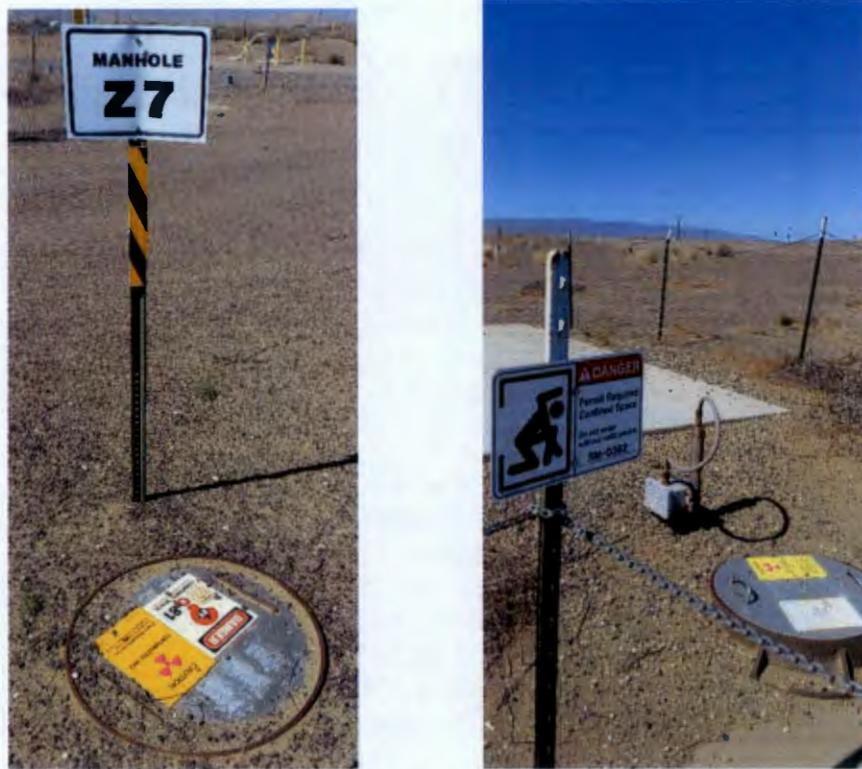
As discussed in Section 4.1.4, manholes Z-7 and Z-9 (Figure 10) represent confined space hazards adjacent to the sites. These confined spaces are properly marked and currently managed within the PFP confined space program. Because of the installation of an additional slab on top of the existing slab, both slabs are elevated above-grade; to mitigate any potential tripping hazards, a chained barrier is installed around each slab. No other industrial safety hazards were identified during the walkdown.

At the time of this report, steam condensate and some surface drains continue to discharge to TEDF and pass through manhole Z-7. The Z-9 manhole is essentially part of the 216-Z-20 site, and it has a S&M confined space posting as well as the PFP posting. The final disposition of these and the other various manholes and turnover of the associated confined spaces will be addressed as part of the administrative endpoint requirements. Since these sites are located outside the protected area, the radiological postings at the sites must be maintained.

Figure 10. Manholes Z7 and Z9
