**FACILITY STATUS CHANGE FORM**

<b>Date Submitted:</b> August 1, 2013	<b>Area:</b> 300 Area	<b>Control #:</b> D4-300-020-1
<b>Originator:</b> Chris Strand	<b>Facility ID:</b> 3716	
<b>Phone:</b> 554-2720	<b>Action Memorandum:</b> Action Memorandum #1

# FACILITY STATUS CHANGE FORM

## Attachment 2: Project Photographs

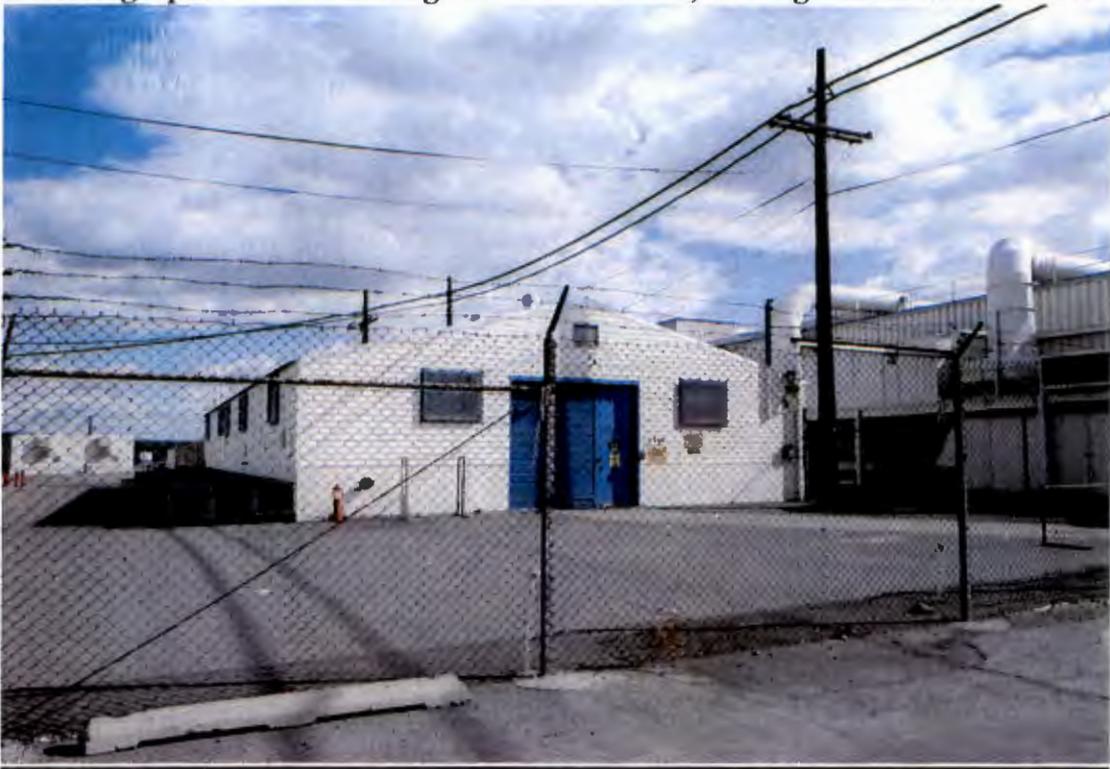
**Photograph 1. 3716 Building before demolition, looking west in March 1987.**

The 3716 Building was a 4,800 square feet corrugated metal, steel framed structure resting on a reinforced concrete slab. It was originally constructed in the 1940's as the TC-36 Automotive Repair Shop. The structure was mounted 1.3m (4 ft) above grade on concrete wall with concrete floor slab on grade. In 1962, the building was relocated from its original location to a site just south of the 333 building and renamed as the Metallurgical Development Laboratory.

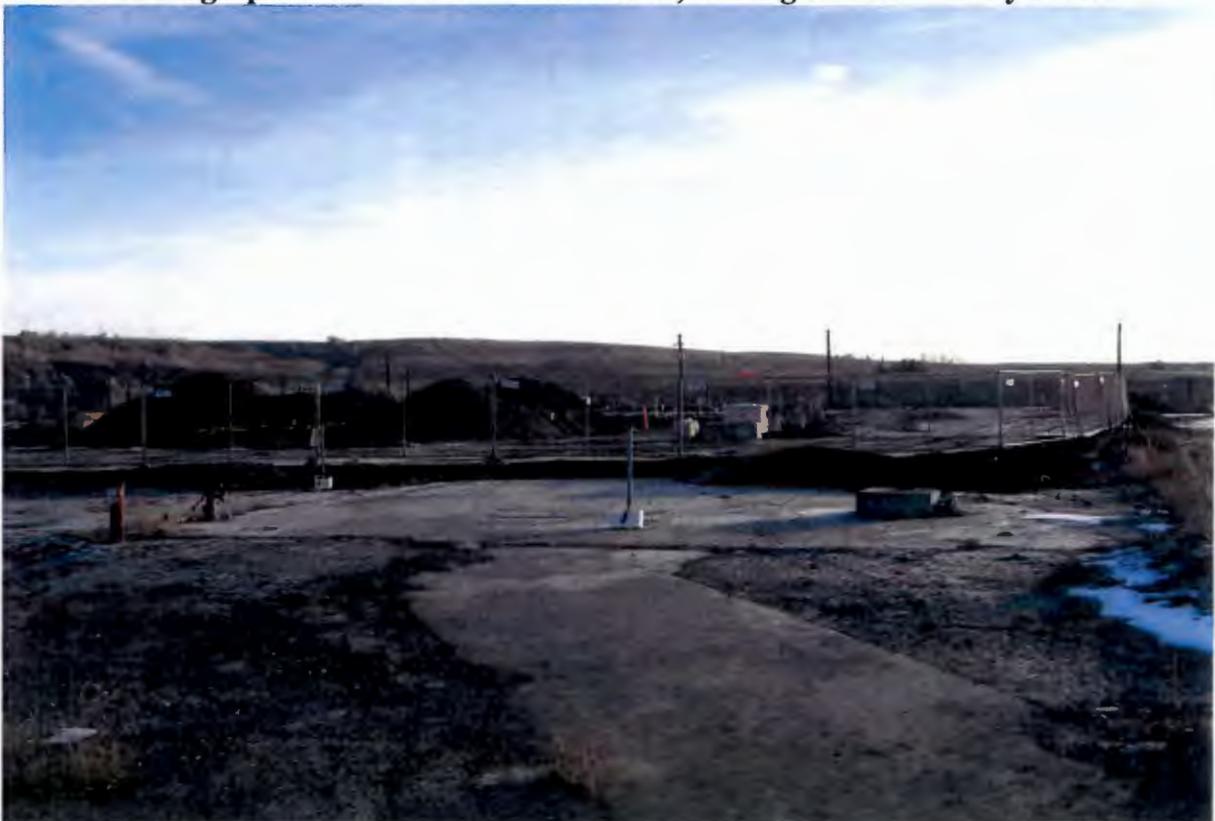
**Photograph 2. 3716 site after demolition, looking east on January 2006.**

Demolition: Demolition of the above-grade structures was completed in January 2006 with building debris disposed of at ERDF. Demolition of the slab and foundation were at that time deferred to adjacent waste sites UPR-300-17 and 300-15 remedial actions (reference D4-300-020). Both waste sites underwent subsequent remedial actions that were performed in 2009 and 2012 respectively.

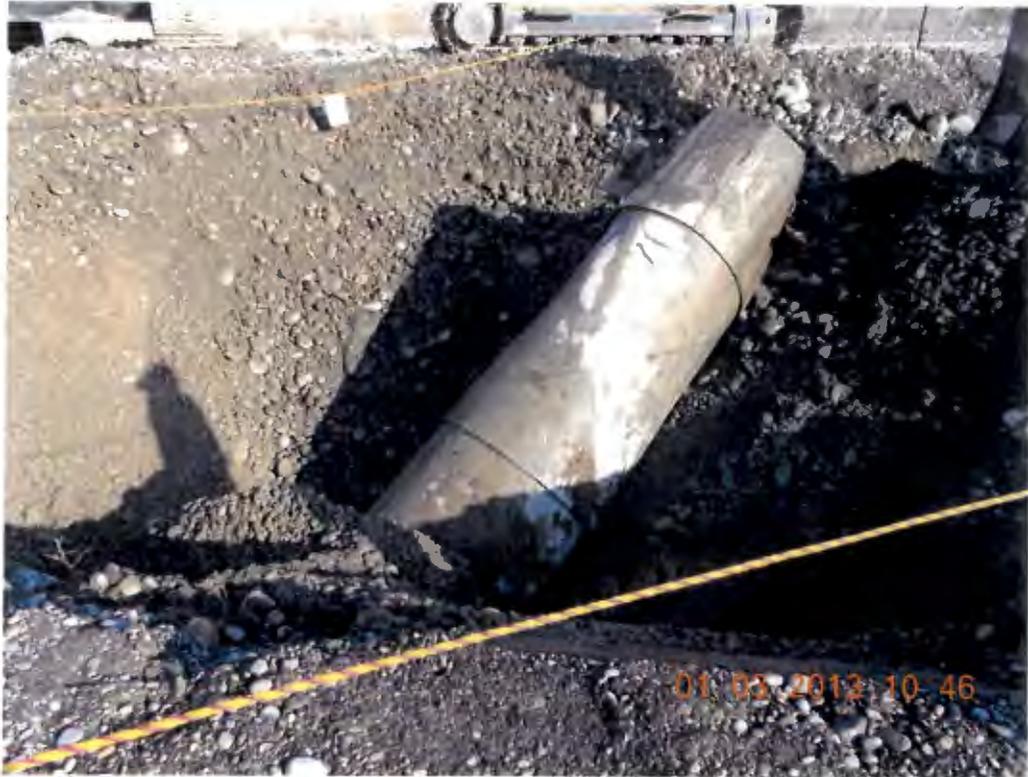
**Photograph 3. 3716 press pit during removal, looking on January 2013.**

Following below-grade demolition of the slab, foundation, and press pit, the area underwent closure verification sampling and GPERS surveys were performed. The excavation was then backfilled with clean fill and revegetated in February of 2013.
