FACILITY STATUS CHANGE FORM

Date Submitted:	Area: 200W	Control Number: D4-PFP-028
Originator: James Leary	Facility ID: 243ZA	Phone: 509 942-6675

243ZA, Low Level Waste Storage Facility

Attachment 2: Pre-Demolition and Post-Demolition Photographs

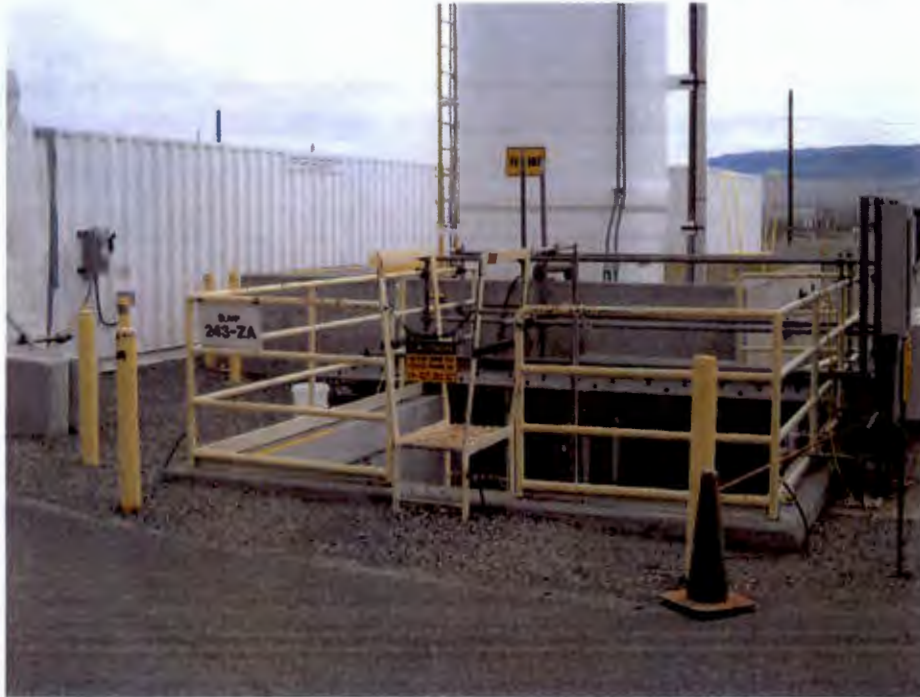
The 243ZA Low Level Waste Storage Facility was affiliated with the 243Z Low Level Waste Treatment Facility. It collected and stored waste water from various PFP sources, pumped the waste water to 243Z for treatment, then stored the treated water prior to disposal via the Treated Effluent Disposal Facility. The tanks were of fiberglass (Isophthalic Polyester Resin) construction. The waste water tank TK-101, with a holding capacity of 1,000 gallons, was located in the 17 foot deep concrete pit along with pumping equipment and piping. Tank TK-102 was in a concrete above-grade secondary containment and had a holding capacity of 5,600 gallons. It was about 5 feet in diameter and 22 feet tall and was used as a surge tank to receive the treated water from 243Z. The 524 square foot structure had 312 square feet above grade and 212 square feet below grade. It was constructed in 1993. Drawings H-2-82719 through H-2-82721 provide additional detail.

Figure 1. 243ZA Pre-demolition

The 243ZA Low-Level Waste Storage Facility was deactivated between June 2015 and August 2015. In August of 2015 all elements (including tanks, associated piping and equipment) were demolished and removed to a slab on grade condition.

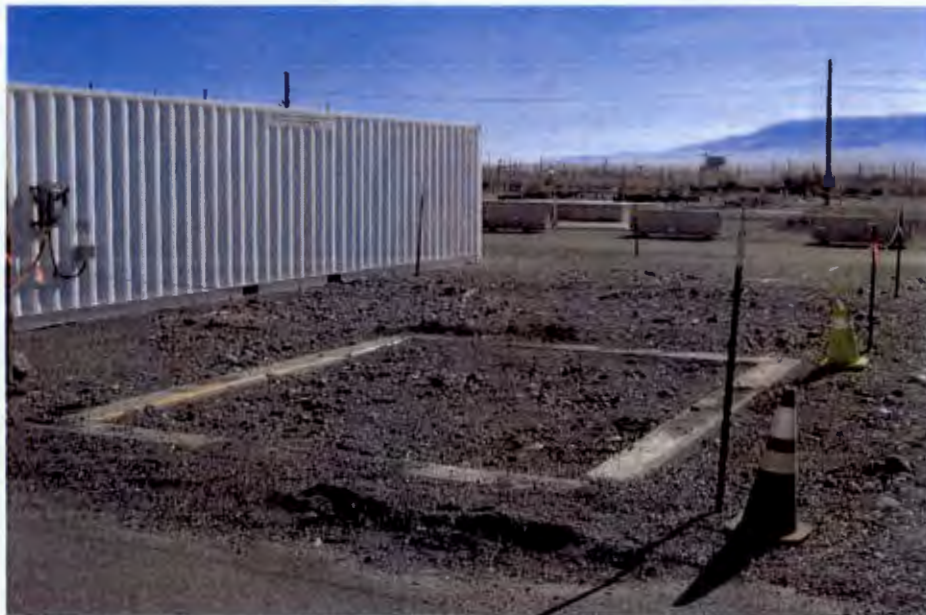
The 243ZA slab and sump pit have been left in place. The sump pit has been backfilled with gravel. A layer of gravel was placed over the slab and pit and contoured to provide a stabilized condition suitable for D4 activities to proceed in adjacent areas. A walkdown of the area where the structure previously stood has been conducted to confirm that demolition is complete, waste has been removed and the area is properly posted in accordance with radiological and occupational safety requirements. (See Endpoint Criteria Checklist DOE/RL-2015-34, Rev 1, Appendix A, Section 1).

No anomalies were discovered during demolition. The slab remains in place, and all pipe penetrations (drains, sanitary water, etc.) have been isolated, cut flush to the slab, and sealed. Soils around the slab displayed no visual evidence of staining or discoloration.

Figure 2. 243ZA Post-demolition
