FACILITY STATUS CHANGE FORM

Action Memorandum/Removal Action Work Plan:
DOE/RL-2005-13/DOE/RL-2011-03

243Z, Low Level Waste Treatment Facility

Attachment 2: Pre-Demolition and Post-Demolition Photographs

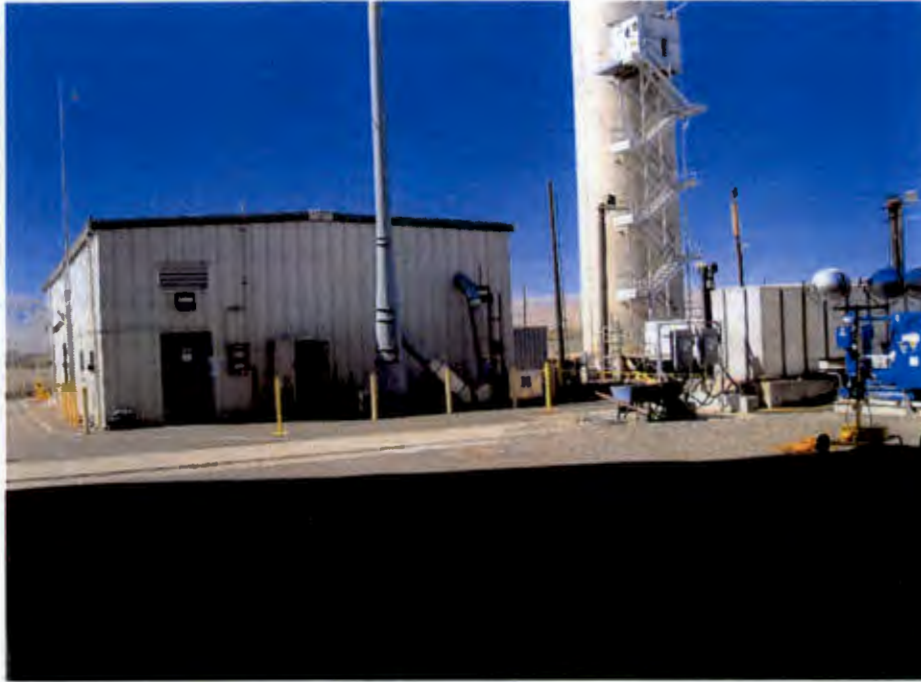
Figure 1. 243Z and 296Z015 Pre-demolition

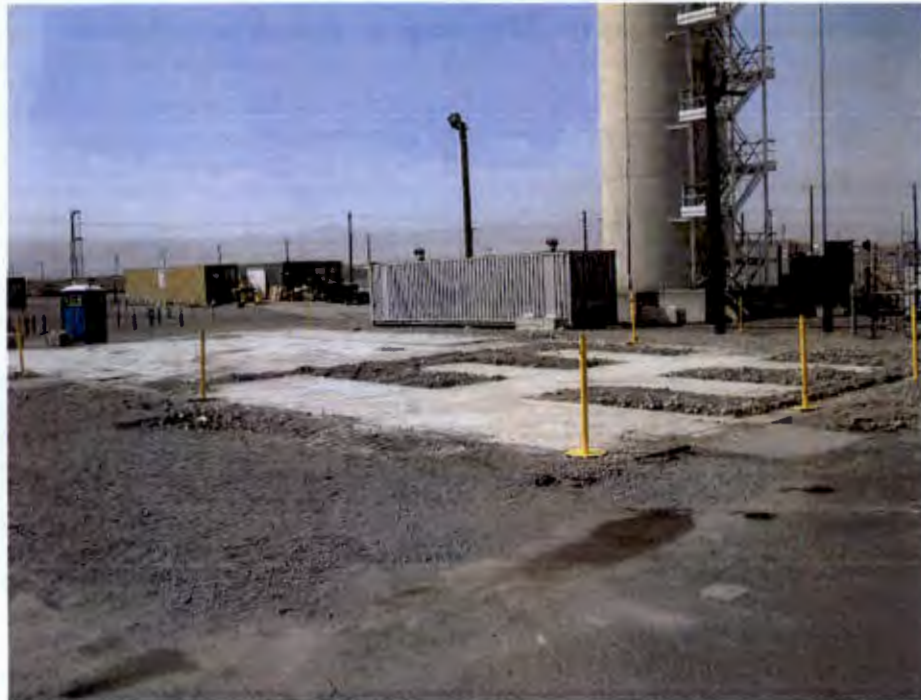
The 243Z slab has been left in place, and a layer of gravel placed on top and contoured to provide a stabilized condition suitable for D4 activities to proceed in adjacent areas. A walkdown of the area where the structure previously stood has been conducted to confirm that demolition is complete, waste has been removed and the area is properly posted in accordance with radiological and occupational safety requirements. (See Endpoint Criteria Checklist DOE/RL-2015-34, Rev 1, Appendix A, Section 1).

No anomalies were discovered during demolition. The slab remains in place, and all pipe penetrations (drains, sanitary water, etc.) have been isolated, cut flush to the slab, and sealed. Soils around the slab displayed no visual evidence of staining or discoloration.

Figure 2. 243Z and 296Z015 Post-demolition
