FACILITY STATUS CHANGE FORM

Date Submitted: March 28, 2008	Area: 100-N	Control #: D4-100N-0011
Originator: Dan Saueressig	Facility ID: 1312-N LERF	
Phone: 373-5473	Action Memorandum: 100-N Ancillary Facilities

D4 Project Facility Completion Form

**ATTACHMENT
(SUPPLEMENTAL INFORMATION)**

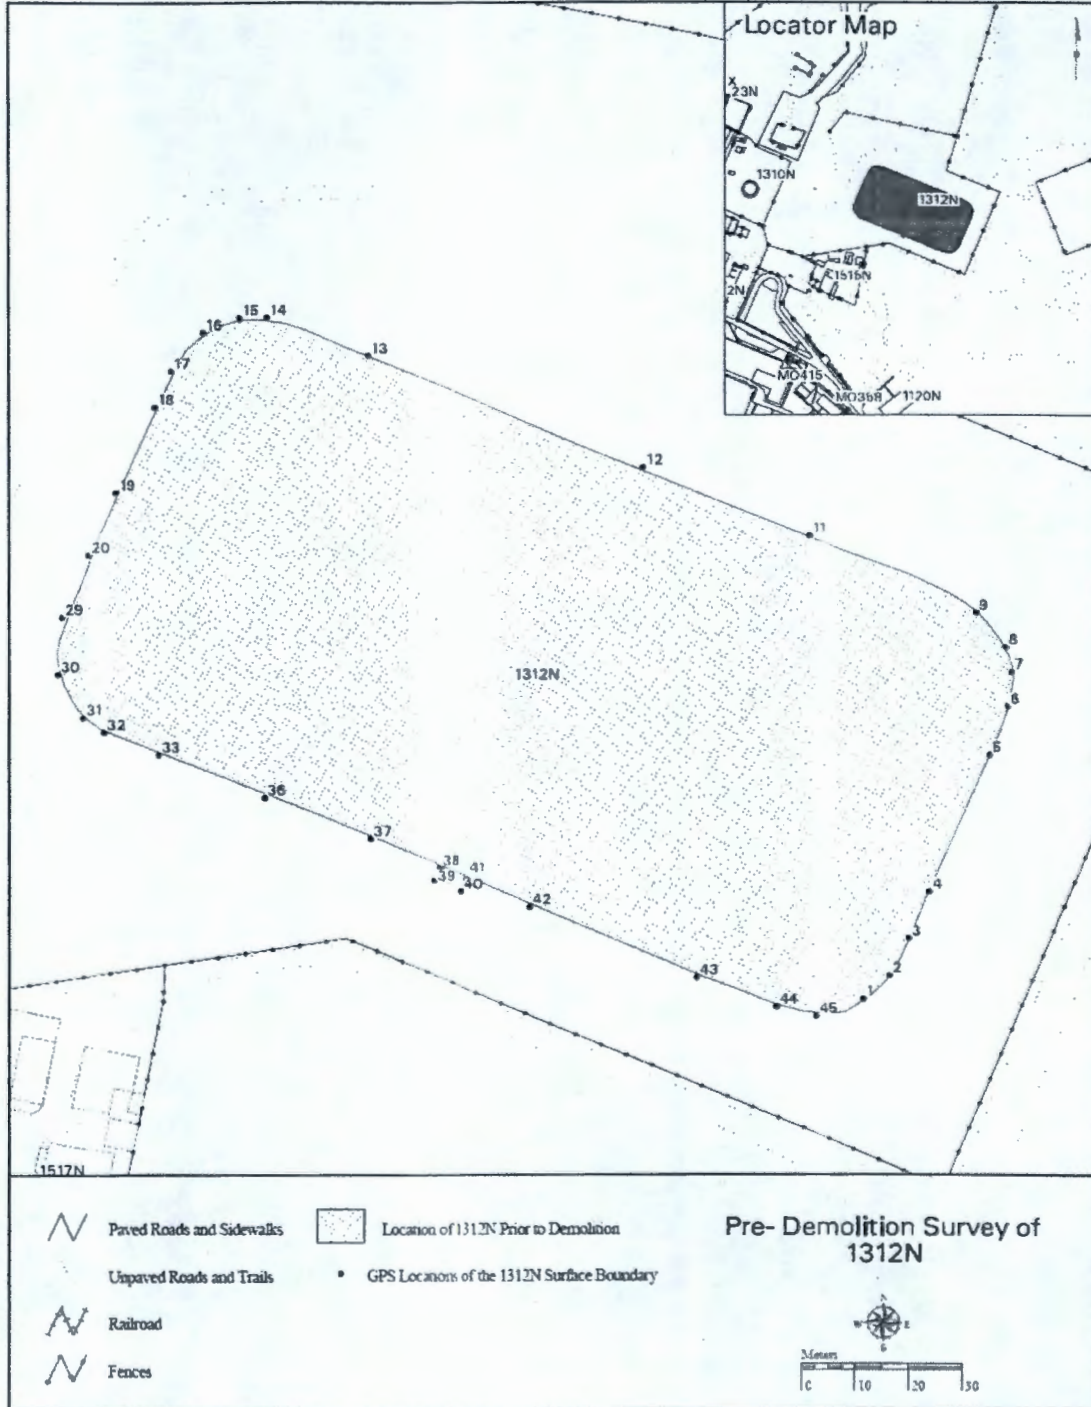
Figure 1. – Pre-Demolition Civil Survey

An assessment of the remaining contaminants of concern is attached (Attachment, Table 2). A civil survey of the area is also attached (Attachment, Figures 1-3, Tables 3 and 4).

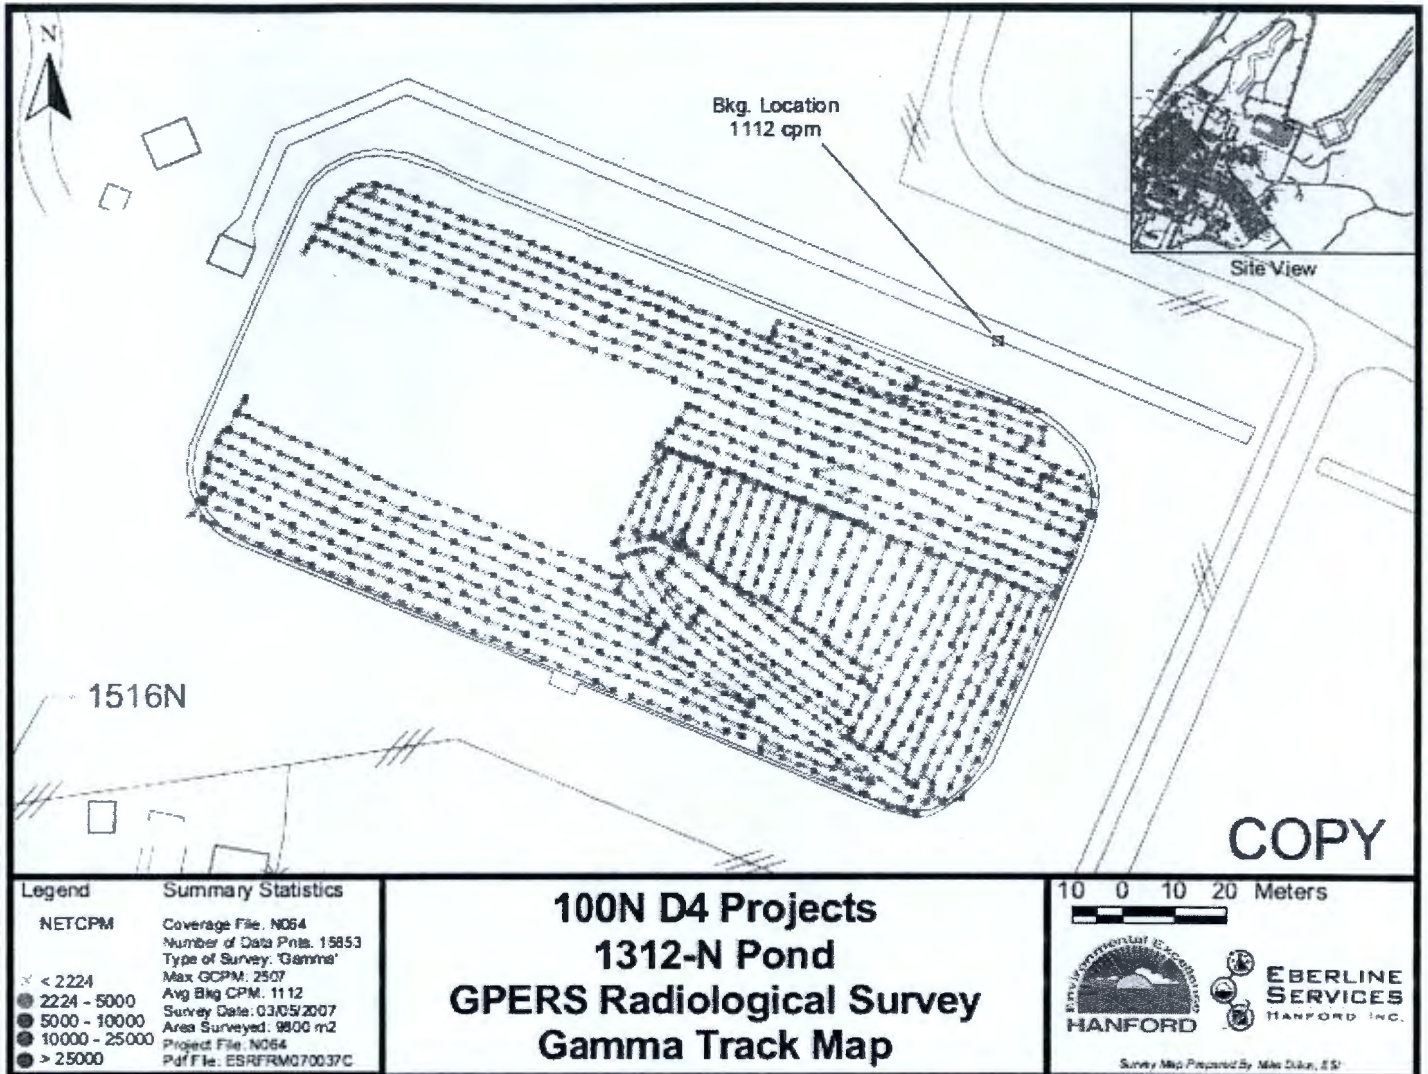
Figure 5. – GPERS (LARADS) Gamma Survey 1 of 1312-N Basin

Radiological surveys were completed after demolition and no radiological contamination was identified (GPERS Report included in Attachment, Figures 5-11).

Contaminant of Concern	Determination of no impact to the soil
Radionuclides	<ol style="list-style-type: none"> 1. Small amounts of contamination found in inlet pipes and concrete apron below the inlet pipes. The contamination was fixed and removed with the pipes and concrete apron. 2. GPERS analysis for beta and gamma contamination found that all sampling points were less than 2 times background.

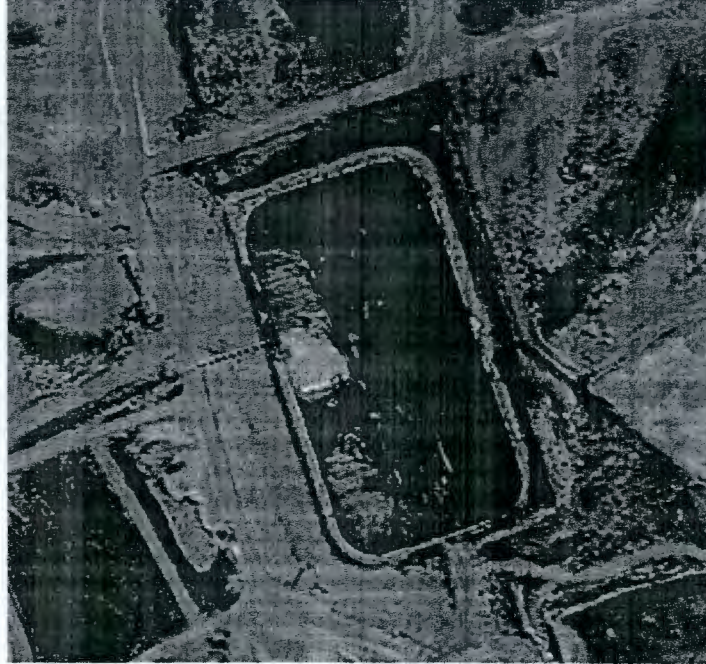
Photo 1

1312-N Liquid Effluent Retention Basin, Pre-Demolition, Aerial

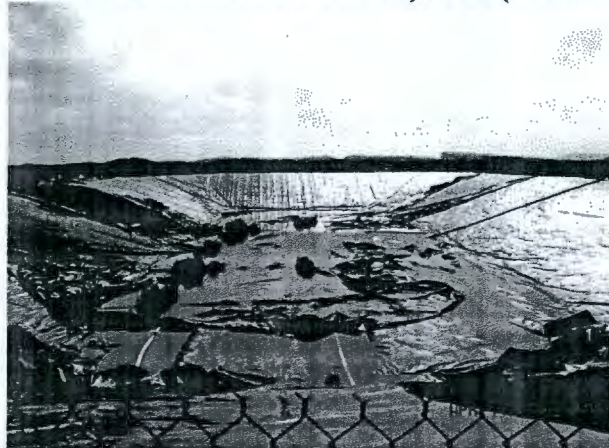
Photo 2

1312-N Before Demolition March 11, 2006 (from west end)

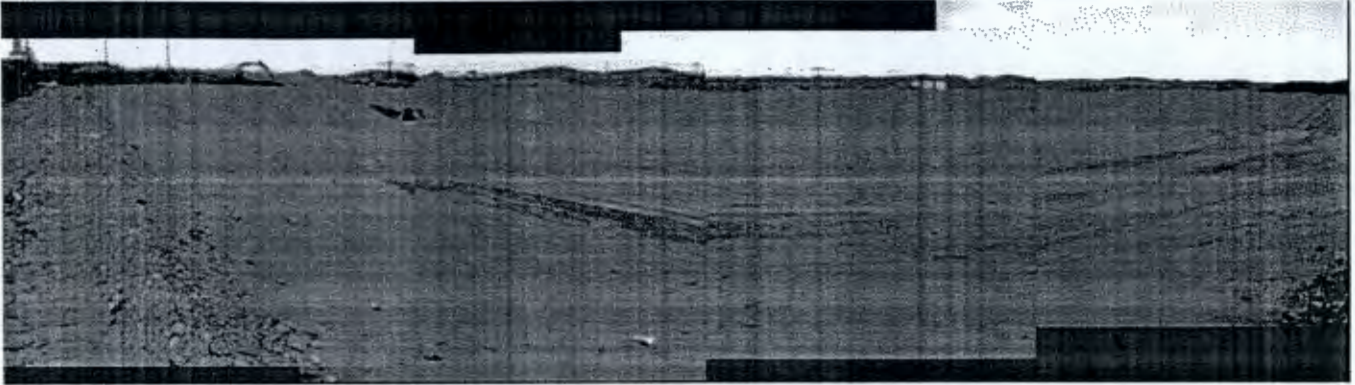
Photo 3

No soil staining was identified during the visual inspection of the excavated area.

1312-N LERF Soil Inspection After Demolition April 17, 2007 (from south corner)

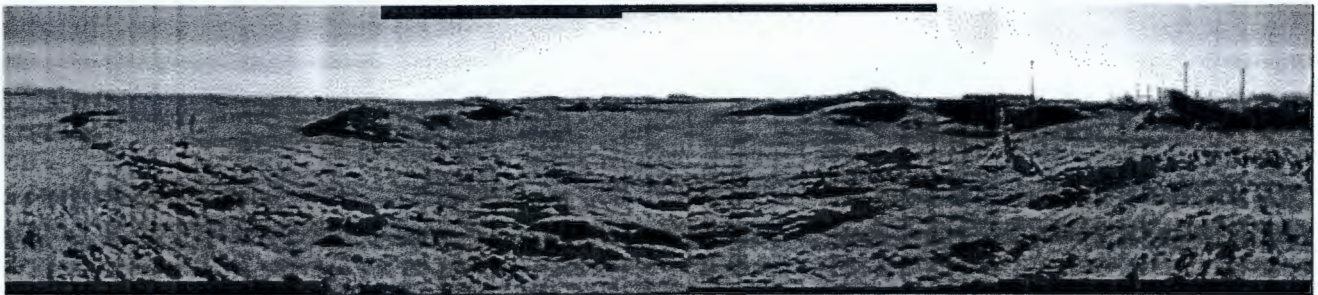
Photo 4

1312-N After Contouring and Seeding February 19, 2008 (from west end – same point of view as Photo 2)

Backfill of the LERF was complete in December 2007, with approximately 15 feet of fill placed in the basin per agreement with the lead regulatory agency. The backfilled and contoured basin was seeded, straw mulched, and crimped on February 15, 2008. Sagebrush seedlings were planted on February 22, 2008.
