Response Action Report for Research Technology Laboratory Complex

CH2MHILL
Plateau Remediation Company

Date Published
July 2019

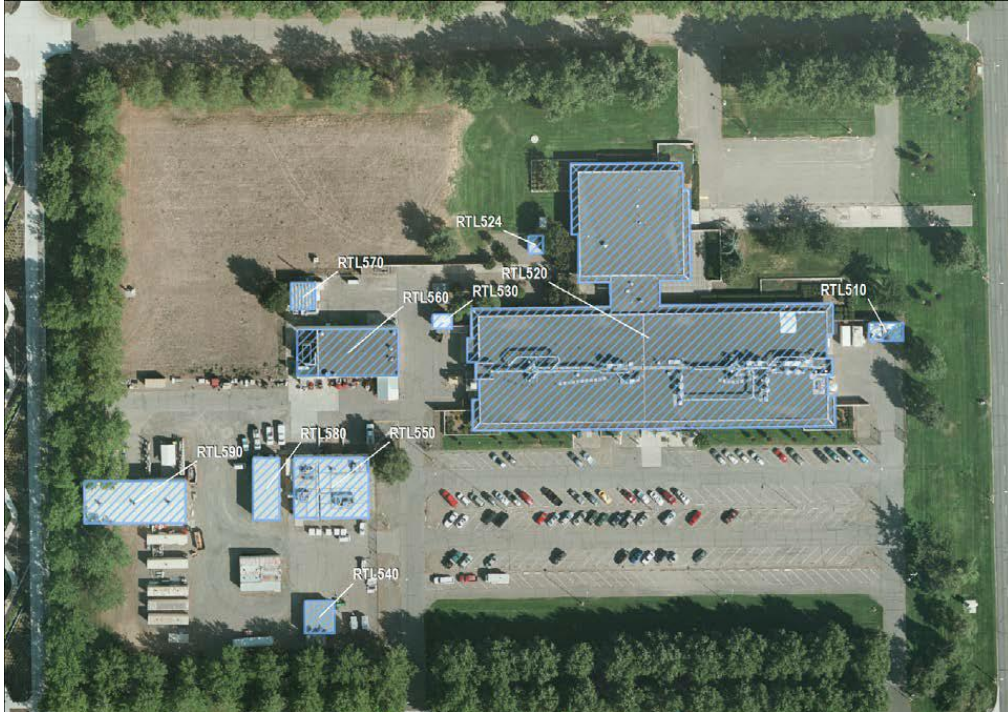
Figure 1. Layout of the RTL Complex

The RTL complex (Figures 1 and 2) was located within the Richland city limits and within the urban expansion area identified by Benton County, Washington. This parcel is currently identified as “business research park” and “general commercial” by the city of Richland and Benton County, respectively. The RTL complex was bounded to the south by 3rd Street, to the north by 4th Street, to the west by Innovation Boulevard, and to the east by George Washington Way.

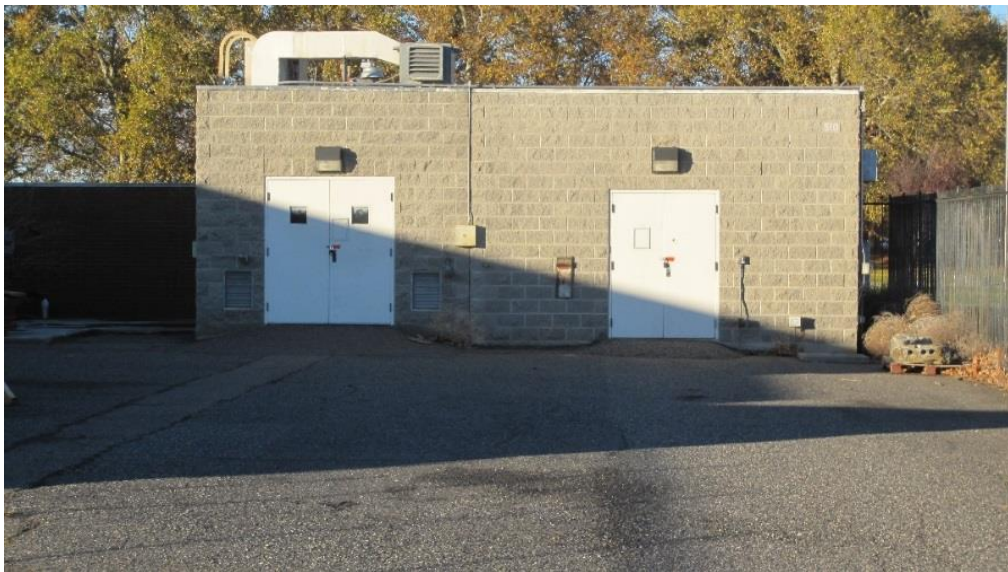
7
8 **Figure 3. RTL 510 – Support Building**

3 RTL 510 provided chemical and flammable gas storage. The building was a one-story, flat-roofed,
4 concrete block structure erected on a short, concrete foundation wall containing a concrete above-grade
5 floor (Figure 3). There were two unequally sized rooms, one of which contained a round concrete pipe
6 and a below-grade storage pit.

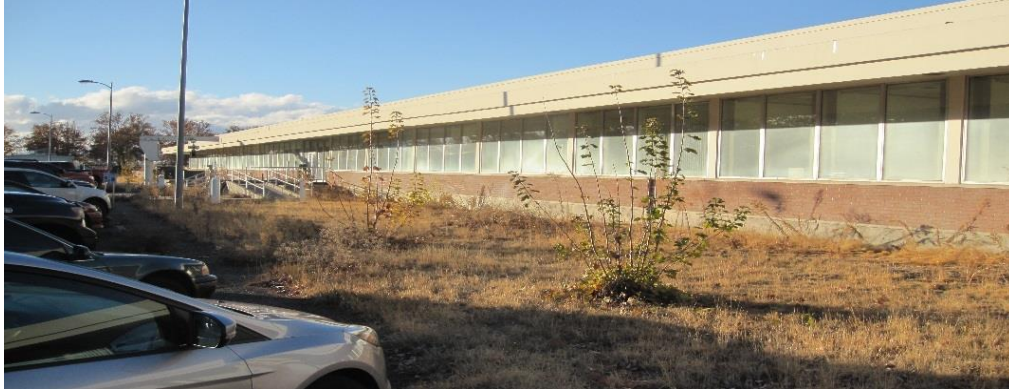
10
11 **Figure 4. RTL 520 – Main Building**

2 RTL 520 was the main building within the RTL complex, constructed in 1966 by Douglas Aircraft
 3 Company to make nuclear fuel rods. Battelle purchased the complex and land in 1982 from Exxon,
 4 the subsequent owner. RTL 520 housed 95 offices comprising 1,235 m² (13,290 ft²), 33 laboratories
 5 comprising 1,460 m² (15,710 ft²), and common space of 2,439 m² (26,250 ft²) for a total area of 5,134 m²
 6 (55,250 ft²). The main laboratory/administration building was constructed of reinforced concrete
 7 (including the roof), with outside curtain walls of concrete block faced with red brick. The outside
 8 windows were heavy, double-paned, and had aluminum frames (Figure 4). There was also a partial
 9 basement of approximately 650 m² (7,000 ft²) constructed of concrete foundation walls.

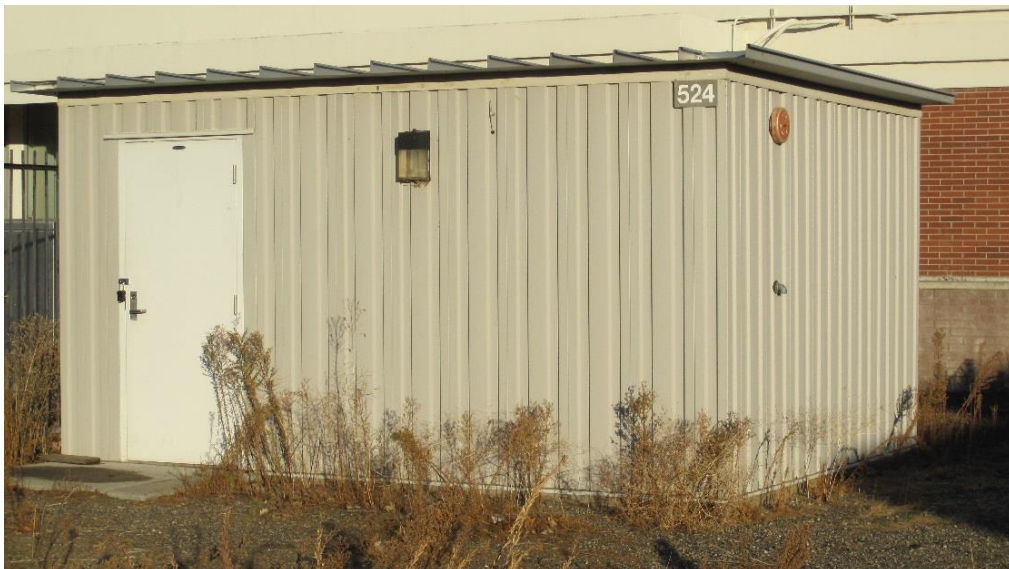
16
17 **Figure 5. RTL 524 – Fire Riser Building**

13 RTL 524 was a 3.7 m by 4.6 m (12 ft by 15 ft) pre-engineered metal building on a concrete slab and
 14 foundation (Figure 5) that was built to protect the fire sprinkler riser installed as part of an RTL complex
 15 fire system upgrade in approximately 2004.

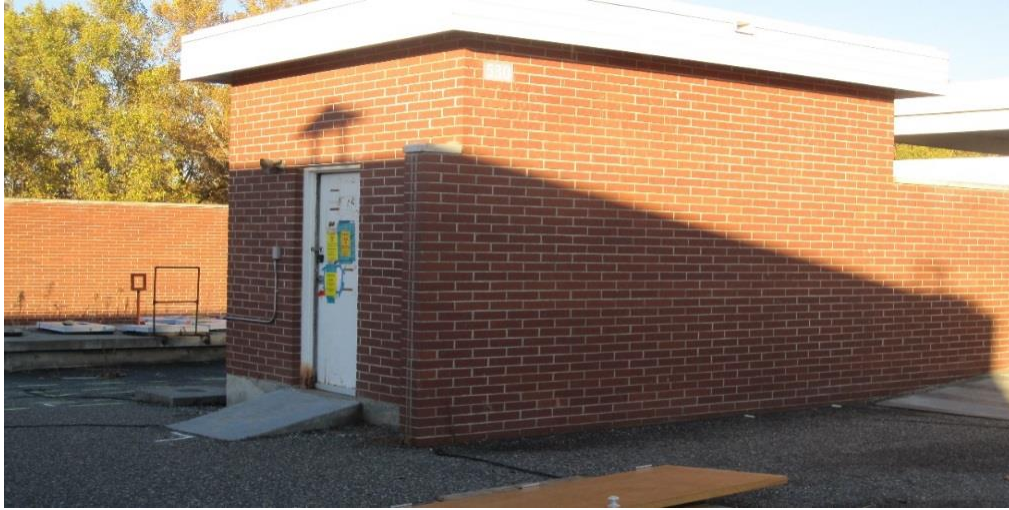
Figure 6. RTL 530 – Radioactive Material Storage Building

2 RTL 530 provided space for the temporary storage of experimental radioactive materials and was
3 attached to the 520 Building (Figure 6). The perimeter was 3.7 m by 4.3 m (12 ft by 14 ft). The building
4 was constructed of reinforced concrete with outside concrete curtain walls and a flat built-up roof (felt,
5 asphalt, and gravel). The floor was concrete and contained a pit with a lead cover for storing highly
6 radioactive materials. The facility was used for radioactive waste storage. The building was modified
7 in 2000 to add a high-efficiency particulate air filter exhaust system.

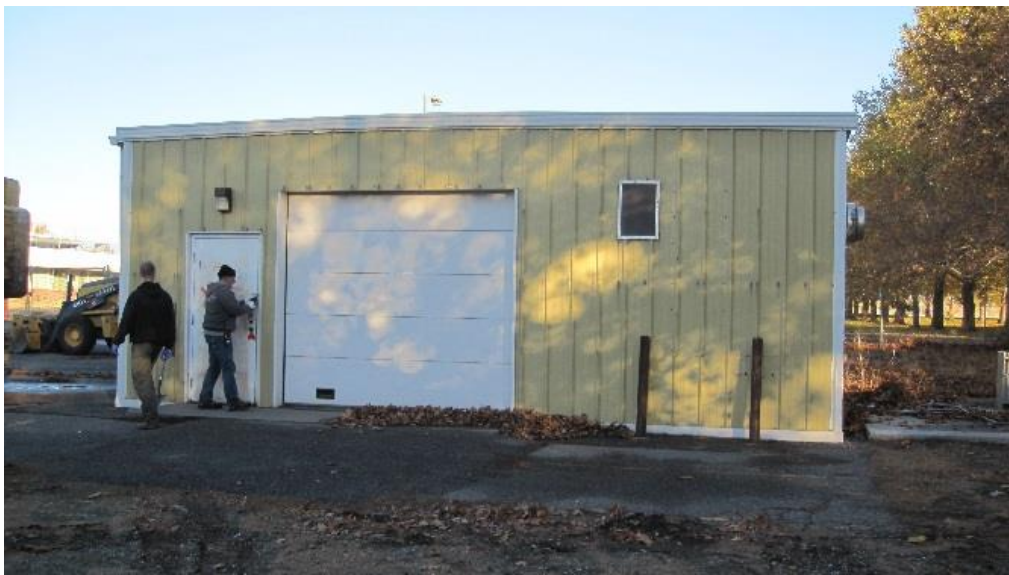
Figure 7. RTL 540 – Paper Shredder Facility

11 RTL 540 was a metal structure with concrete foundation, and it previously served as a paper shredding
12 facility (Figure 7). It recently consisted primarily of storage areas.

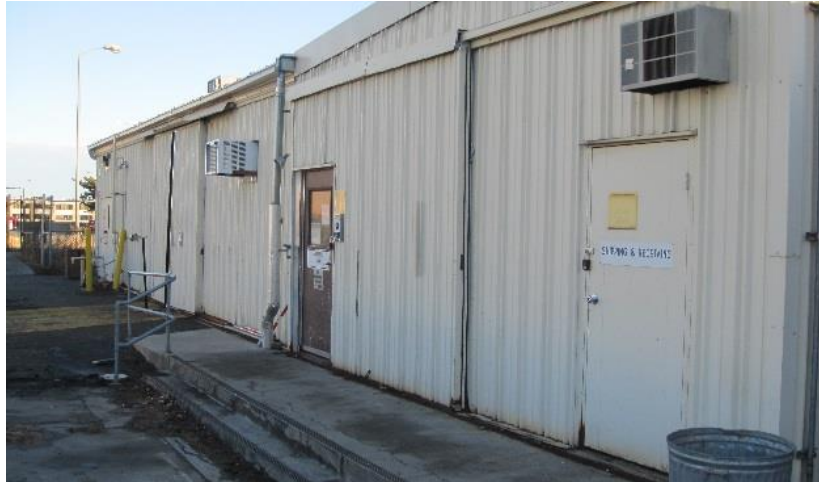
5
6 **Figure 8. RTL 550 – Technical Services Building**

2 RTL 550 was a one-story, prefabricated, insulated metal structure erected on a concrete foundation and
 3 a concrete slab-on-grade floor (Figure 8). It consisted of three metal buildings that had been tied into one
 4 unit. Rooms consisted primarily of offices, maintenance shops, and storage.

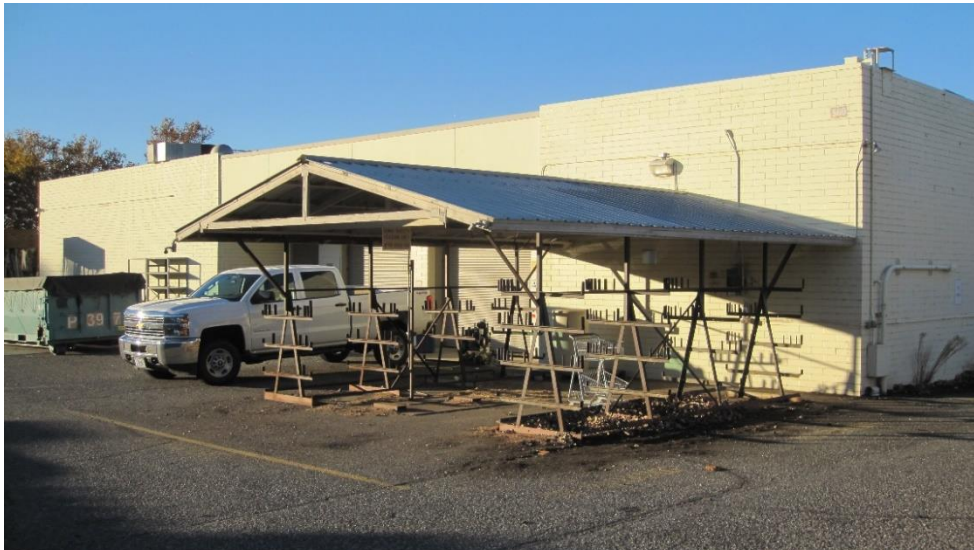
17
18 **Figure 9. RTL 560 – Utility Building**

8 RTL 560 (Figure 9) provided space for mechanical equipment such as boilers, chillers, and a cooling
 9 tower, all of which provided heating and cooling for RTL 520. The perimeter was 14.6 m by 24.4 m
 10 (48 ft by 80 ft). This concrete block building was erected on concrete footings with a concrete slab floor.
 11 The roof was constructed with a steel girder, wood purlins, and rafters, and was covered with plywood
 12 decking, rigid insulation, and built-up roofing. Two roll-up doors were installed on the south side of the
 13 building. The building contained two 200-horsepower, natural-gas-fired boilers and two 150-ton chillers.
 14 A cooling tower, which was used as a circulating water heat dump, was located adjacent to RTL 560.
 15 A small (37.2 m² [400 ft²]), insulated steel building was attached to the southwest corner of RTL 560 and
 16 was used as a storage/stockroom.

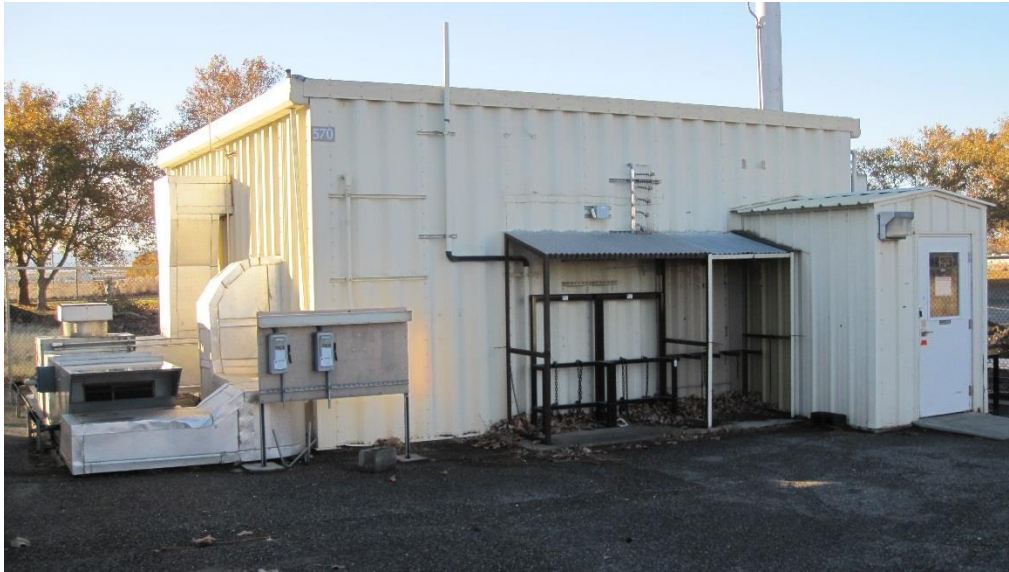
Figure 10. RTL 570 – Autoclave Center

2 RTL 570 served as an autoclave center (Figure 10). The building was made with prefabricated, insulated
3 steel erected on concrete foundation and had a concrete slab floor and a flat, insulated metal roof.

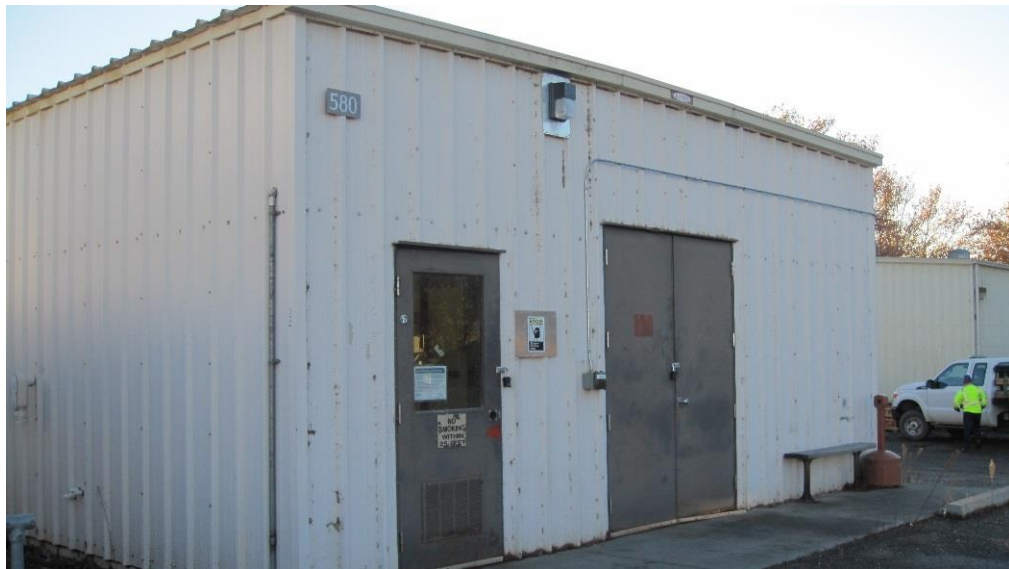
Figure 11. RTL 580 – Craft Shop Building

7 RTL 580 served as the craft shop (Figure 11). The building was a one-story, prefabricated, insulated
8 metal structure erected on a concrete foundation and a concrete slab-on-grade floor.

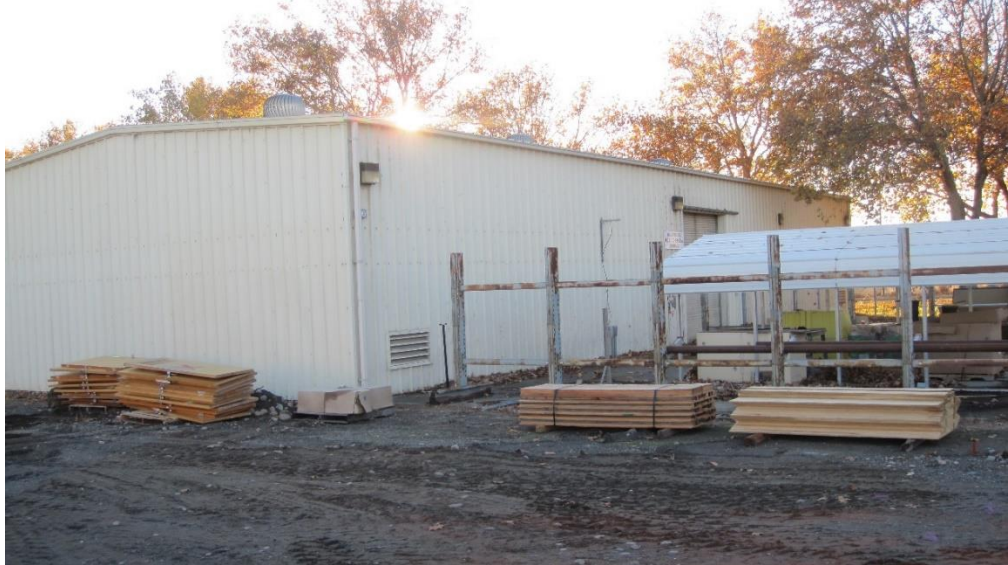
5
6 **Figure 12. RTL 590 – Hazardous Waste Chemical Storage/Warehouse**

2 RTL 590 was primarily used for storage (Figure 12), including a chemical waste storage area with an
 3 in-service fume hood. The building was a one-story, prefabricated, insulated metal structure erected on
 4 a concrete foundation and a concrete slab-on-grade floor.

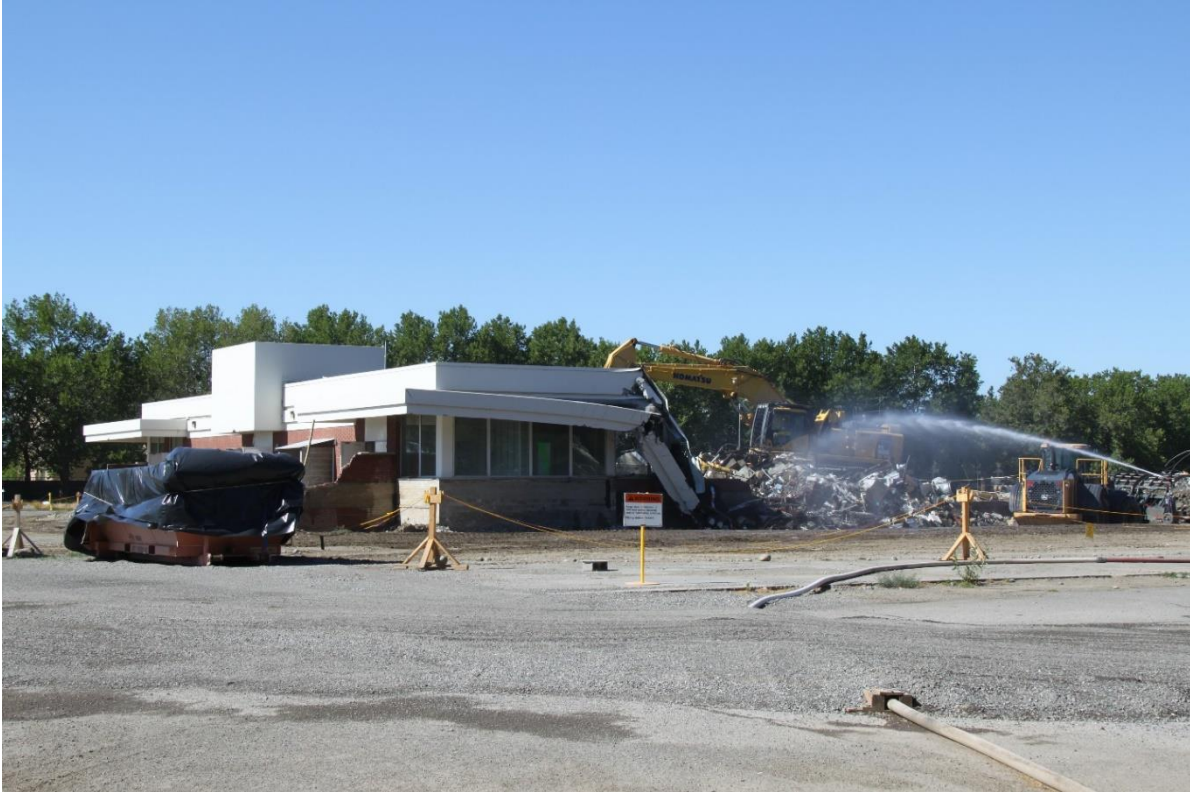
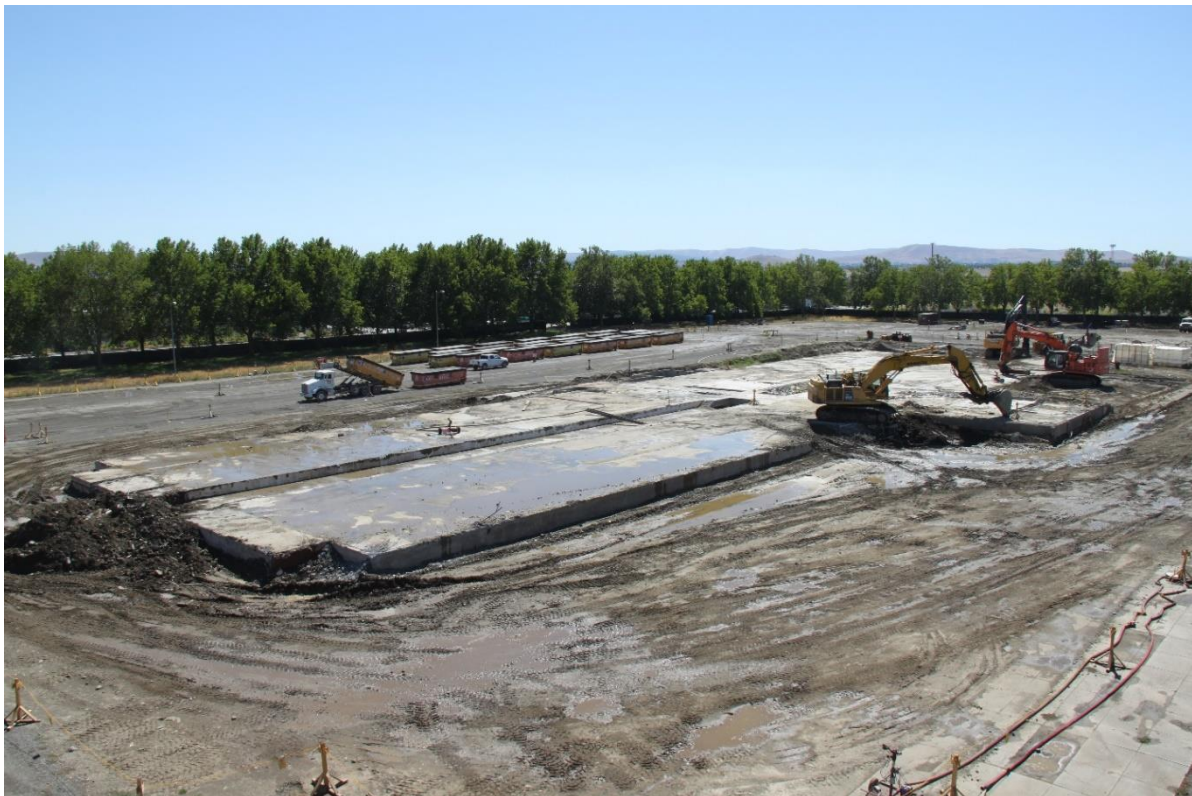
Figure 13. RTL Complex During Demolition

2 The RTL complex facilities were demolished; the slab, pipelines, and vault were removed; and soil in the
3 area of the vault and RTL 520 was excavated in accordance with the RAWP (DOE/RL-2010-34).
4 Figure 1 shows the RTL complex prior to demolition. Figures 13 and 14 depict the RTL complex during
5 demolition. Figures 15 and 16 show the RTL complex after demolition and excavation.

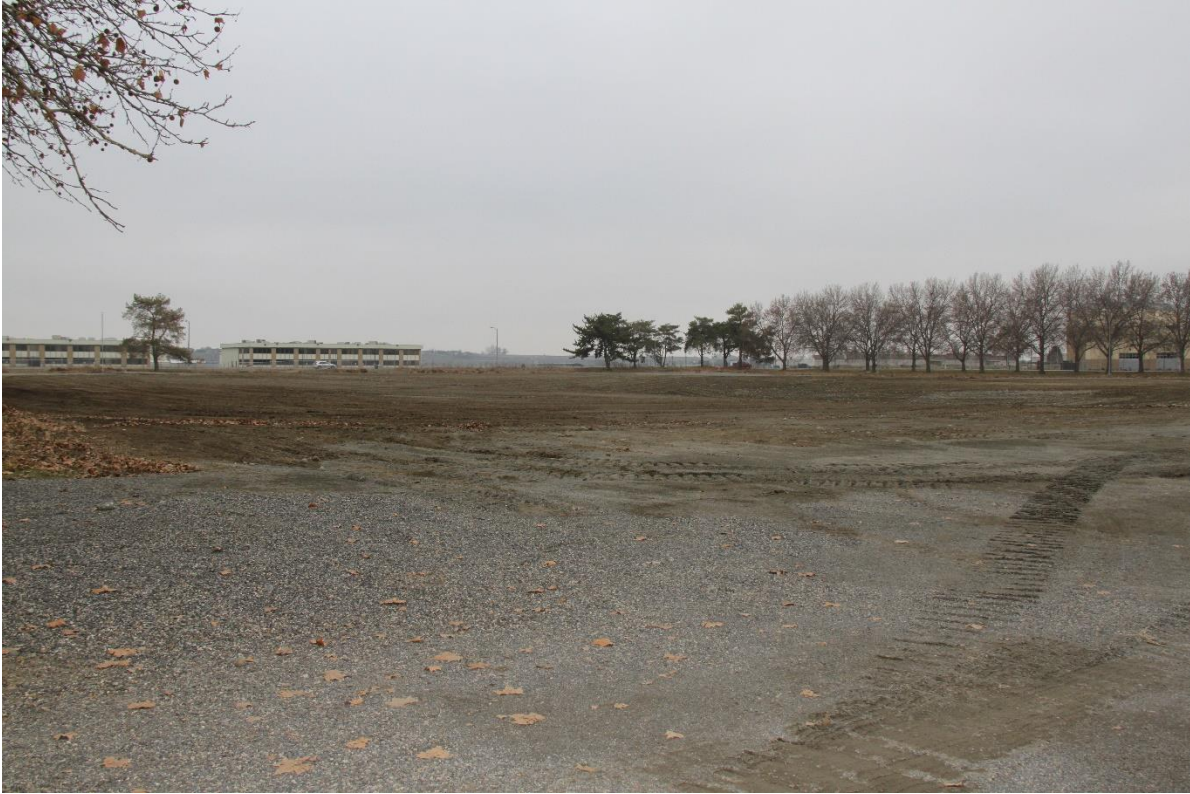
Figure 18. RTL Complex After Partial Backfill and Site Stabilization

5 Following evaluation of the remaining soil, the site was stabilized by performing a partial backfill of the
6 excavated areas with stockpiled soil. The stockpiled soil was sampled, analyzed, and the results compared
7 to the release limits in the survey report (Golovich et al., 2019a) and sampling report (Golovich et al.,
8 2019b) prior to backfill activities. All data for the soil were below the established release limits. Figure 18
9 depicts the partial backfill and site stabilization.
