216-U-1 and 216-U-2 Cribs Interim Stabilization Final Report

WHC-SD-DD-TI-063

This report documents the task and activities necessary to interim stabilize 216-U-1 and 216-U-2 cribs. Interim stabilization was necessary to maintain the site in a stable configuration until closure activities have been determined and initiated. Site size is approximately 3 acres.

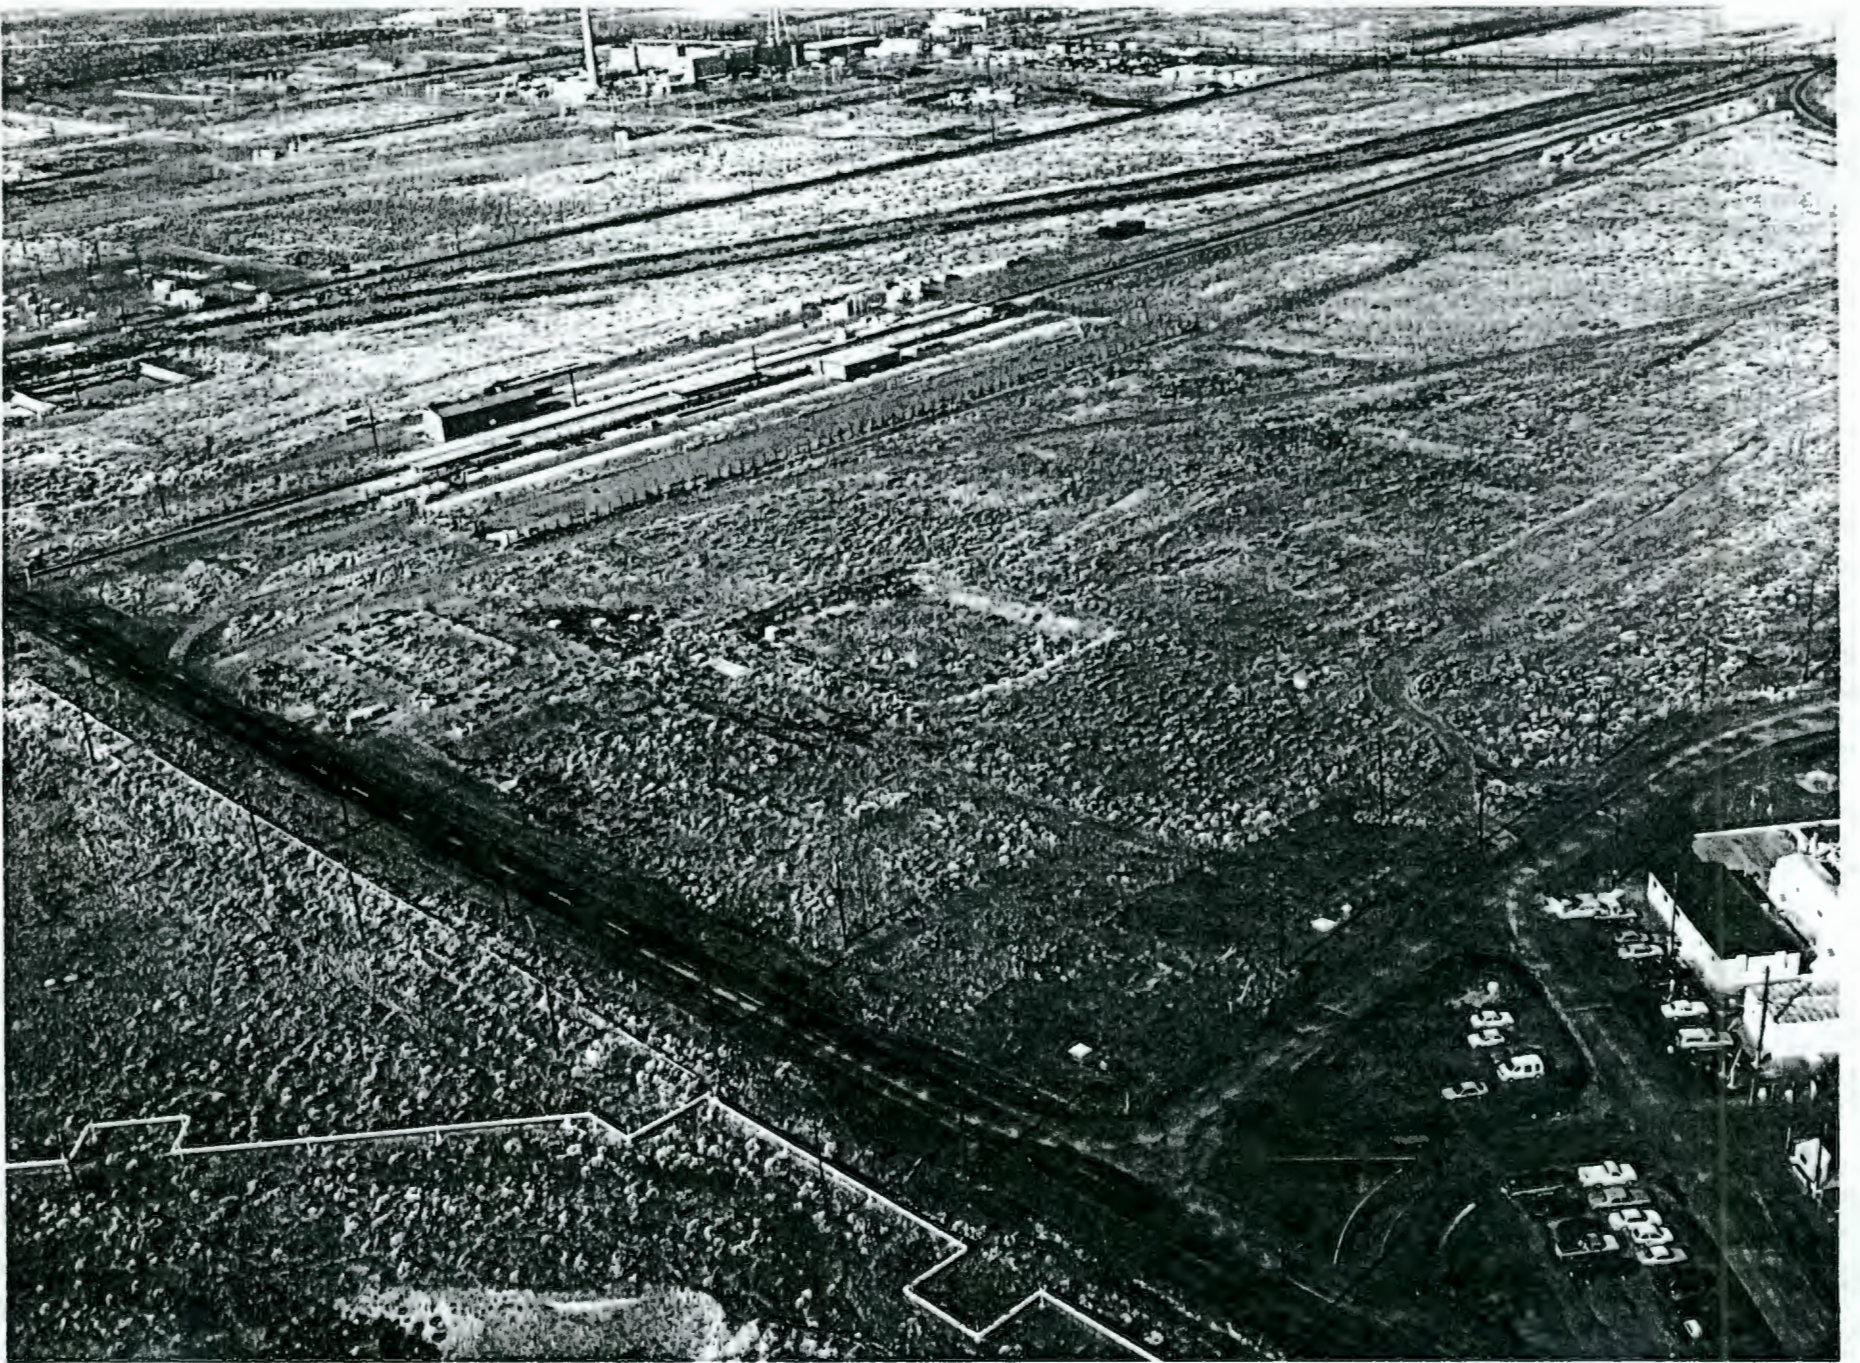
Figure 1. Aerial Views of the Job Site Looking Northwest.

The 216-U-1 and 216-U-2 cribs are located in the central portion of the 200 West Area of the Hanford Site. The surface contamination zone associated with the cribs was bounded to the south by 16th Street, the east by U Plant, the north by tile field 2607-W5, and to the west by Bridge Port Avenue. The areas north and west of this zone are open for several hundred feet. Included in the surface contamination zone with 216-U-1 and 216-U-2 cribs were the 241-U-361 settling tank, septic tank 2607-W5, and a portion of tile field 2607-W5, which receives effluent from septic tank 2607-W5. The surface contamination zone covered 2.4 acres. Refer to Figures 1, 2, and 3, respectively, for an aerial view, map of the site, and a view of the crib area prior to interim stabilization.

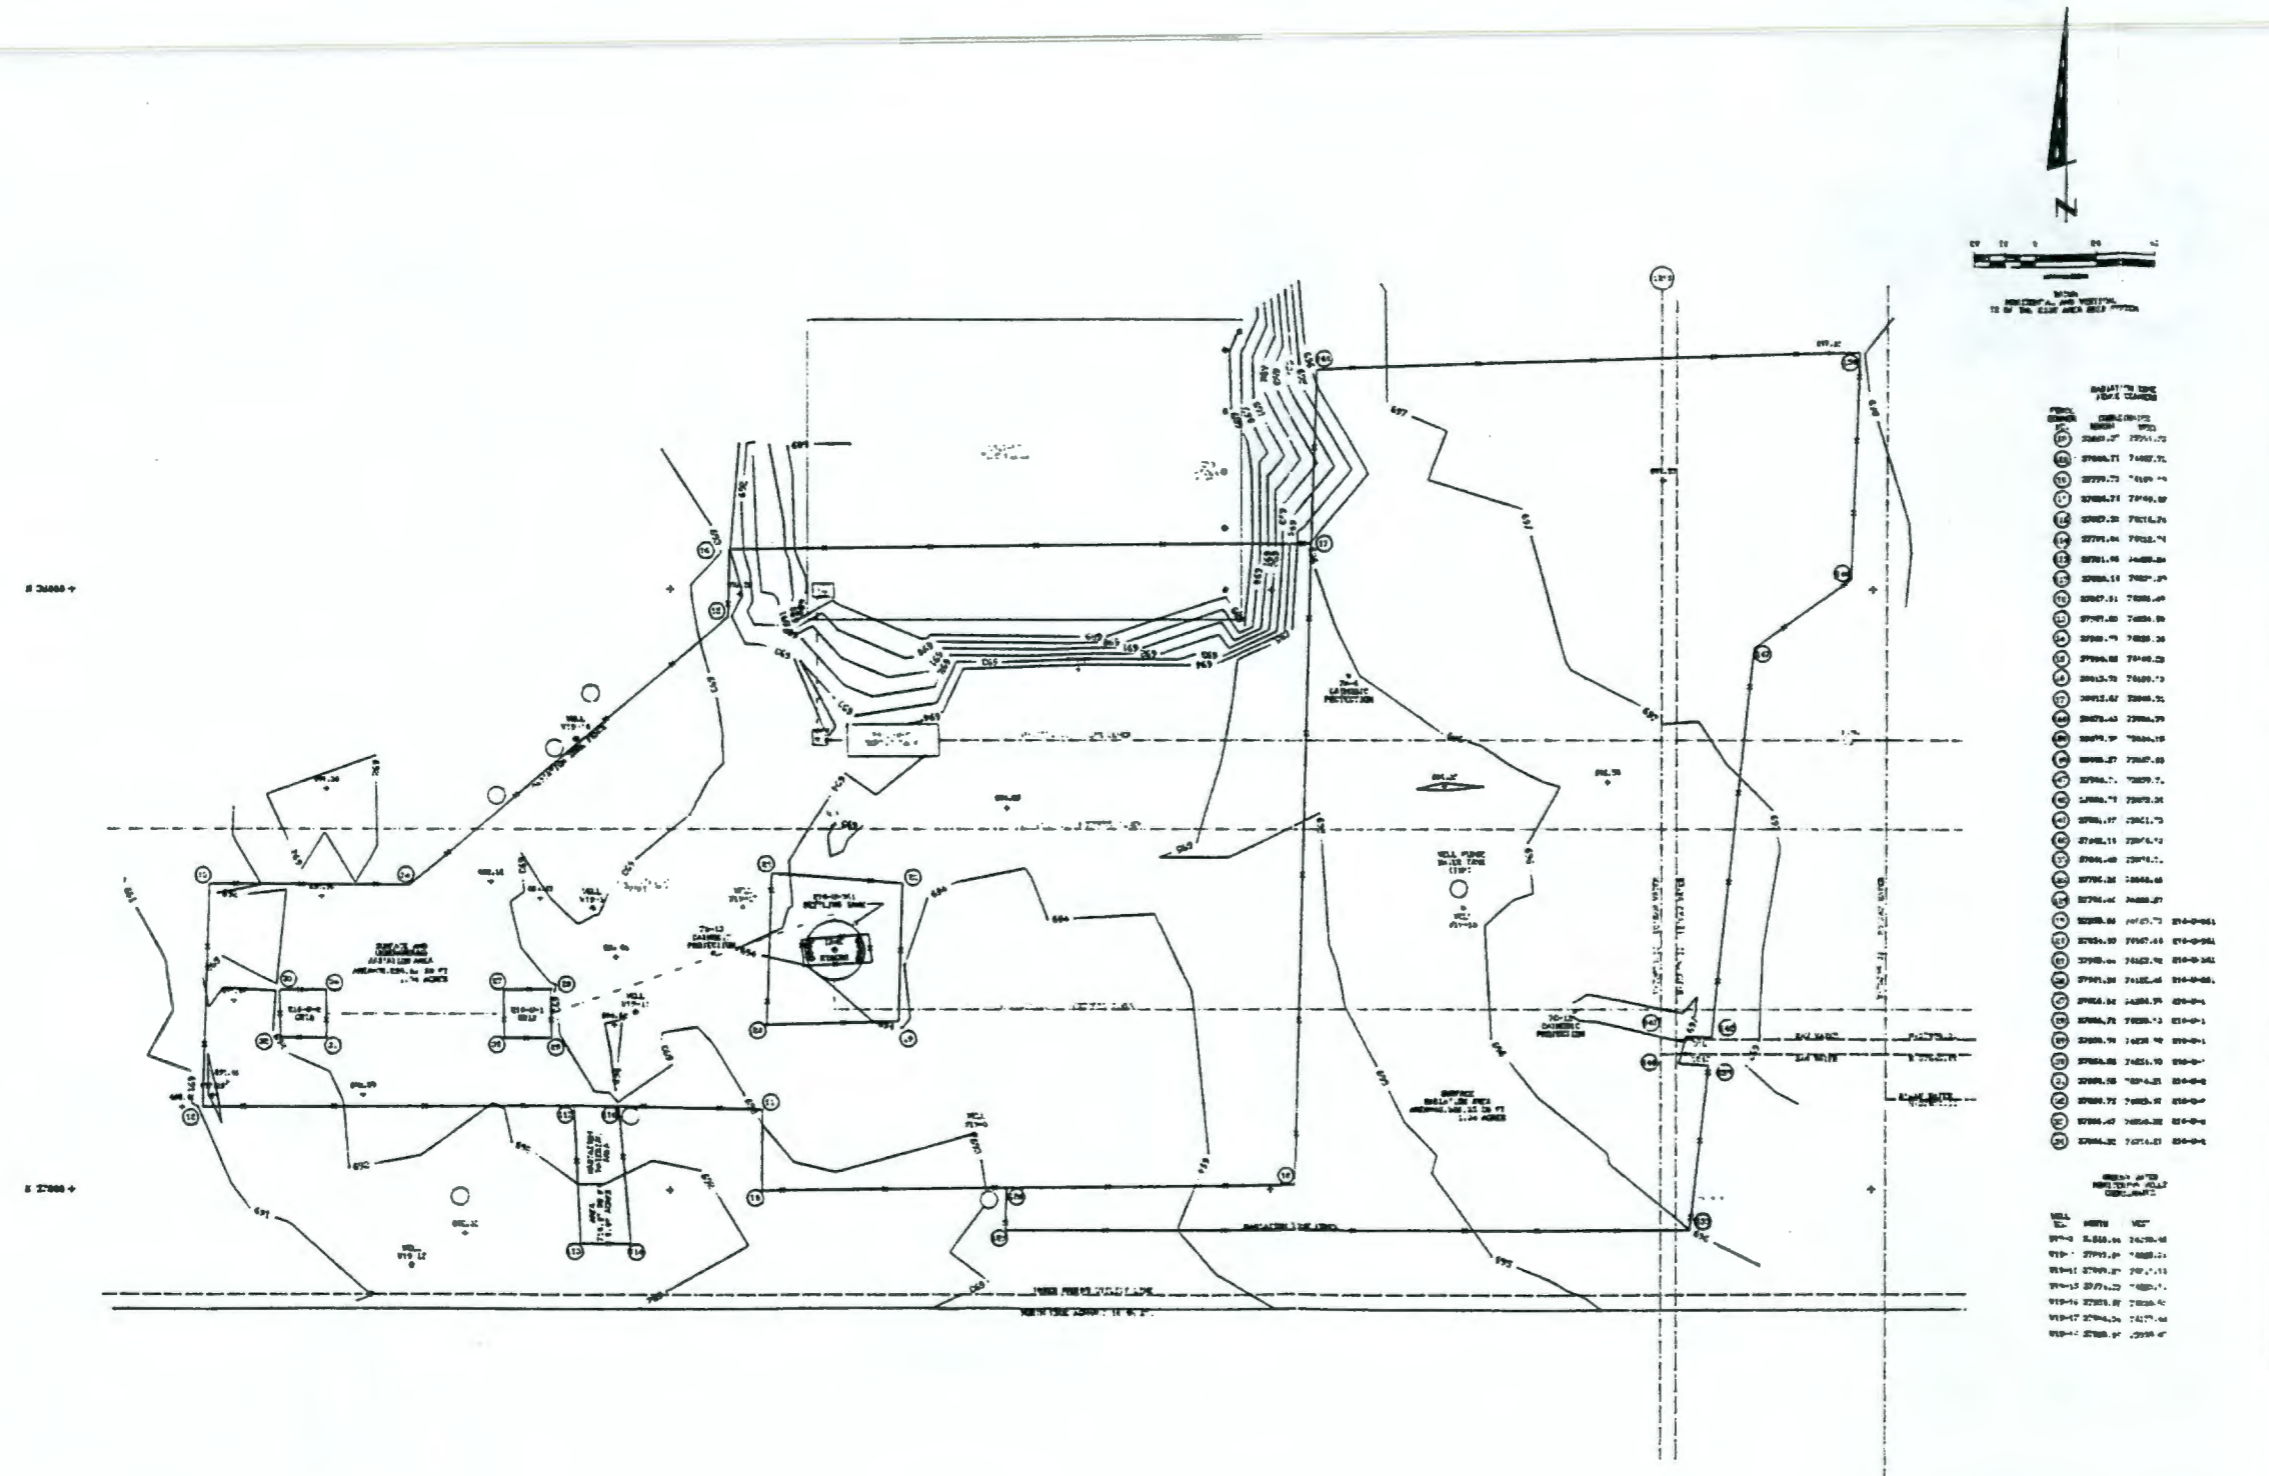
Figure 2. Topographic Map of the Job Site Prior to Interim Stabilization.

U.S. DEPT. OF ENERGY
 KAISER ENGINEERS HANFORD
 216-U-1 AND 216-U-2 CRISIS STABILIZATION
 TOPOGRAPHIC MAP
 PROJECT N/A
 DATE 11-24-78
 DRAWN BY: COTHR
 CAD FILE: 216101.D
 ENG 1 OF 1

Civil surveys were necessary to accurately record site characteristics prior to interim stabilization activities. Information from these surveys was used to produce an as built map of the site prior to interim stabilization (see Figure 2). This map included topographic contours, underground pipelines, radiation zone boundaries, cribs, tanks, wells, and other above grade structures.

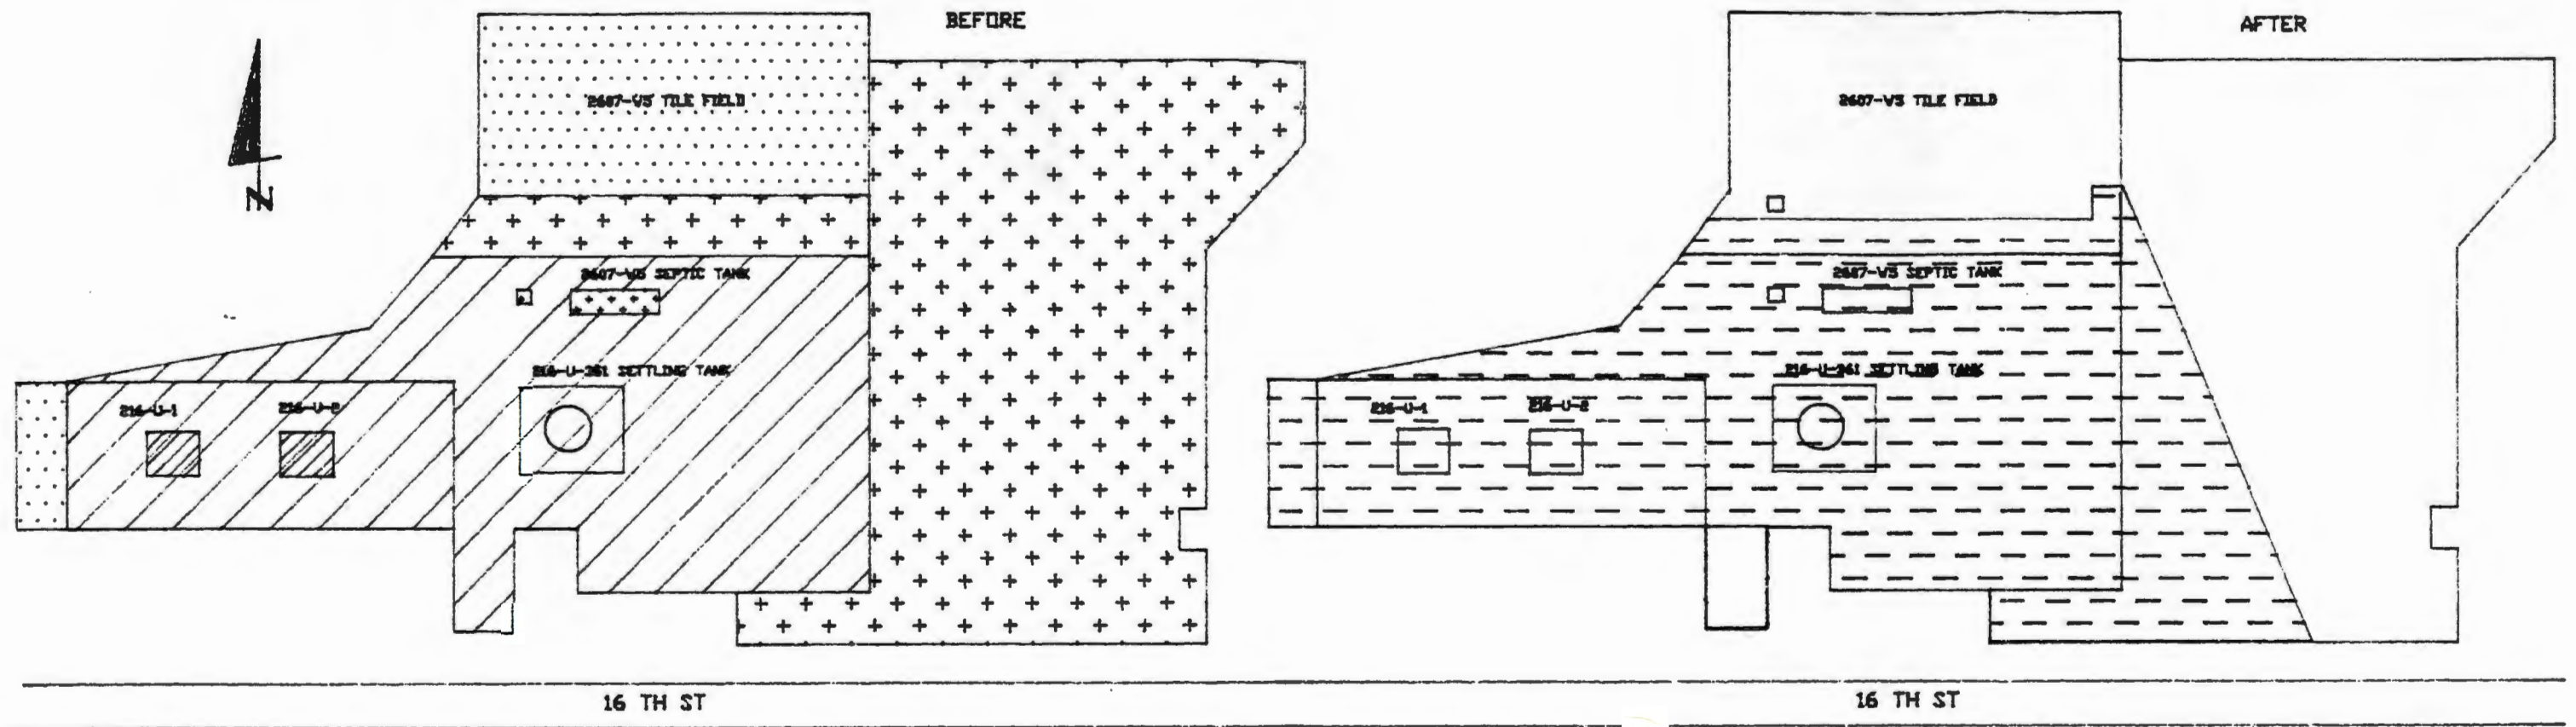
Figure 5. Before and After Representation of Work Performed.

NO RADIOLOGICAL POSTING
-

SURFACE CONTAMINATION
-

UNDERGROUND RADIOACTIVE MATERIAL
-

SURFACE CONTAMINATION AND UNDERGROUND RADIOACTIVE MATERIAL
-

ADDITIONAL SURFACE CONTAMINATION (FOUND DURING PROJECT)

The surface contamination associated with the 216-U-1 and 216-U-2 cribs was divided into several distinct zones based on the scope of work to be performed during the interim stabilization (Figure 4). As work progressed, the scope of work changed. This was due to finding more extensive radioactive contamination than was originally known. See Figure 5 for a before and after drawing depicting the interim stabilization activities.

In general, the areas over the 216-U-1 and 216-U-2 cribs, and the 241-U-361 settling tank were to be stabilized. In addition, the stabilized area was extended east of the cribs approximately 300 feet after it was determined that the area could not be decontaminated as was originally hoped. The remainder of the site was successfully decontaminated, with the consolidated soil being stabilized with 18 to 24 inches of clean soil. The entire area excluding the area above 241-U-361 settling tank was mulched and crimped. Revegetation will occur during the proper time of the year. Total work area encompassed 2.4 acres, with an additional 11,650 ft² (approximately one-fourth acre) decontaminated or stabilized after the discovery of additional contamination.

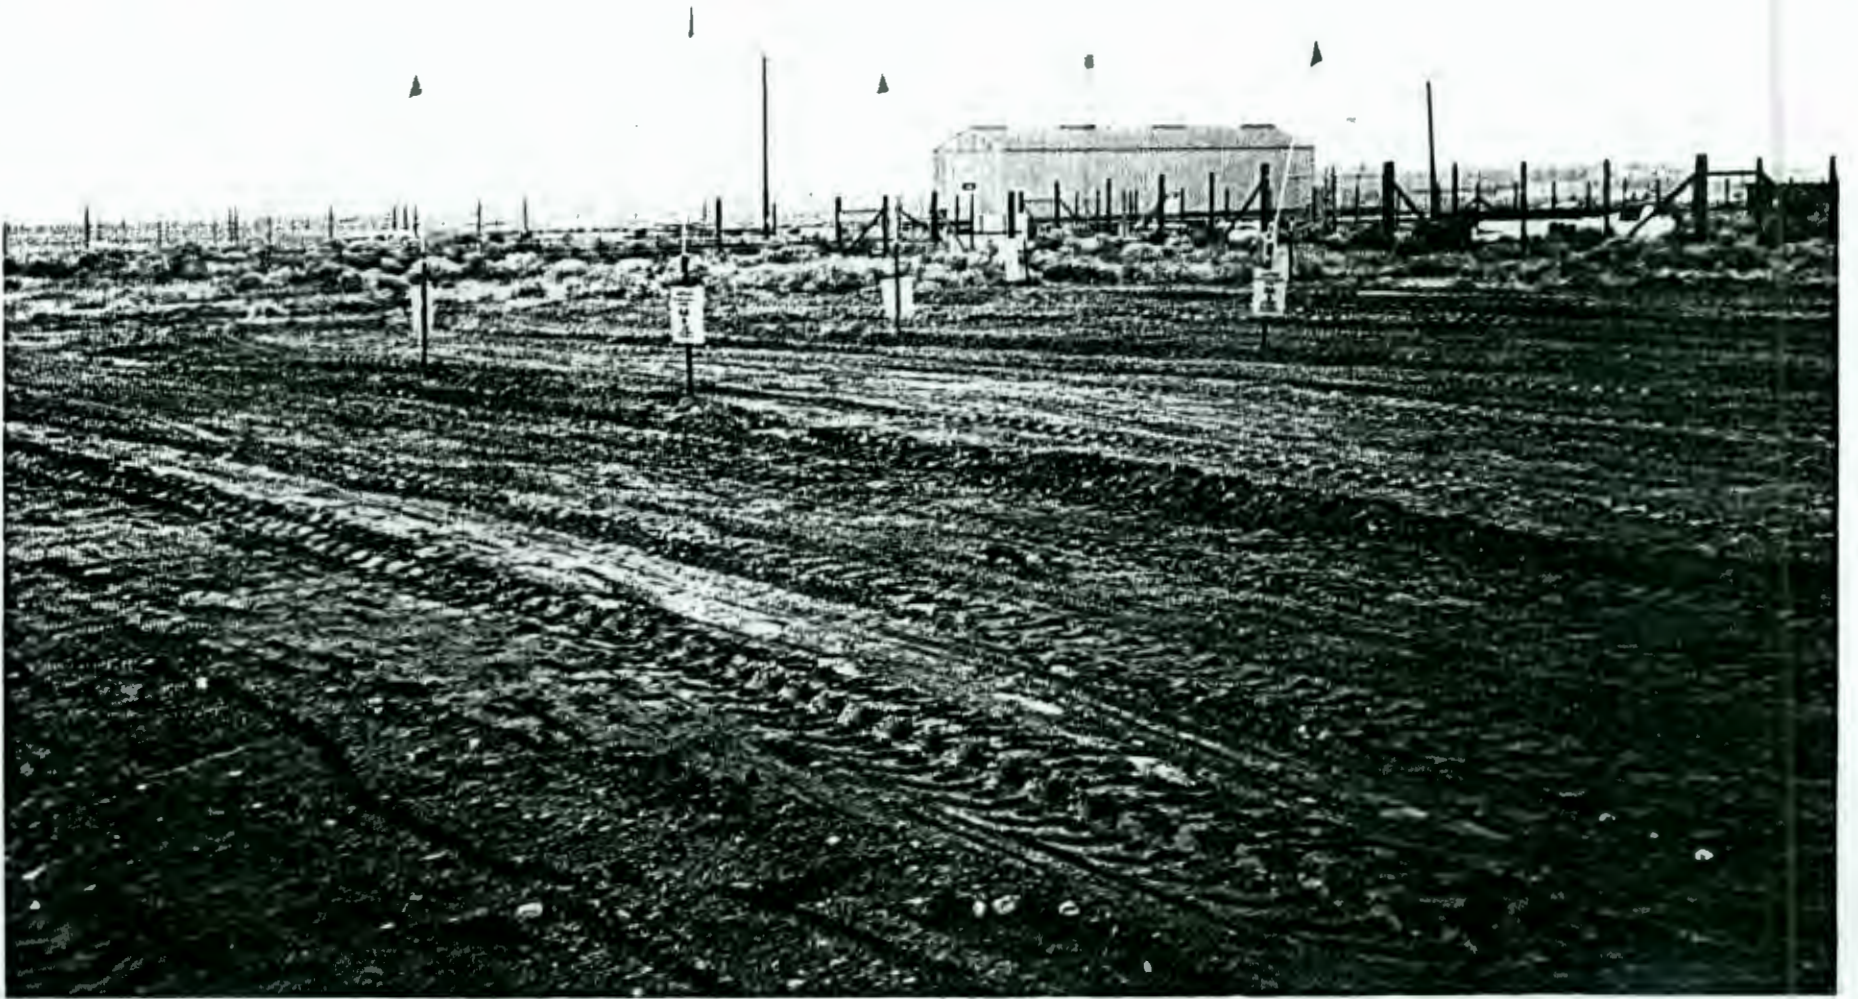
Figure 6. Area Near Cribs After Interim Stabilization.

Photographs (Figure 6) and civil surveys (Figure 7) were conducted to record site characteristics after interim stabilization had occurred.

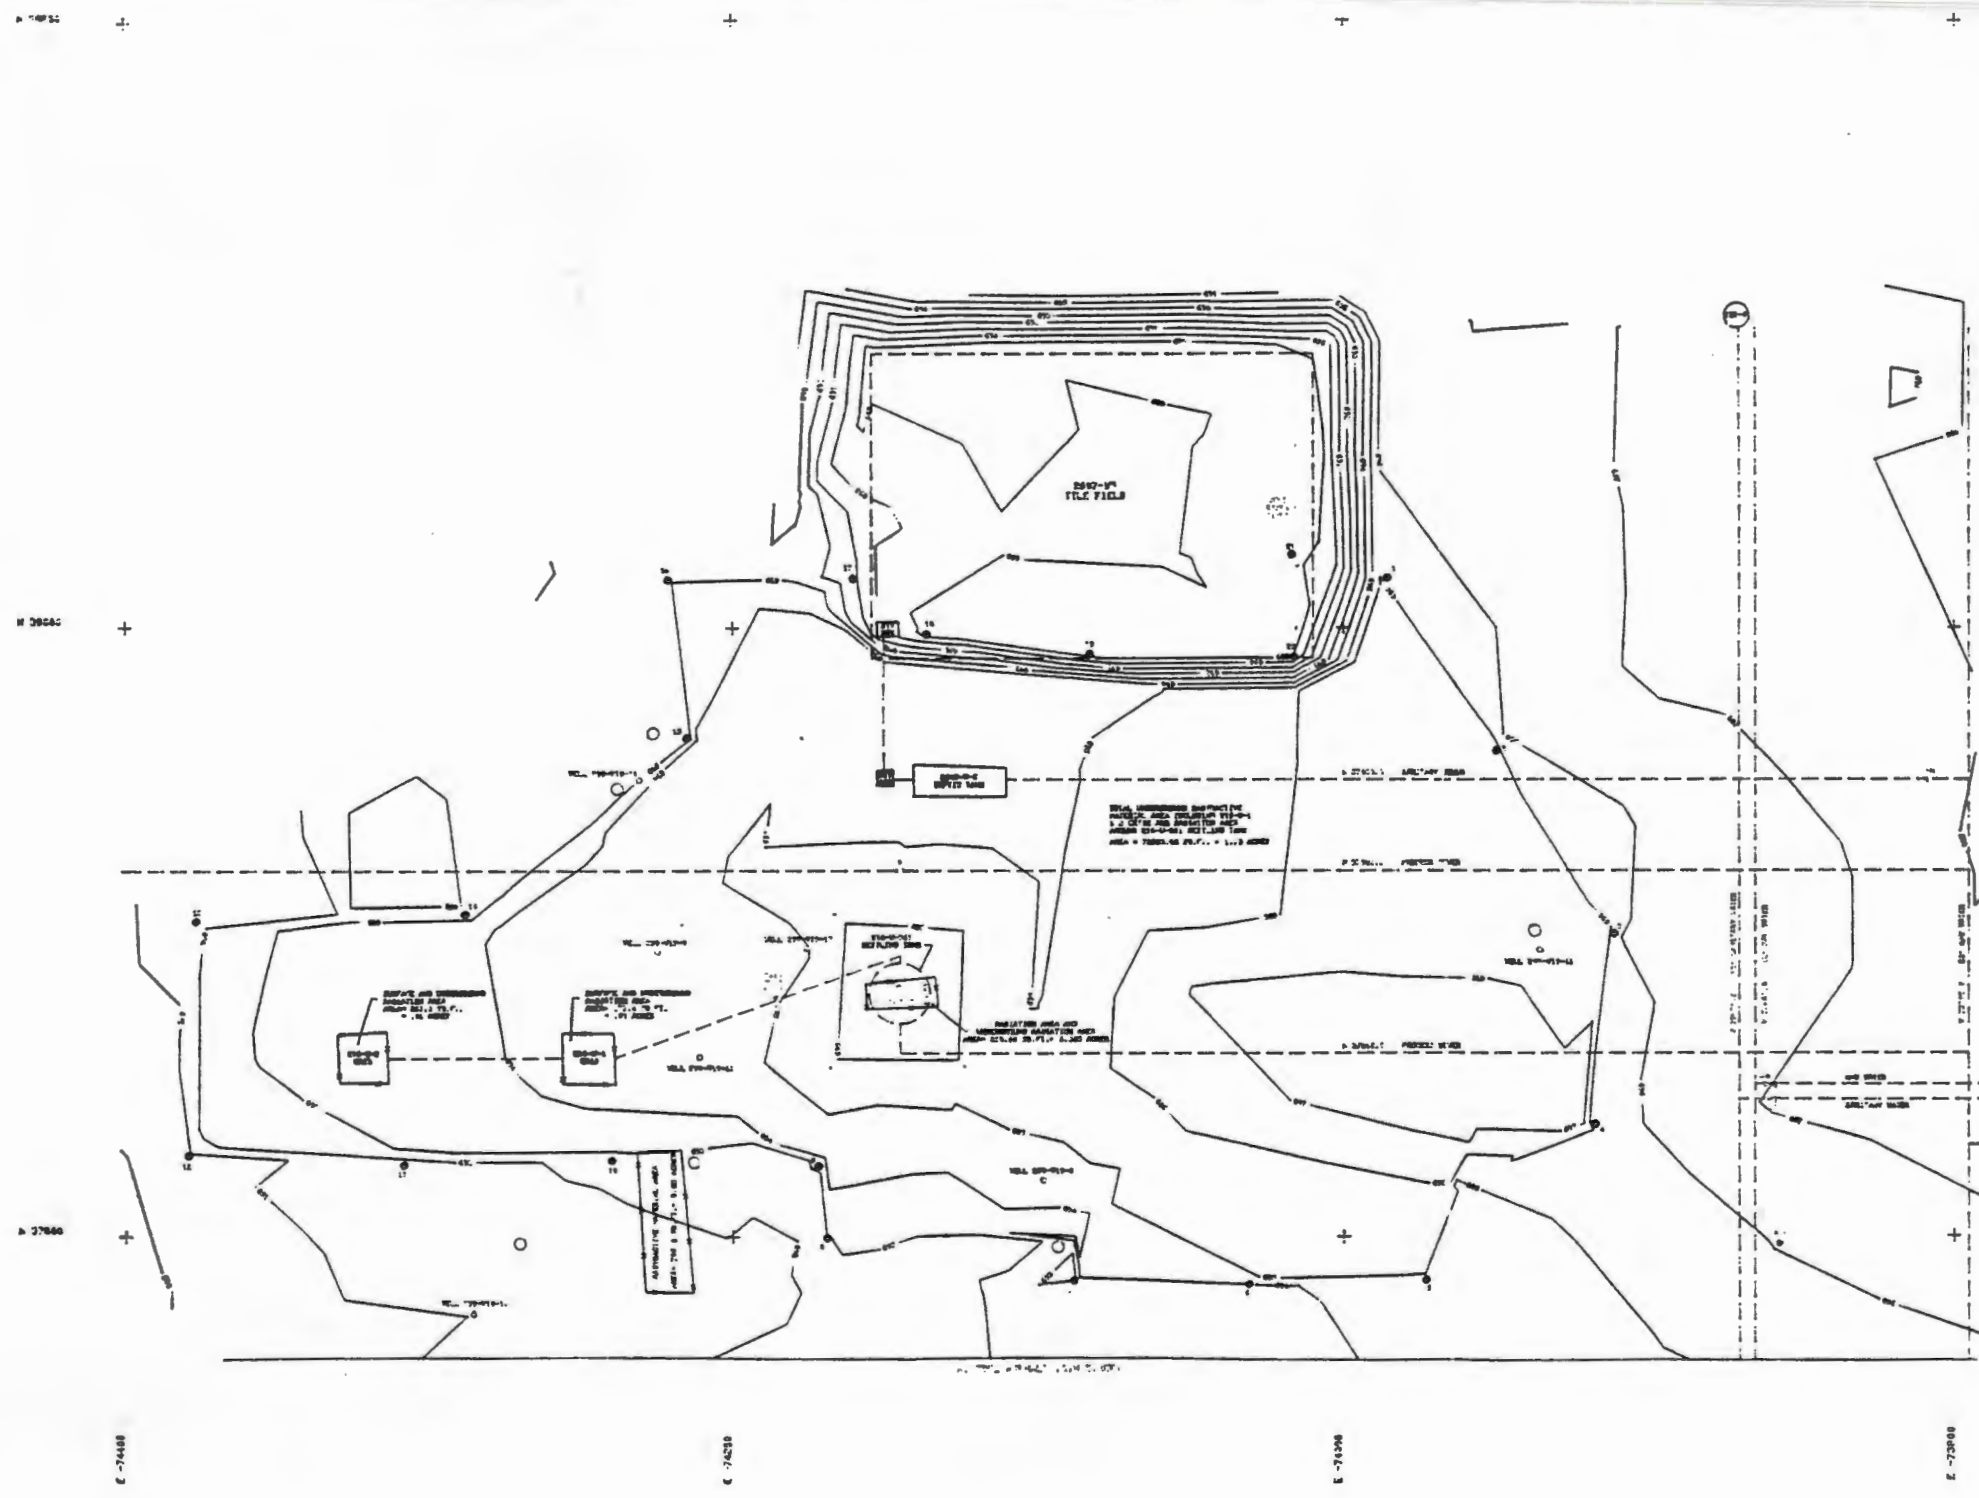
Figure 7. Topographic Map of the Job Site After Interim Stabilization.

U.S. DEPT. OF ENERGY	
KAISER ENGINEERS HANFORD	
216-U-1 & 2 CRIBS AFTER STABILIZATION	
TOPOGRAPHIC MAP	
PROJECT: N/A	
DATE: 01/17/88	
DRAWN: H. E. FOSTER	
CHECKED: R. J. BERRY	
SHEET 1 OF 1
