WASTE SITE RECLASSIFICATION FORM

Operable Unit: 100-KR-2 **Control No.:** 2016-010

100-K-121 (115KE Facility)

100-K-121
INFORMATION SHEET

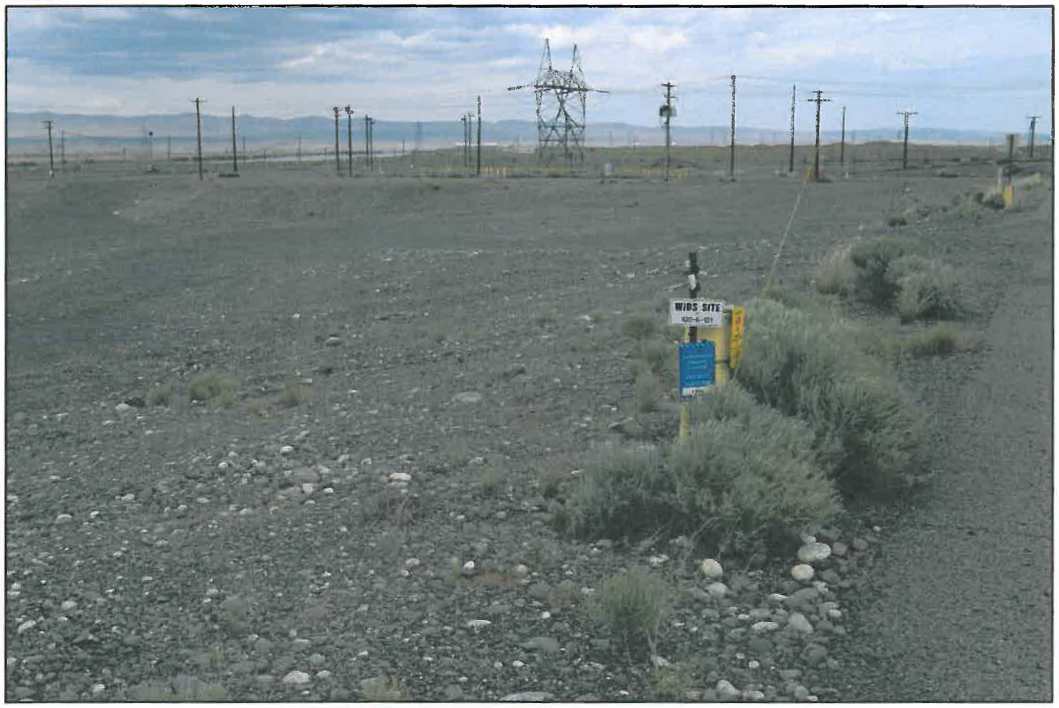
Post-backfill photo
