FACILITY STATUS CHANGE FORM

Date Submitted	Area: 200W	Control Number: D4-REDOX-036
Originator: Daniel Turlington	Facility ID: 2718S	Phone: 509-373-0176

2718S was constructed in 1952 in the 200W area south of REDOX. The building was known as the Sand Filter Sample Building (Attachment 1).

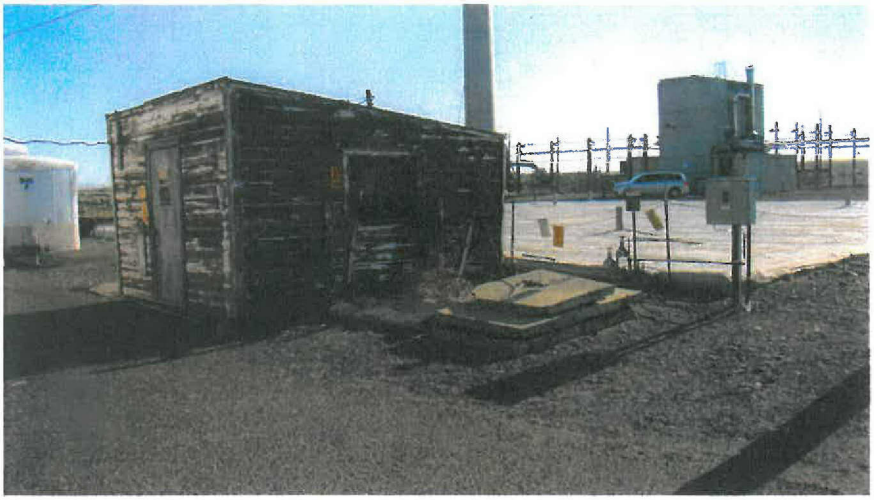
2718S Pre Demolition

2718S During Demolition

2718S Post Demolition

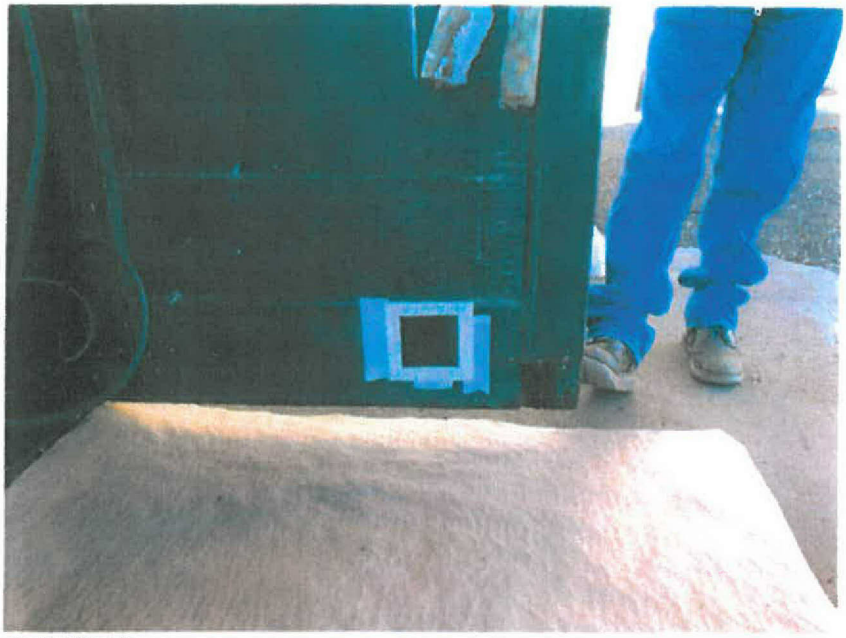
Sample Number	Sample Date	Sample Result ($\mu g/100\ cm^2$)	Control Level ($\mu g/100\ cm^2$)	Sample Location
16-20095-001	01/20/2016	<0.025	0.2	Inside of north door.
16-20095-002	01/20/2016	0.029	0.2	Inside of west door.

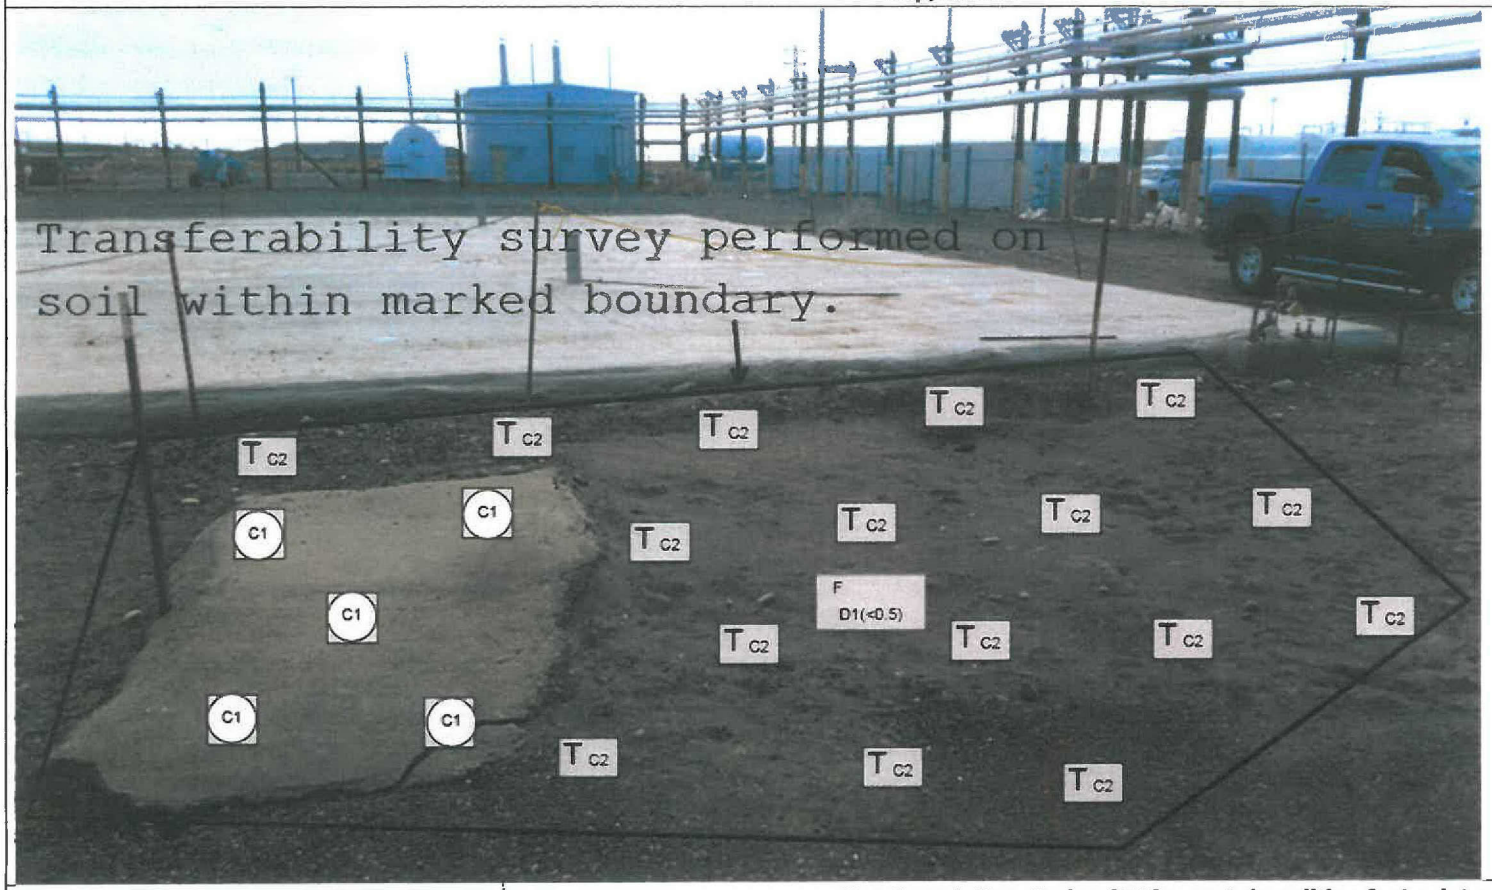
Map Name: 2718s foot print	Map Description: Redox 2718s, post demolition foot print survey.

-Smear survey taken on concrete slab.

-Transferability survey performed every square meter.

-No contamination levels found above table 2-2.
