1. **Calc. No.** RPP-CALC-54266
Rev. 0

4. Job/Project Name/Number	5. Calculation Title/Subject	6. Date
T2R20	POST-HARD HEEL RETRIEVAL CAMERA/CAD MODELING SYSTEM WASTE VOLUME ESTIMATE FOR TANK 241-C-108	1/28/2013

Calculation Title/Subject: **POST-HARD HEEL RETRIEVAL CAMERA/CAD MODELING SYSTEM WASTE VOLUME ESTIMATE FOR TANK 241-C-108**

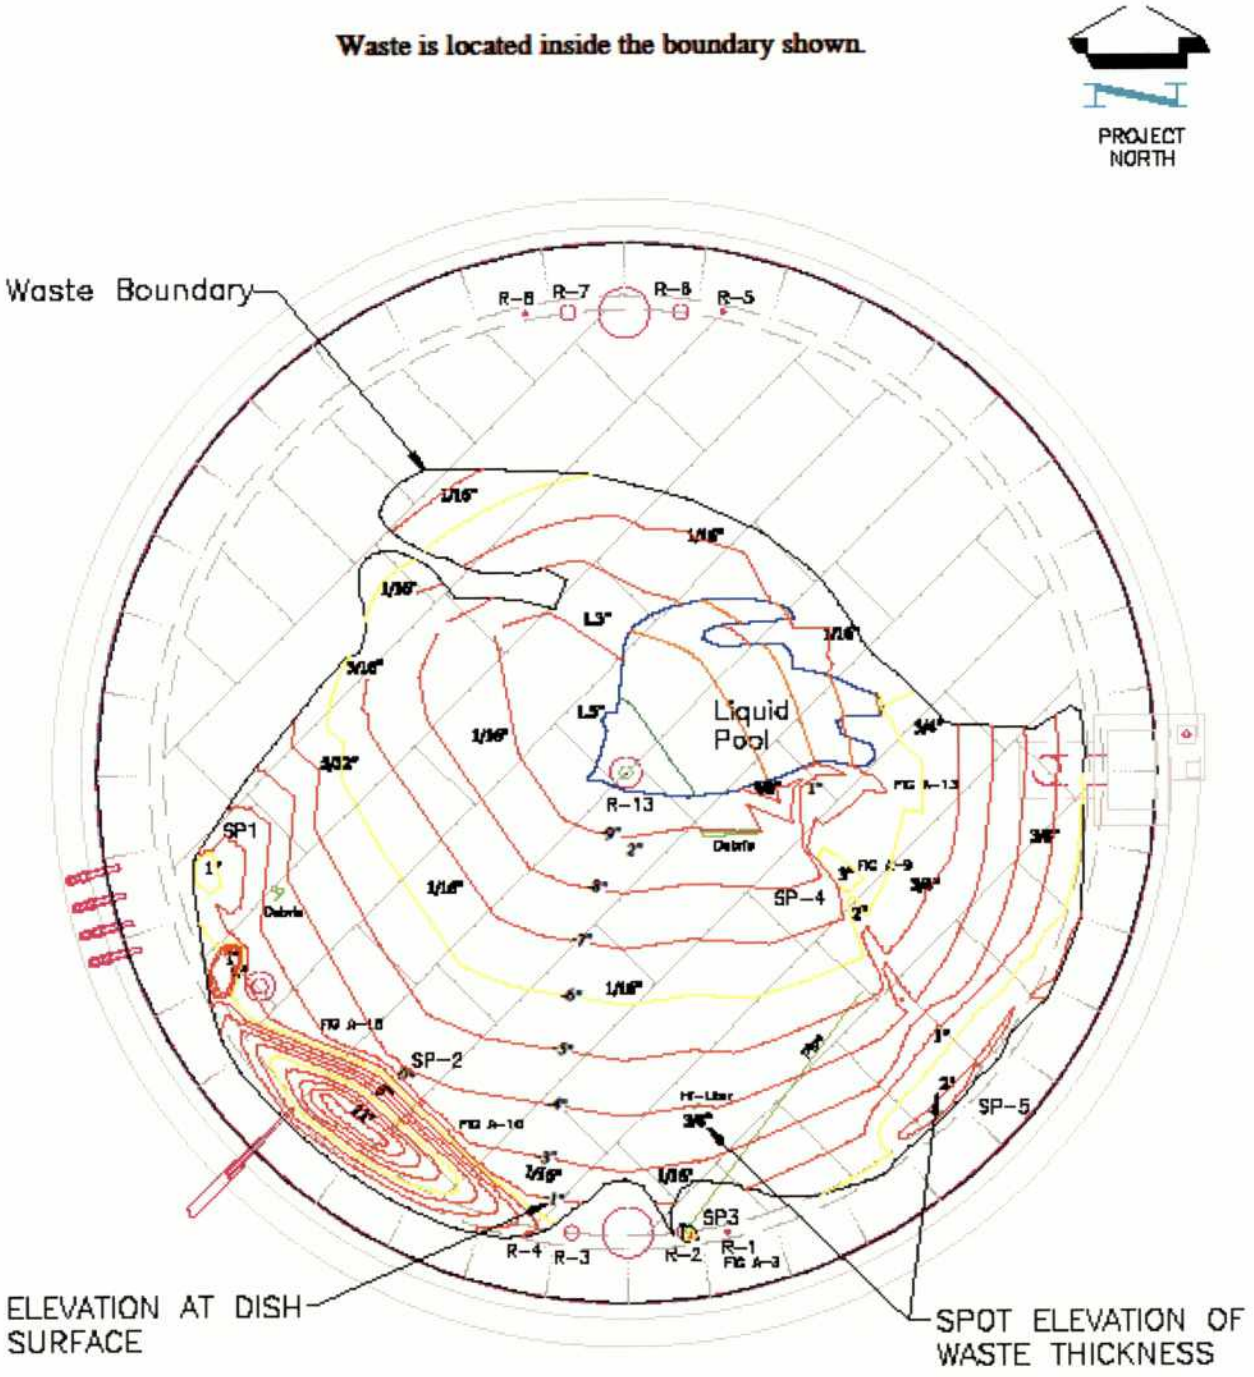
Figure B-16. Tank 241-C-108, AutoCAD Civil 3D 2011, Rev. 2, Post-Hard Heel Retrieval Tank Waste Volume, Contour Map.

The estimated volume of waste on the tank bottom, calculated using AutoCAD Civil 3D, was 304.7 ft^3. The waste volume consists of an estimated 279 ft^3 (7.902×35.31 ft^3/m^3) of solids piles and a 25.7-ft^3 (0.727×35.31 ft^3/m^3) pool of liquids and submerged solids near the center of the tank (Table 3-2). The shape of the pool, not round and off-centered (Figures B-16 and B-17), indicates that the shape of the tank dish is not the same as in the tank template drawing. This was taken into account in estimating the depth of waste at different locations in the tank.

Waste is located inside the boundary shown.
