BHI-01399
Rev. 0

108-F Biological Laboratory D&D Project Closeout Report

Submitted by: Bechtel Hanford, Inc.

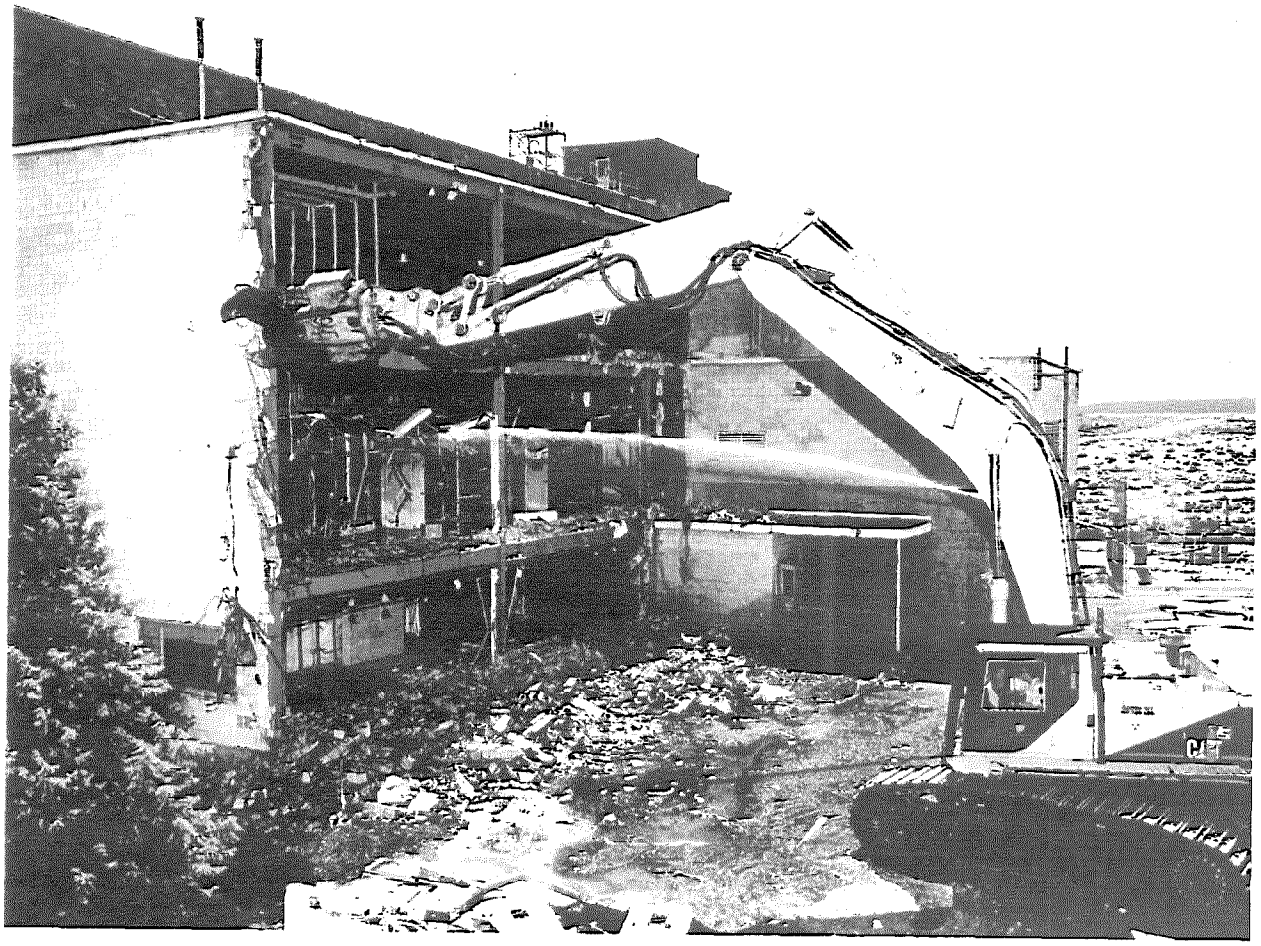
Photo 1. Heavy Equipment Removing Concrete Wall on Westside of 108-F as Water is Sprayed to Control Dust.

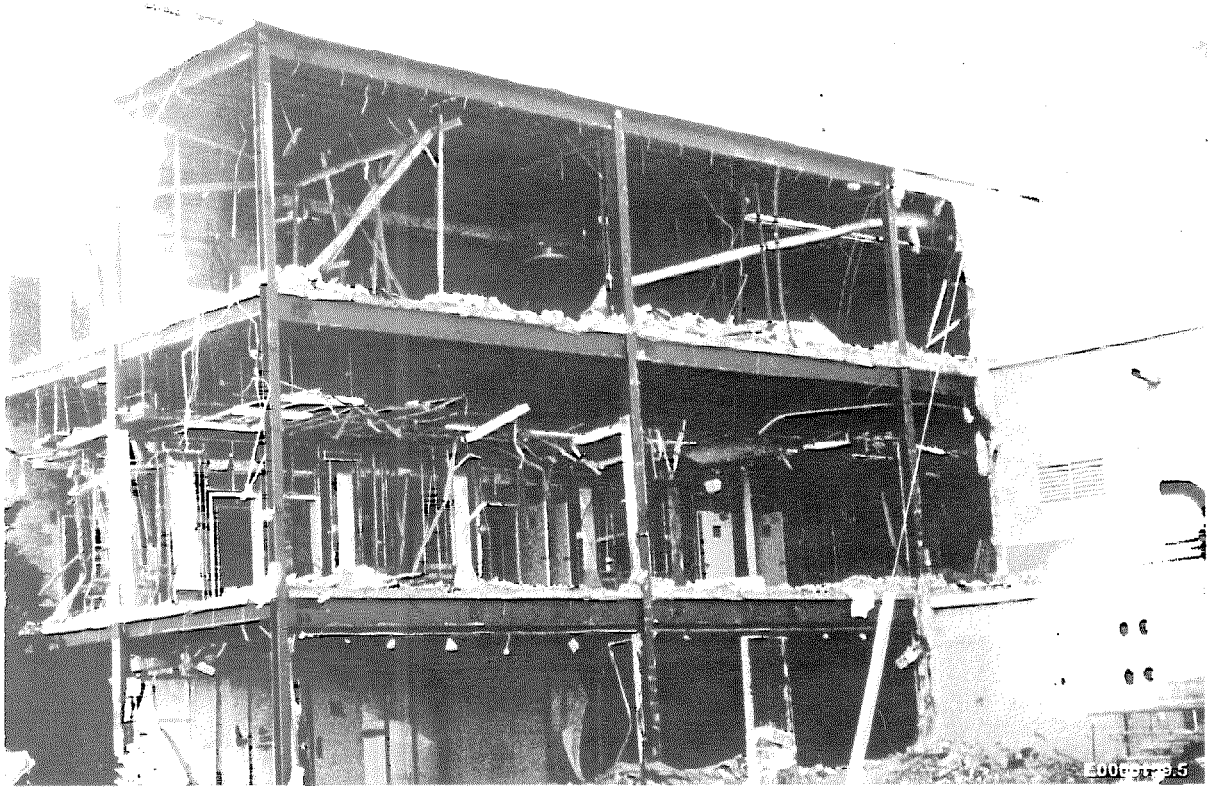
Photo 2. West Side of Building (Annex) After Concrete Walls Removed.

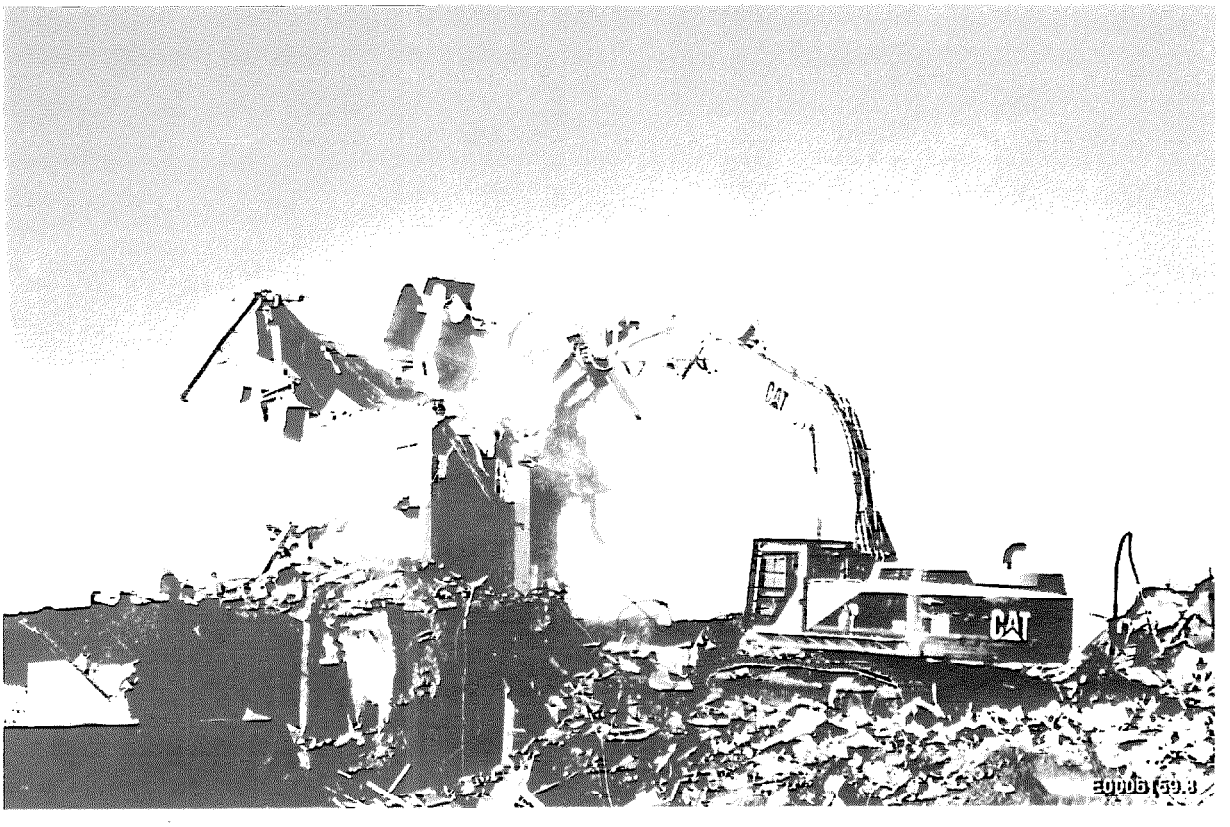
Photo 4. Demolition of Southern Half of 108-F Building.

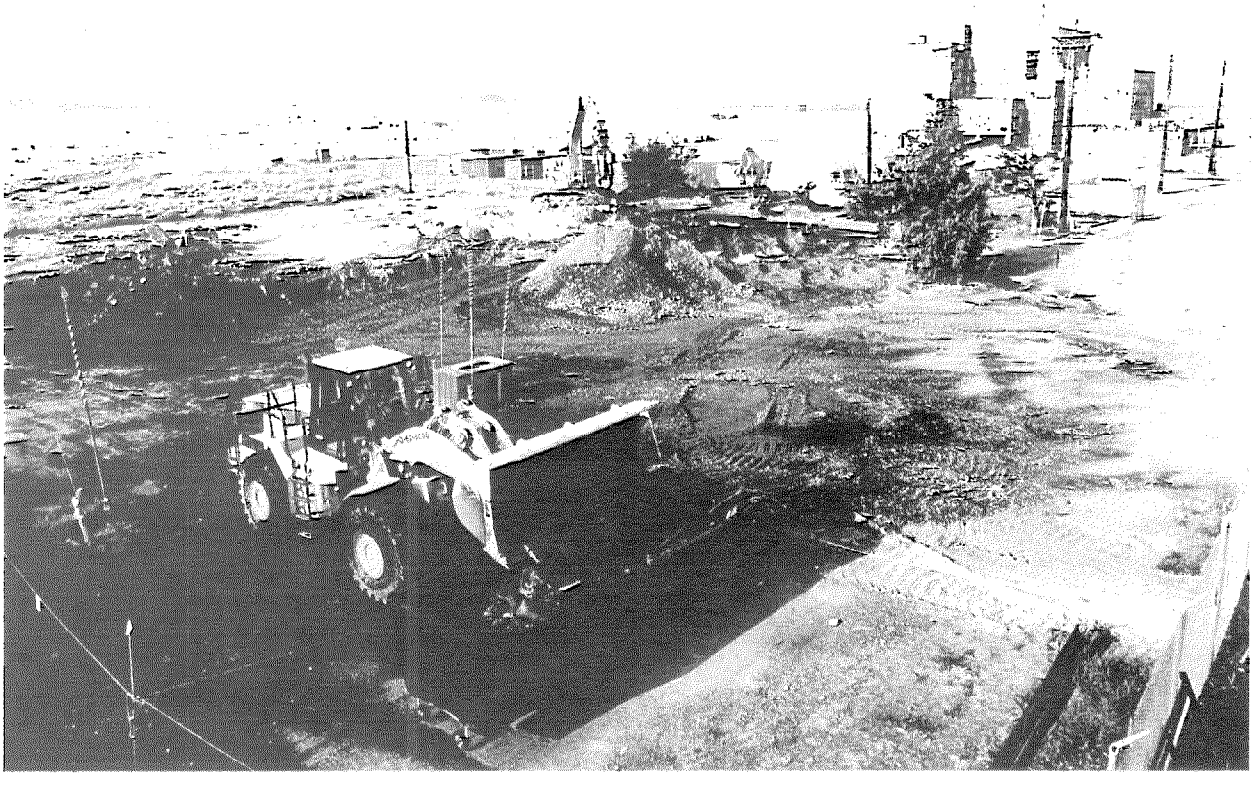
Photo 6. Contaminant Soil Being Loaded in ERDF Container.

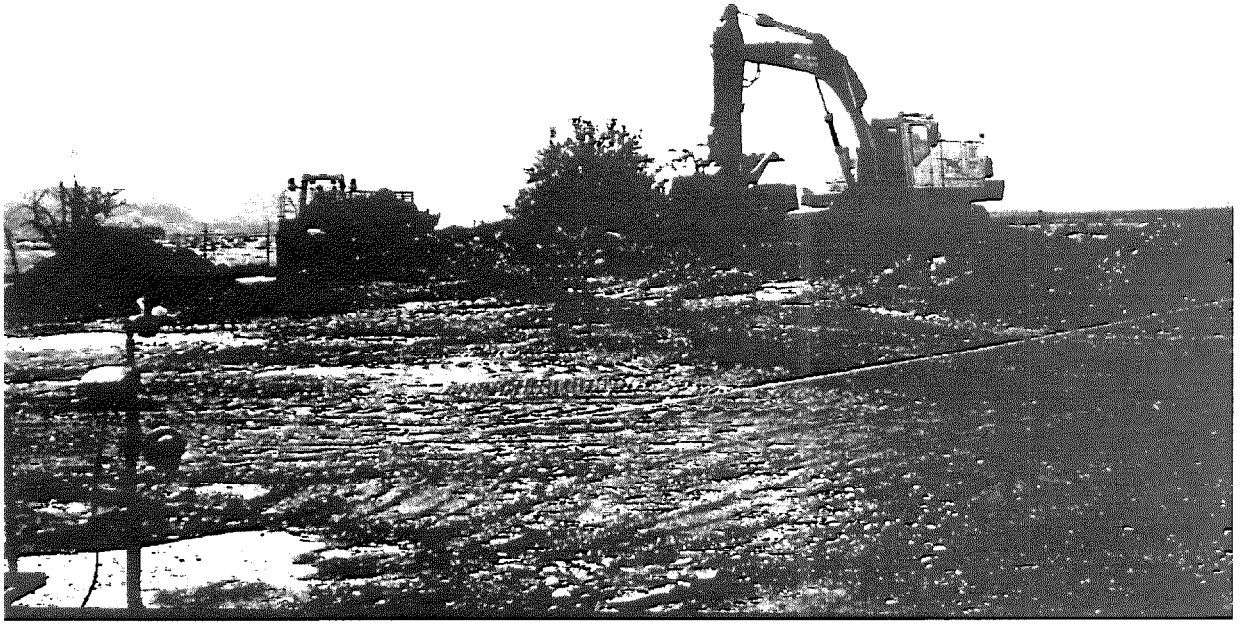
Photo 7. Site of 108-F Biological Laboratory After D&D Operations Completed.
