TRANSMITTAL OF APPROVED WASTE SITE RECLASSIFICATION FORM AND SUPPORTING DOCUMENTATION FOR THE 100-N-35, OIL RELEASES FROM HANFORD GENERATING PLANT (HGP) SUBSTATION EQUIPMENT, REVISION 0

WASTE SITE RECLASSIFICATION FORM

Waste Site Code(s)/Subsite Code(s): 100-N-35, Oil Releases from Hanford Generating Plant (HGP) Substation Equipment

PHOTOGRAPHS OF THE HANFORD GENERATING PLANT TAKEN DURING THE VISUAL SITE INSPECTION

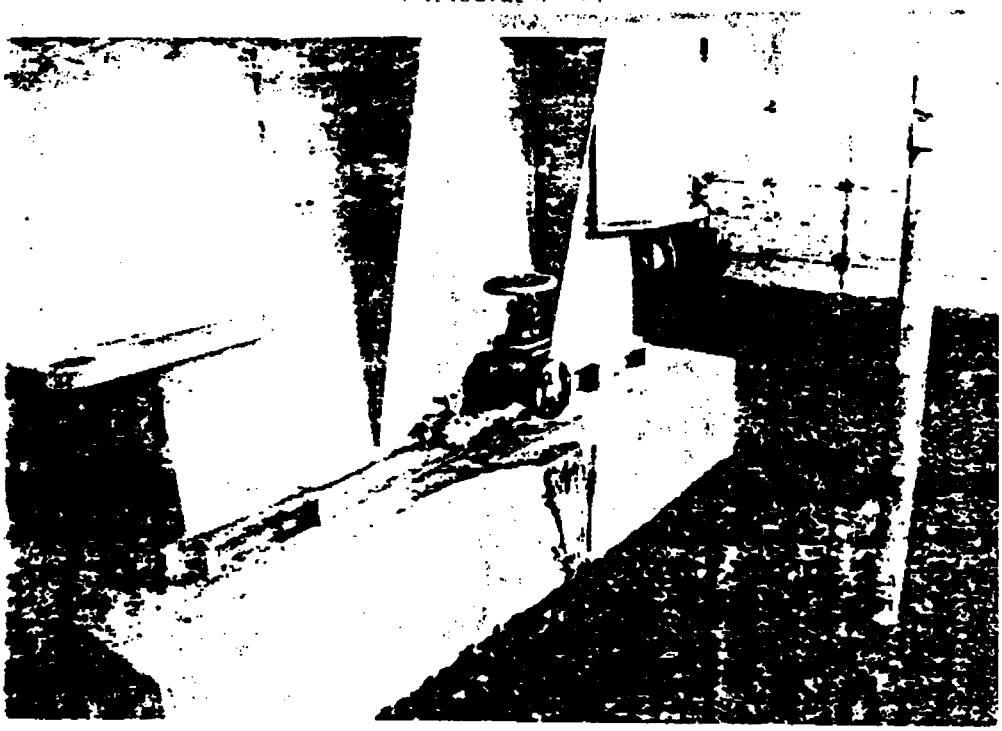
Photograph No. 1

unpaved and covered with crushed rock. Each transformer has a fluid pump attached to one side and a main valve on the adjacent side. The pumps and valves protrude beyond the transformer pads. The valves and pumps of several of the transformers have passive leaks, as indicated by fluids present on the outside of the transformer and oil stains on the concrete pads and crushed rock below (Photographs 1 and 2, Appendix A).

Picture Description: SWMU [illegible] transformer yard - oil stains on concrete pad under valve

SWMU 1, the transformer yard, showed evidence that several of the transformers had released dielectric fluids onto the soil. Documentation was not received from WPPSS personnel to substantiate their statement that the dielectric fluids in the transformers do not contain PCBs. Based on the dates of operation of these transformers (1966-1986), it is strongly suspected the mineral oil spilled on the ground contains PCBs. An RFI is recommended to investigate PCBs in the soils.

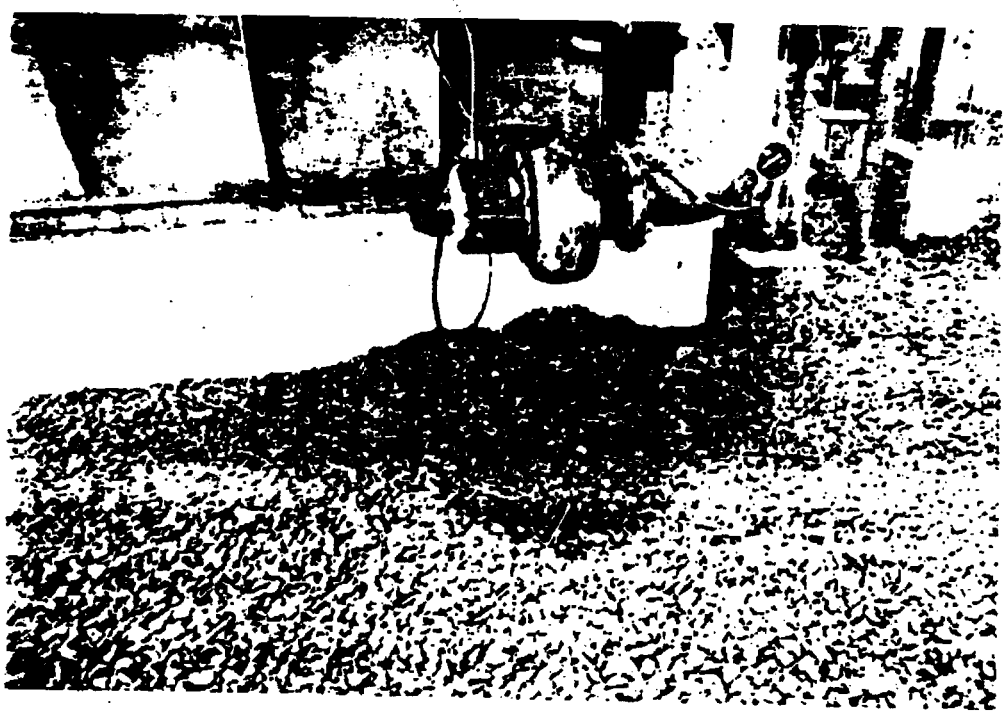
Photograph No. 2

Picture Description: SWMU [illegible] transformer yard - oil stains [illegible]

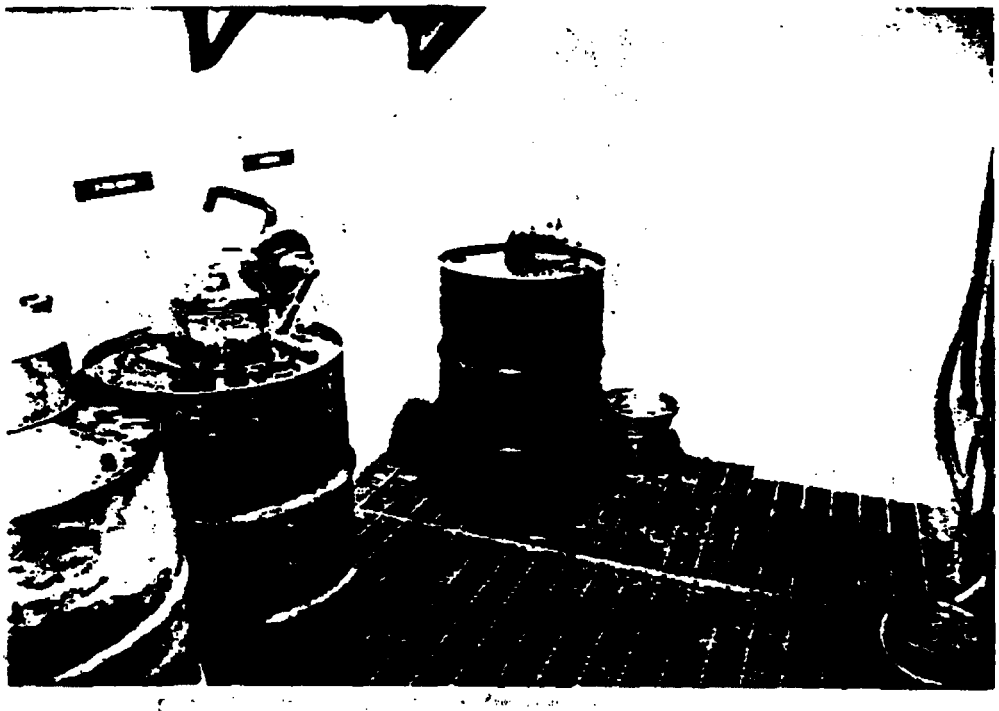
Photograph No. 3

Picture Description: SWMU 2, HGP oil storage area

SWMU 2, the HGP building oil storage area, is used to store both product and waste chemicals, some of which have hazardous constituents. The room is well designed for this purpose and gives no indication of any releases to the environment. No further actions are recommended at this SWMU.

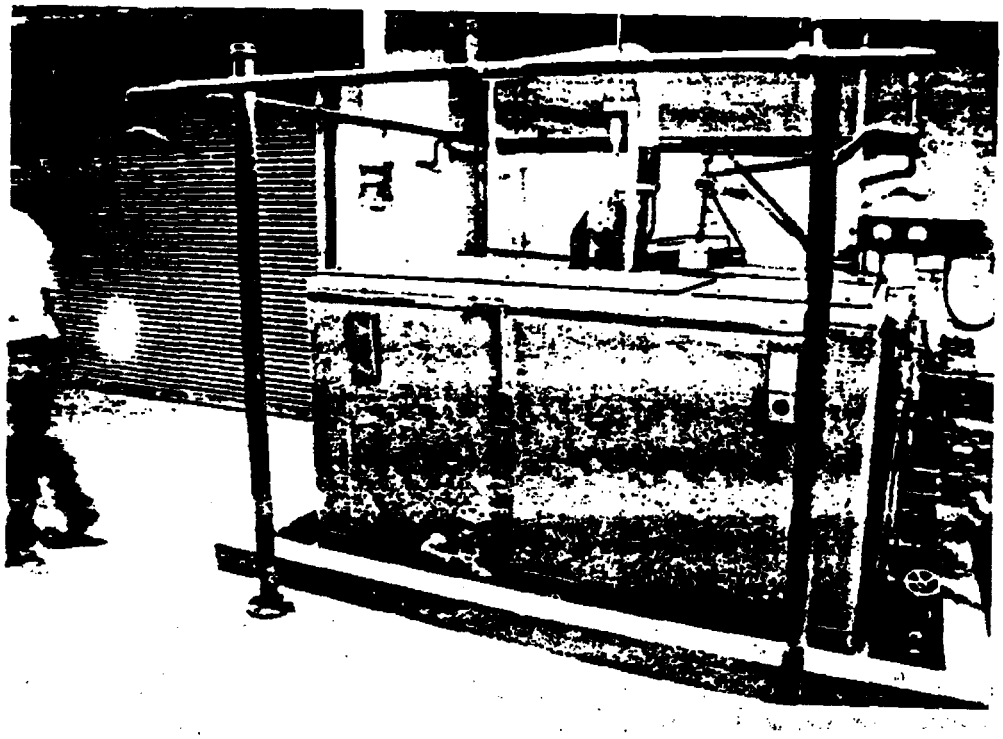
Photograph No. 4

Picture Description: SWMU 4, Turbine oil filter unit

SWMU 4, the turbine oil filter unit was used to clean turbine oil during plant operation. The filters that contained waste are no longer in this inactive unit, and their disposal location is unknown. The unit is on a concrete floor surrounded by a concrete curb that should have contained any small leaks. No releases of hazardous constituents are likely from this unit (except for the filter units) and no further action is recommended.

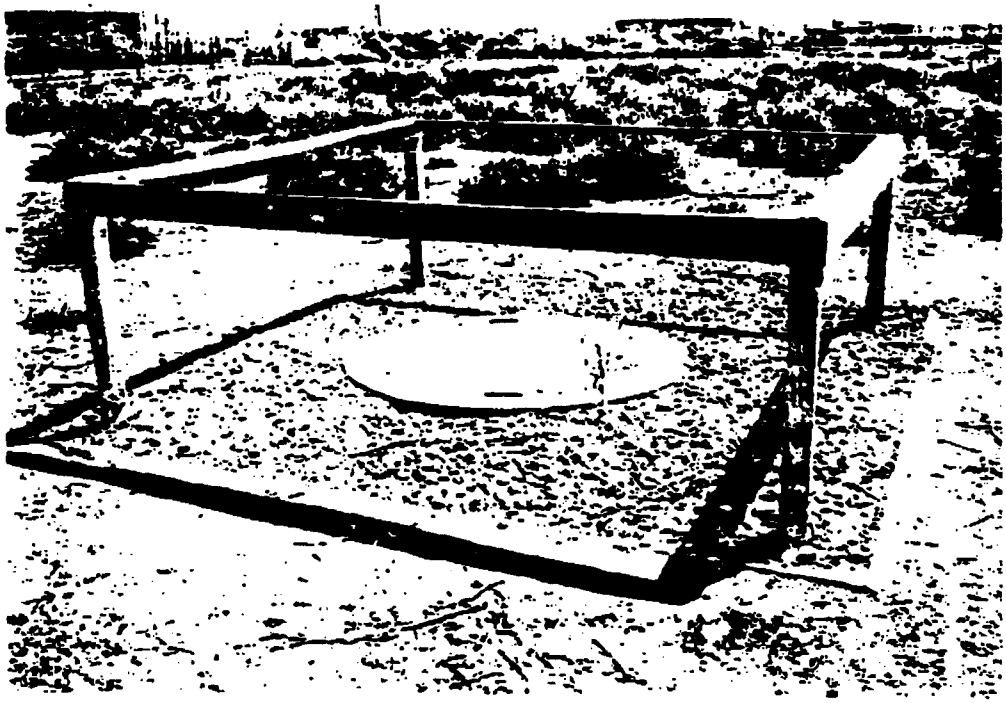
Photograph No. 9

Picture Description: SWMU [illegible] wastewater treatment unit, behind maintenance garage

SWMU 9, the wastewater treatment units, have been used to receive sanitary wastes that should not contain any hazardous constituents (with the exception of the unit behind the maintenance garage). Further action is only recommended for the unit near the maintenance garage.

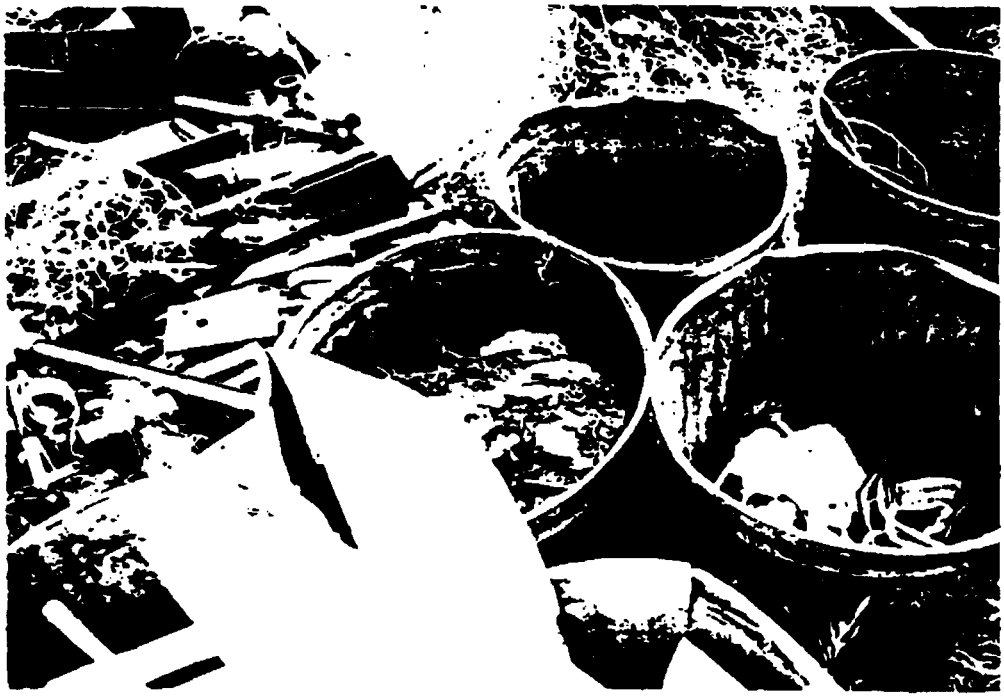
Photograph No. 13

Picture Description: SWMU 13, Disposal and storage Area, scrap metal

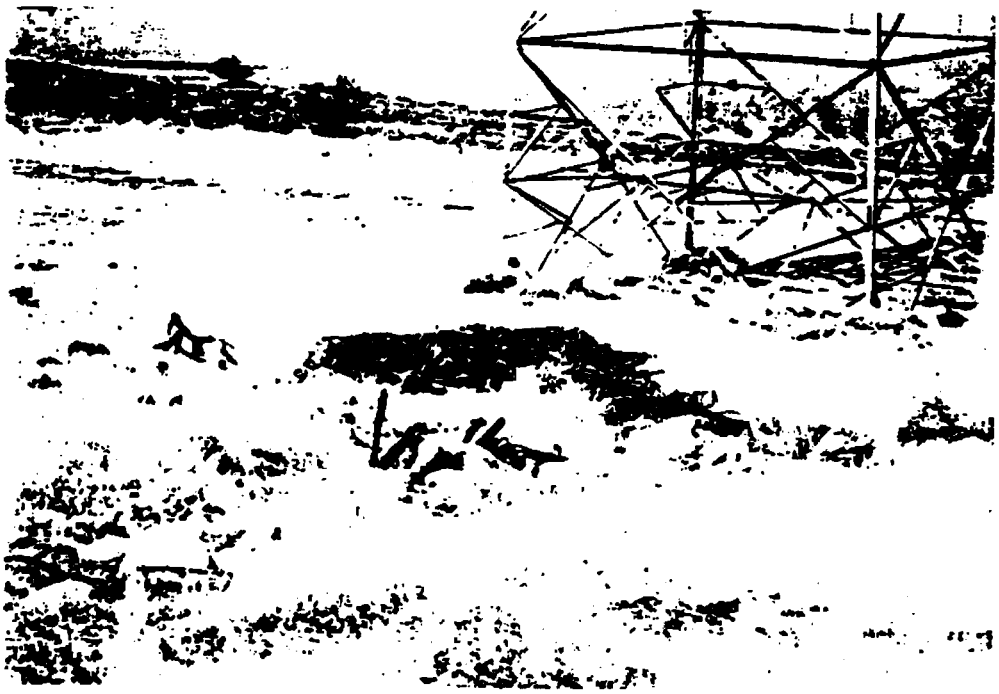
Photograph No. 15

Picture Description: SWMU [illegible], Disposal and storage Area, pile of steel bands

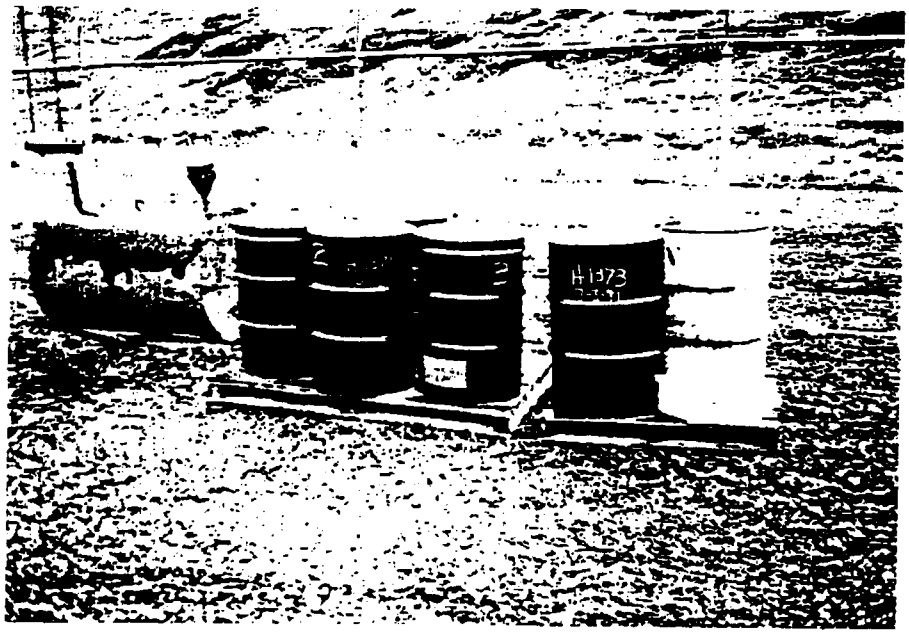
Photo No. 4

Picture Description: Midway Substation - Waste oil tank recently removed near untanking tower and soil from excavation awaiting removal

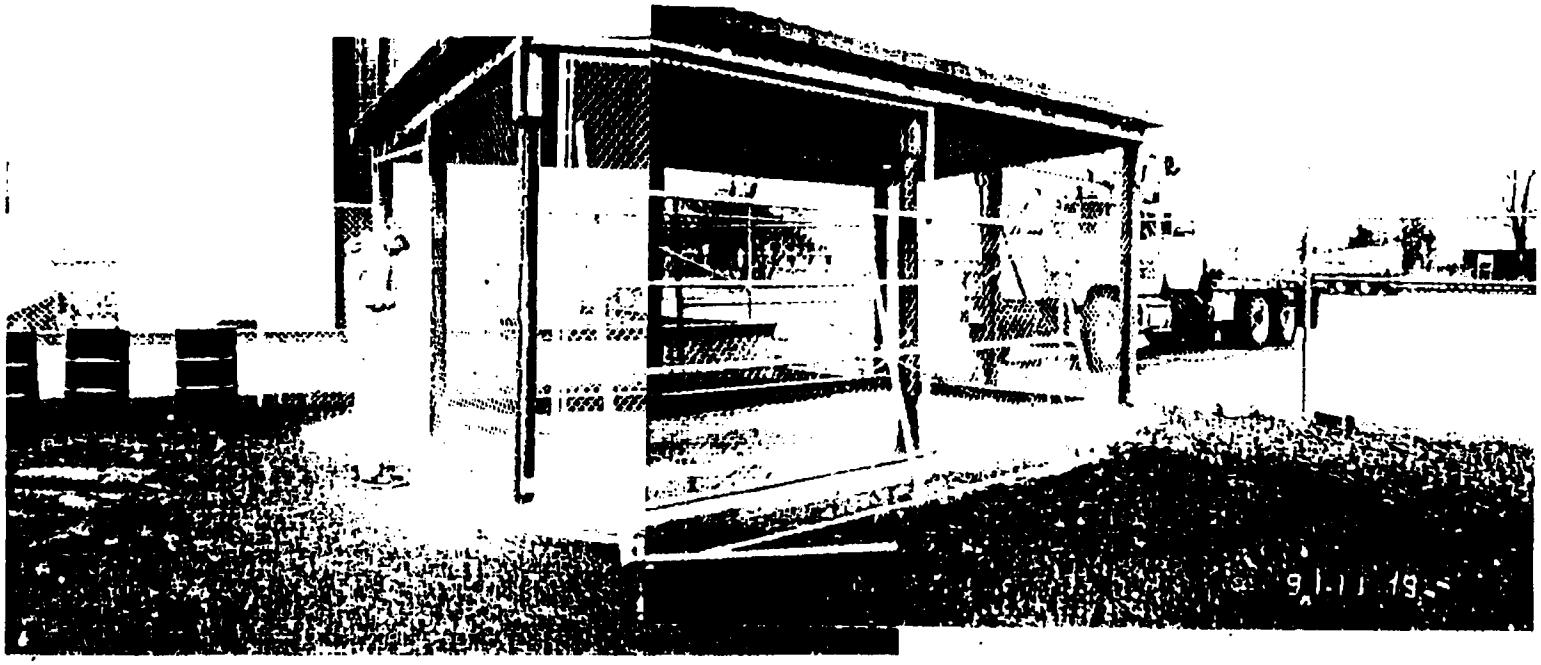
Photo No. 5

Picture Description: Midway Substation - Former hazardous waste generator storage area

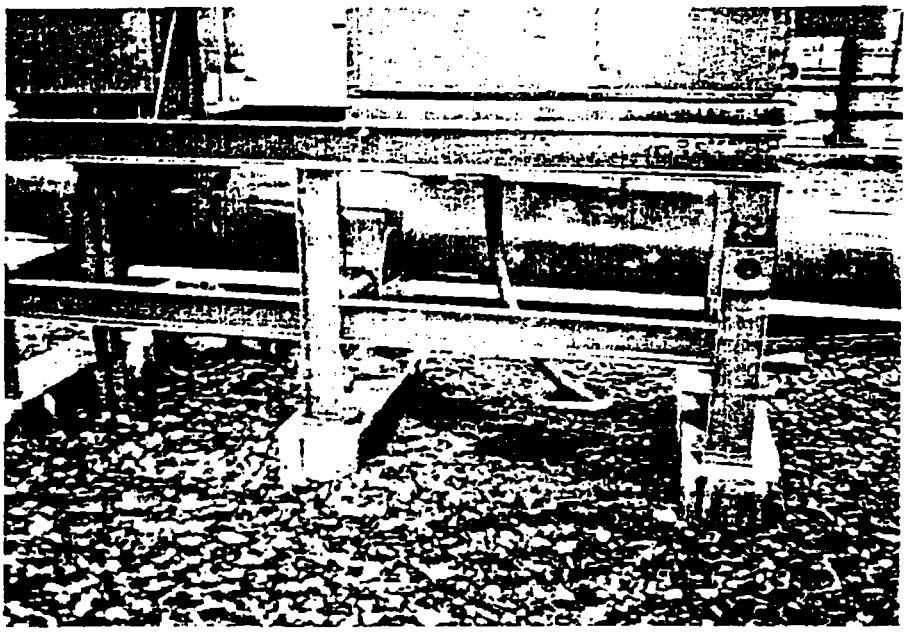
Photo No. 6

Picture Description: Hanford Substation - Compressor pump blowoff

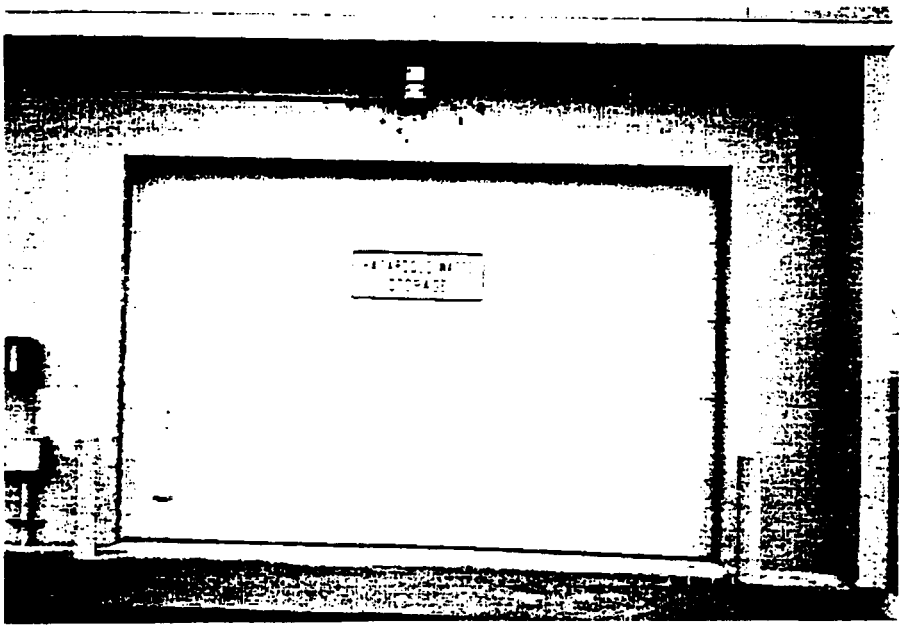
Photo No. 7

Picture Description: H.J. Ashe Substation - Hazardous waste generator storage building

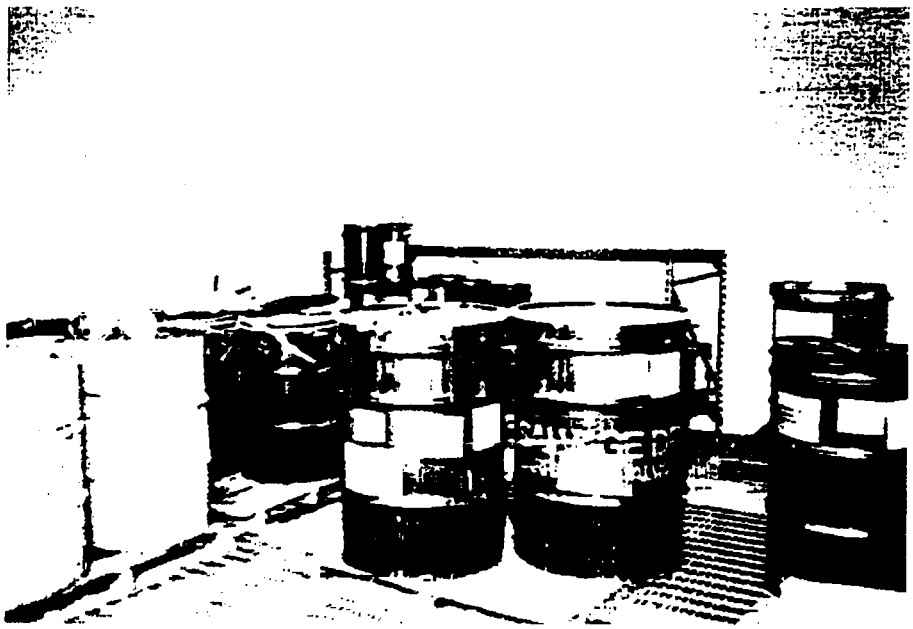
Photo No. 8

Picture Description: Ashe Substation - Inside generator storage building

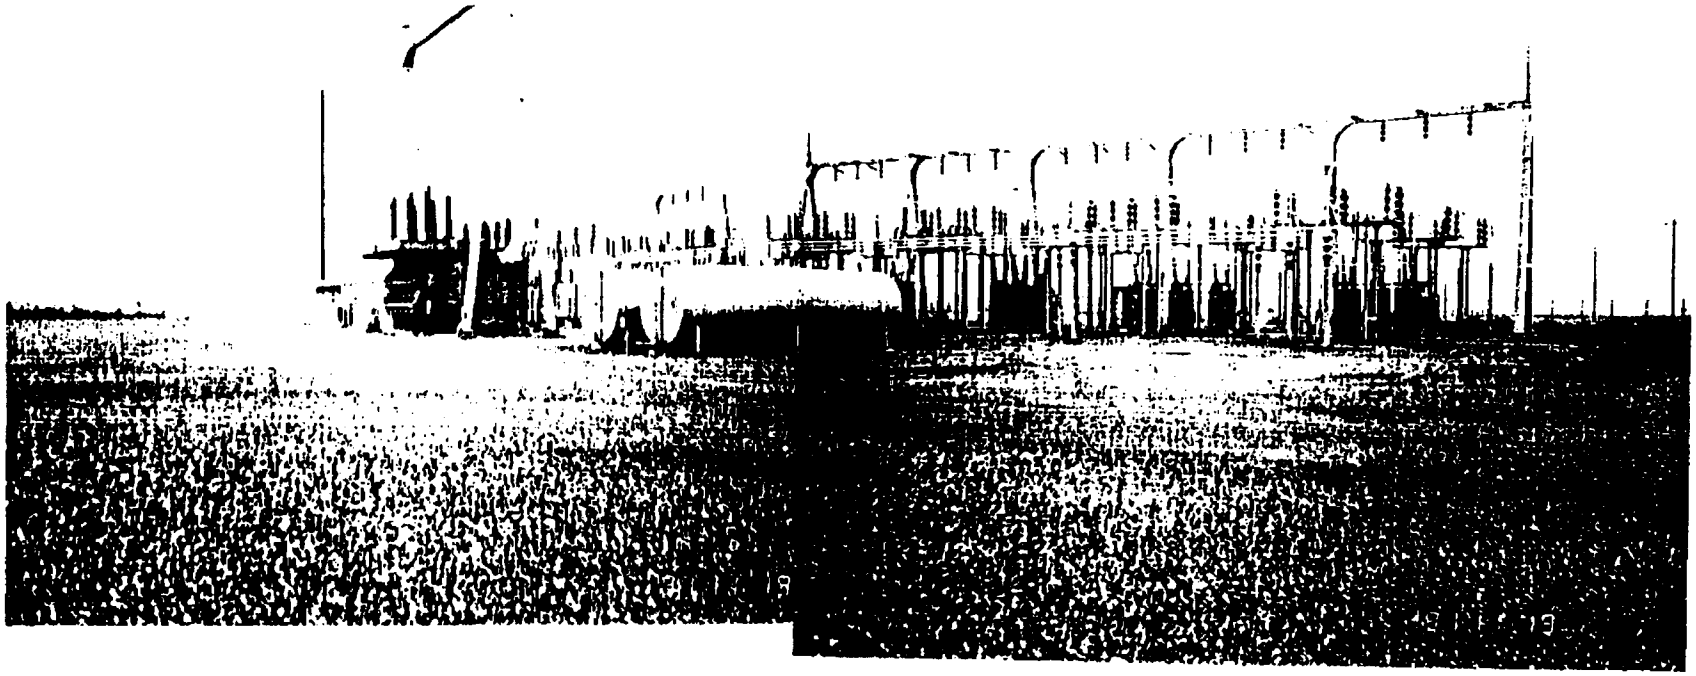
Photo No. 14

Picture Description: White Bluffs Substation

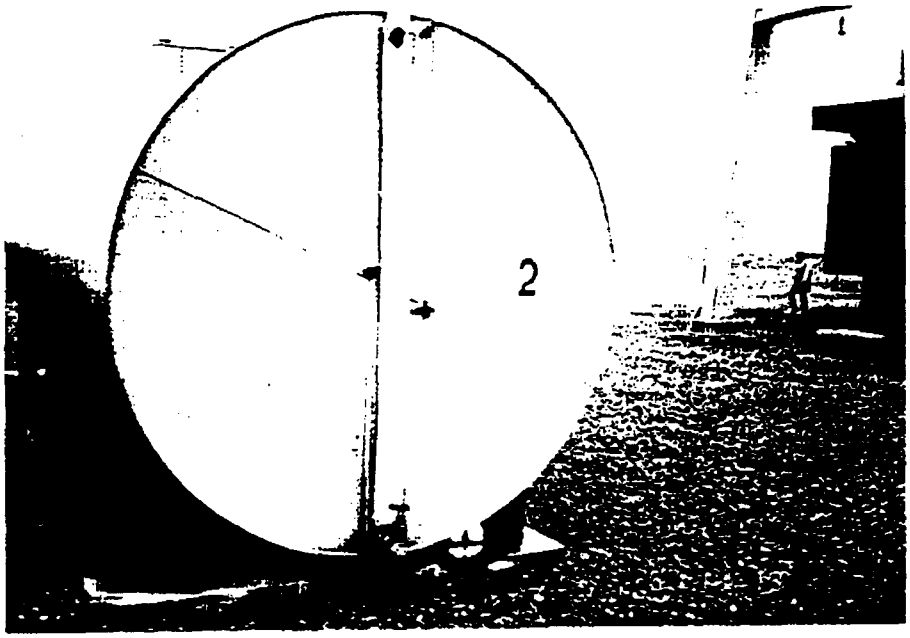
Photo No. 15

Picture Description: White Bluffs Substation - Make-up mineral oil tank
