TRANSMITTAL OF THE APPROVED WASTE SITE RECLASSIFICATION FORM AND SUPPORTING DOCUMENTATION FOR THE 600-333 UNDERGROUND STORAGE STRUCTURE, REVISION 0

Date Submitted: 02/10/2011 Originator: M. L Proctor Phone: 372-9227	**WASTE SITE RECLASSIFICATION FORM** Operable Unit(s): 100-IU-6 Waste Site Code: 600-333 Type of Reclassification Action: Closed Out ☐ Interim Closed Out ☐ No Action ☐ RCRA Postclosure ☐ Rejected ☒ Consolidated ☐	Control Number: 2011-008

SUPPORTING INFORMATION FOR RECLASSIFICATION OF THE 600-333, UNDERGROUND STORAGE STRUCTURE

Attachment to Waste Site Reclassification Form 2011-008

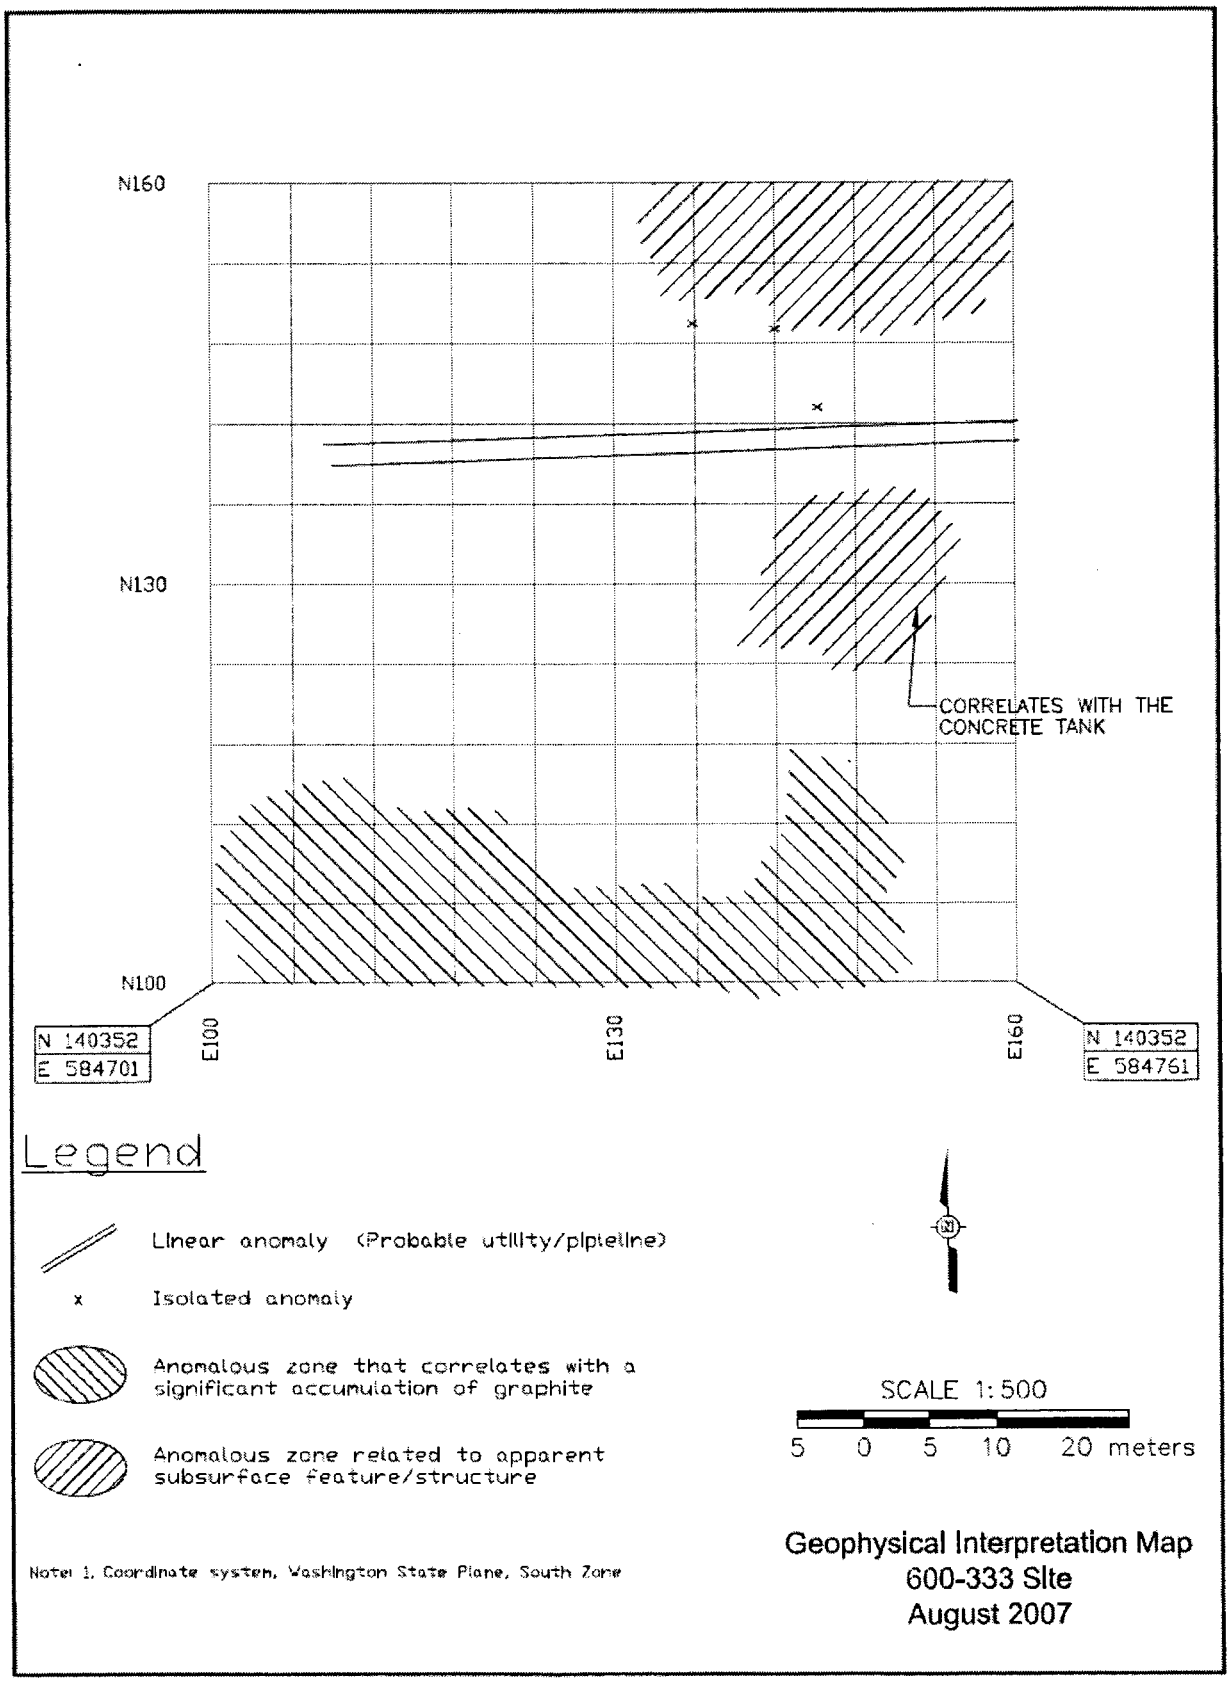
Figure A-2. 600-333 Waste Site Geophysical Interpretation Map.

A geophysical site investigation was conducted at the 600-333 waste site in August 2007 to determine if there was additional buried infrastructure around the feature that might help resolve the function of the structure (e.g., septic tank). The geophysical anomaly associated with the concrete structure in Figure A-2 of the Attachment appears to be consistent with its observed size and shape. No other nearby geophysical anomalies shown in Figure A-2 appear to be associated with the observed underground concrete structure. An east-west-trending anomaly was observed (i.e., probable utility/pipeline) passing to the north of the structure, but it did not appear to be associated with it. The anomaly identified at Washington State Plane coordinates N 43, E 143 is related to a linear anomaly (e.g., manhole). The anomalous zone in the northeastern corner in Figure A-2 has the characteristics of the buried remnants of a structure (i.e., building). The anomalous zone along the southern border of this site is correlated with the abundance of graphite that is scattered across the surface in this area (Figure A-2).
