AN EVALUATION OF THE STRUCTURAL INTEGRITY OF PUREX STORAGE TUNNEL #1 (S-2-1)

An Evaluation of the Structural Integrity of PUREX Storage Tunnel # 1

May 17, 1991

Los Alamos Technical Associates, Inc.

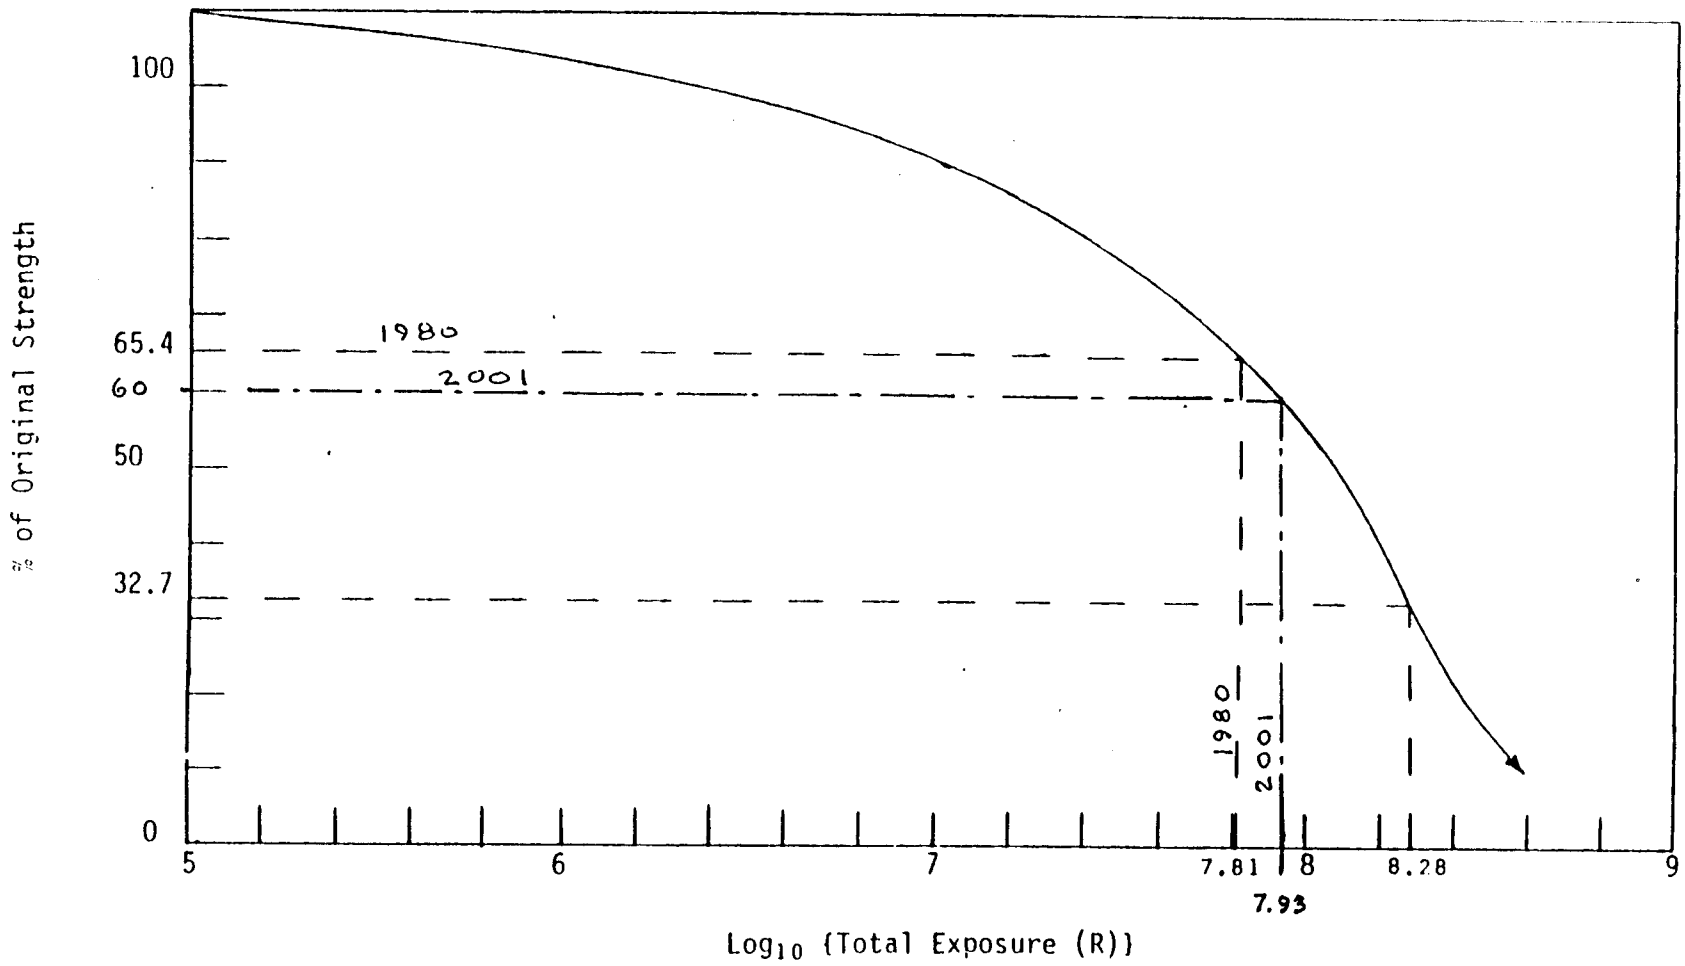
FIGURE A-1: EFFECT OF GAMMA RADIATION ON WOOD BENDING STRENGTH[1]

percent of original integrity is estimated to be 60%. The calculations that are the basis for the estimate are as follows:

$$TE = 1 \times 10^6 (t-1) + 4.71 \times 10^7 (1-t^{1.5})$$

$$TE = 1 \times 10^6 (40-1) + 4.71 \times 10^7 (1-40^{1.5}) = 8.59 \times 10^7$$

$$Log_{10}(8.59 \times 10^7) = 7.93$$

Percent of Original Strength = 60% (from Figure A-1 of Silvan [1980], see the appendix for a copy of Figure A-1 with the new data superimposed).

The result of this additional loss of strength would be minimal.

Therefore, it is recommended that the dangerous waste in the tunnel remain as is and that if a decision for final disposition is not made by the year 2001, that the structural integrity again be evaluated in light of any then available information including any further tests on wood preservation that may have been completed at that time. Further tests of the timbers in the tunnel, either destructive or non-destructive, are not indicated at this time.
