DOE/RL-93-47
Revision 0

North Slope Expedited Response Action Proposal

Date Published
October 1993

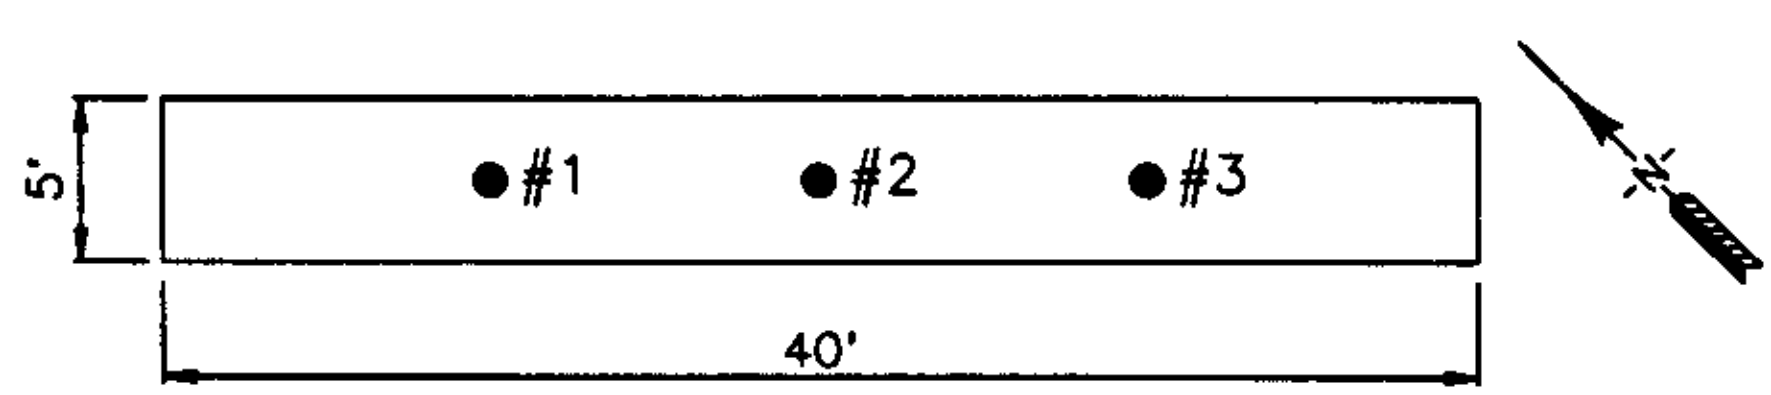
Figure 3. H-12-L Acid Neutralization Pit.
(overhead view of sample locations)

Samples were taken within the pit at the native soil (sand/silt) and pea gravel interface. A map of the sample locations is provided in Figure 3. The samples were field screened for pH. The pH of samples 1 and 2 was approximately 6.5, while sample 3 was 5.9 to 6.2. Soil samples taken from locations 2 and 3 were sent for analysis at a offsite laboratory. The offsite soil samples were analyzed one per CLP (EPA 1990a,b) and one per RCRA (EPA 1986) protocol for ICP/AA metals and anions.

No areas of contamination above regulatory limits were detected as a result of the sampling effort. Sample results are contained in Appendices H and I.

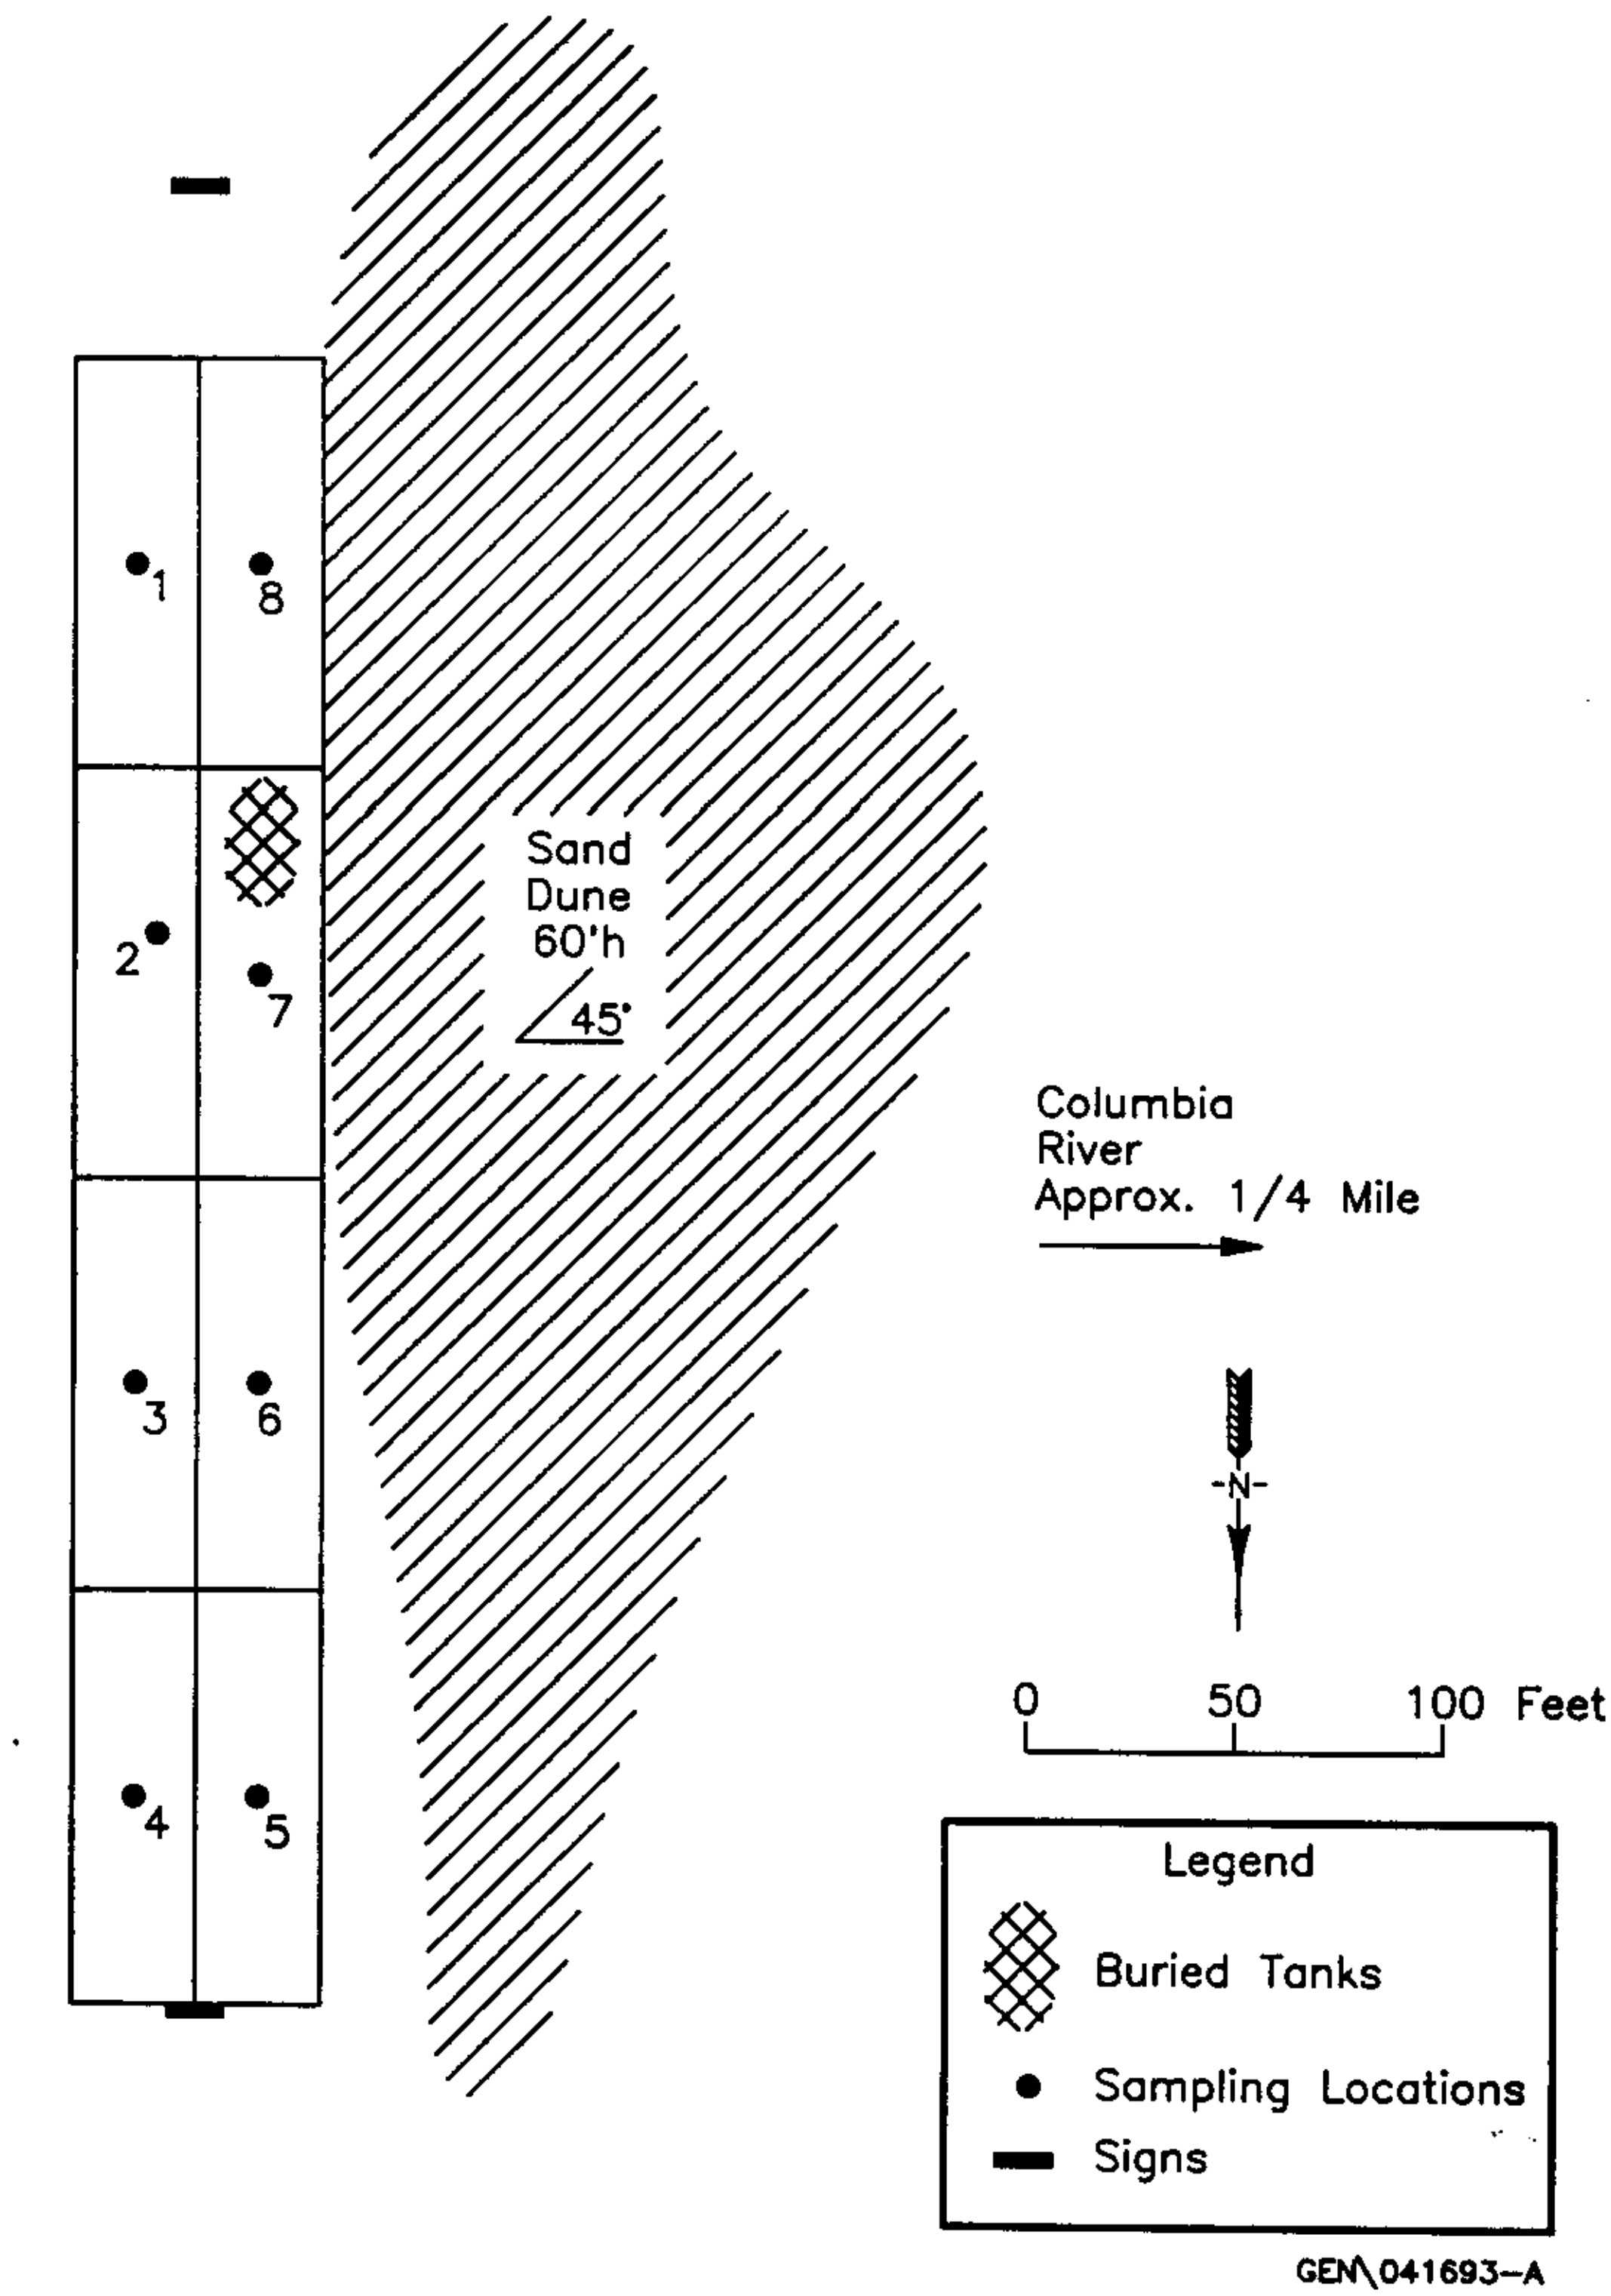
Figure 4. 2-4,D Burial Ground Sampling Location.

A 2,4-D field screening test kit was used to analyze for 2,4-D at each of the sampling locations. The results of this test indicated the presence of 2,4-D at sampling location #8. The test indicated the presence of 2,4-D at approximately 2 ppm, which is near the detection limit of the field test kit. However, 2,4-D was not detected in subsequent field runs of the analysis. A sample from this location was sent to an offsite laboratory for confirmatory analysis under CLP protocol. The offsite laboratory did not report any 2,4-D.

An additional field screening sample was taken at location #7 from the 6-ft level as clay "globules" were seen in the cuttings. Field analysis did not indicate the presence of 2,4-D. Two composite samples (one consisting of soils from locations 1, 2, 3, and 4 and one from locations 5, 6, and 7) were also sent for analysis at an offsite laboratory.

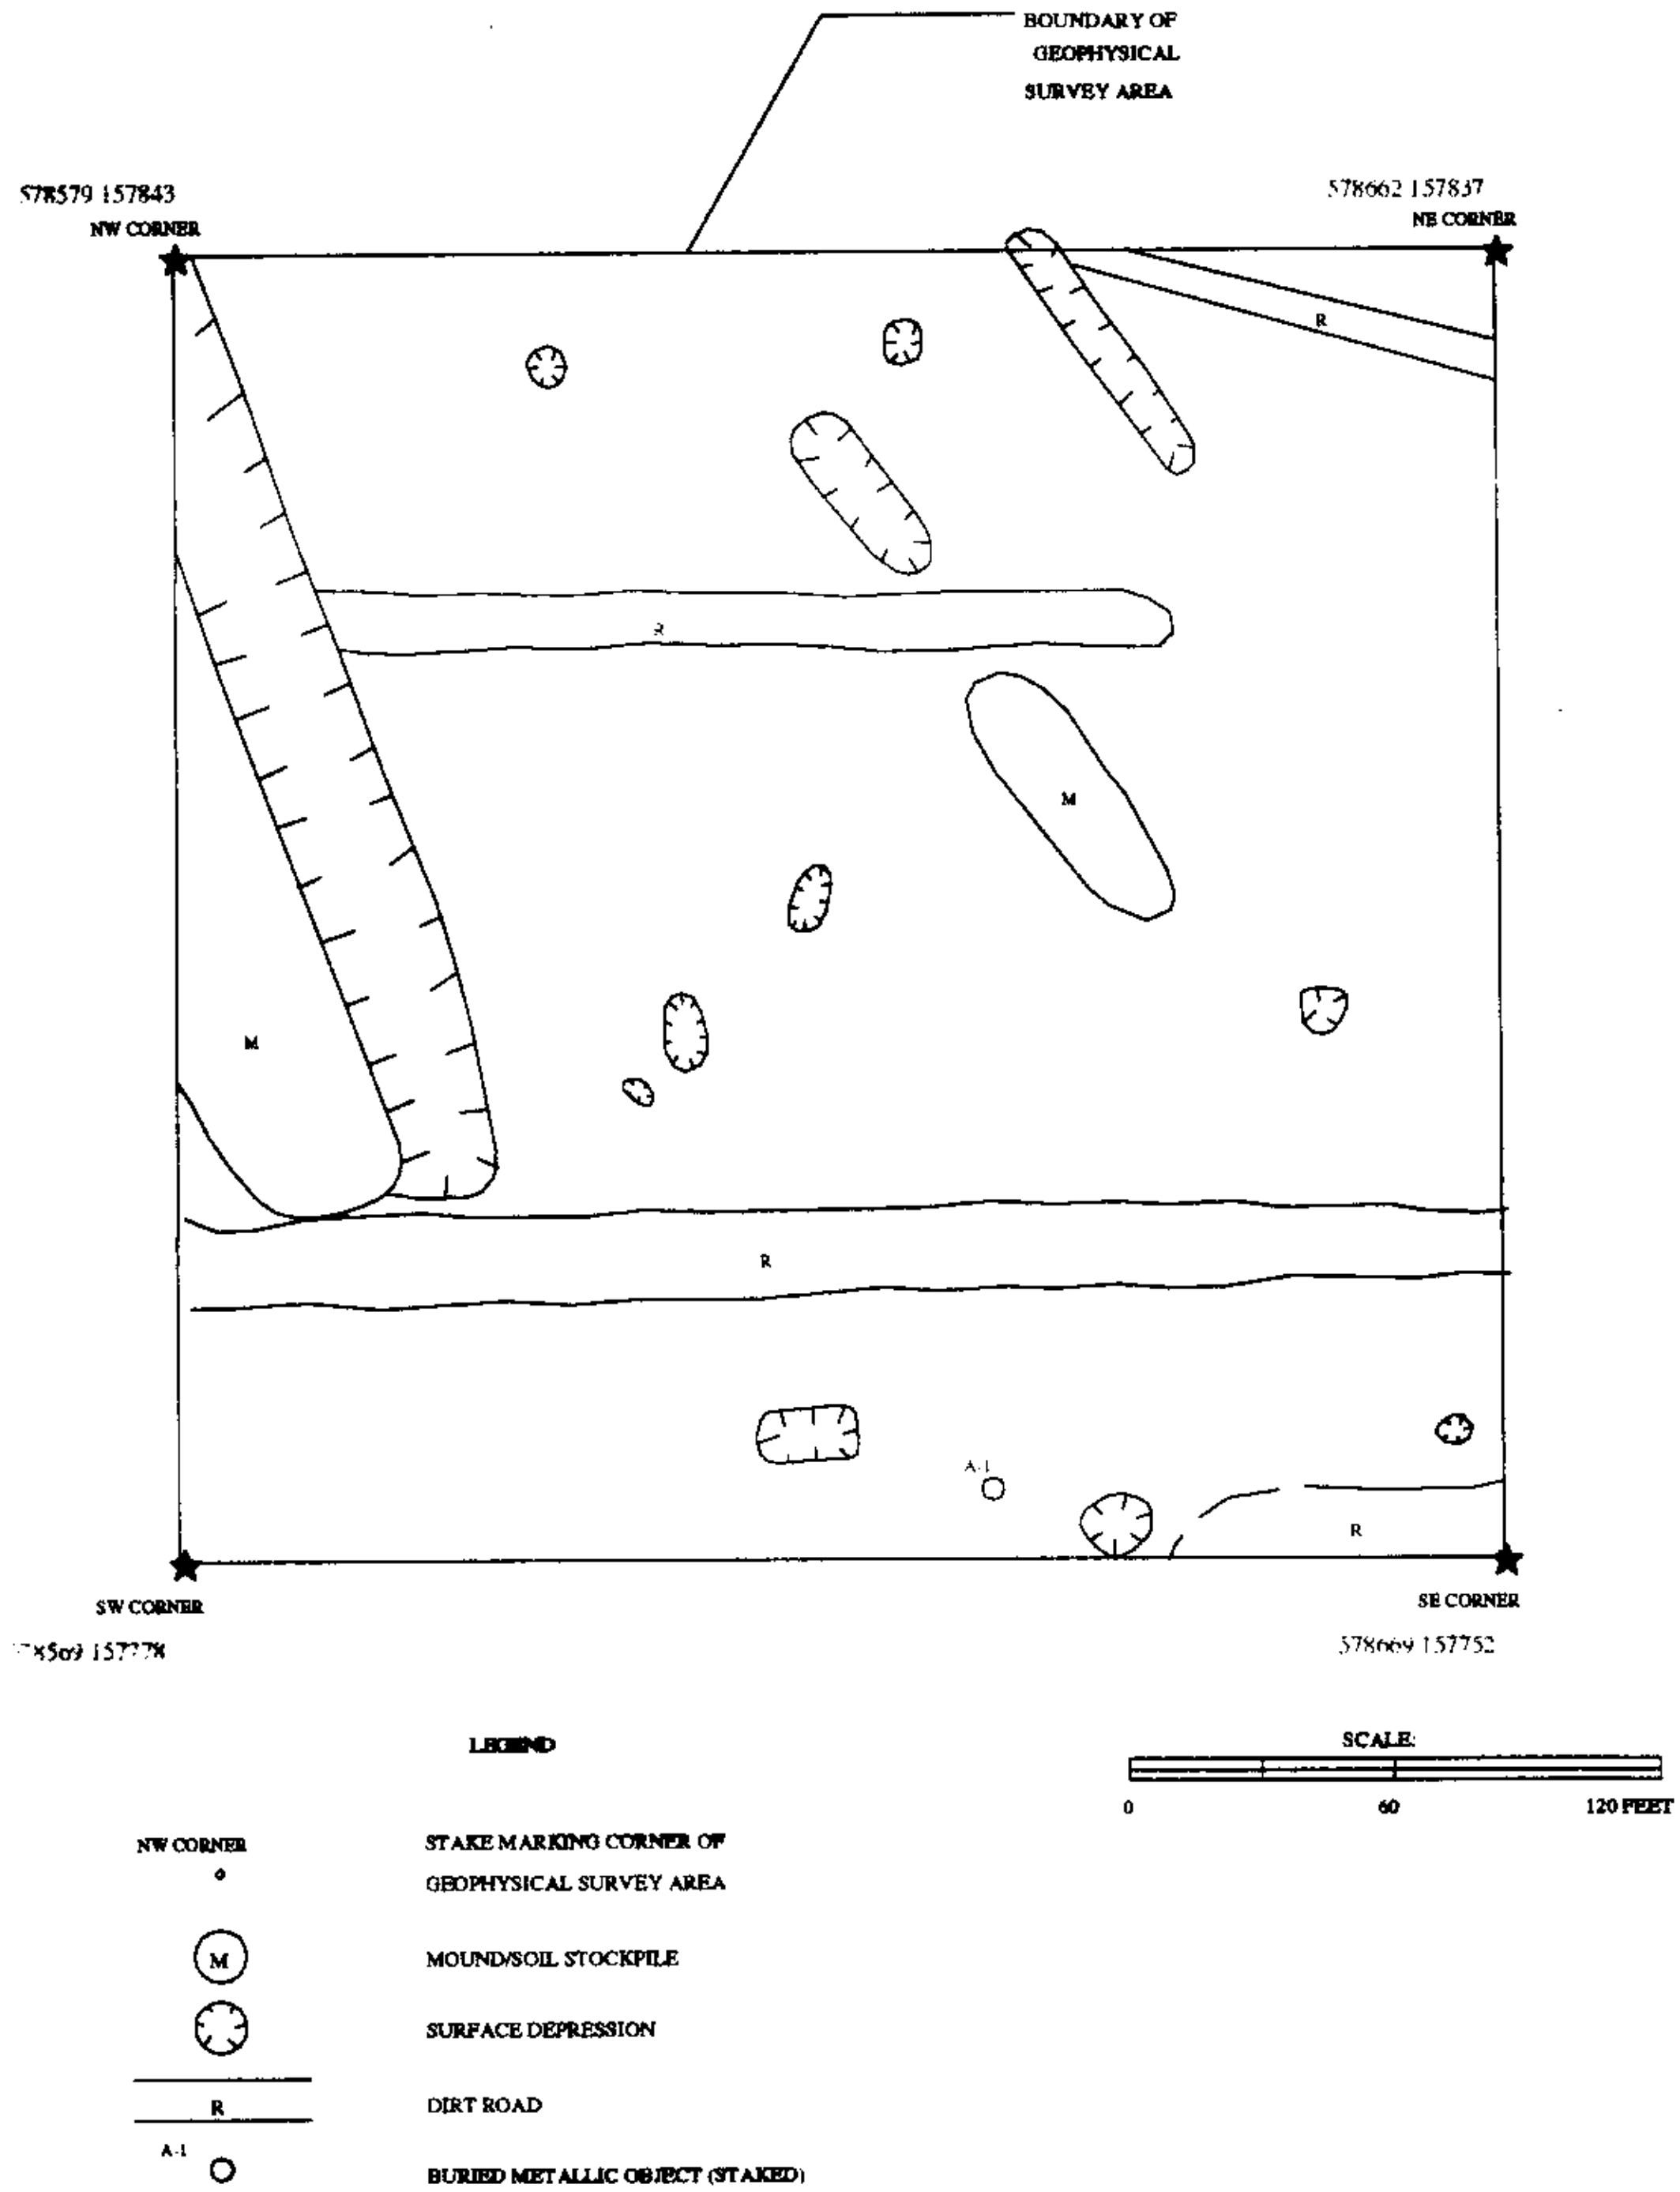
Figure E-1. Site Map with Geophysical Interpretation
Site PSN-04 (North) Wahluke Slope.

A-1 is evidenced by strong magnetic but relatively weak EM-31 anomalies. This anomaly coincides with two small depressions and is probably caused by a trench containing metallic debris. A-2 and A-3 are indicated by strong magnetic and EM-31 anomalies. Anomaly A-2 is associated with a topographic depression and is caused by a trench containing metallic debris. No apparent surface disturbances are associated with anomaly A-3, which also appears to be caused by a trench containing metallic debris. Anomaly A-4, which is apparent only on the contour maps of EM-31 conductivity, is associated with a slight topographic depression. When passing through the depression, the EM-31 is closer to a subsurface geologic layer having higher conductivity than the overlying layer, resulting in a slight increase in conductivity. This anomaly was staked in the field because a large amount of surface metallic objects such as drums and metal pails were removed from the depressed area prior to conducting the geophysical survey, indicating possible contamination of near-surface soils. Anomaly A-5 is evident on contour maps of both magnetic and EM-31 data. A piece of buried steel cable is exposed at the surface, and the anomaly likely results from a small pit containing steel cable and possibly other debris. Anomaly A-6, which is evident on contour maps of both magnetic and EM-31 data, was caused by approximately 20 1-quart containers of oil discovered under a pile of wood. Most of these containers contain liquid, and no evidence of subsurface disposal was found at this location. Anomaly A-7 is a low-amplitude anomaly that occurs only on the contour map of in-phase component for southeast-northwest survey lines. This anomaly is likely caused by a small object buried in the shallow surface. This anomaly was not field checked or staked.
