Document No.
UNI-3262

Date
April 17, 1986

RIVER DISCHARGE LINES CHARACTERIZATION REPORT

J. F. Beckstrom, J. M. Steffes

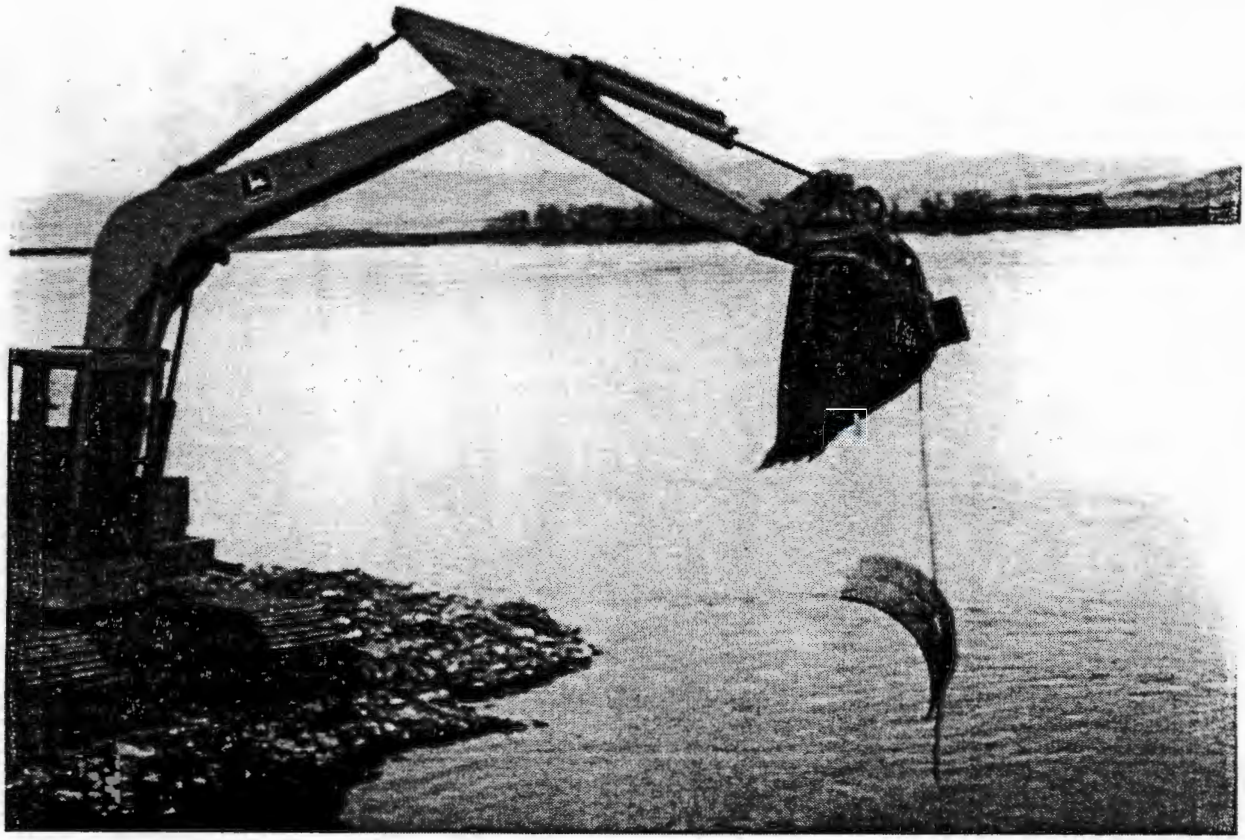
Figure 6. Backhoe Removing Sample Section from River.

Figure 7. Backhoe Placing Sample in Bucket of Front Loader.

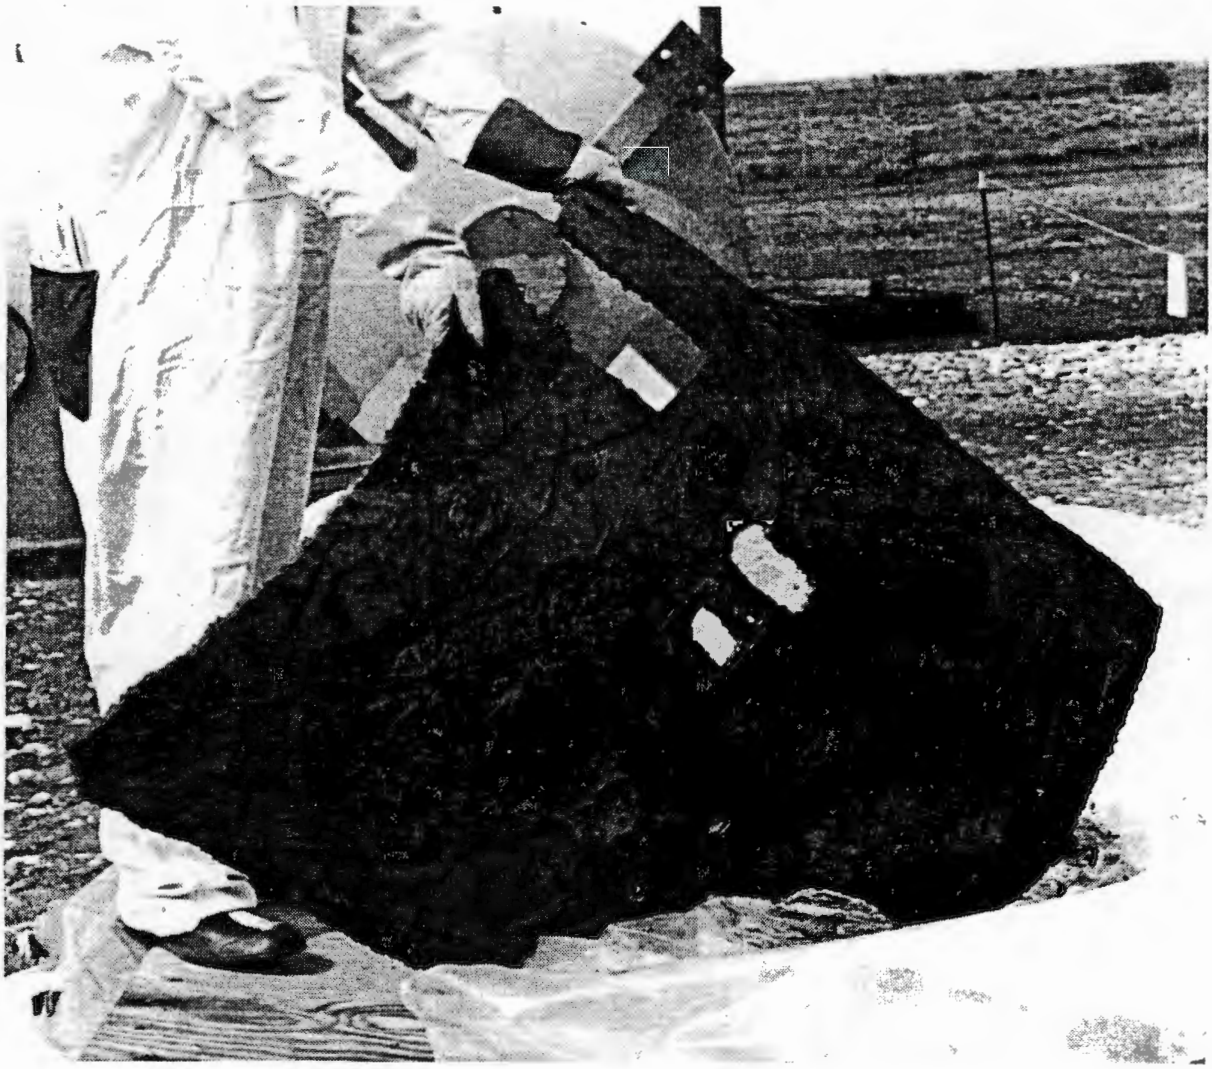
Figure 8. Sample Section Exterior Surface after Removal from River.

No contamination was found on the exterior surface of any pipe (Figure 8). All identified radioactive material was located on the interior surfaces and in the loose scale (sediment) from inside the inactive pipe. Table 3 lists the instruments used to determine the isotopic concentrations and activities found in the 100-Area river lines. The Model 6700 Multichannel Analyzer's calibration and quality control procedures were conducted in accordance with UNI-M-76 REV1, Effluent Analytical Program. Figure 9 shows the sample section in the front loader as technical smears were taken.

The contact dose rate on the outside pipe surface was zero. The contact dose rate on the interior surface was less than 1 mrem/hr.

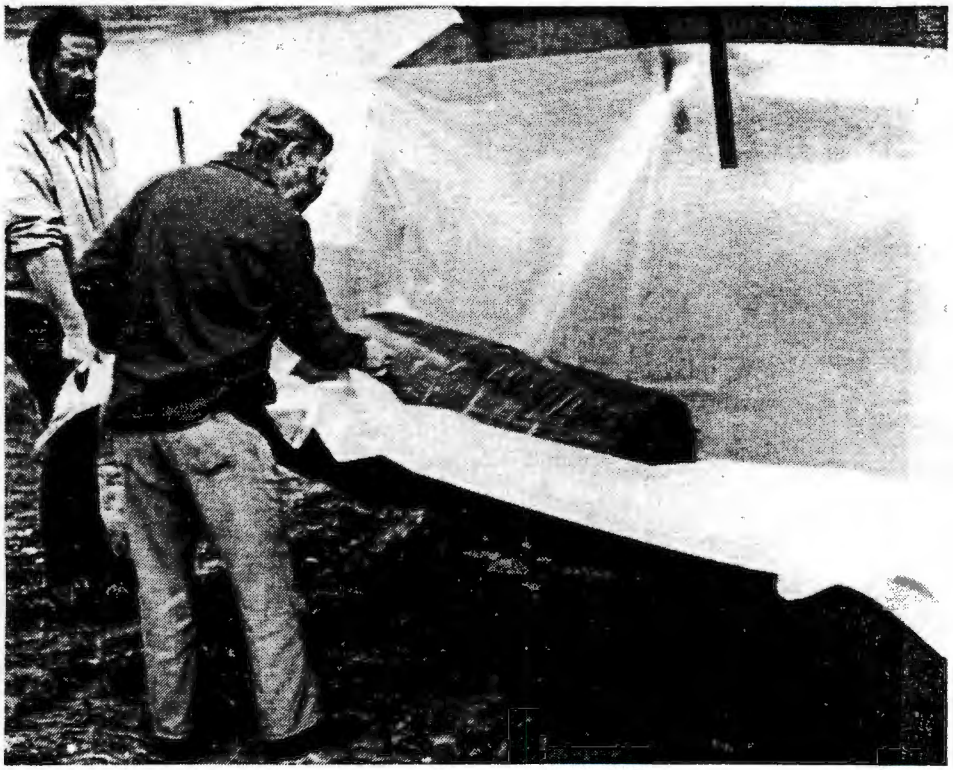
Figure 9. Technical Smears were Taken from Sample Section.
