W-105, RESPONSE TO LOI 73

KAISER ENGINEERS HANFORD CONCURRENCE PERTAINING TO THE WESTINGHOUSE HANFORD COMPANY INVESTIGATION OF THE STRUCTURAL FAILURE IN THE 8" CARRIER AT 200E LERF BASINS (PROJECT W-105)

From: Materials and Welding Engineering
Phone: 3-4156 S2-03
Date: September 4, 1991
Subject: INVESTIGATION OF STRUCTURAL FAILURES IN 8 INCH CARRIER PIPES AT 200E LERF BASINS (PROJECT W-105)

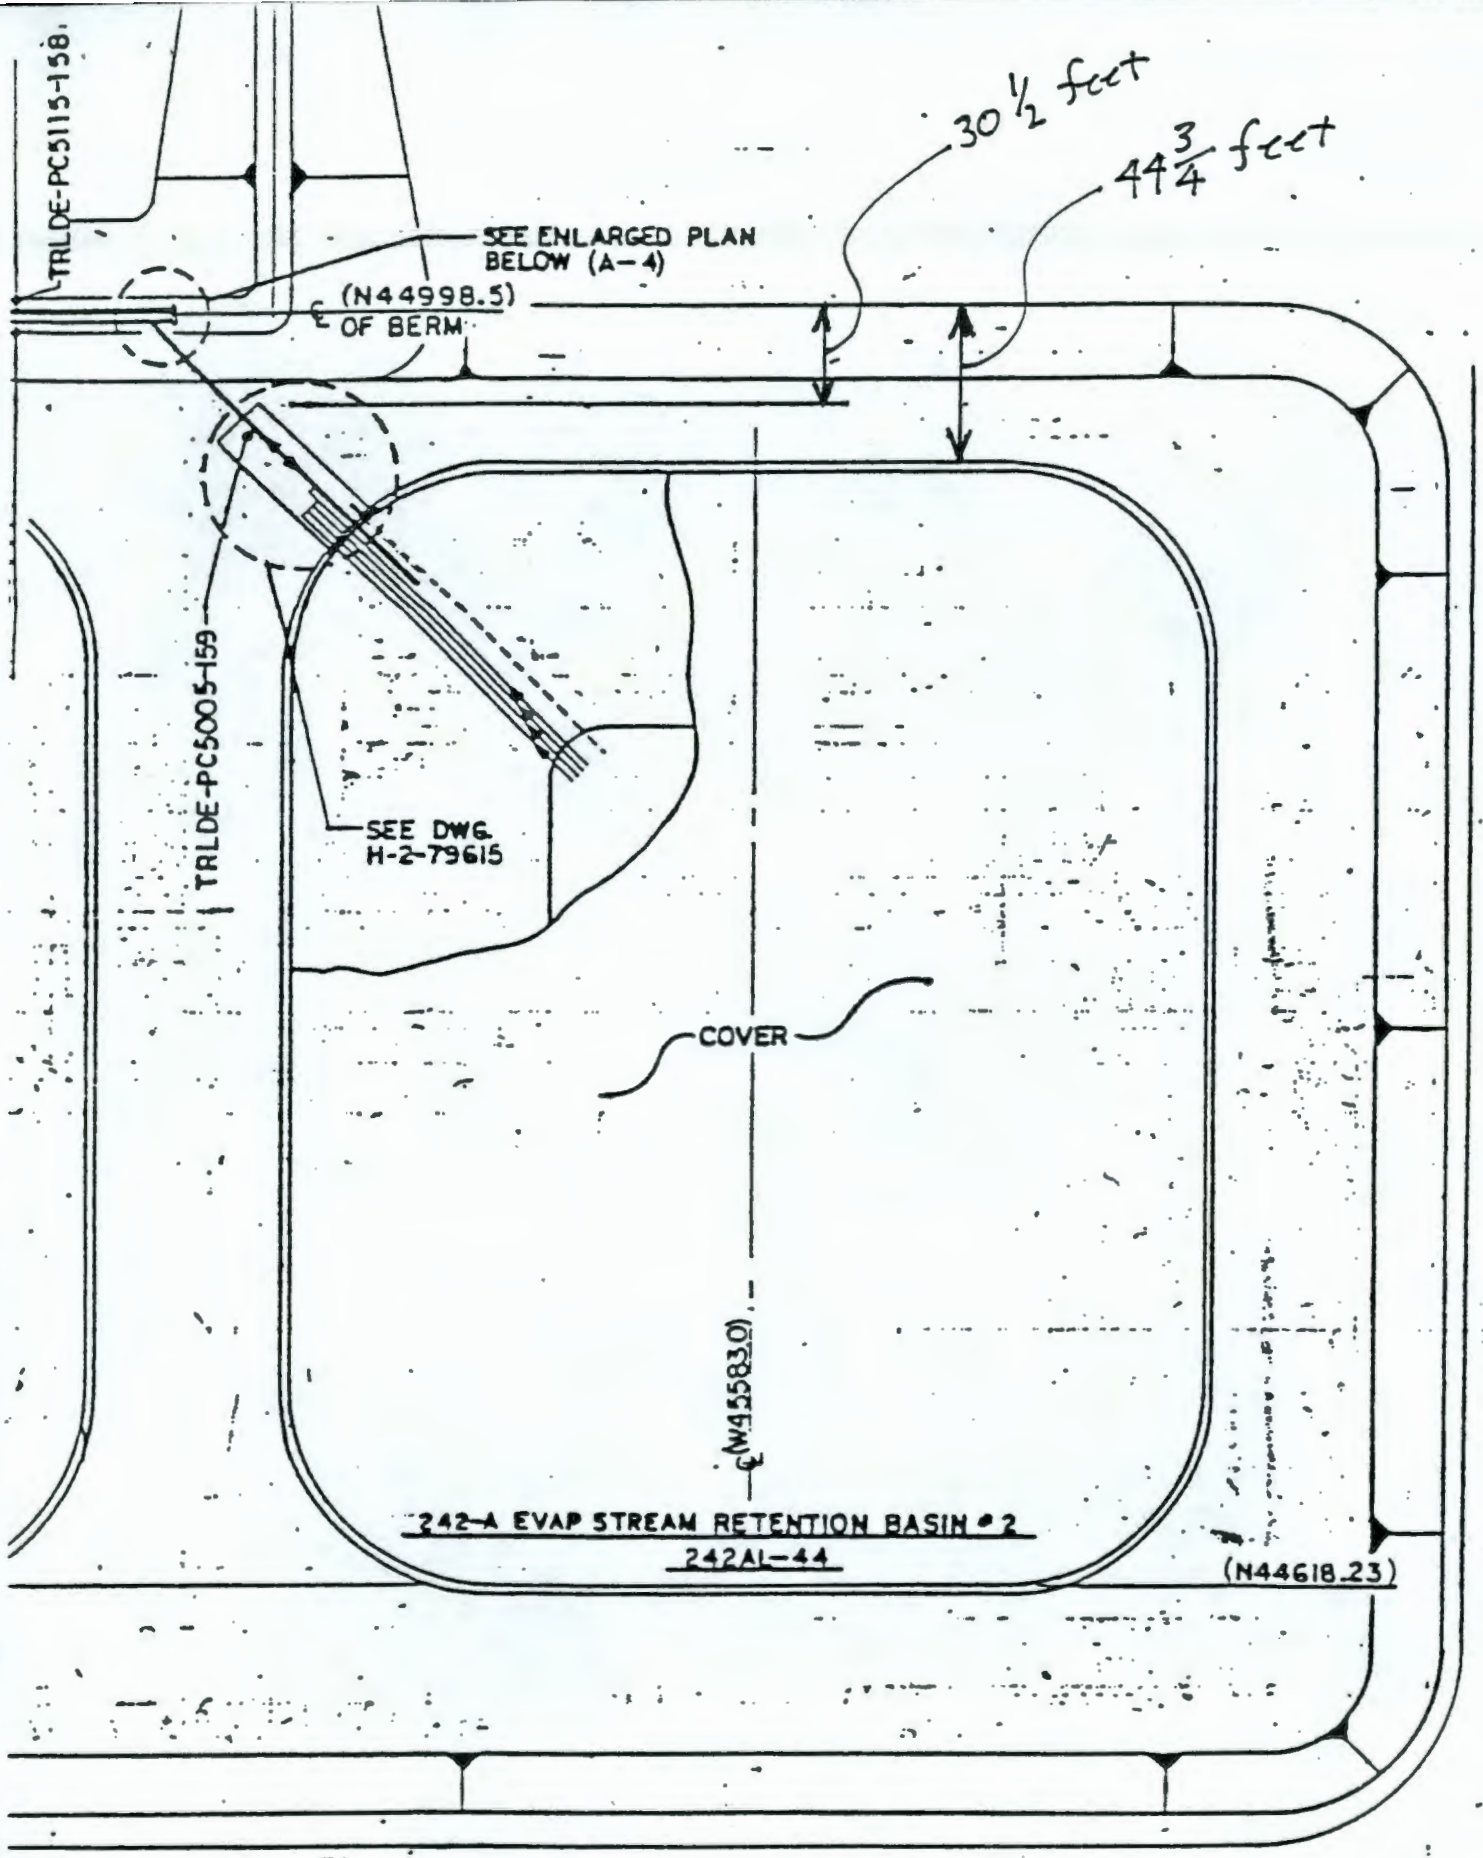
STA 6+42.70
N44999.50
W45757.75

12 X 8 RDCR,ECC SOCKET (FOB)
M17-TYP 2 PLACES

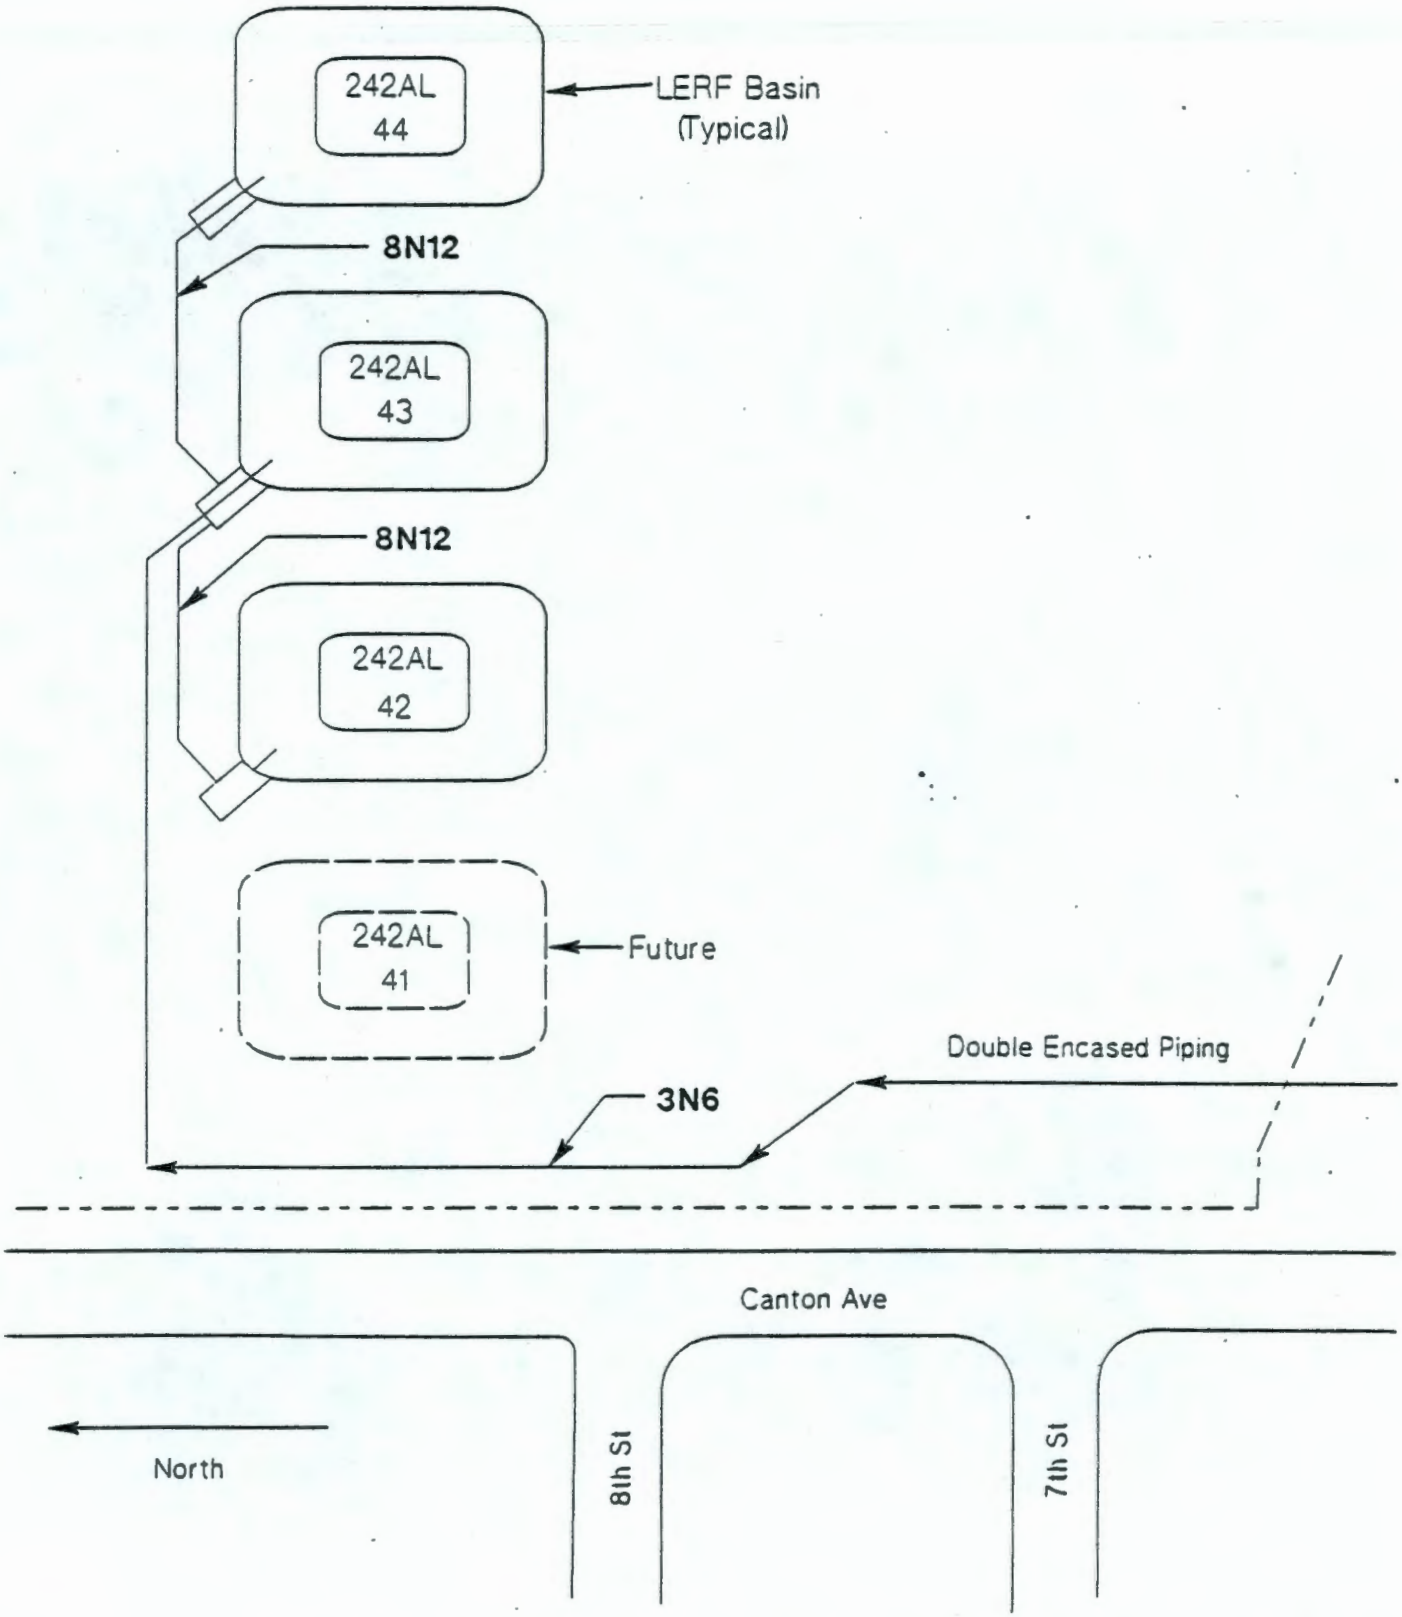
Figure 1. 242-A Evaporator Liquid Effluent Retention Facility (LERF)

The double containment pipe consists of a small diameter carrier pipe centered in a larger diameter containment pipe and supported by guides spaced uniformly. The guides are rigidly attached to the carrier but free to slide inside the containment pipe. The containment pipe has risers for the leak detection system that are spaced uniformly along its length. Three-inch carrier pipe in 6-inch containment pipe (3N6) is used to transfer effluent to the basins. Eight-inch carrier pipe in 12-inch containment pipe (8N12) is used to transfer effluent from one basin to another. Each of the two 8N12 piping assemblies are approximately 250 feet long and have 45° elbows at each end. Short sections extend from the elbows toward the basins (see Figure 1).

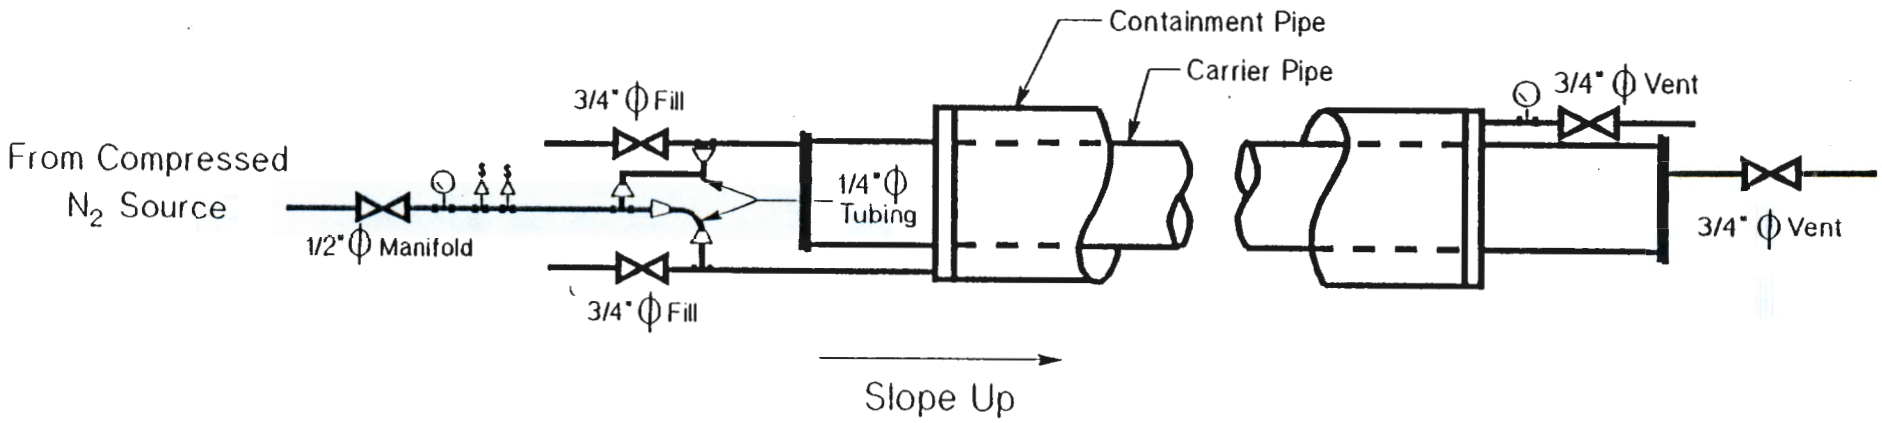
Figure 2

The hydrostatic test rig (see Figure 2) relied on 1/4-inch tubing connected between the carrier and the containment pipes to maintain an equal pressure between the two at all times during filling, pressurizing and venting. Two gauges were used during hydrostatic tests. One gauge was installed at the fill end and one at the vent end on the containment pipe for pressure testing of the 12-inch containment pipe. The gauge at the fill end was assumed to indicate at all times the pressure in both the 12-inch containment pipe and the 8-inch carrier pipe.

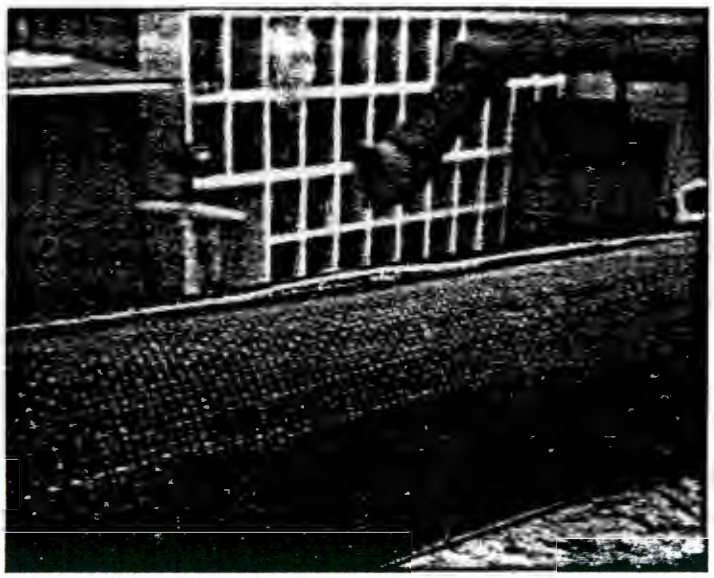
The information obtained in this investigation indicates that the external overpressurization of the carrier pipe during some portion of the hydrostatic testing operations is the likely cause of failure. The failure mode is buckling from the excessive external pressure. The pipefitters devised the test equipment and carried out the hydrostatic testing operations with limited field engineering support. The process control package (PCP), by reference to the construction specification, set forth the hydrostatic test requirements which called for equalizing the pressure between the containment pipe and carrier pipe during the test operation. The precise events that led to the deviation from this requirement have not been identified.

Figure 3. Failed Section of 8-Inch Carrier Pipe at LERF Basins 42-43 Prior to Removal

The piping assemblies have been repaired and successfully retested using a new hydrostatic test procedure. Fibercast has examined and tested the failed pipe sections and reported that the pipe exceeds the required wall thickness and that the pipe material meets all manufacturing standards. Therefore, the piping assemblies are considered fit for service.

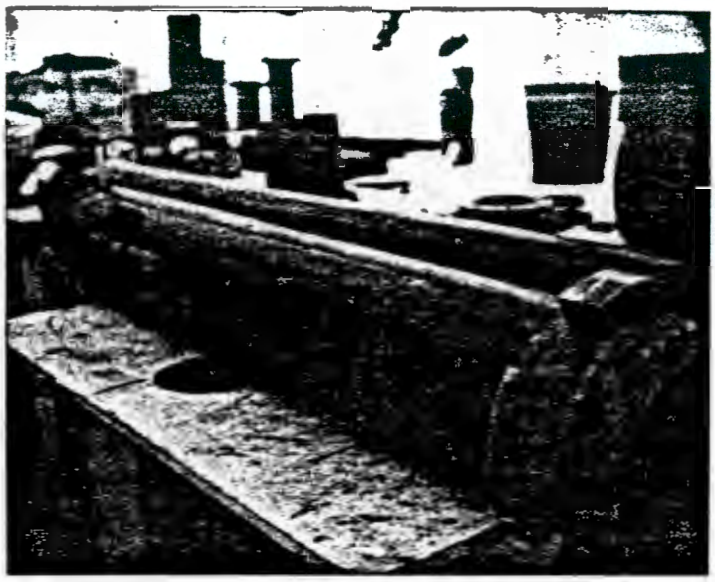
Figure 4. Failed Section of 8-Inch Carrier Pipe from LERF Basin 42-43

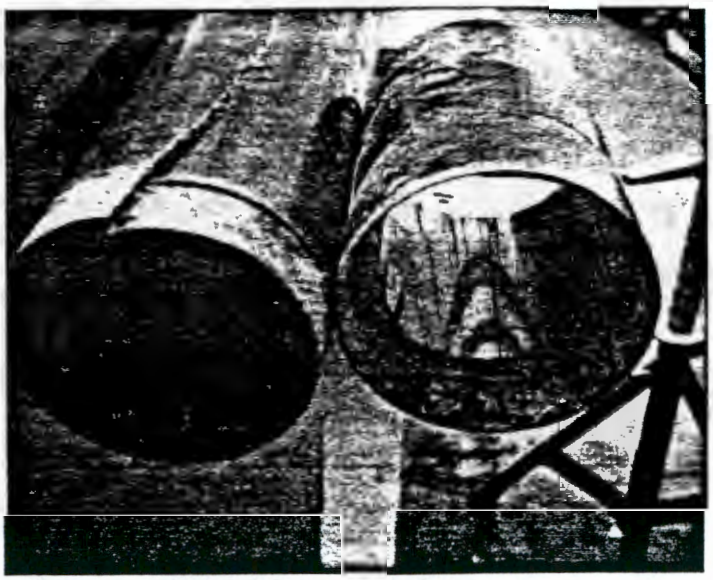
Figure 5. Failed Section of 8-Inch Carrier Pipe from LERF Basins 42-44 (Near Side)
