ULTRASONIC INSPECTION RESULTS FOR DOUBLE-SHELL TANK 241-AP-101 - FY 2003

Chris E. Jensen
CH2M HILL HANFORD GROUP, INC.
Richland, WA 99352
U.S. Department of Energy Contract DE-AC27-99RL14047

Abstract:
This report documents the required ultrasonic examination of double-shell tank 241-AP-101 performed during FY 2003. This examination included specified primary wall areas, welds, and lower knuckle. Results indicated that there was no reportable wall thinning, cracking, or pitting in any of the plate areas examined.

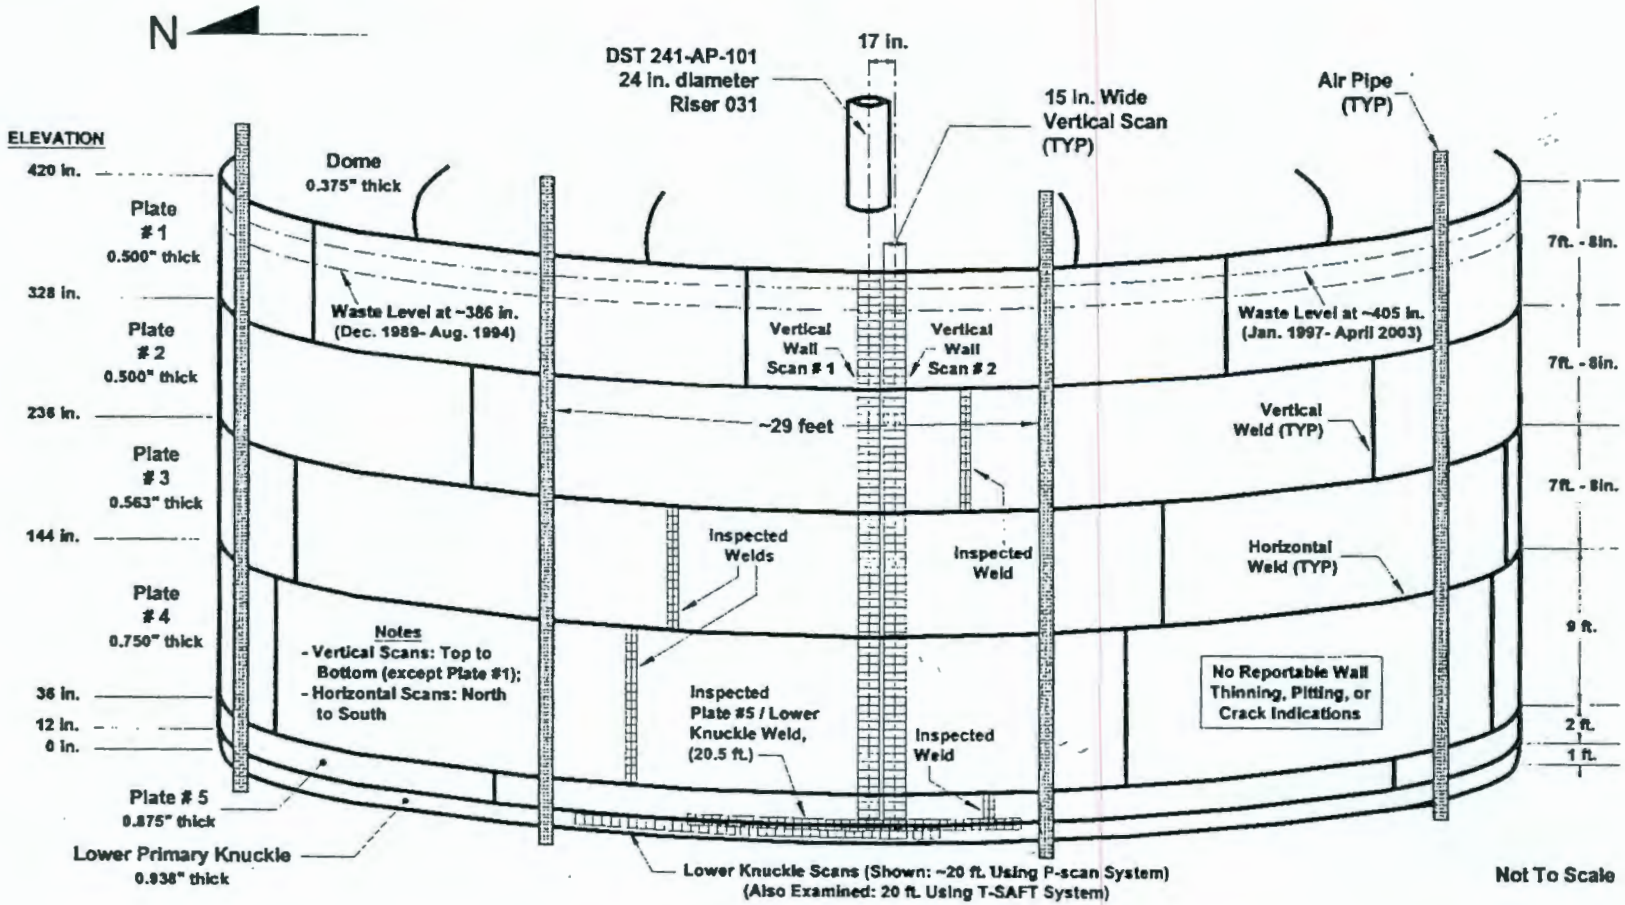
Figure 10-1. Schematic of UT Scan Paths on West Side of Tank 241-AP-101 Wall (via Riser 031)

The P-scan crawler was deployed through the 24 inch diameter annulus inspection Riser 031 on the west side of tank 241-AP-101 for examinations of the primary wall, the lower knuckle, and vertical and horizontal welds. All tank welds examined were in the "as-welded" condition. The T-SAFT crawler was also deployed through the 24 inch diameter annulus inspection Riser 031 for examination of the lower knuckle. The various scan paths for the crawlers are shown in Figure 10-1, along with other pertinent tank information. Additional P-scan measurements of the lower knuckle were made using the P-scan crawler equipped with the extension arm lined up with air slots in the insulating concrete. The locations of these scan paths are shown in the Figure 10-2 schematic.

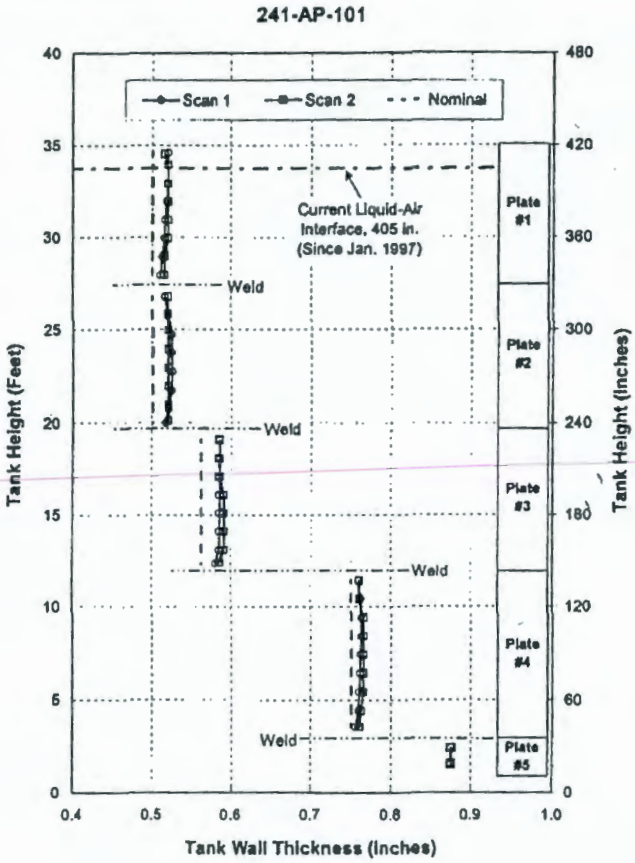
Figure 11-1. Scan Data Average Wall Thickness Compared to Nominal Plate Thickness

Lower Primary Knuckle Wall: A horizontal strip (19.6 feet long by approximately 12 inches wide) along the lower primary knuckle wall was examined using the P-scan system. The overall lower knuckle wall average (0.9373 inches) was virtually the same as the nominal plate thickness value (0.9375 inches). Vertical strips totaling 2.3 feet long by approximately 1 inch wide of the lower portion of the lower knuckle were examined using the P-scan transducer lined up with four different air slots. The inspections yielded wall thickness average values and minimum wall thickness values that exceeded the nominal value. No reportable wall thinning, pitting indications or crack-like indications were found using the P-scan system.

A horizontal scan (20.0 feet long) using the T-SAFT system was performed just above the lower knuckle weld, which probed the entire lower knuckle region below the transducers for circumferential cracks. No reportable crack-like indications were found using the T-SAFT system.

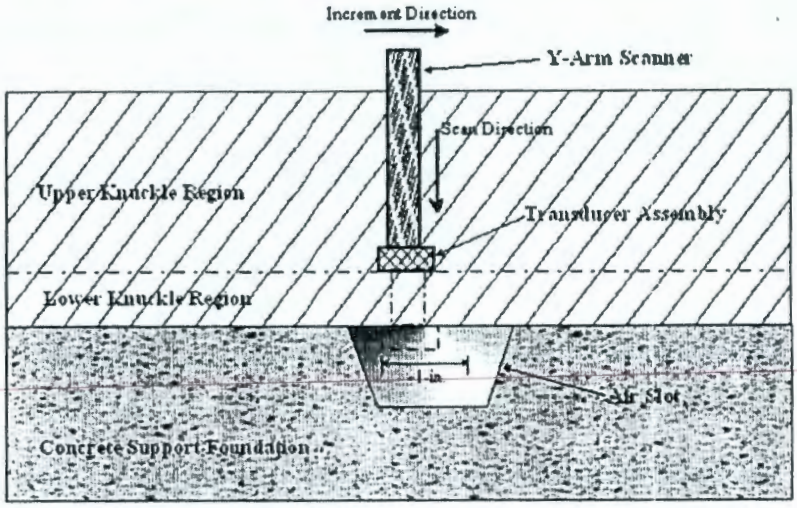
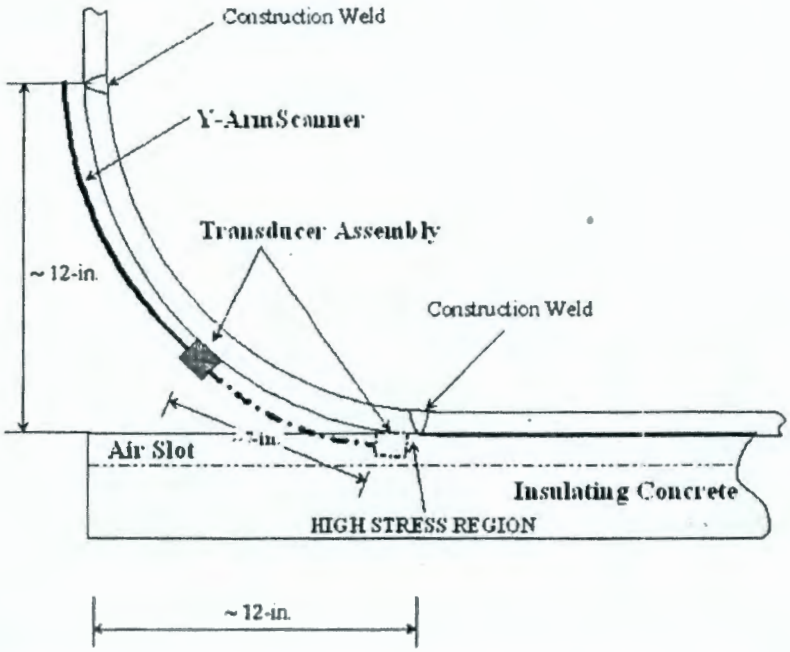
Figure 3.5. Lower Knuckle Examination in Air Slot Regions (End View)

The results of the ultrasonic examination of the knuckle region of Tank 241-AP-101 provided by COGEMA have been evaluated by PNNL personnel. The results of the examination of Tank 241-AP-101 indicated no circumferential crack-like indications were present anywhere in the knuckle region between the upper knuckle weld and the lower knuckle weld over the approximately 240 circumferential inches scanned.

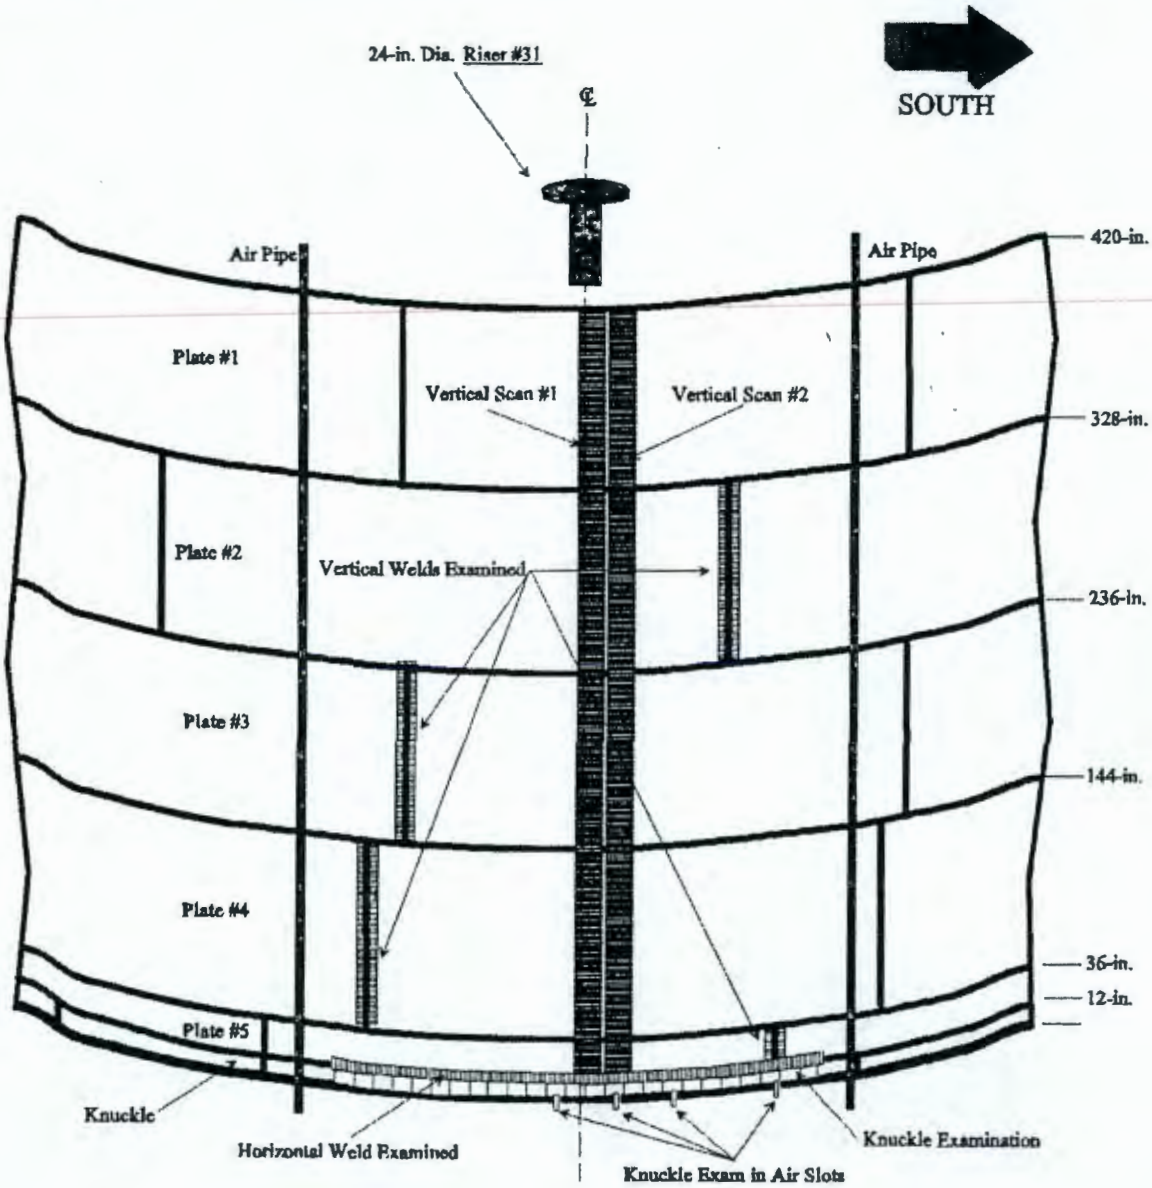
Figure 4.2. Sketch of Scan Paths on Tank 241-AP-101

Figure 4.2 describes the areas on the primary wall of Tank 241-AP-101 that were ultrasonically examined. Two 15-in.-wide vertical scan paths were performed on Plates #1, #2, #3, #4, and #5 below the entrance to Riser 31. Vertical weld HAZ examinations were done on Plates #2, #3, #4, and #5, and the horizontal weld HAZ examination was done on the transition Plate #5 to knuckle weld. The upper portion of the knuckle was examined as well as four areas that extended down to the lower knuckle weld in the air slot regions.

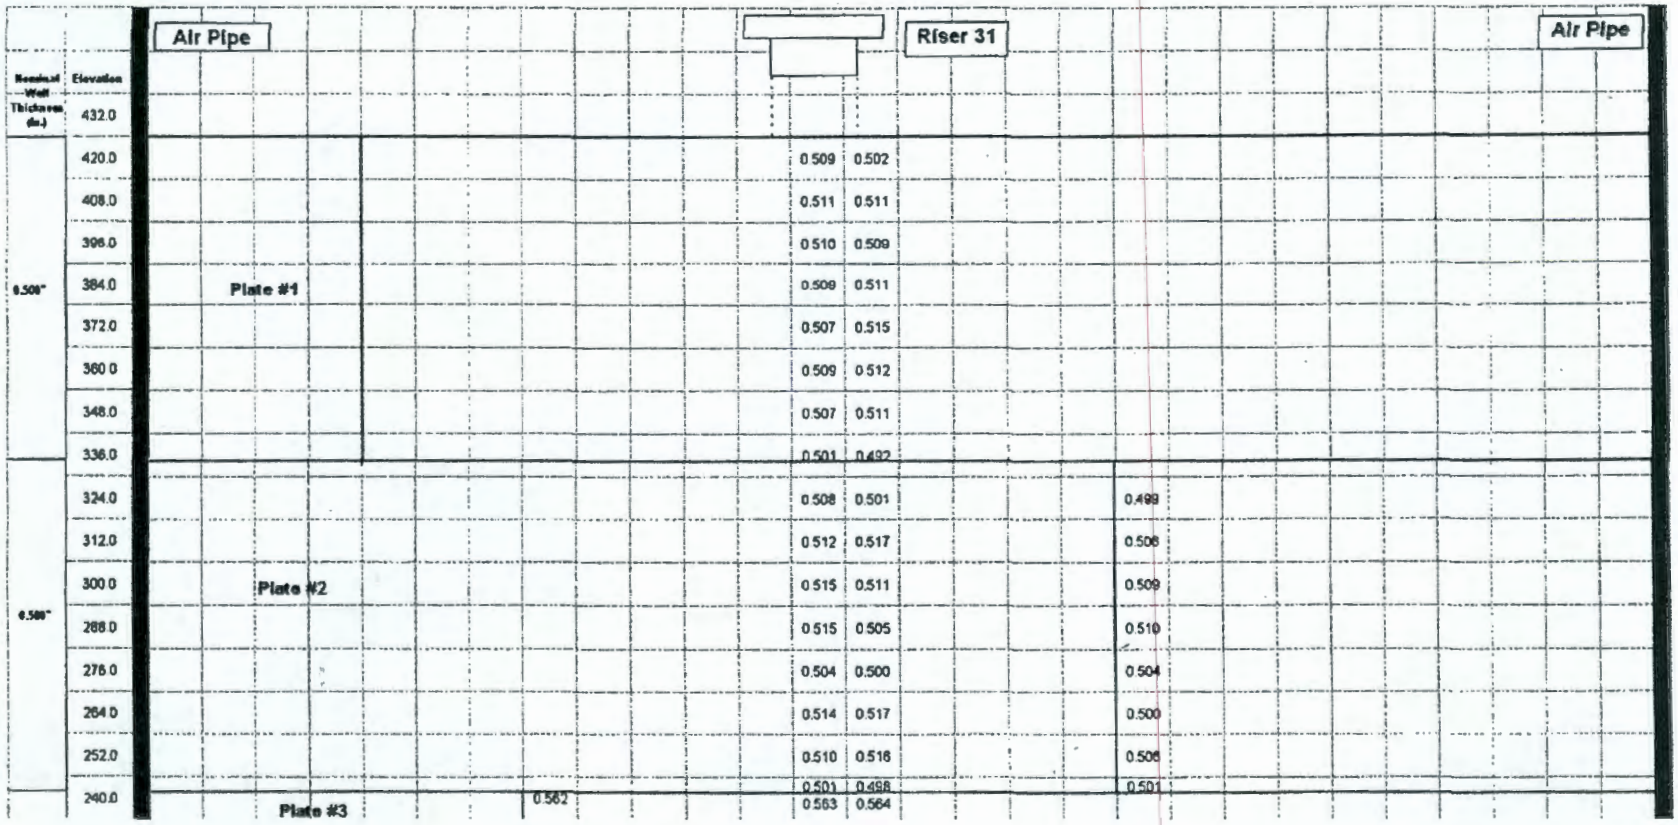
Figure 5.1. UT Data from Tank 241-AP-101

Figure 5.3 shows the examination performed on the knuckle of the primary tank wall. The readings distributed around the circumference of the tank knuckle represent the minimum reading in each 12-in. long by 12-in. wide portion extending down around the knuckle. The four areas denoted as Slot 1, Slot A, Slot B, and Slot D, represent small areas that were scanned extending down to the lower knuckle weld in the air slots. These scan areas are approximately 1-in. long (increment direction around the circumference of the tank), and 7-in wide (scan direction is down around the knuckle and into the air slot) as shown previously in Section 3 of this report.

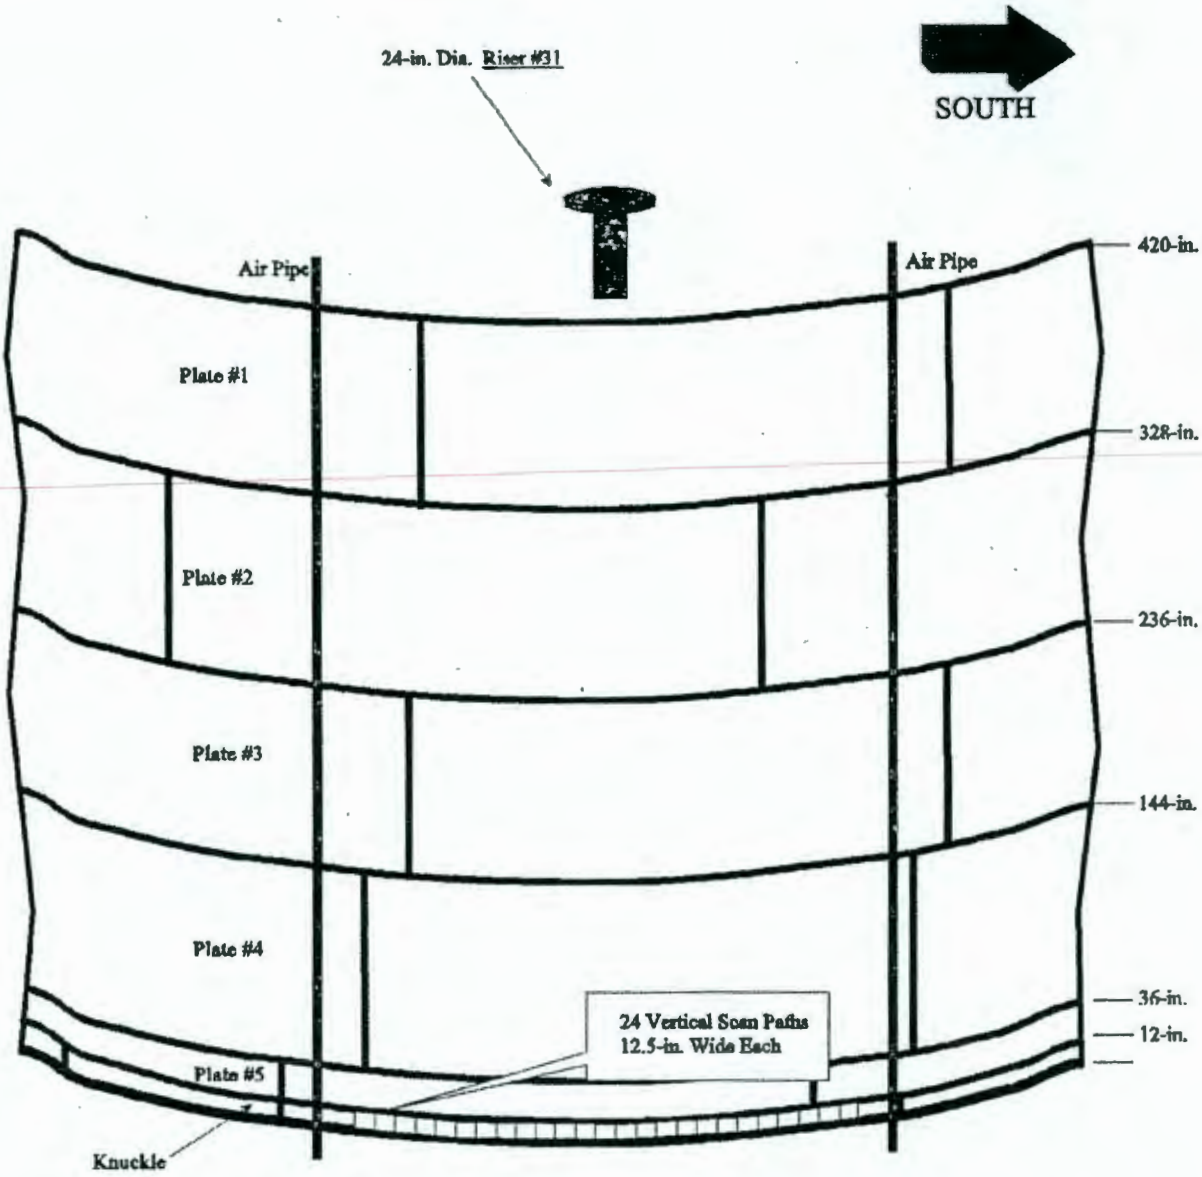
Figure 4.2 Sketch of Scan Paths on Tank 241-AP-101

The results of the examination of Tank 241-AP-101 indicated no circumferential cracking was present anywhere in the knuckle region between the upper knuckle weld and the lower knuckle weld over the approximately 240 circumferential inches scanned.

The results of the examination of the knuckle region of Tank 241-AP-101 have been evaluated by PNNL personnel. The UT concentrated on the examination of the knuckle region from the upper knuckle weld to the lower knuckle weld (approximately 19 in. measured on the inside diameter) and extended circumferentially around the tank approximately 240 in. The data provided by the COGEMA Level III UT of the results of the examination of Tank 241-AP-101 indicated no circumferential crack-like indications were present in the approximately 240 circumferential inches scanned of the knuckle region.
