15-TF-0043

COMPLETION OF HANFORD FEDERAL FACILITY AGREEMENT AND CONSENT ORDER INTERIM MILESTONE M-045-91F DELIVERABLE

RPP-RPT-58498

Single-Shell Tank Leak Integrity Summary

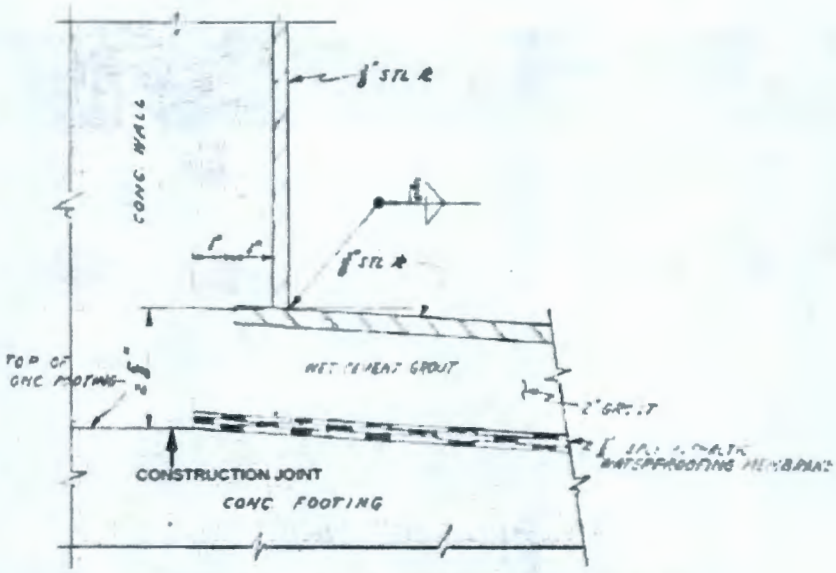
Figure 3-4. SX Farm Tank Bottom Liner to Sidewall Design Detail

Tank design was identified as a contributing cause to liner failure primarily based on design features limiting thermal expansion of the bottom liner with the addition of high heat waste. For A and SX Farms, the orthogonal transition between the tank bottom and tank sidewall was deemed less desirable compared to the earlier tank farm design of a rounded knuckle transition. Figure 3-4 shows this orthogonal transition of the SX Farm tanks. A fillet weld was used to close the seam where the sidewall and tank bottom liners meet versus the butt welding of the knuckle transition of earlier tank designs. A review of the basic differences between fillet and butt welds indicates that the superior butt welds would be preferred for the tank farm waste tanks. Other design specifications changes for A and SX Farms were weld inspection techniques. Welds were inspected using the vacuum soap test at 10 in. of mercury versus the superior full penetration X-ray weld testing. These design changes applied to A and SX Farms were identified as features that could likely cause liner failure.

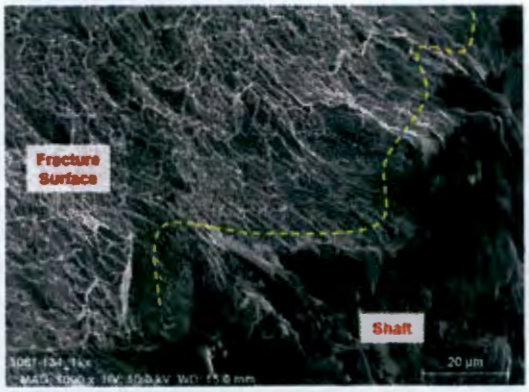
Figure D-1. Example of Ductile Fracture Surface from Tank TX-117 Slow Strain Rate Test

In all tests, there was no evidence of SCC at the specimen fracture surface (as seen by the ductile fracture surface in Figure D-1); however, at positive applied potentials, corrosion was observed for six of the compositions. An example of this corrosion is shown in Figure D-2, and complete results are provided in RPP-RPT-56141, *FY2013 DNV DST and SST Corrosion and Stress Corrosion Cracking Testing Report*. This corrosion phenomenon was investigated using follow-on CPP tests.

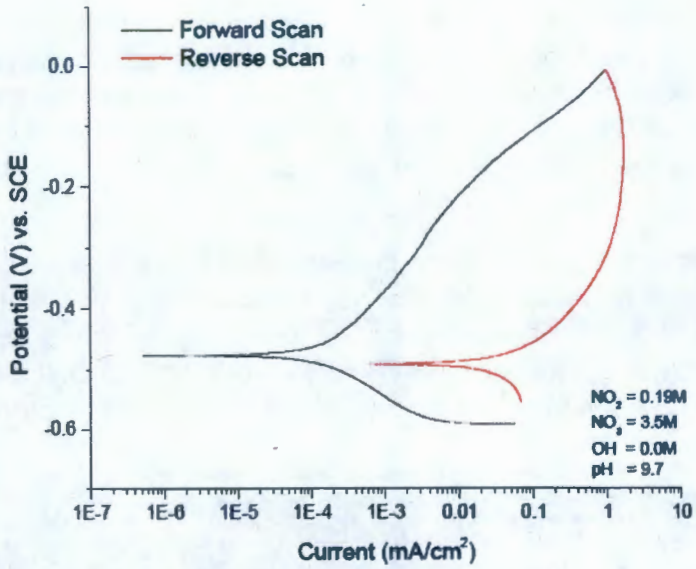
Figure D-3. Cyclic Potentiodynamic Polarization for Tank TX-117 Simulant

Pitting corrosion and a positive or mixed hysteresis was observed for the tanks that exhibited corrosion during the SSR tests, such as the Tank TX-117 result shown in Figure D-3.

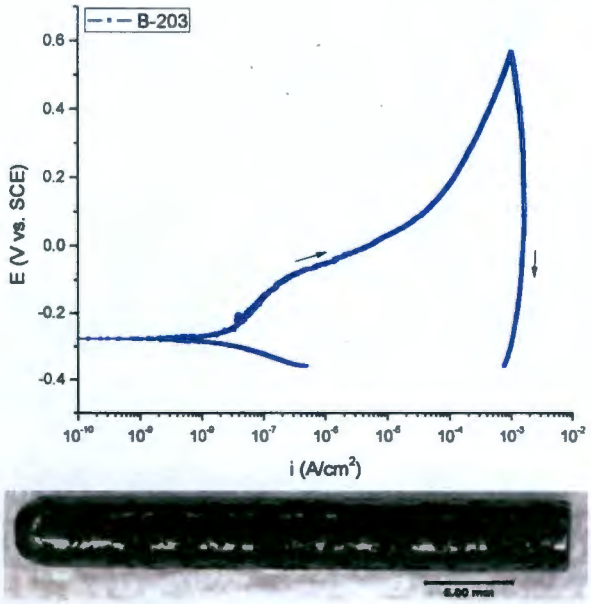
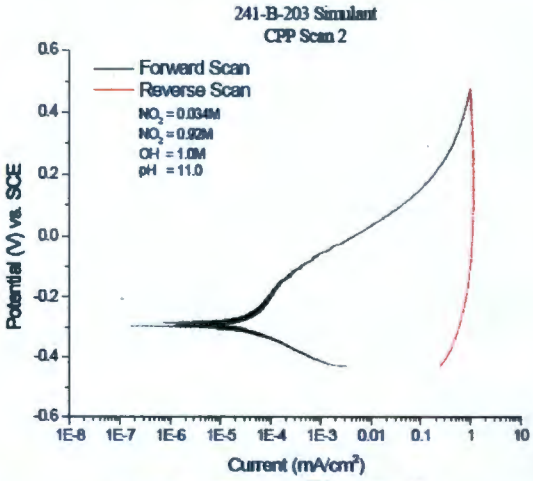
Note that aggressive waste layer CPP testing was conducted at two laboratories: 222-S Laboratory and DNV-GL. The results showed good agreement between the laboratories for the simulants that were tested because they use the same testing protocol. To illustrate this point, Figure D-4 shows the results comparison for the Tank B-203 simulant. Current and future testing can have confidence that the results are reproducible regardless of the laboratory used.

DNV-GL B-203 cyclic potentiodynamic curve (top) and electrode optical micrograph (bottom)

222-S Laboratory B-203 cyclic potentiodynamic curve (top) and electrode optical micrograph (bottom)

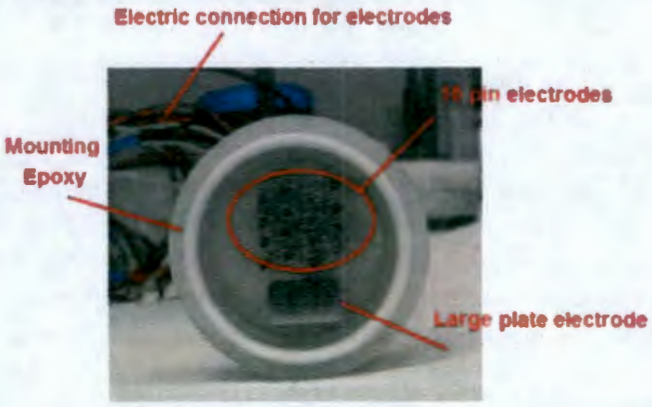
Figure D-5. Multi-Electrode Array for Liquid-Air Interface Corrosion Testing

Corrosion was not initiated at OCP after 48 days, so the MEA was polarized to accelerate the corrosion. Corrosion initiated in the large plate electrode and two-pin electrodes in the bulk solution, but not at the LAI. A 50 ppm and 500 ppm ammonia purge was used similar to the vapor space testing completed at SRNL, and the ammonia appeared to stifle the corrosion that was occurring in the bulk solution.
