STANDBY STATUS REPORT - HOT SEMIWORKS FACILITY

C. R. Cooley
Chemical Engineering Development Operation
Chemical Development Operation
Chemical Research and Development Operation
HANFORD LABORATORIES OPERATION

September 1, 1957

HANFORD ATOMIC PRODUCTS OPERATION

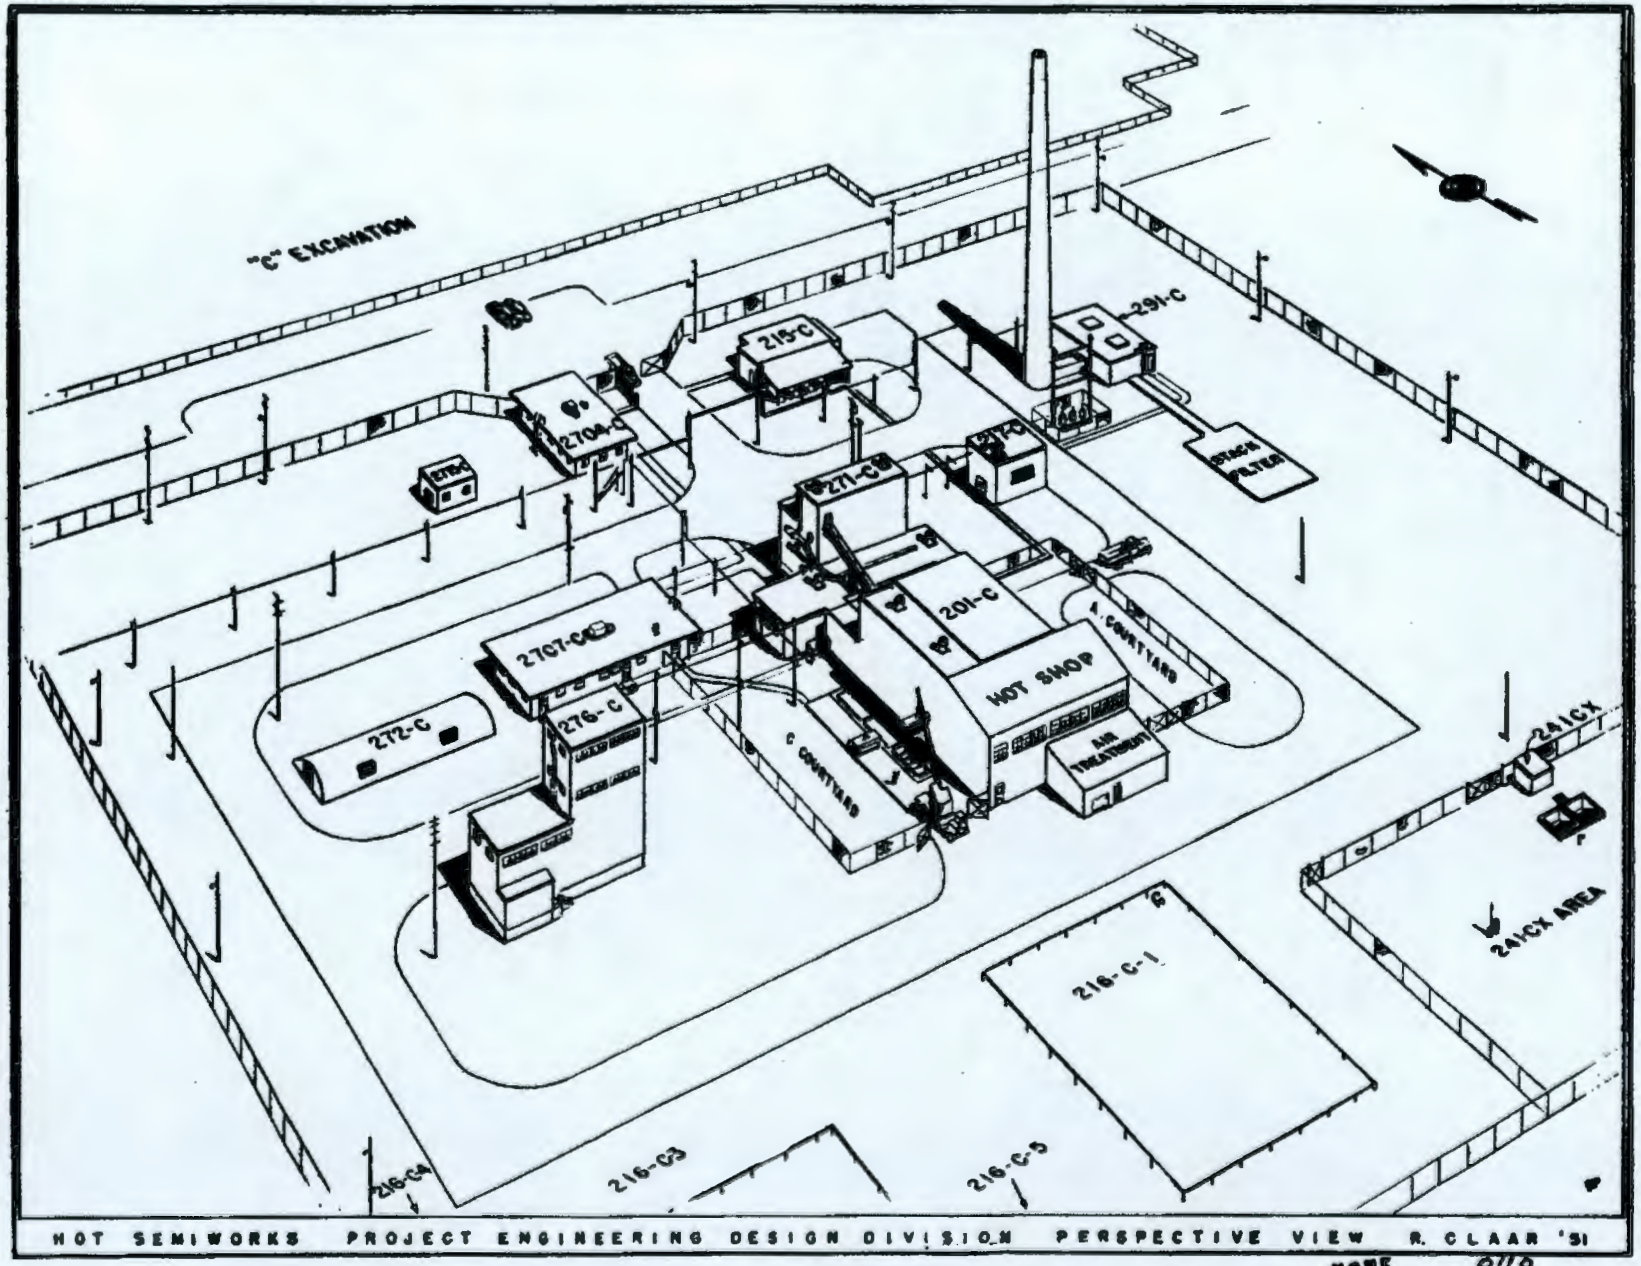
NONE 6116

HOT SEMIWORKS PROJECT ENGINEERING DESIGN DIVISION PERSPECTIVE VIEW R. CLAAR '51

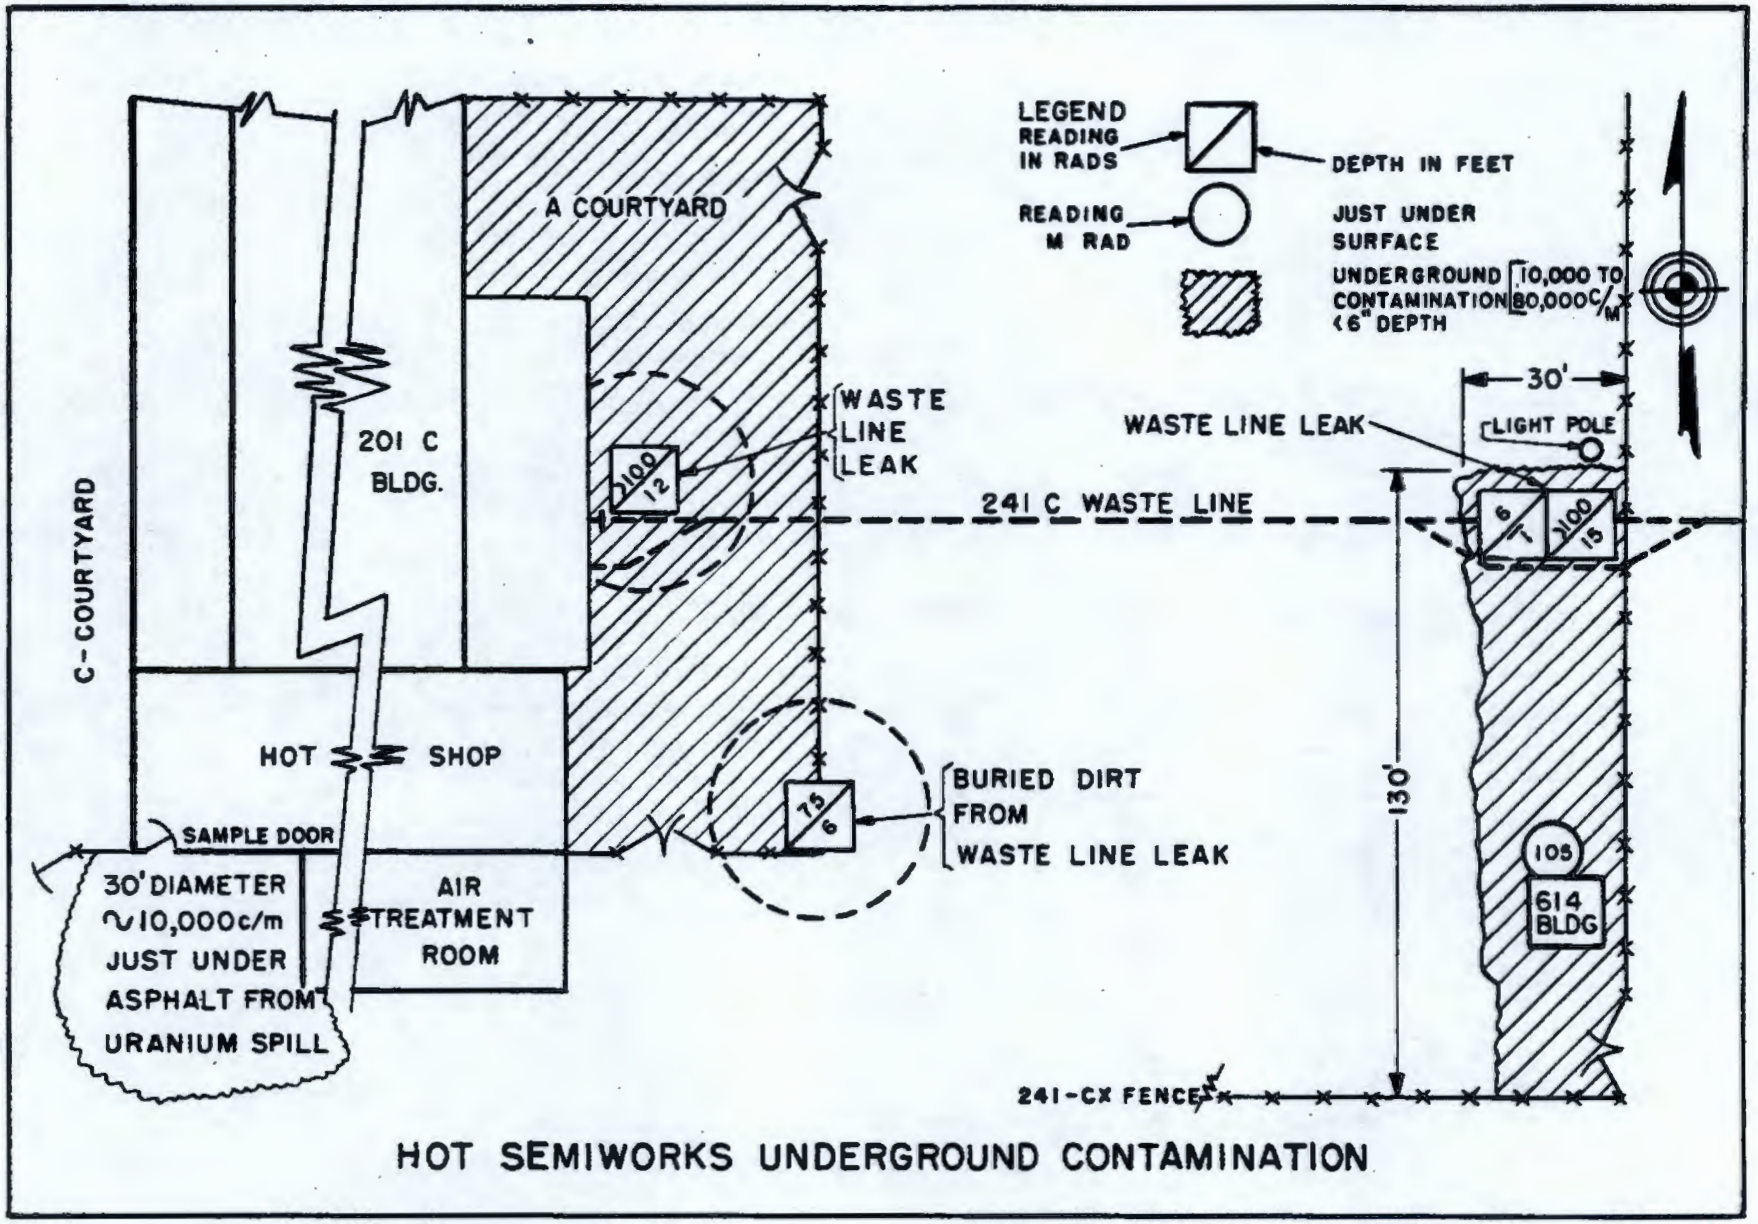
APPENDIX E.

HOT SEMIWORKS UNDERGROUND CONTAMINATION
