BHI-00177
Rev. 00

T Plant Aggregate Area Management Study Technical Baseline Report

Authors
D. H. DeFord
R. W. Carpenter

Date Published
April 1995

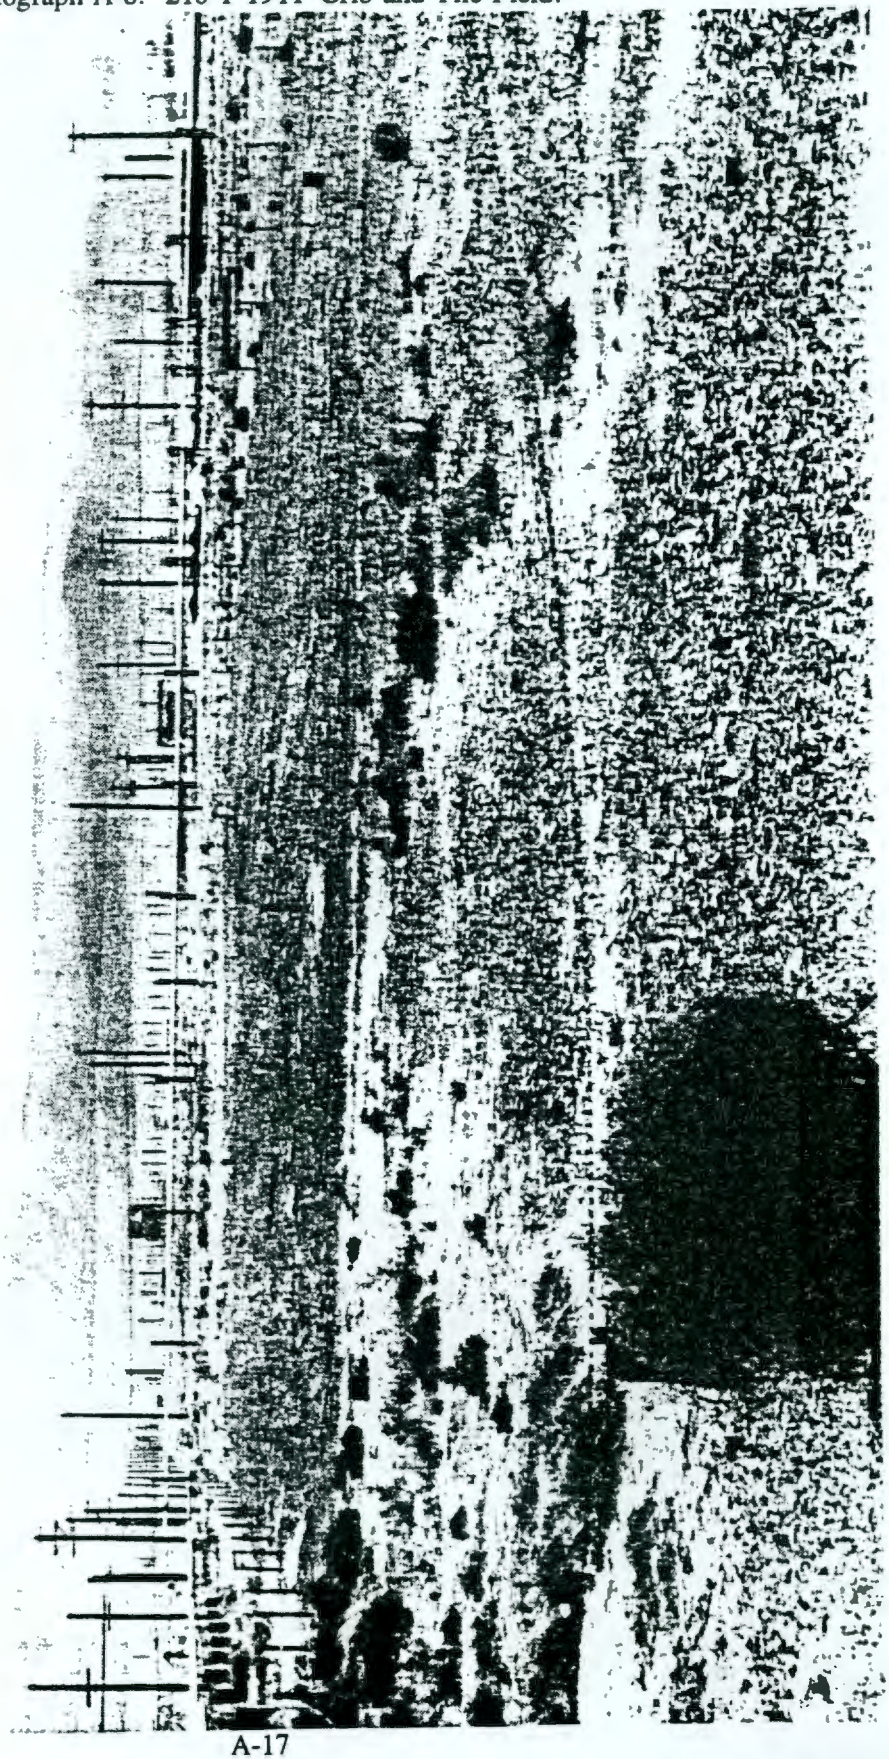
Photograph A-8. 216-T-19TF Crib and Tile Field.

The crib also received waste from the 224-T building after sludge buildup in the 201-T through 204-T tanks caused the closing of the 216-T-32 crib. The site was deactivated by capping the pipeline to the crib and rerouting the effluent to the 216-T-19 crib (BHI 1994).

The crib and tile field received 110,000,000 L of high-salt and neutral/basic waste containing 5,170 metric tons of inorganic compounds. Radionuclides include: cesium-137, ruthenium-106, strontium-90, cobalt-60, uranium-238, and plutonium (BHI 1994).

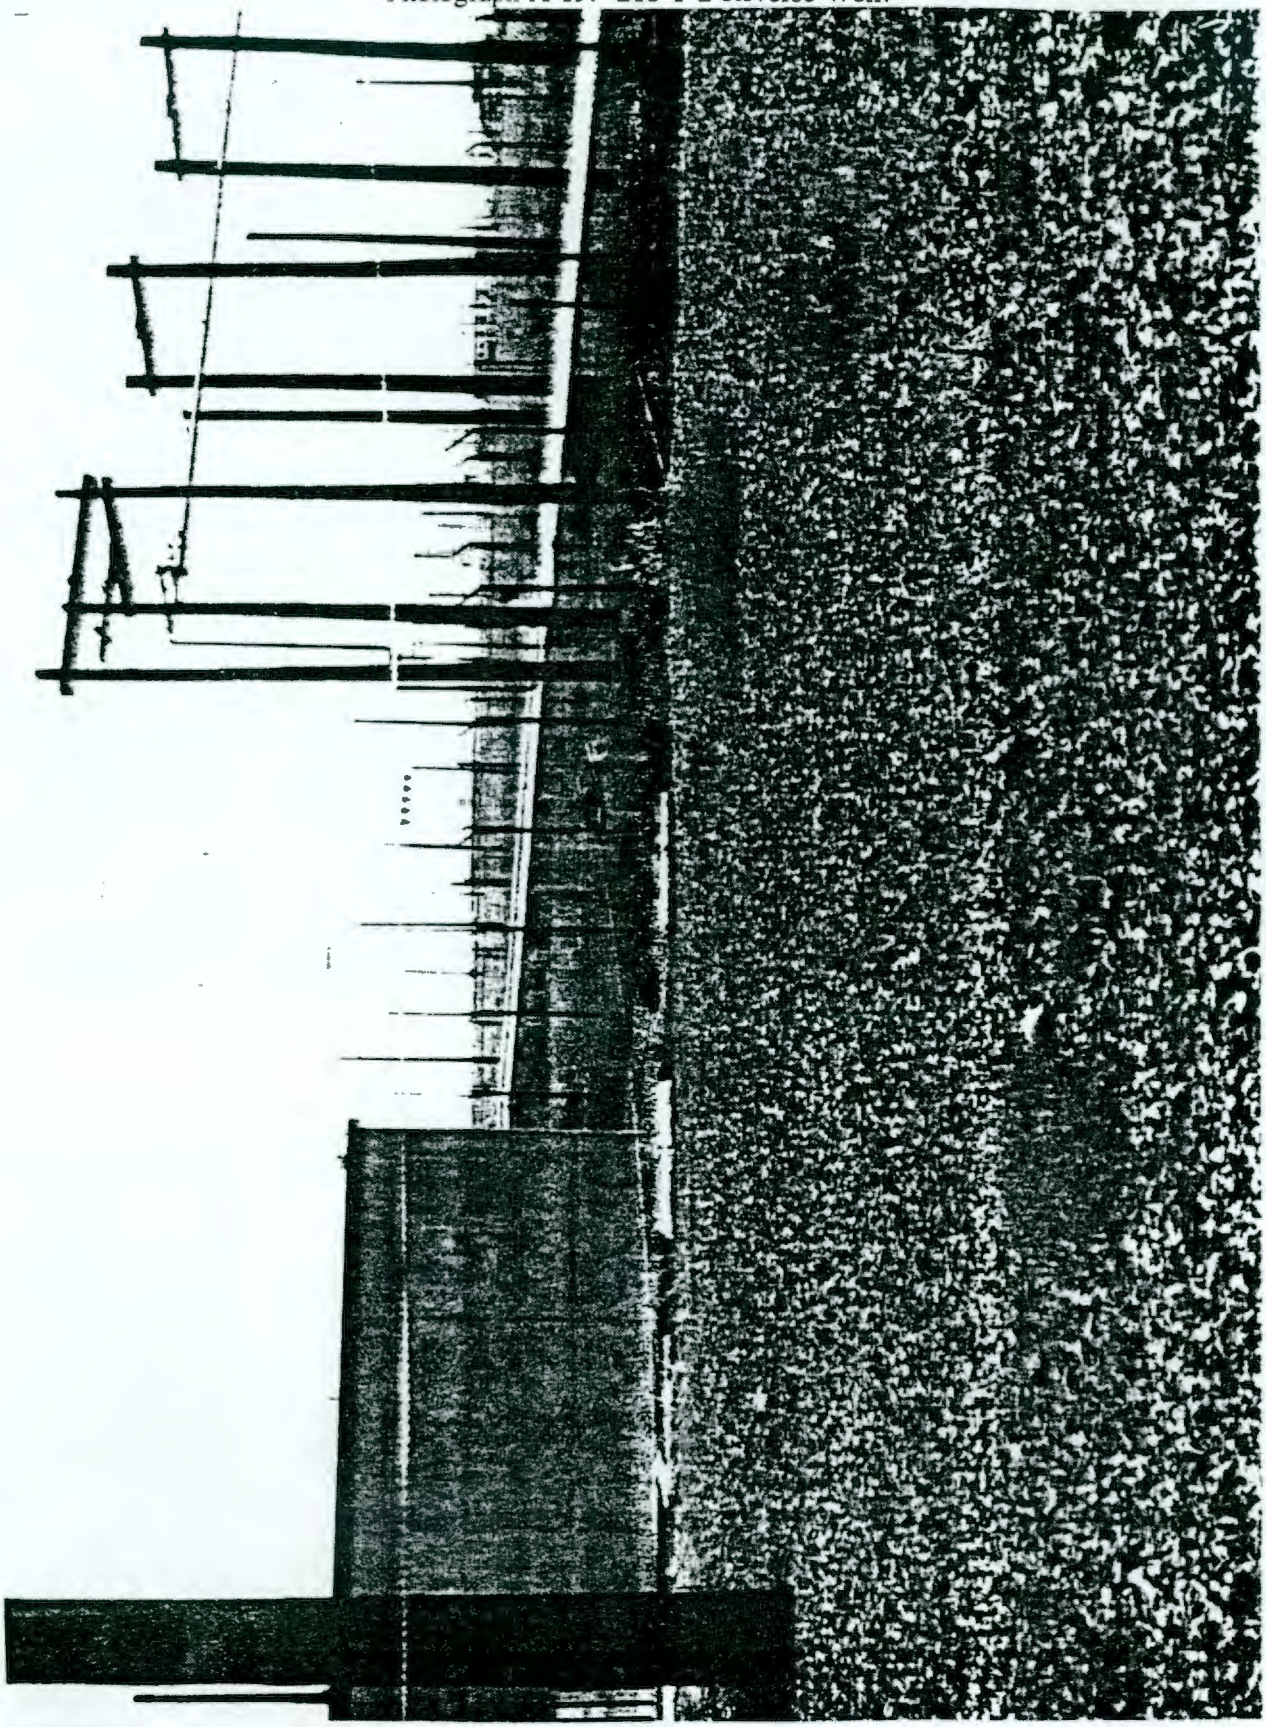
Photograph A-19. 216-T-2 Reverse Well.

The 216-T-2 reverse well is an inactive waste site located within 15 ft of the southwest corner of the 222-T building (Maxfield 1979). The unit is a registered underground injection well that received 6,000,000 L of decontamination sink waste and sample slurper waste from the 222-T building (Stenner et al. 1988; DOE-RL 1988). The pipeline is blanked at the well. The waste has a moderate level of activity and a small area of infiltration (Maxfield 1979). After the pipeline was blanked the effluent was rerouted to the 216-T-8 crib (Lundgren 1970).
