FACILITY STATUS CHANGE FORM

Date Submitted:	Area:	Control #:
Jul 30, 2012	300 Area	D4-300-067
Originator:	**Facility ID:**	
John Harrie	3763 and 3766	
Phone:	**Action Memorandum:**	
509.308.9935	Action Memorandum #3

300 D4
3763
GPERS Radiological Survey
Gamma Track Map

300 D4
3766/3763
GPERS Radiological Survey
Gamma Track Map

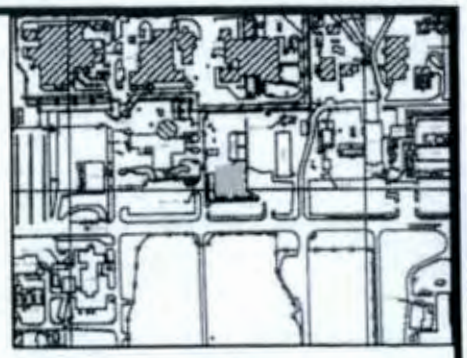
Coverage File: D4 200
Number of Data Pnts: 1091
Type of Survey: gamma
Max GCPM: 1687
Avg Bkg CPM: 1132
Survey Date: 7/18/2012
Area Surveyed: 1,282 m^2
Project File: ESRFRM120114
Pdf File: ESRFRM120114C

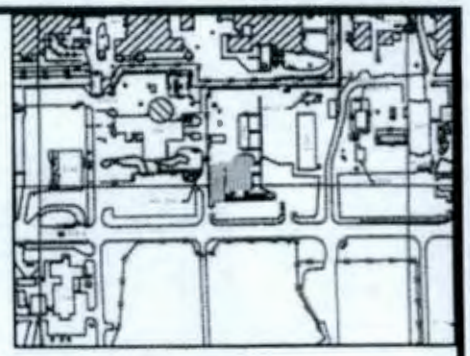
Legend	Summary Statistics
NET CPM	Coverage File: D4 193
× <1714	Number of Data Pnts: 1097
1714 - 5000	Type of Survey: gamma
5000 - 10000	Max GCPM: 1813
10000 - 25000	Avg Bkg CPM: 1143
25000	Survey Date: 7/11/2012
	Area Surveyed: 1024 m^2
	Project File: ESRFRM120111
	Pdf File: ESRFRM120111
