EDMC#:	0073945
SECTION:	2 OF 3
DOCUMENT #:	07-AMCP-0282
TITLE:	Administrative Decommissioning for Wells with Surveys

SURVEY DATA REPORT				Request No. 072-163
Project No. NA	Title: Well Decommissioning Well A8411			File No. 6AT12R27
Job No. 65400811.1225400 CA10	Prepared By S. Wray	Date 3/12/07	Reviewer	Page 1 of 1

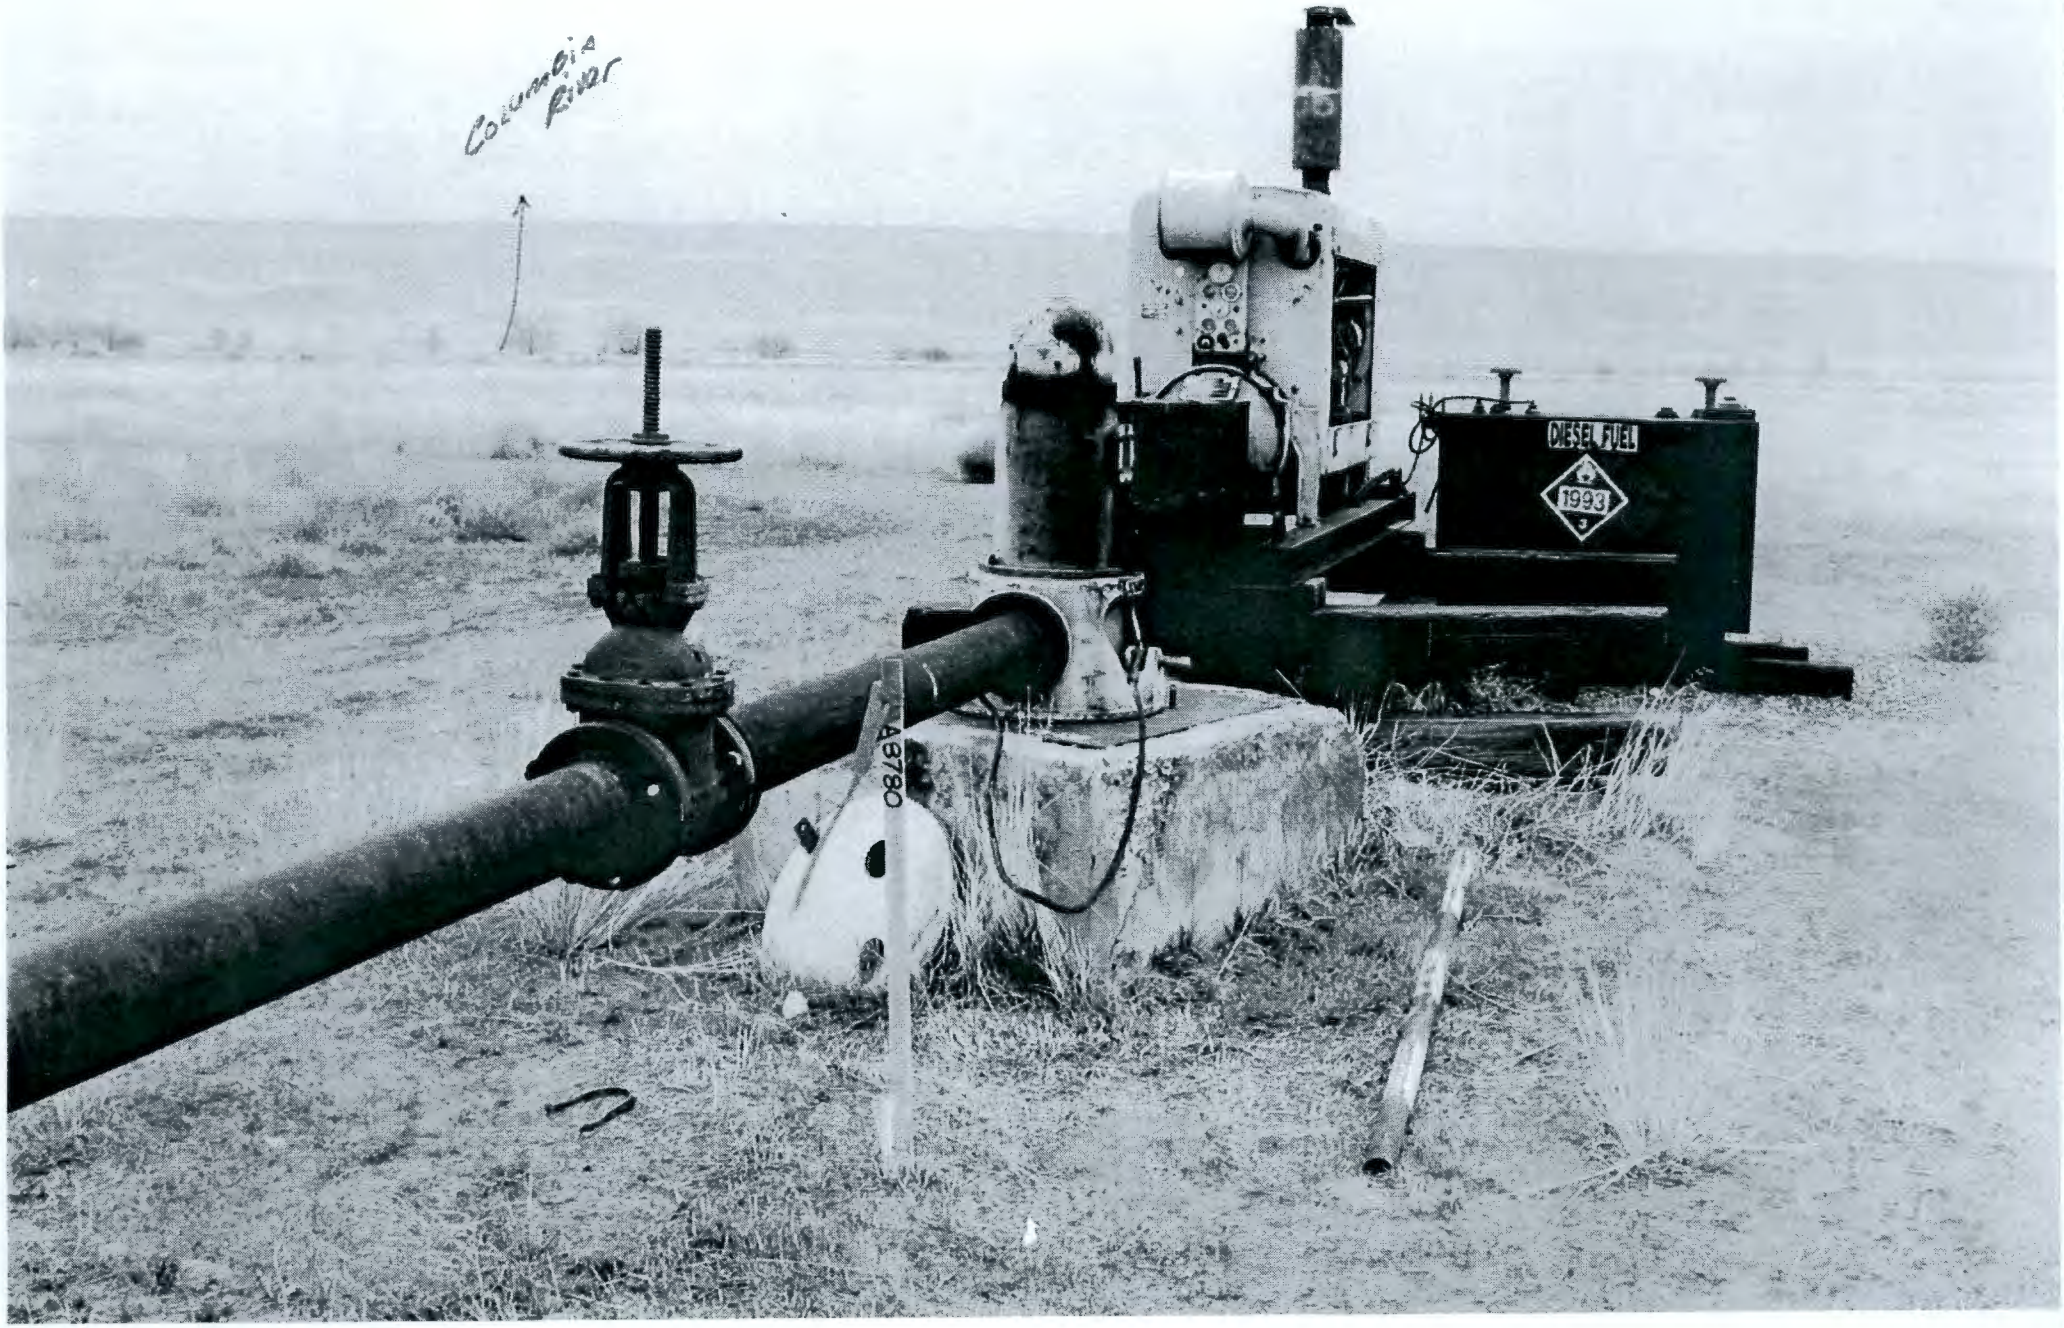
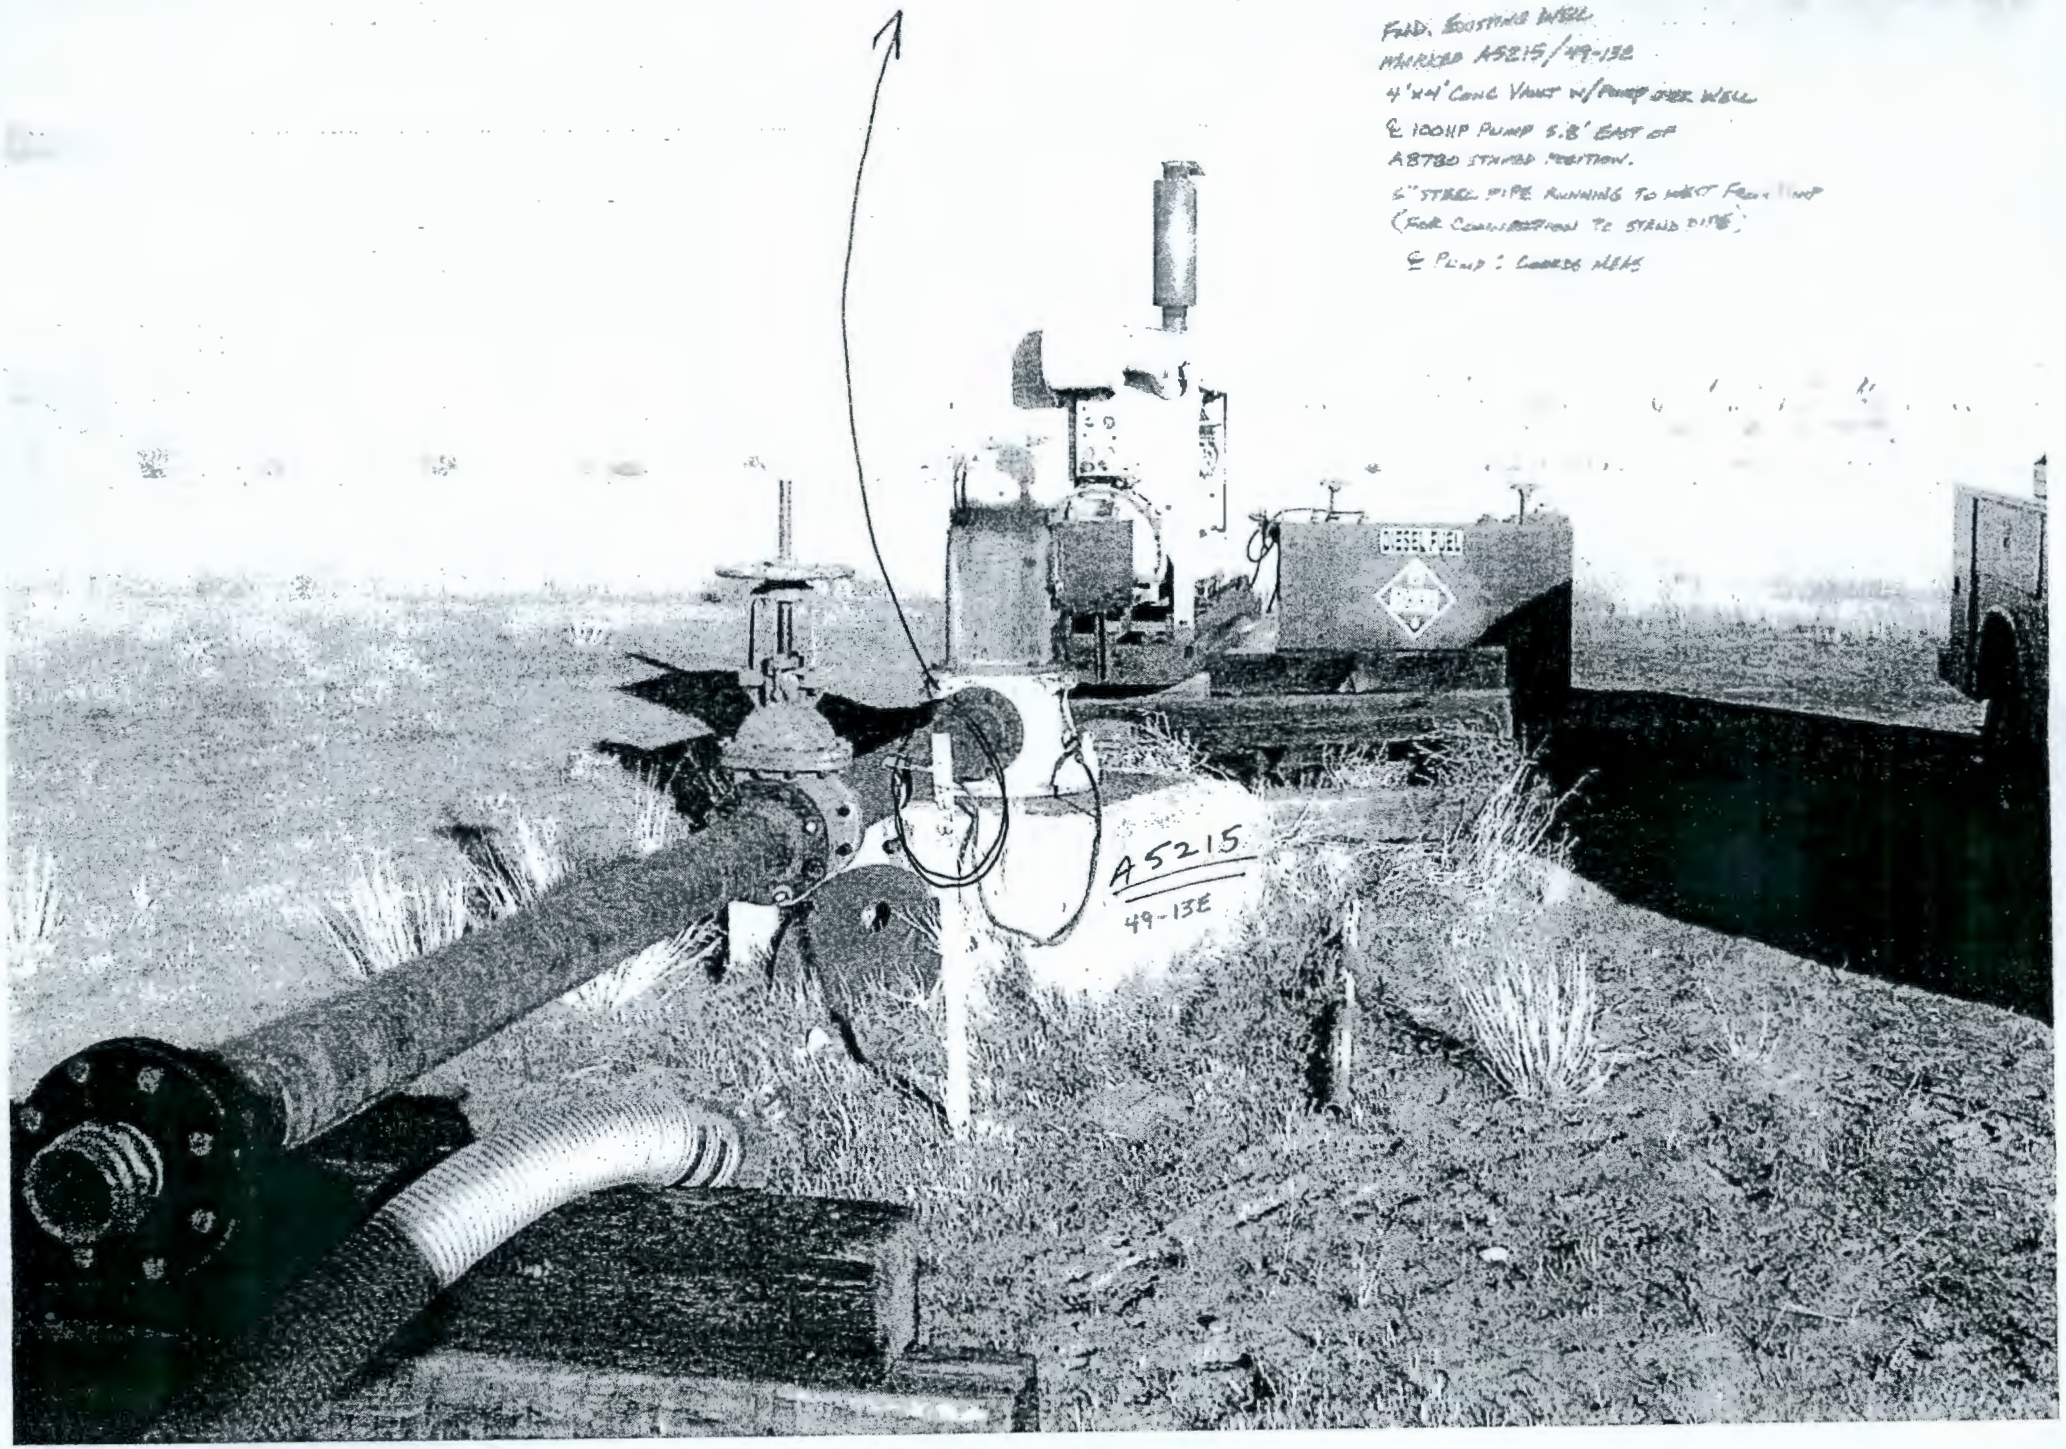
A8780 699-49-7C

Well ID	Coordinates Given	Description
A8780	N138385.50 E586041.30	No well found. Took photo. Found Exist Well Marked A5215 / 49-13E 4 ft sq. conc. vault w/pump over well. C/L 100 hp pump is 5.8ft east of A8780 staked position. 6" stl pipe runs to west from pump. Located @ N 138386.45, E 586042.79

699-49-7C (A8780) LOCATE 2" CAN COMPLETED, WELL DECOMMISSIONED 1-1-87
